Grenfell Tower – fire safety investigation:
The fire protection measures in place on the night of the fire, and conclusions as to:
the extent to which they failed to control the spread of fire and smoke;
the extent to which they contributed to the speed at which the fire spread.

**Phase 1 Report – Master file
incorporating Section 1, 2,3 and 4
&
Summary, Conclusions and Next Steps**

Dr Barbara Lane FREng CEng

12th April 2018

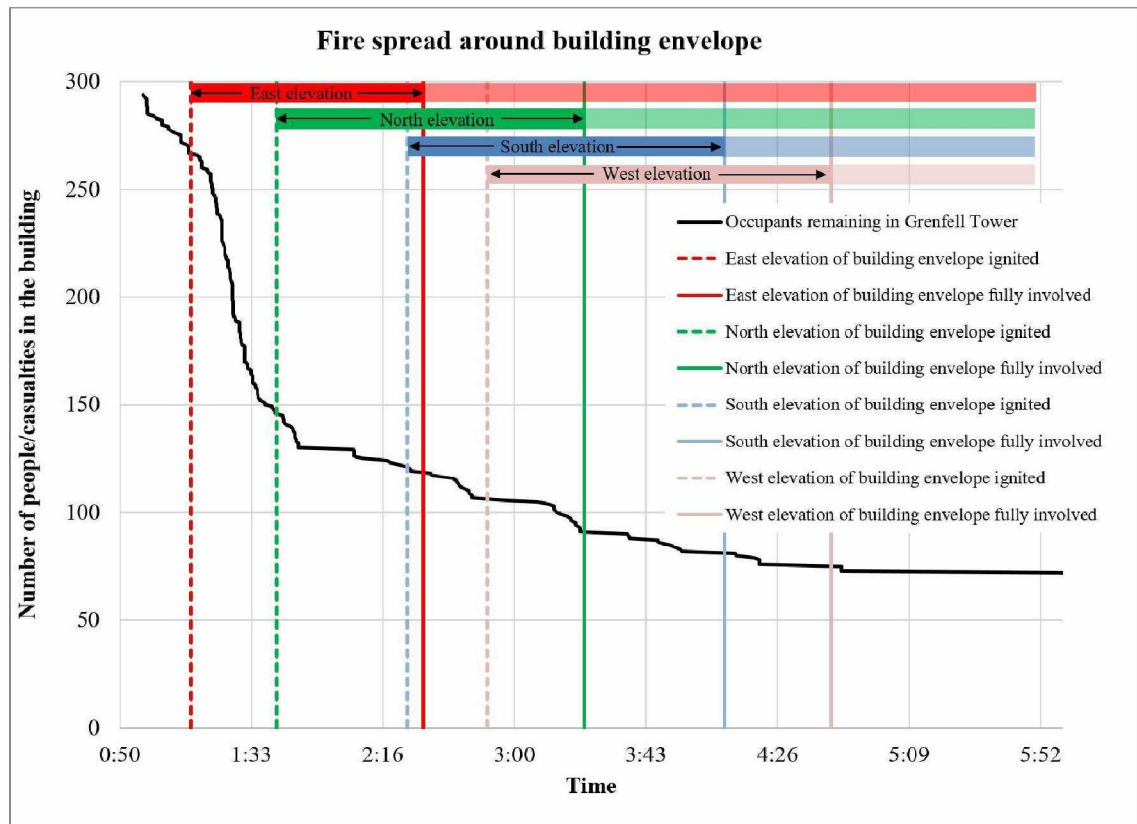
Figure B: Fire spread around the building envelope, and the number of occupants remaining in the Tower, presented as they change with time

- 2.11.18** By 04:03, the two flame fronts appear to effectively converge on Level 22 and Level 23, near the Southeast corner of the building.

- 2.11.19** I have analysed photographs taken by others, outside Grenfell Tower during the fire, to calculate which flats were affected by the external flame fronts I have described above.

- 2.11.20** Within minutes of the fire spreading to the external building envelope outside Flat 16, it spread across multiple levels on the exterior East elevation - all the flats directly above Flat 16. The affected flats were then at high risk of internal fires.

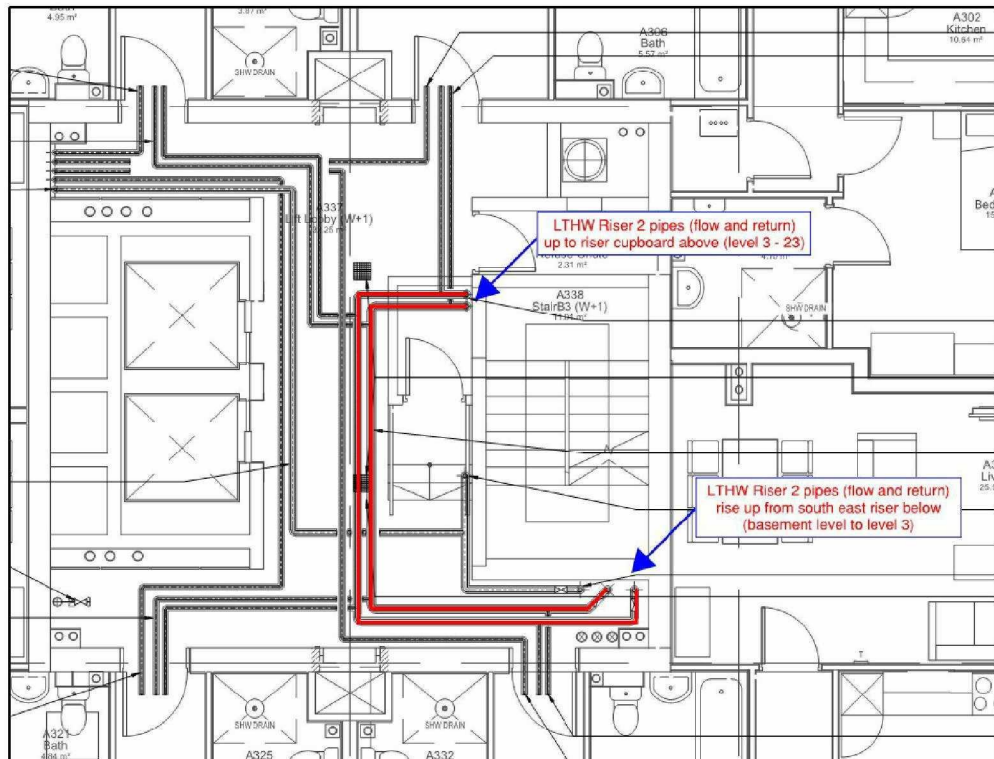
Figure 4.21: Lateral LTHW lateral piping through level 3 common lobby (RYD00000577)

- 4.7.50 The pipes appear to have been fire stopped at each floor level. The service riser does not appear to form a protected shaft. The new riser cupboard is not shown on the fire strategy drawings by Studio E (SEA00003112). The new cupboards are not described in the Exova fire strategy report (EXO00000582).

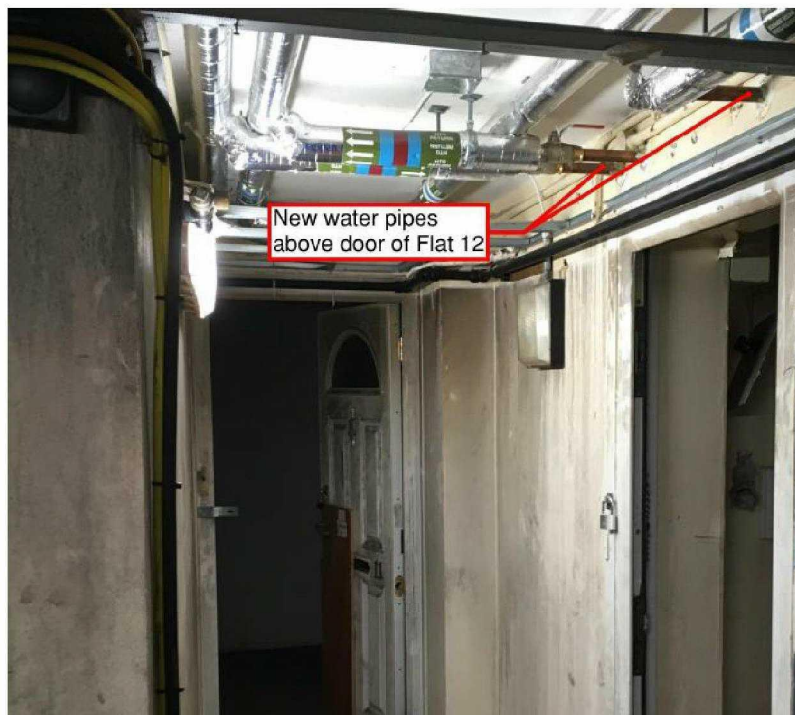
Figure 4.23: New pipework fitted in ceiling of Level 4 common lobby

- 4.7.53 These changes are reflected in the Studio E As-Built drawings as indicated in this section.
- 4.7.54 The pipe distribution works in the lobby were then concealed above a new suspended plasterboard ceiling, described in Section 4.7.140.
- 4.7.55 Based on the Studio E Grenfell Tower Regeneration Project Room Data Sheets, Employer Requirements, dated 20-11-2013, holes were core drilled through the concrete wall above each flat front door for new water and heating pipes to each flat on every level (SEA00002540). This means that 18 holes were drilled on each floor, and 360 holes over all levels. Please see Figure 4.23 for an example of this distribution taken during my post fire inspection of the building.

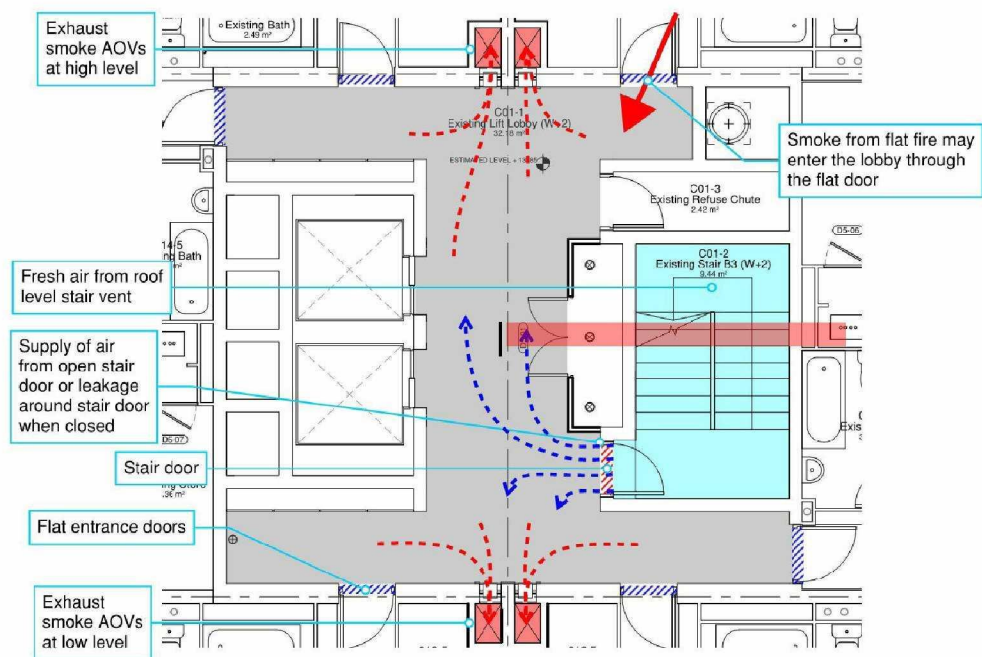
Figure 4.29: Operation of the refurbished smoke ventilation system on the fire floor.
SEA00010474

- 4.7.120 The operation of the smoke ventilation system on the fire floor is shown schematically in Figure 4.29.

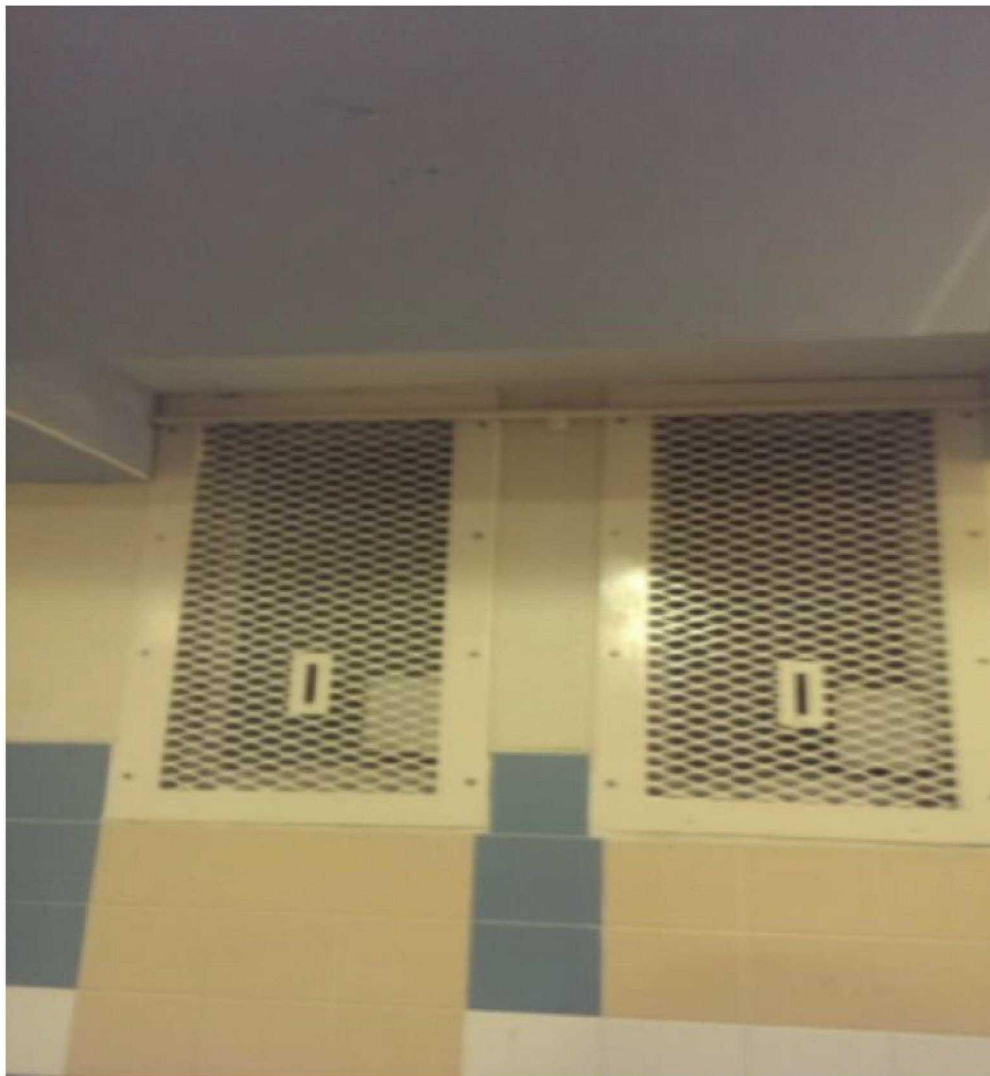
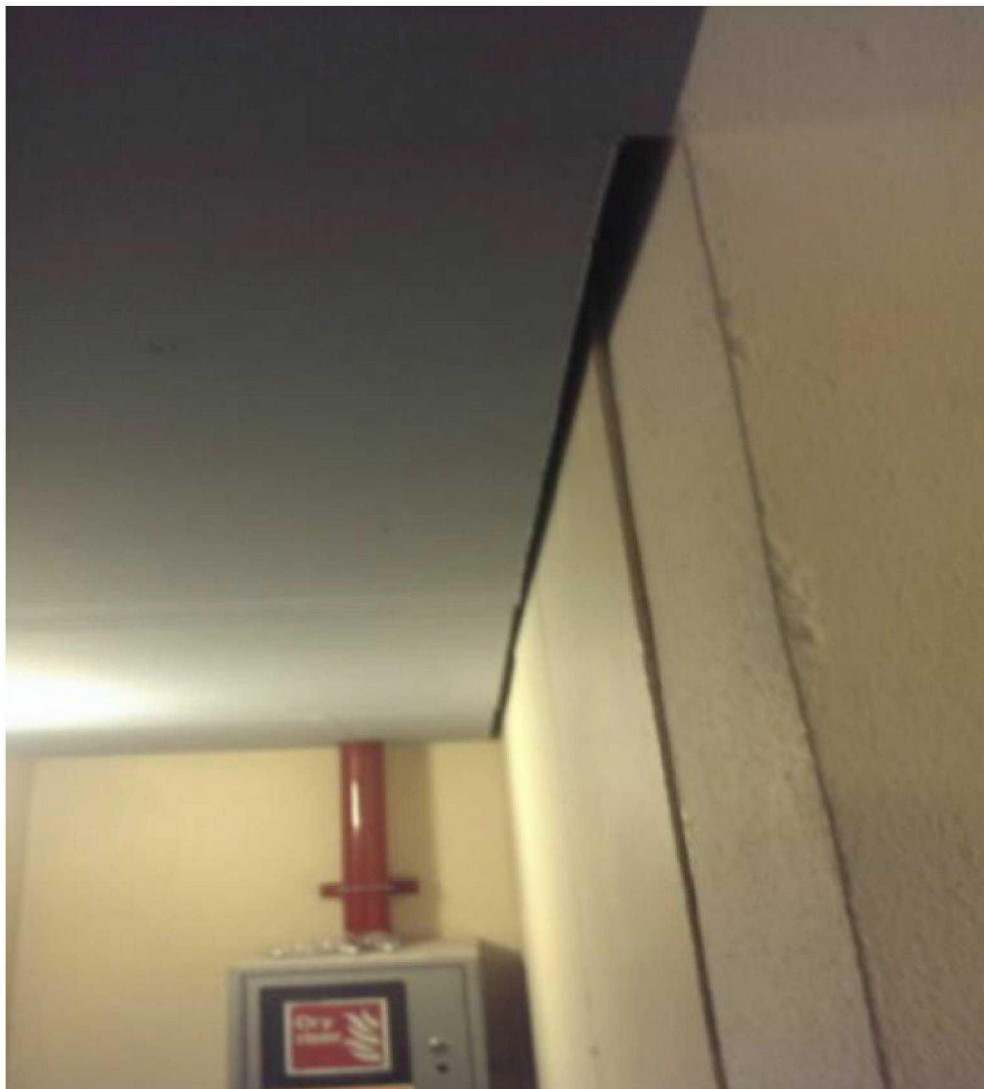
Figure 4.36: New ceiling around vents on Level 14 (CST00000170)

- 4.7.143** Pre-fire photographs of the Level 14 new ceiling installations are shown in Figure 4.36 and Figure 4.37.
- 4.7.144** Carl Stokes’ correspondence indicates that he believed that the ceiling and new cupboards were of fire resisting construction. There is no evidence in the refurbishment design information reviewed to date to support this.
- 4.7.145** During my site inspections I did observe the new ceiling cupboard enclosure. The ceiling construction was mounted on metal stud framing and not timber as stated by Mr Stokes. Please refer to Appendix C and Section 14.
