**Grenfell Tower – fire safety investigation:
The fire protection measures in place on the night of the fire, and conclusions as to:**

**The extent to which they failed to control the spread of fire and smoke;
The extent to which they contributed to the speed at which the fire spread.**

Phase 1 Report – Section 9

Dr Barbara Lane FREng FRSE CEng

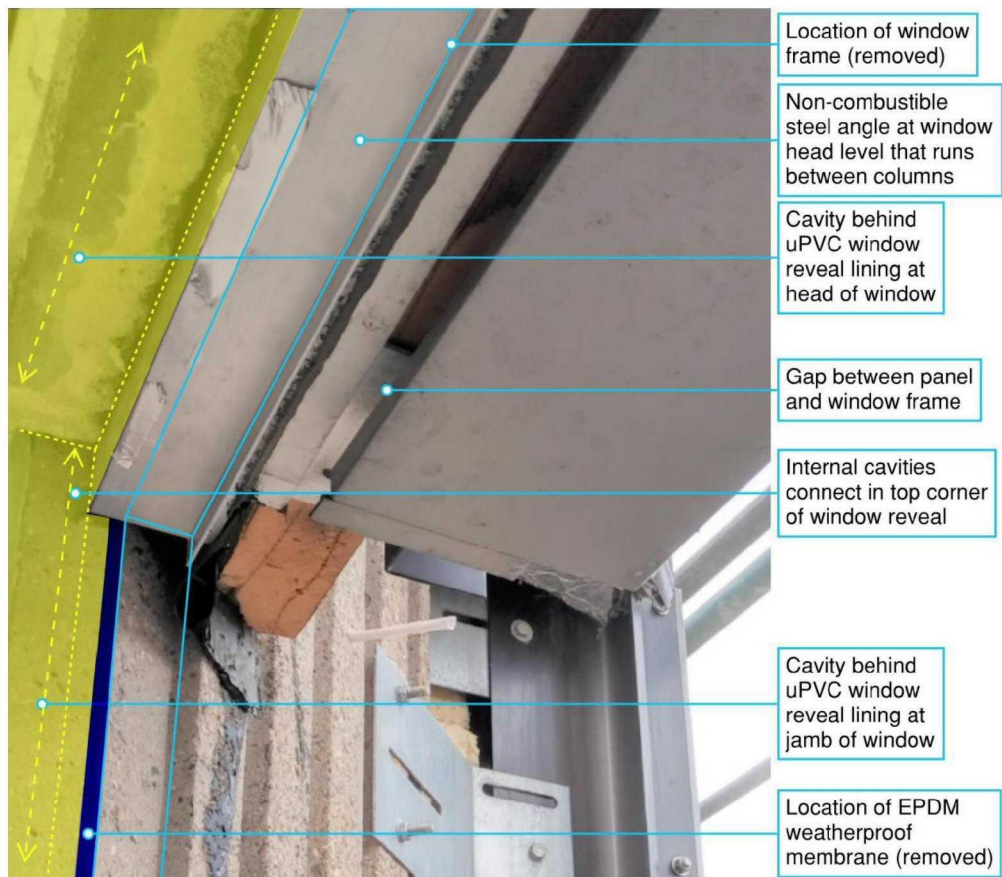
9.2.3 Vertical cavity between window jamb and concrete columns, underneath the uPVC reveal lining (Figure 9.1);

Figure 9.1: Cavities underneath window reveal linings at head and jamb of window and that they are connected.

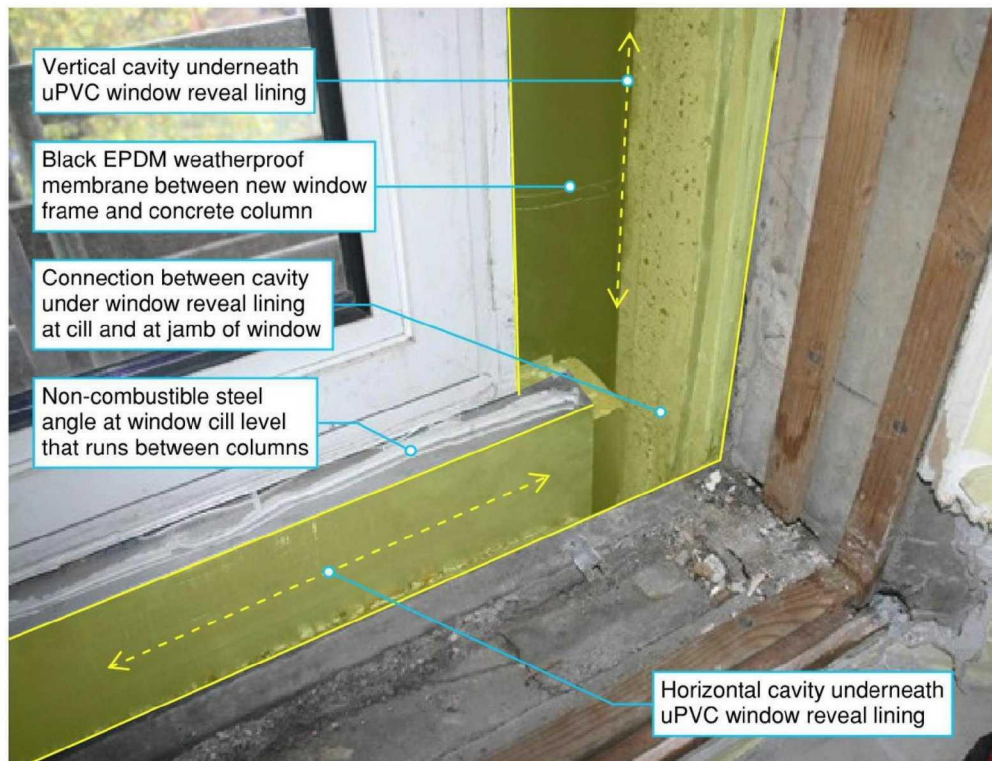
Figure 9.2: window reveals after uPVC linings removed showing cill and jamb next to column (Flat 13, Level 4)

9.2.5 Figure 9.2 shows the cavities behind the uPVC window reveal linings at the jamb and cill of the windows, highlighted in yellow. These cavities were formed by the movement of the new windows out away from the building relative to their original position, and were also partially filled with 25mm combustible insulation, glued to the underside of the uPVC window reveal linings. Note that they are connected where they meet in the bottom corner.

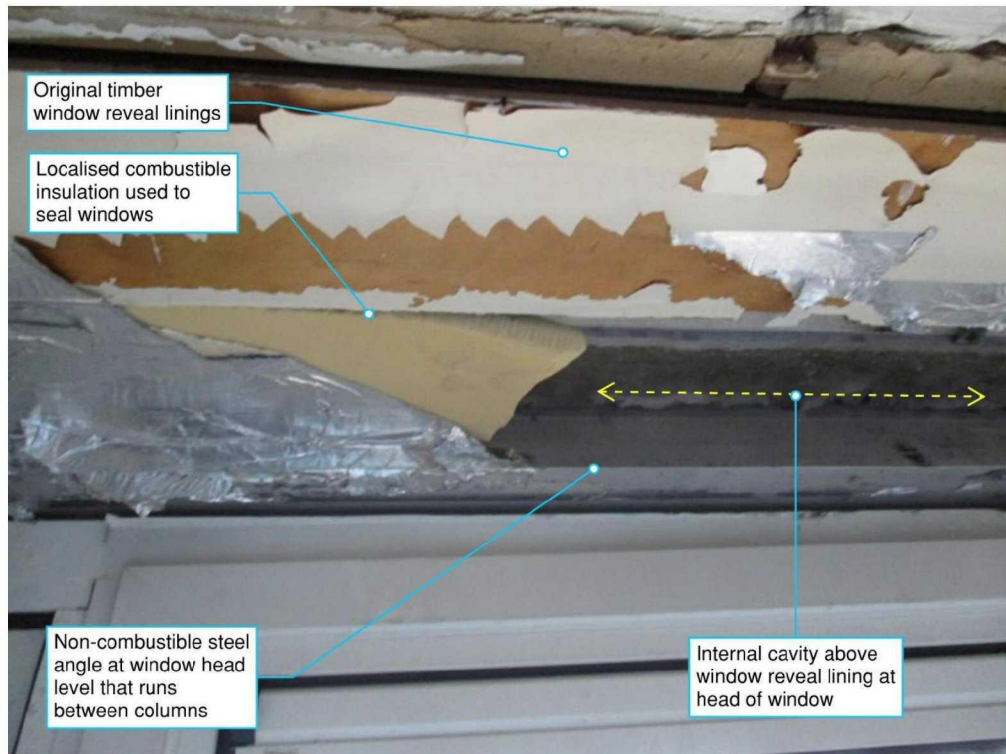
Figure 9.3: materials and cavities under uPVC window reveal lining at head of window

9.2.7 Figure 9.3 shows the cavity at the head of the window behind the uPVC window reveal lining which has been removed. It also shows how localised combustible insulation was placed within this internal cavity.

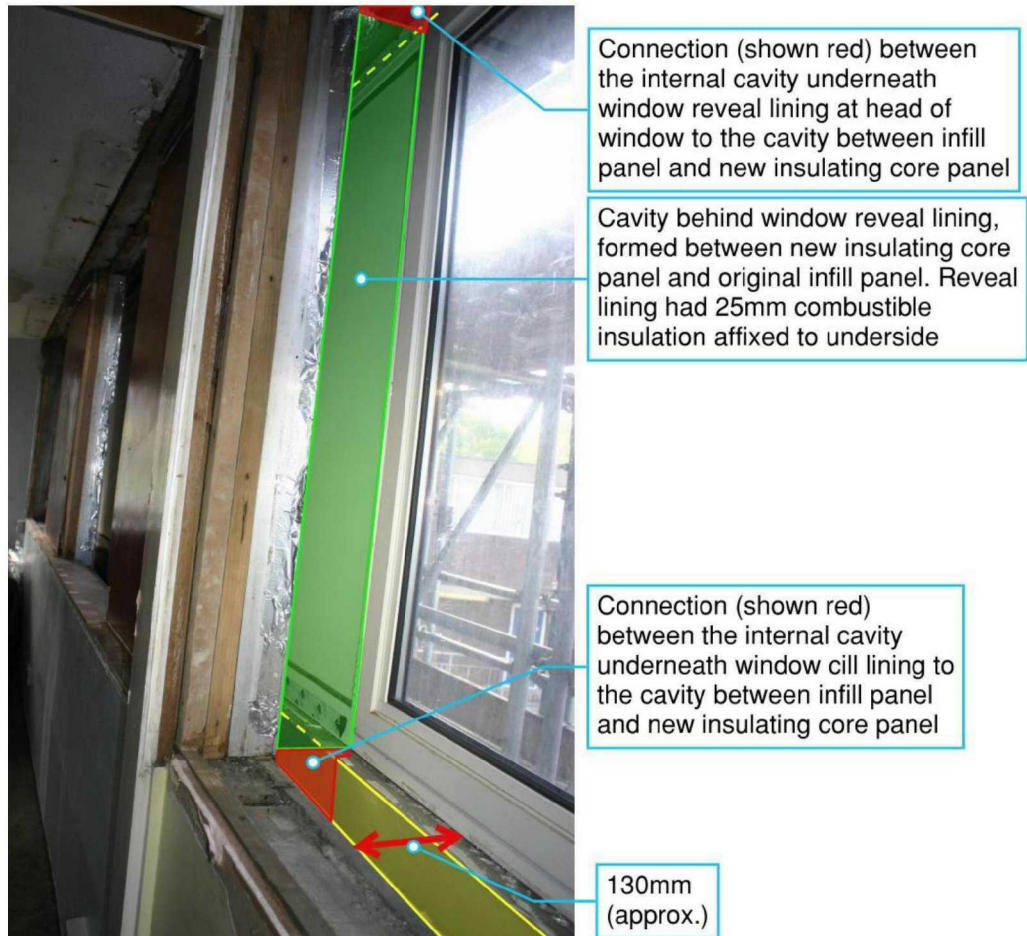
Figure 9.4: cavity and materials under uPVC window reveal lining at infill panel side jamb of window

9.2.9 Figure 9.4 shows that, at the side opposite the column, a large cavity is formed by the space between the original infill panel between the windows and the new insulating core panel which was installed (shaded green, Flat 13). There is a connection with the internal cavities under window reveal linings at both the head and cill of the windows outlined in Figure 9.2 and Figure 9.3, which is shaded in red.

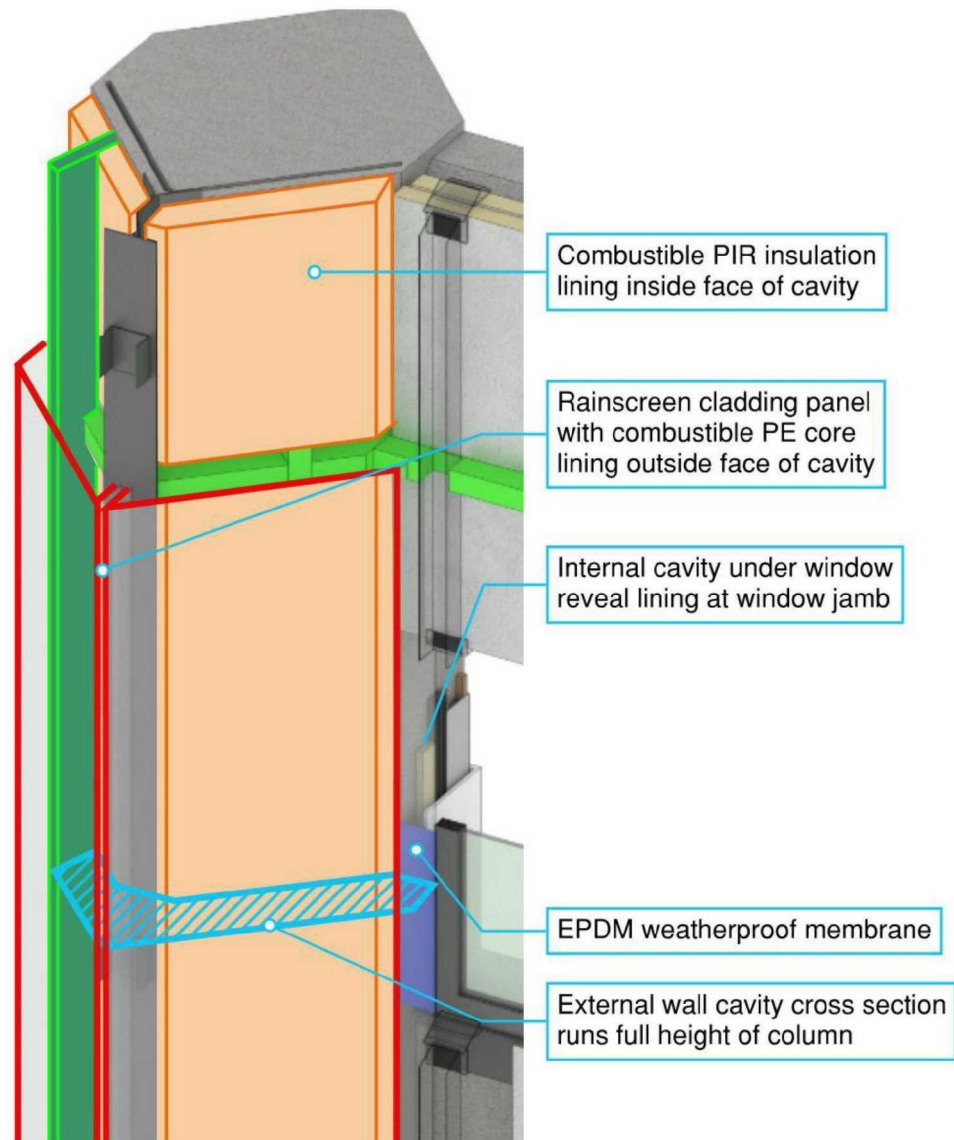
Figure 9.5: 3D render of the external wall construction

9.2.11 The relationship of that external wall cavity to the internal cavity at the jamb is also shown. It is clear in Figure 9.5 that the EPDM weatherproof membrane is the only thing separating these two spaces.

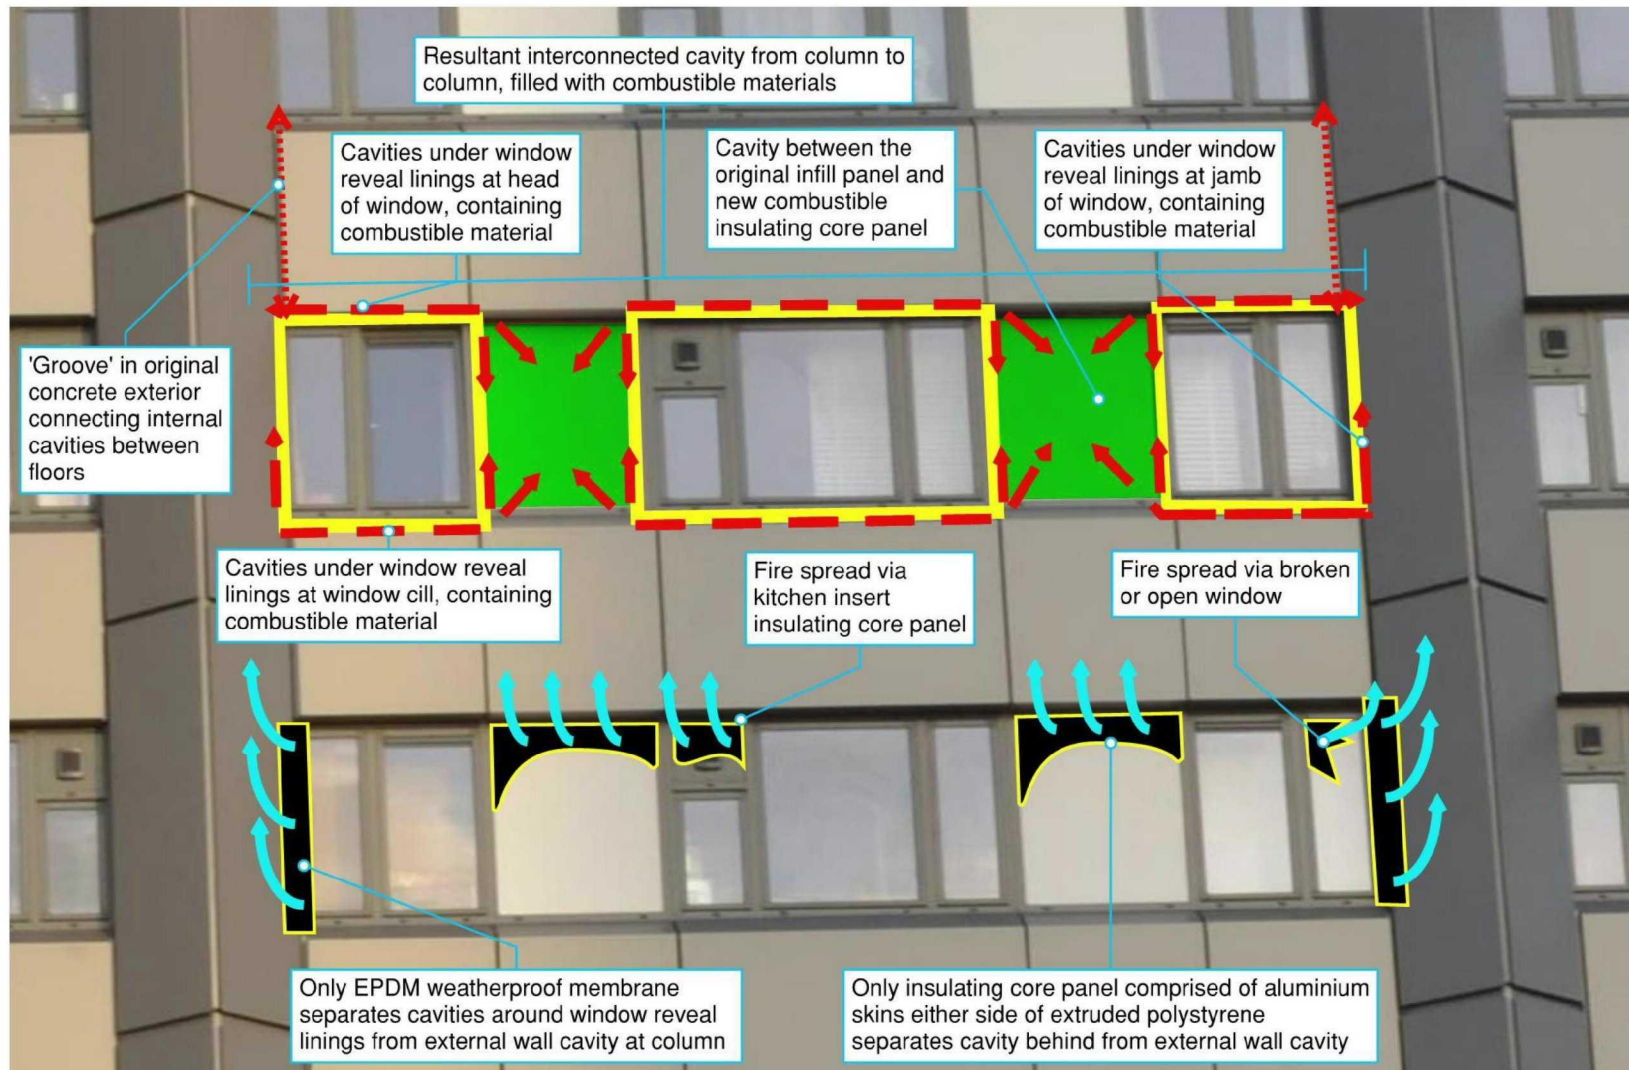
9.2.16 Therefore, this combination of interconnected cavities behind the uPVC window reveal linings formed a network that spanned the full width between each column. This is represented on the exterior of the building in Figure 9.7.

Figure 9.7: Resultant network of cavities superimposed on exterior of building, and routes into external wall cavity (SEA00000350)

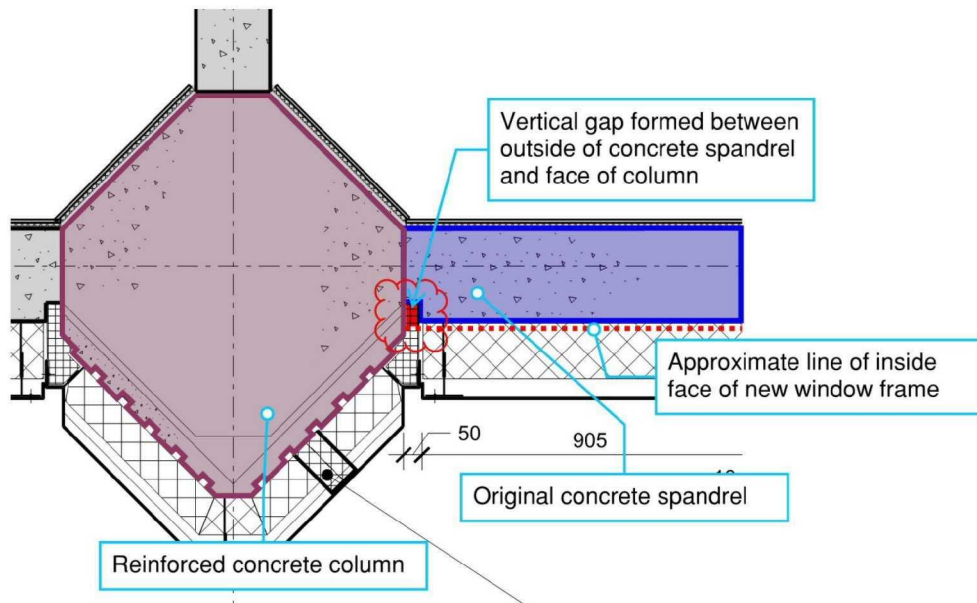
Figure 9.8: Marked up diagram showing gap formed by original concrete exterior of the building marked in red (horizontal section based on SEA00013045)

9.2.21 The Studio E drawing (SEA00013045) identifies that the gap between the column and spandrel should be filled with insulation.

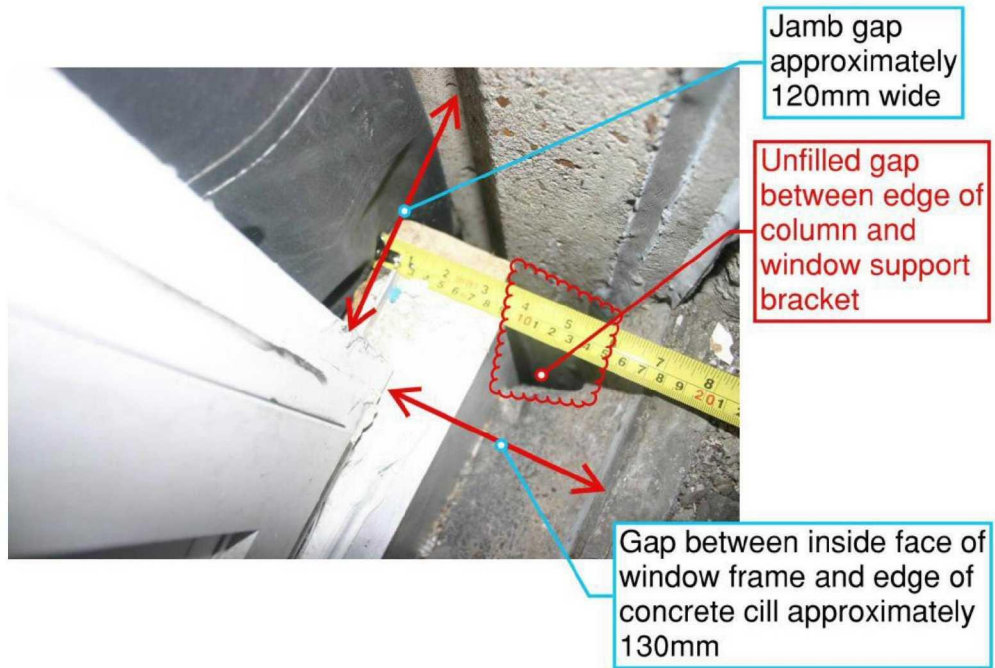
9.2.22 I found evidence of this vertical gap or groove on site as I have presented in Figure 9.9 and Figure 9.10. This groove is formed by the original concrete exterior of the building, which after the refurbishment works, was situated on the interior side of the EDPM weatherproof membrane (see Figure 9.9).

9.2.23 This gap travels the length of each floor between windows and was observed both filled (Figure 9.10) with combustible expanding foam and also unfilled (Figure 9.9).

Figure 9.9: Unfilled gaps in the internal window construction – cill level (Flat 13)

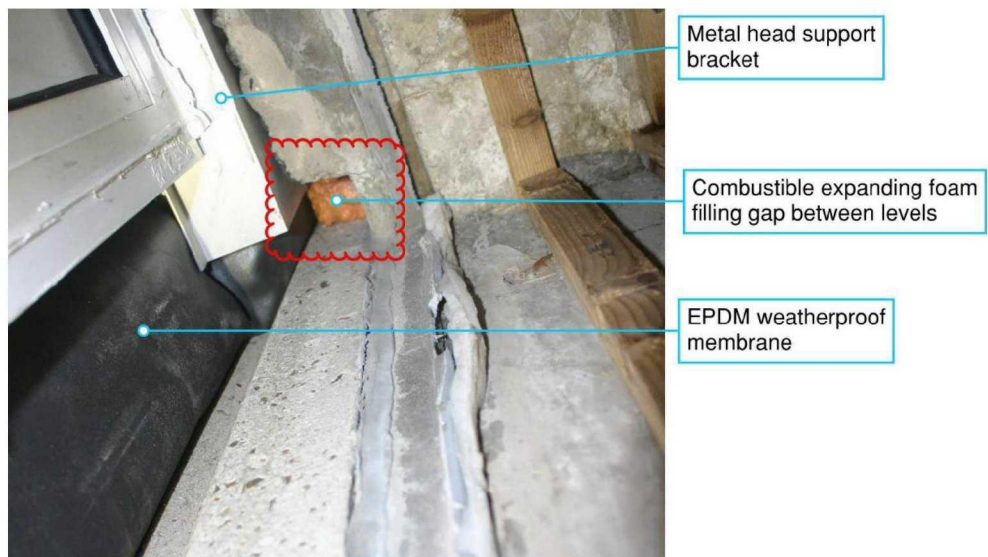
- 9.2.24 Where filled, a combustible expanding polyurethane foam product (HAR00001323) appears to have been used, and from below only.
- 9.2.25 This gap also bypasses the floor slab compartment line (and it is repeated beside each column and on each floor).
- 9.2.26 This gap was not fire rated and represents a potential path of internal fire spread vertically between flats, without breaking the EPDM weatherproof membrane.

Figure 9.10: Gap filled with expanding foam in the internal window construction – Looking up at window head (Flat 13)

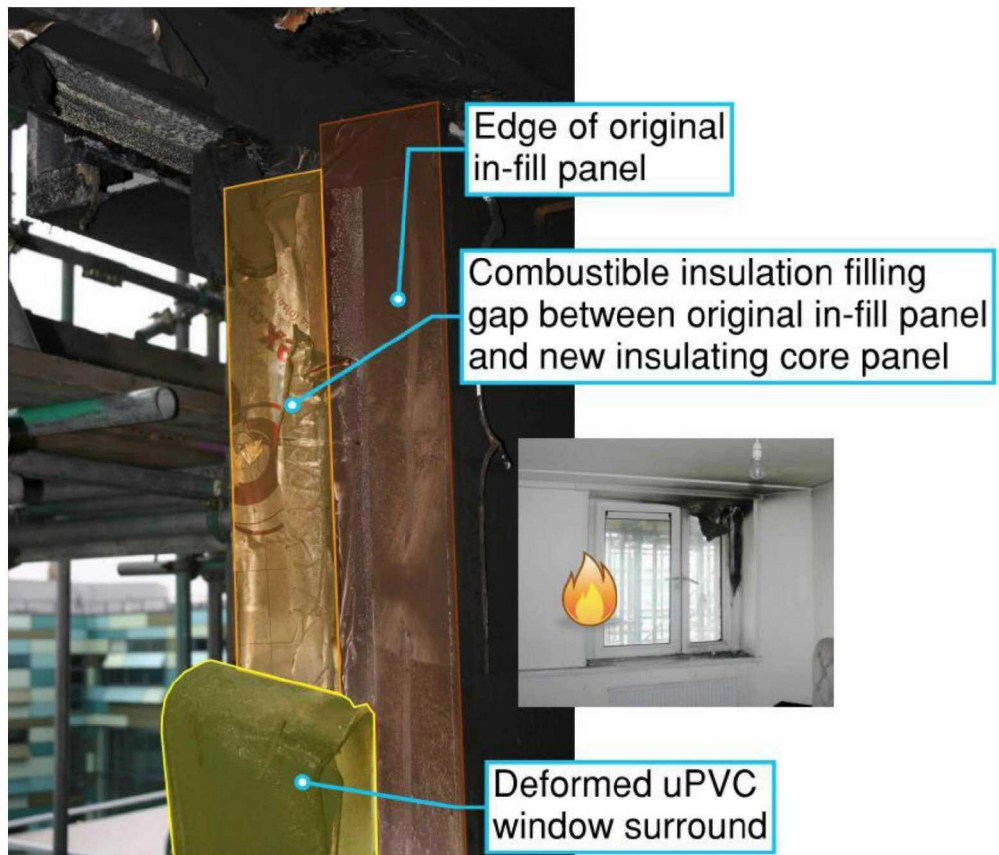
I have also included in Figure 9.13 an example of a heat affected vertical window lining beside the new insulating core panels which I observed onsite. In this photograph the uPVC window lining has softened and deformed to reveal the 25mm combustible insulation behind.

Figure 9.13: Fire on the infill panel side of the window (Flat 16 living room window) with example location inset

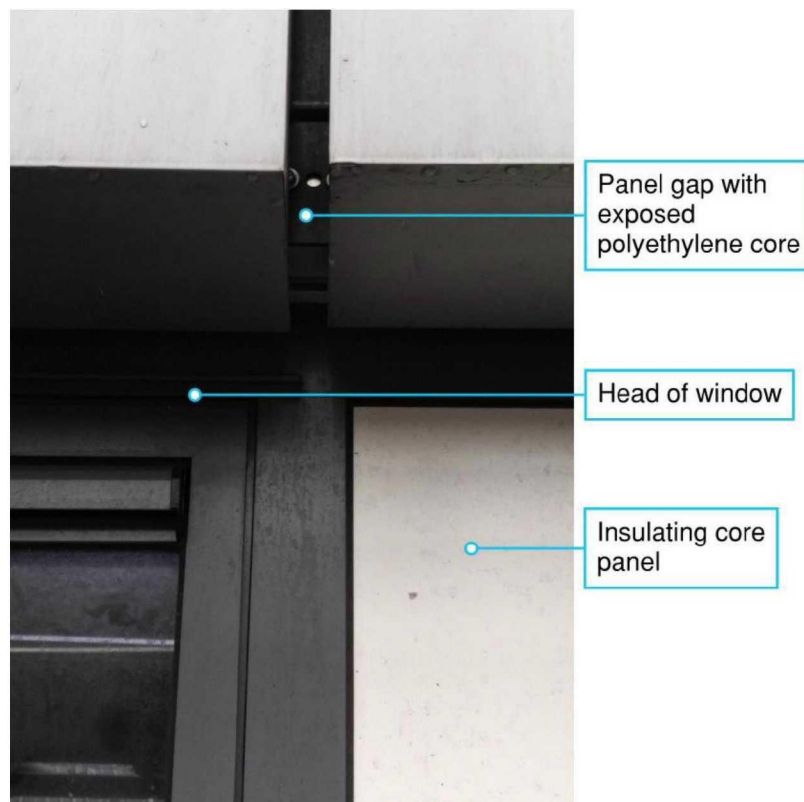
Once flames from the fire are able to penetrate the window by any one of the three scenarios described above, the heat and smoke from the fire could impinge directly on the ACP overlapping on the vertical column and also on the ACP overlapping located above and below the window. Flames can enter both the horizontal and vertical rainscreen cavities through ventilation gaps between the aluminium composite rainscreen panels (Figure 9.22) and also cause ignition of the exposed PE core, shown in Figure 9.19.

Figure 9.19: External wall photograph showing proximity of panel gaps to window and insulating core panel

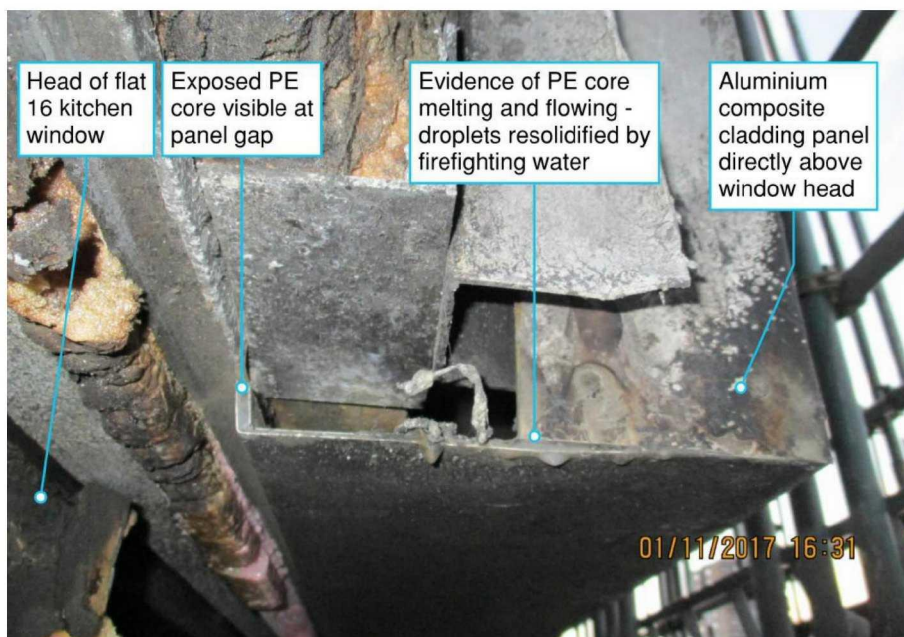
9.3.33 The polyethylene core was exposed along the sides of the panels in this location, as indicated by Figure 9.20. My onsite observations confirm it was exposed and also that it had melted, as shown in Figure 9.21:

Figure 9.21: Photograph of cladding panel directly above flat 16 kitchen window

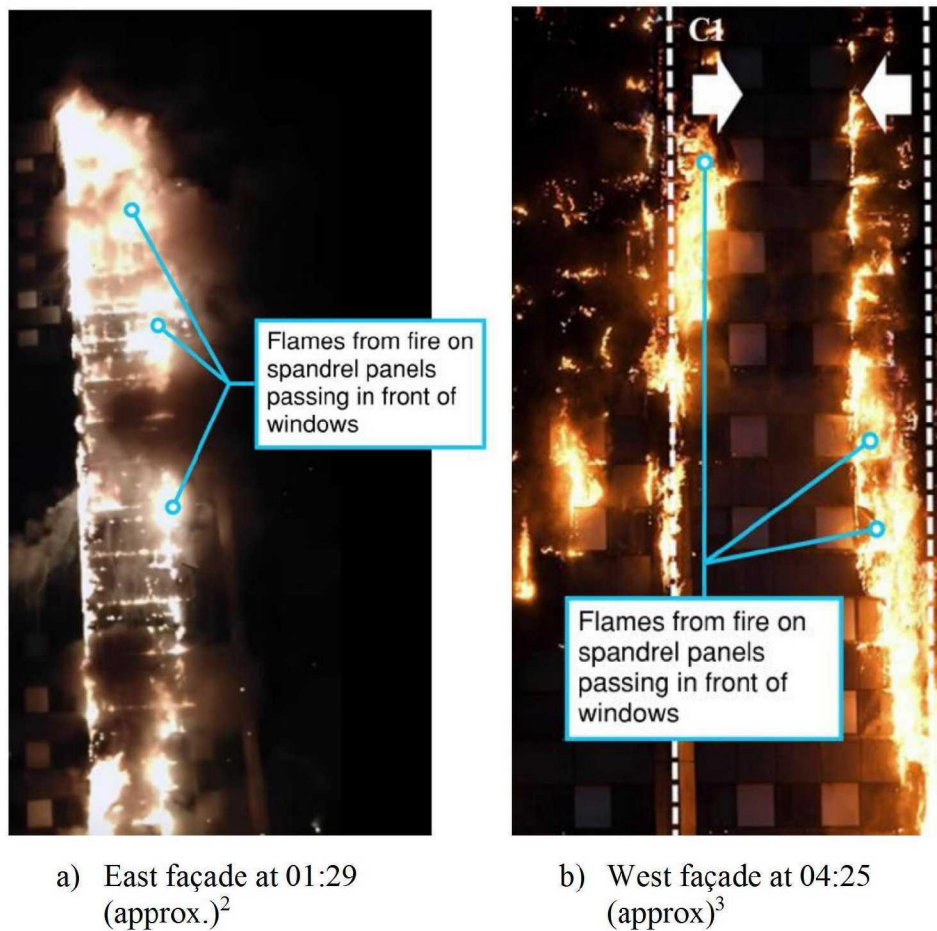
9.4.11 Figure 9.24 presents evidence from the fire on the 14th June 2017 and shows that flames coming from burning spandrel panels were able to engulf some or all of the windows directly above.

Figure 9.24: Evidence of fires from spandrels causing flame fronts in front of windows

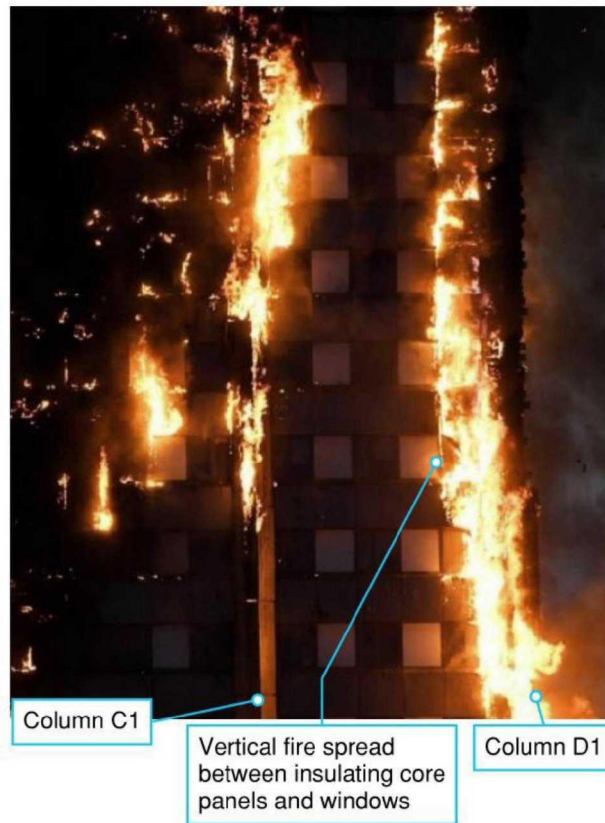
Figure 9.26: Photo evidence of vertical fire spread at the junction between the insulating core panels and windows⁵

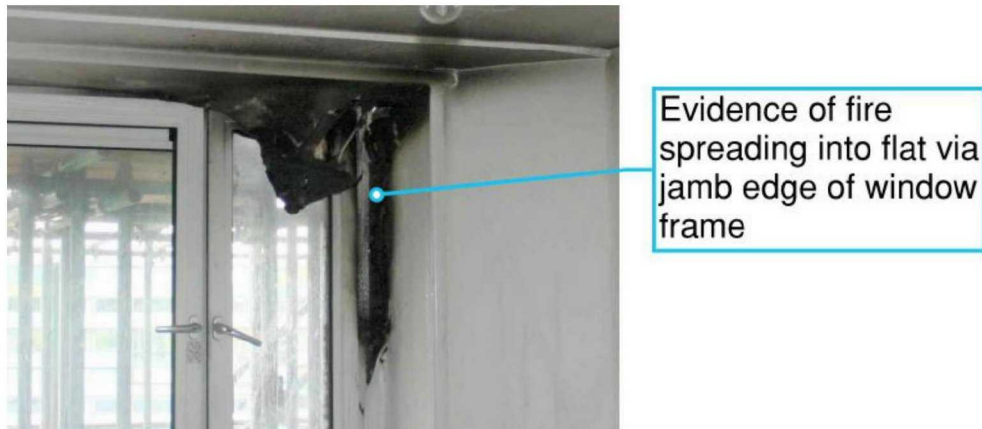
9.5.2 In my inspection of Flat 15 on Level 4 (Figure 9.28), I observed that there was a window exhibiting evidence of fire spread from outside the building to the inside, shown in Figure 9.29. The evidence of fire spread showed that the entry route for the fire was in the top corner of the window, adjacent to the column, consistent with the mechanism of fire spread presented in Section 9.4. That is a fire being able to penetrate from outside the building, into the cavity behind the new uPVC reveal linings via the EPDM weatherproof membrane (route B).

Figure 9.29: Fire spreading into flat from outside (Flat 15 bedroom)

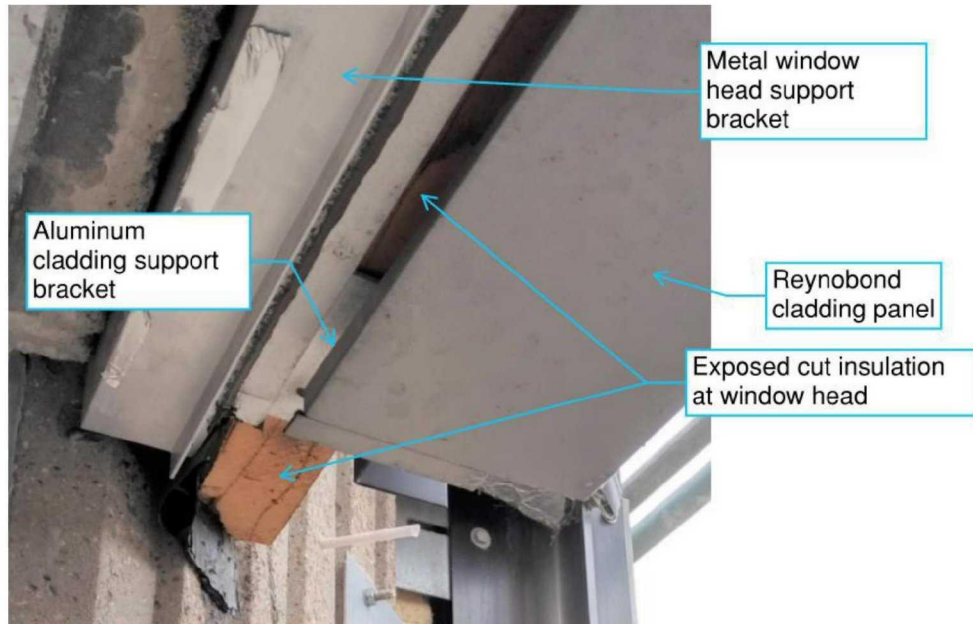
Figure 9.39: Evidence of cut insulation edge above window head

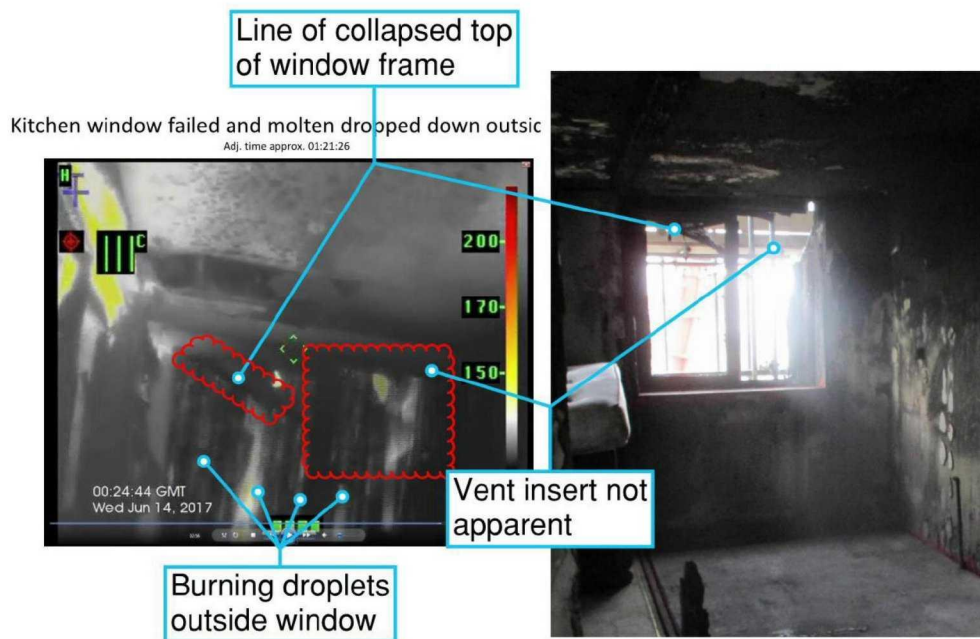
9.5.20 Figure 9.40 includes a still taken from LFB thermal imaging camera of the first fire fighter to enter the kitchen of Flat 16 on the 14th June 2017 timestamped 01:21. The right hand side of this image shows a view out of the kitchen window. Burning droplets are apparent, falling outside the window. Furthermore, the kitchen vent insulating core panel does not appear to be visible, indicating that it had already been affected by fire and fallen away (as discussed in route E).

9.5.21 The site photograph included in Figure 9.40, taken in Flat 16 on the 8th November 2017, corroborates this evidence by indicating that the worst damage to the kitchen window in Flat 16 was in the top corner where the vent insert was originally positioned. Please refer to Figure 9.38 showing the original window configuration with the vent insert in the top right corner.

Figure 9.40: Evidence of loss of vent insert (MET00006109), compared with post-fire photograph of Flat 16 kitchen window
