**Grenfell Tower – fire safety investigation:
The fire protection measures in place on the night of the fire, and conclusions as to:**

Phase 1 Report – Section 9

Routes for fire spread out through the window openings

24th October 2018

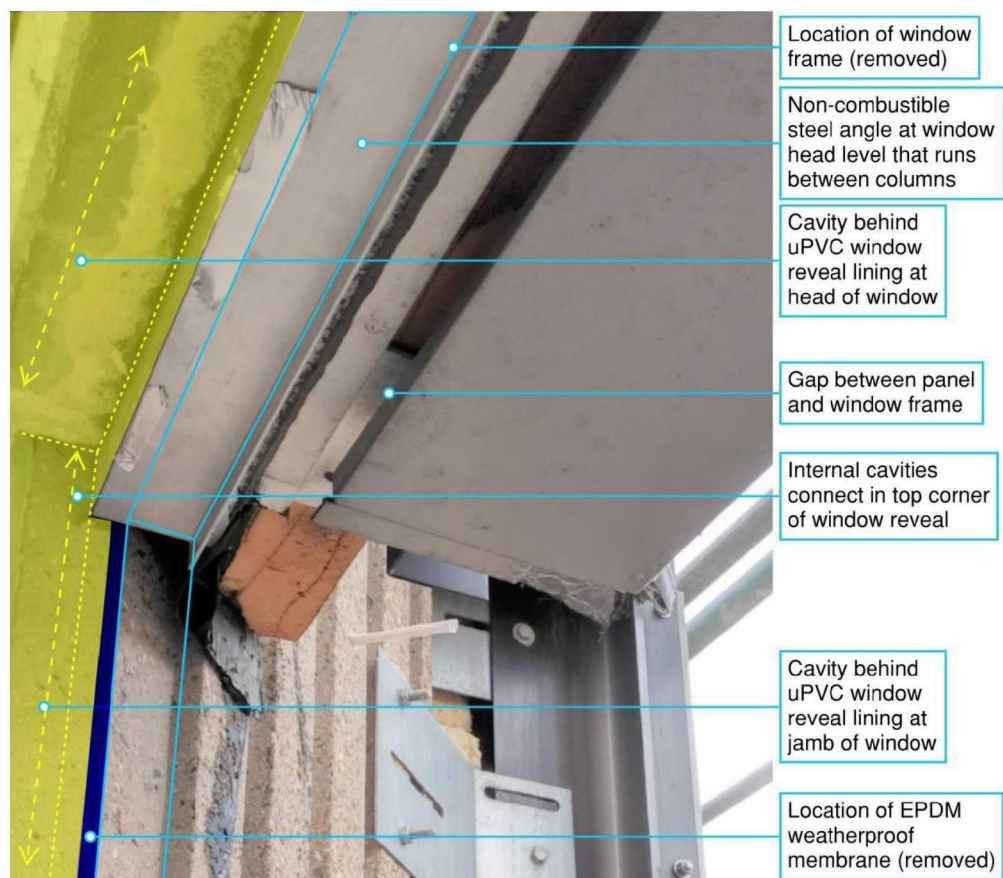
9.2.3 Vertical cavity between window jamb and concrete columns, underneath the uPVC reveal lining (Figure 9.1);

Figure 9.1: Cavities underneath window reveal linings at head and jamb of window and that they are connected.

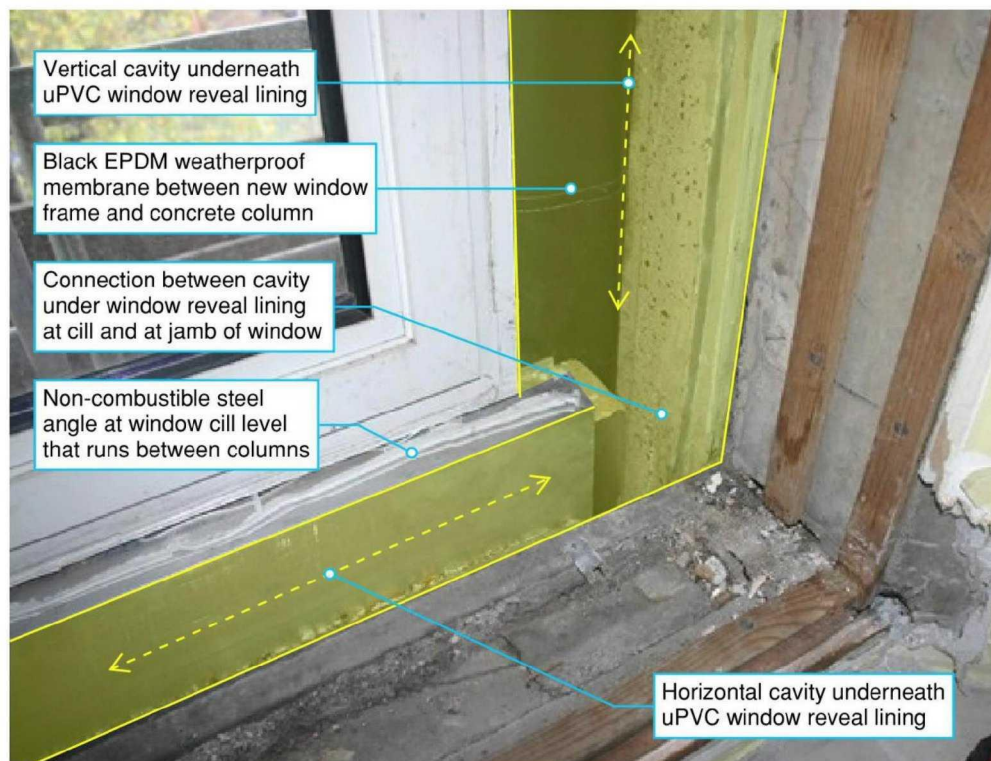
Figure 9.2: window reveals after uPVC linings removed showing cill and jamb next to column (Flat 13, Level 4)

9.2.5 Figure 9.2 shows the cavities behind the uPVC window reveal linings at the jamb and cill of the windows, highlighted in yellow. These cavities were formed by the movement of the new windows out away from the building relative to their original position, and were also partially filled with 25mm combustible insulation, glued to the underside of the uPVC window reveal linings. Note that they are connected where they meet in the bottom corner.

9.2.14 The cavities around the window also contained remnants of the original wooden window reveal linings and supporting timber battens. These items were left in place during the refurbishment works, with the new uPVC reveal linings being glued to the outside of the timber reveal linings. The original timber reveal linings are a further set of combustible materials behind the uPVC reveal linings (visible in Figure 9.2).

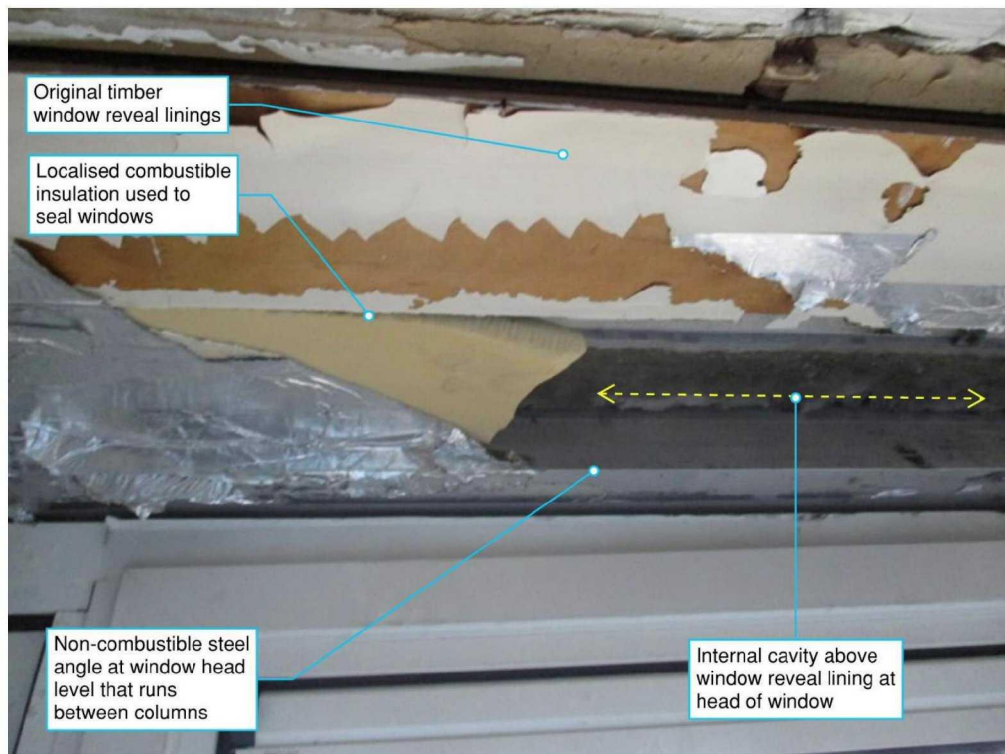
Figure 9.3: materials and cavities under uPVC window reveal lining at head of window

9.2.7 Figure 9.3 shows the cavity at the head of the window behind the uPVC window reveal lining which has been removed. It also shows how localised combustible insulation was placed within this internal cavity.

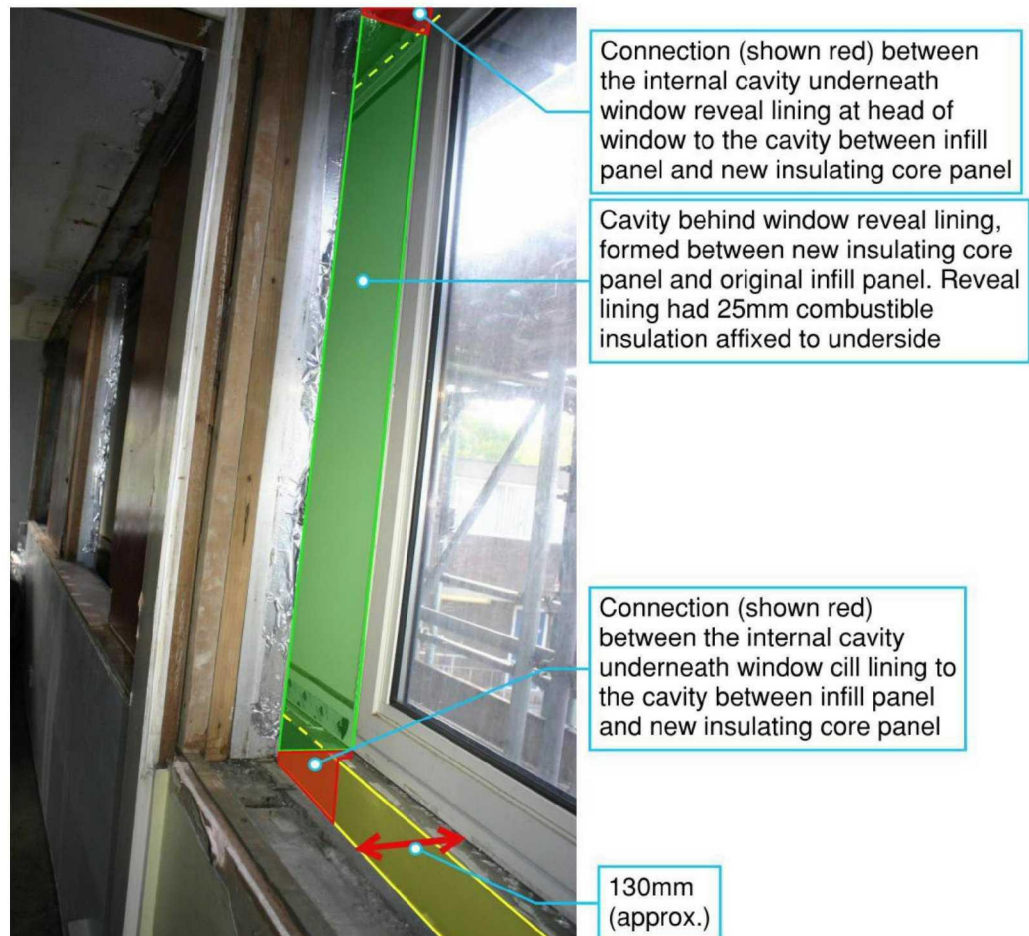
Figure 9.4: cavity and materials under uPVC window reveal lining at infill panel side jamb of window

9.2.9 Figure 9.4 shows that, at the side opposite the column, a large cavity is formed by the space between the original infill panel between the windows and the new insulating core panel which was installed (shaded green, Flat 13). There is a connection with the internal cavities under window reveal linings at both the head and cill of the windows outlined in Figure 9.2 and Figure 9.3, which is shaded in red.

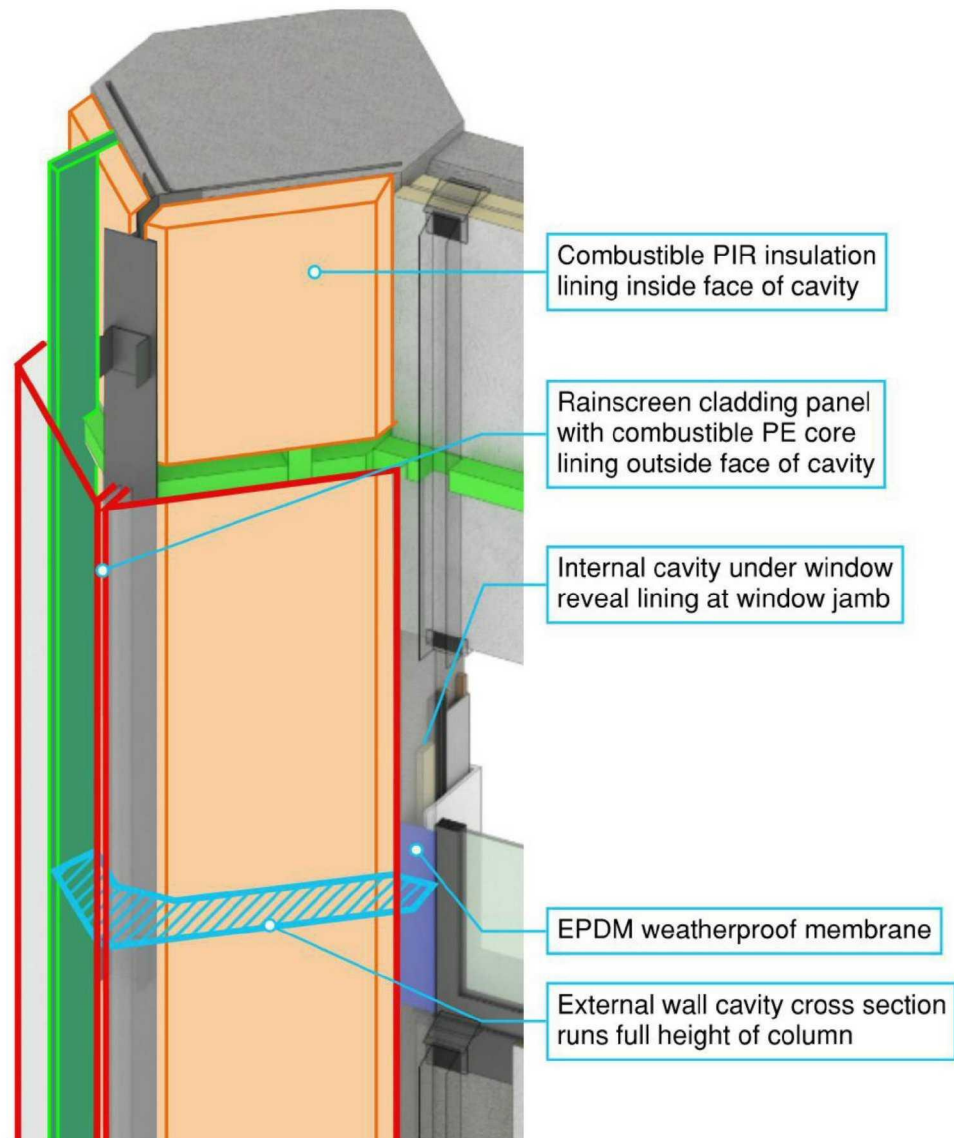
Figure 9.5: 3D render of the external wall construction

- 9.2.11 The relationship of that external wall cavity to the internal cavity at the jamb is also shown. It is clear in Figure 9.5 that the EPDM weatherproof membrane is the only thing separating these two spaces.
- 9.2.12 I have reproduced Figure 8.3 from Section 8 here (Figure 9.6 below) as a reminder of the location of the new window, relative to both the old and new external wall, and this is the reason for the creation of these cavities, in behind the window reveal linings.

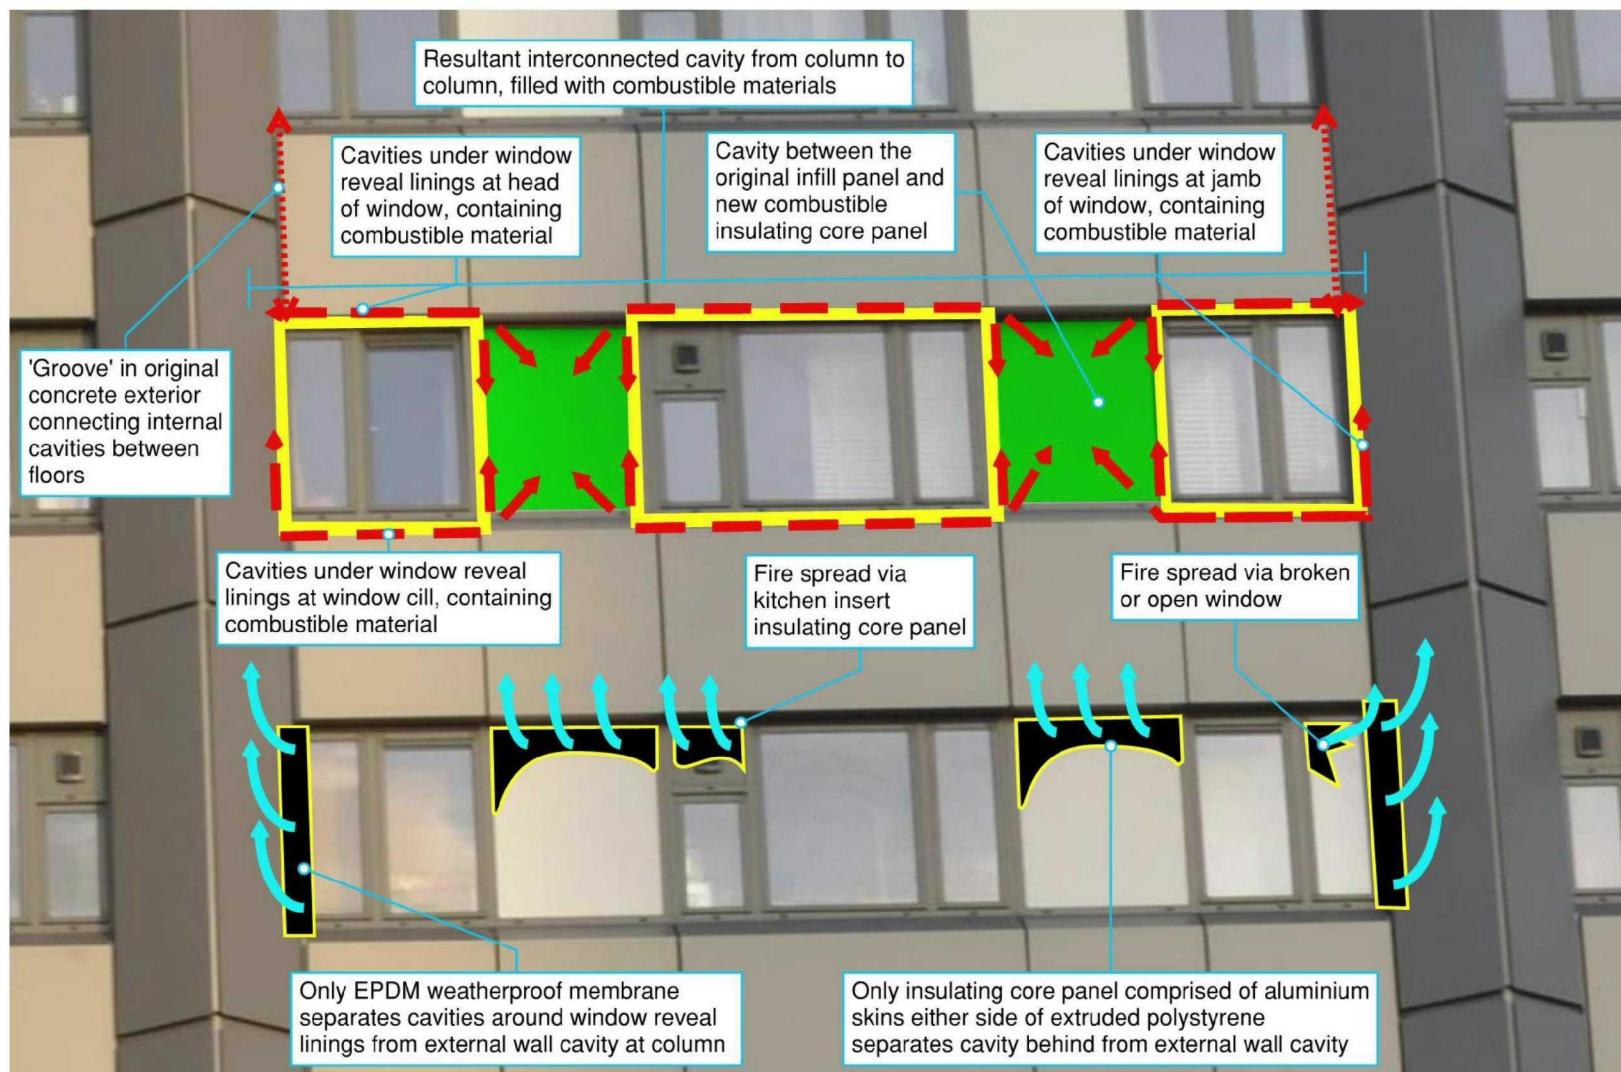
9.2.16 Therefore, this combination of interconnected cavities behind the uPVC window reveal linings formed a network that spanned the full width between each column. This is represented on the exterior of the building in Figure 9.7.

Figure 9.7: Resultant network of cavities superimposed on exterior of building, and routes into external wall cavity (SEA00000350)

- a) yellow lines represent the cavities around the window reveal linings;
- b) green shading represents the cavity formed between the original infill panel and the new insulating core panel.
- c) red dotted arrows therefore demonstrate the connections between the above internal cavities (see 9.2.19 onwards).

9.2.18 The second row of windows with black areas and blue arrows, summarises the routes that a fire within this network of cavities could then take to break into the external wall cavity formed by the rainscreen cladding applied to the building. I will explain all of these routes in section 9.3

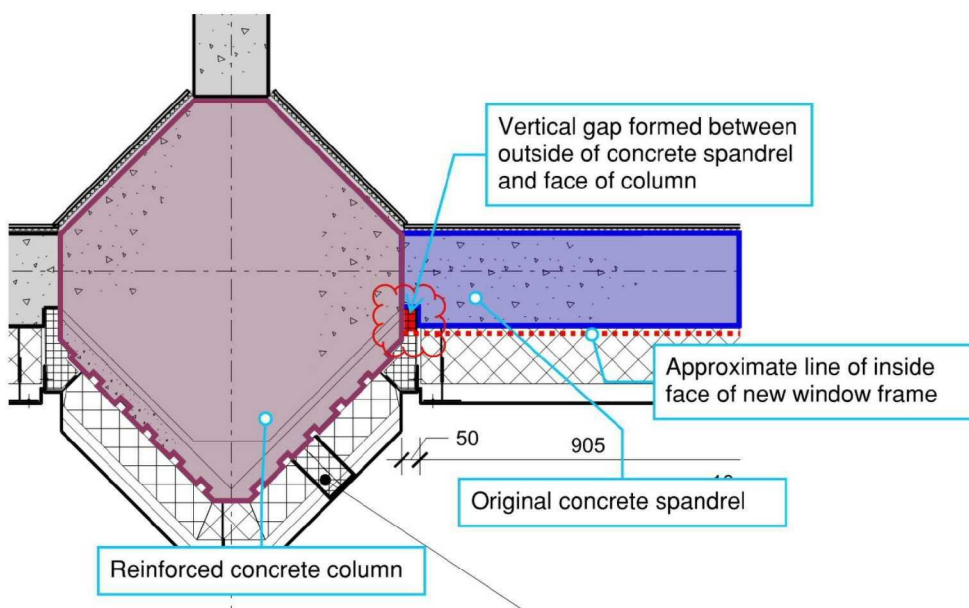
Figure 9.8: Marked up diagram showing gap formed by original concrete exterior of the building marked in red (horizontal section based on SEA00013045)

9.2.21 The Studio E drawing (SEA00013045) identifies that the gap between the column and spandrel should be filled with insulation.

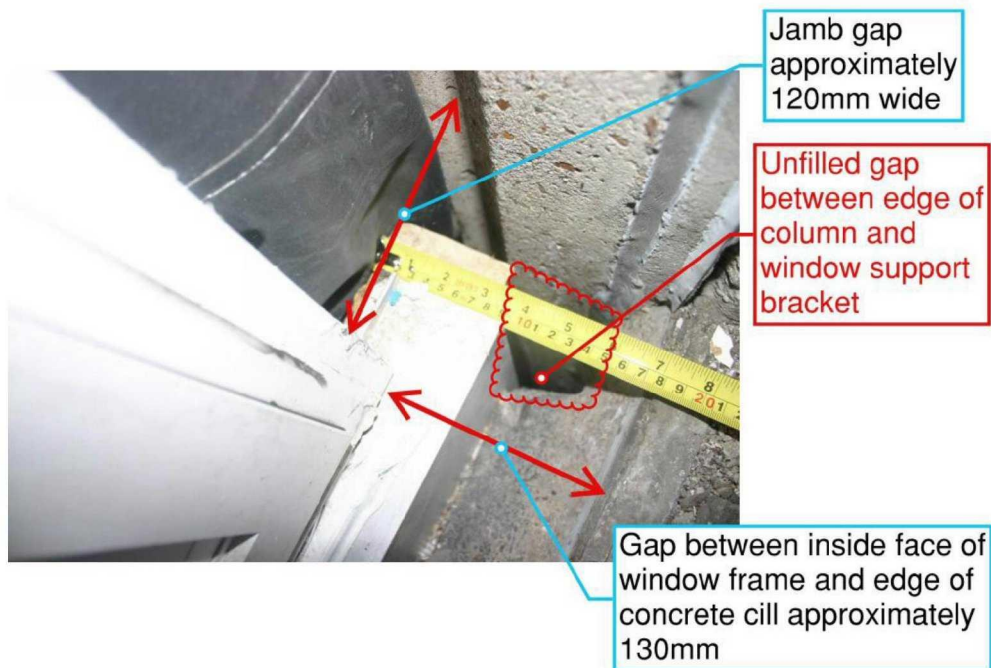
9.2.22 I found evidence of this vertical gap or groove on site as I have presented in Figure 9.9 and Figure 9.10. This groove is formed by the original concrete exterior of the building, which after the refurbishment works, was situated on the interior side of the EDPM weatherproof membrane (see Figure 9.9).

9.2.23 This gap travels the length of each floor between windows and was observed both filled (Figure 9.10) with combustible expanding foam and also unfilled (Figure 9.9).

Figure 9.9: Unfilled gaps in the internal window construction – cill level (Flat 13)

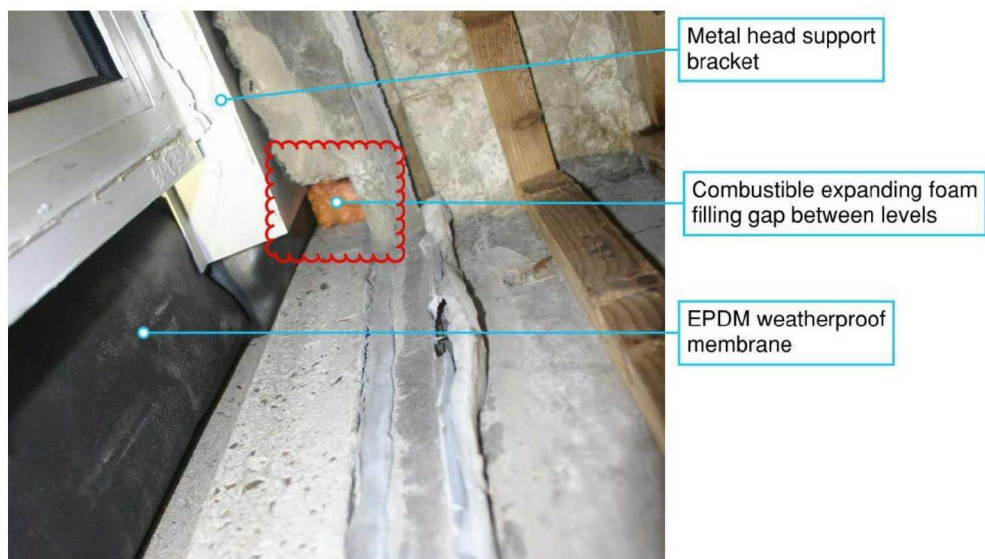
- 9.2.24 Where filled, a combustible expanding polyurethane foam product (HAR00001323) appears to have been used, and from below only.
- 9.2.25 This gap also bypasses the floor slab compartment line (and it is repeated beside each column and on each floor).
- 9.2.26 This gap was not fire rated and represents a potential path of internal fire spread vertically between flats, without breaking the EPDM weatherproof membrane.

Figure 9.10: Gap filled with expanding foam in the internal window construction – Looking up at window head (Flat 13)

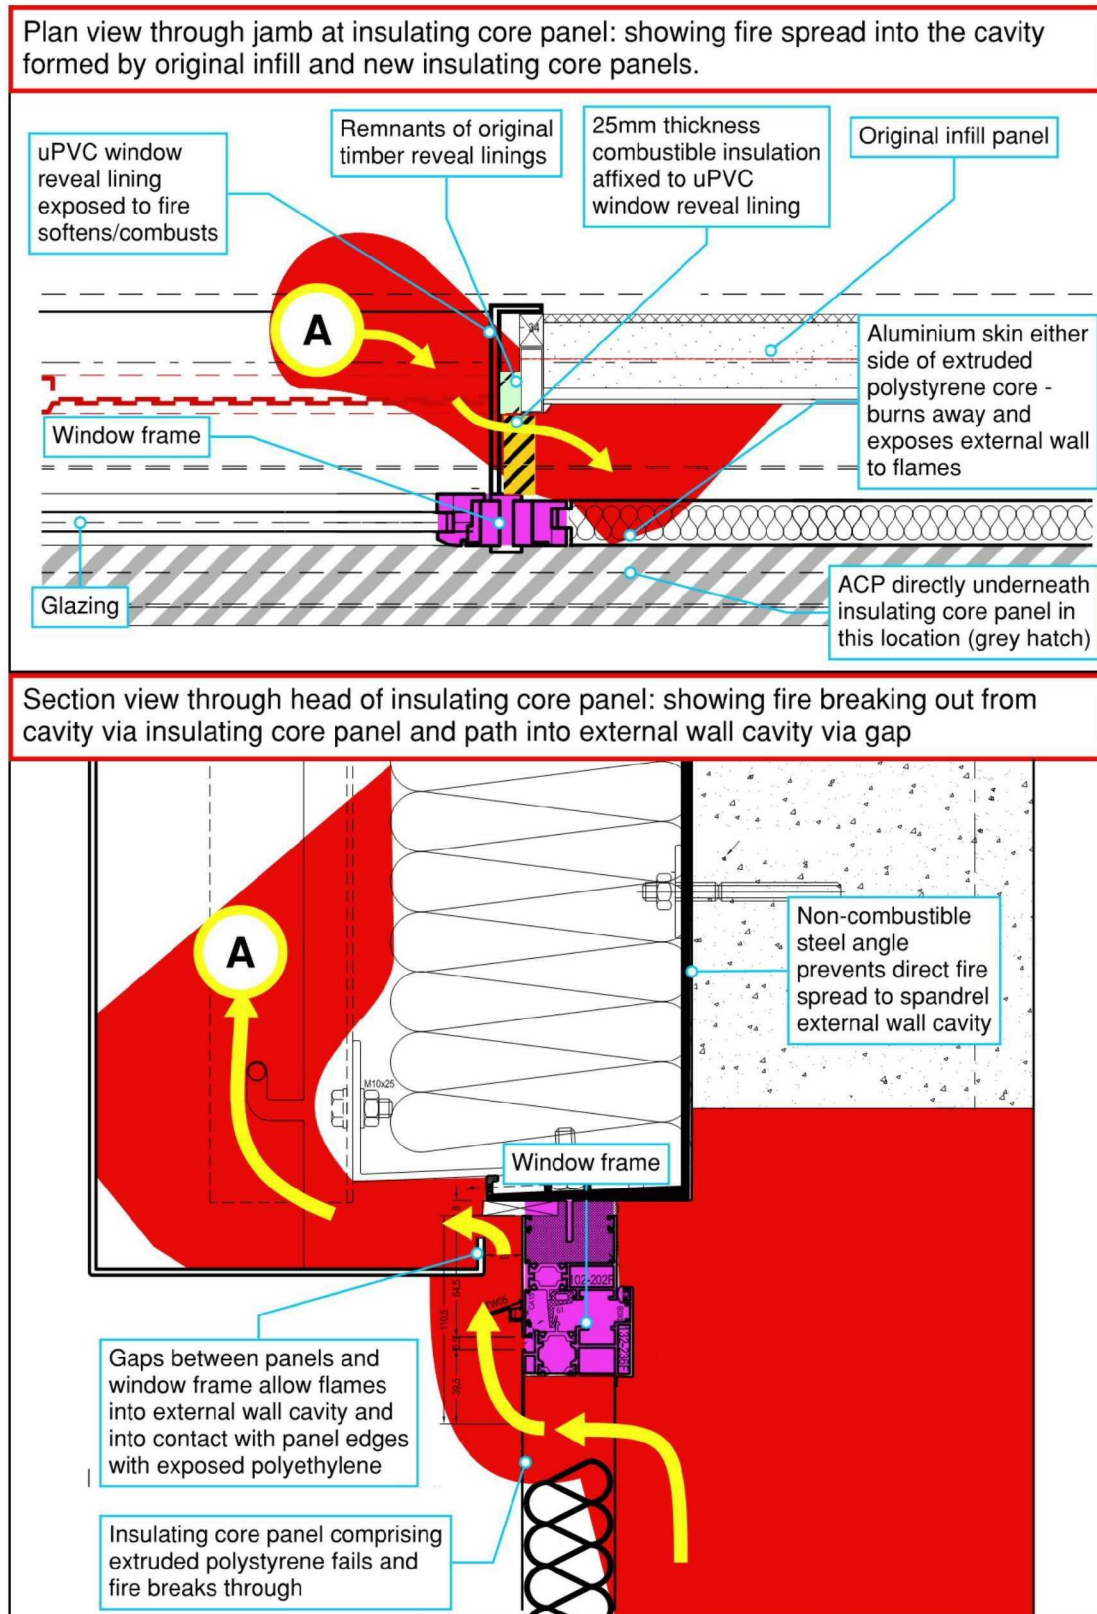
9.3.8 In Figure 9.11 I have illustrated the route of fire spread from a localised fire at or near the insulating core panel side of the window to the spandrel external wall cavity above. In this position radiative heat, hot gases or burning particles from the fire could impinge the vertical materials lining the window jamb. First the uPVC surface lining, then the 25mm combustible insulation affixed to the underside of the uPVC.

Figure 9.11: Diagram of route A (in two parts) originating from a localised fire on or adjacent to cill. (SEA00013045, HAR00008901).

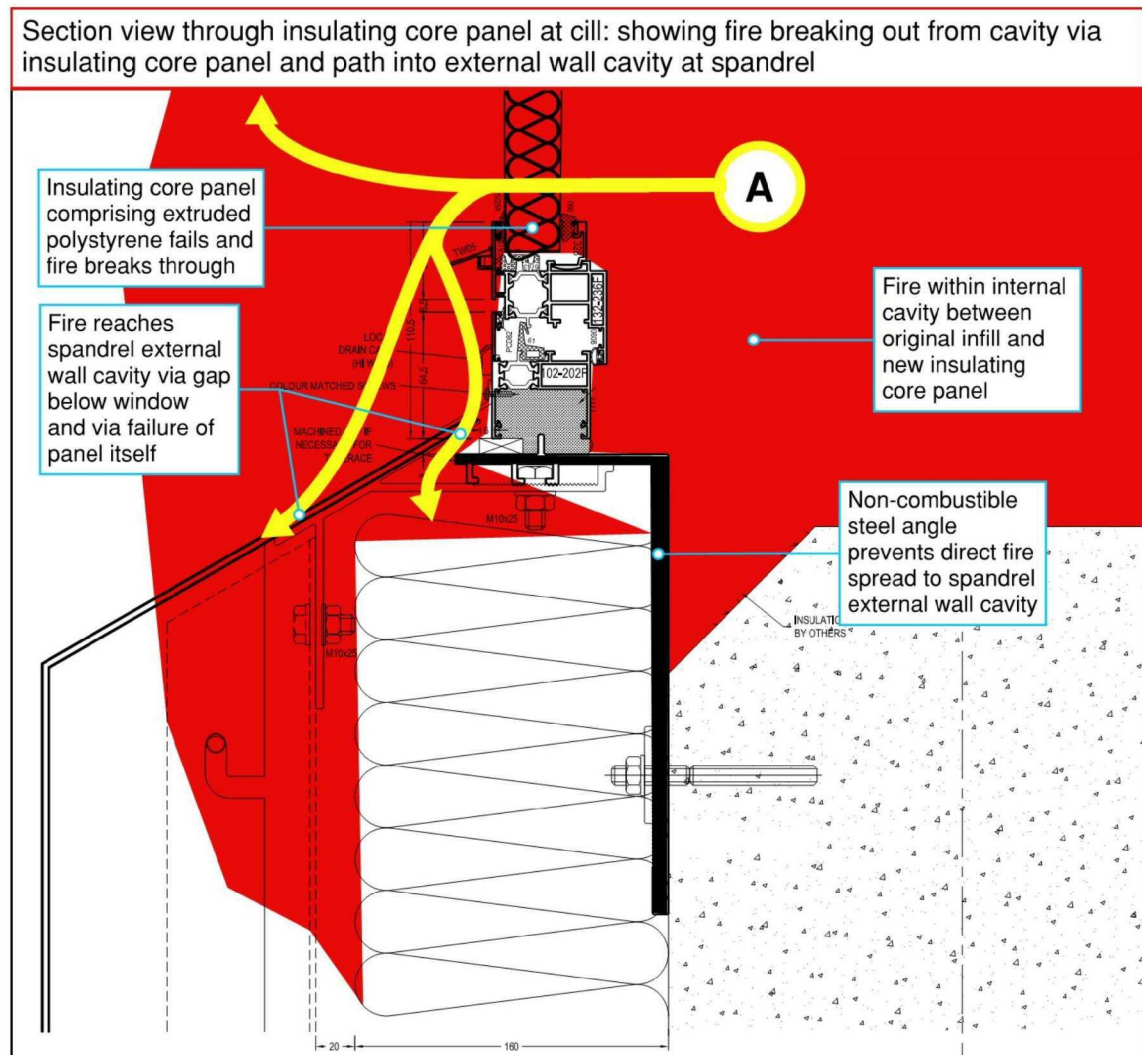
9.3.11 Figure 9.12 shows the ACP cassette where it is folded in towards the insulating core panel, below the window at cill level.

Figure 9.12: Diagram of route A also showing further route into external wall cavity on spandrel panel at cill of window (HAR00008879)

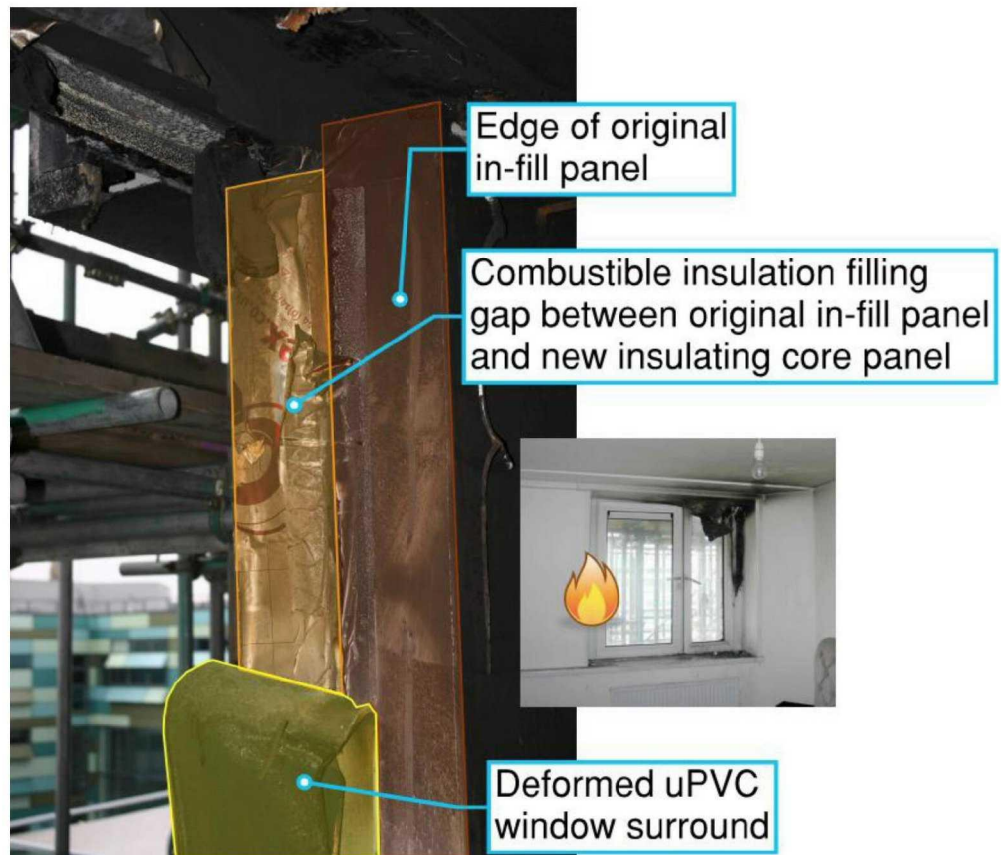
I have also included in Figure 9.13 an example of a heat affected vertical window lining beside the new insulating core panels which I observed onsite. In this photograph the uPVC window lining has softened and deformed to reveal the 25mm combustible insulation behind.

Figure 9.13: Fire on the infill panel side of the window (Flat 16 living room window) with example location inset

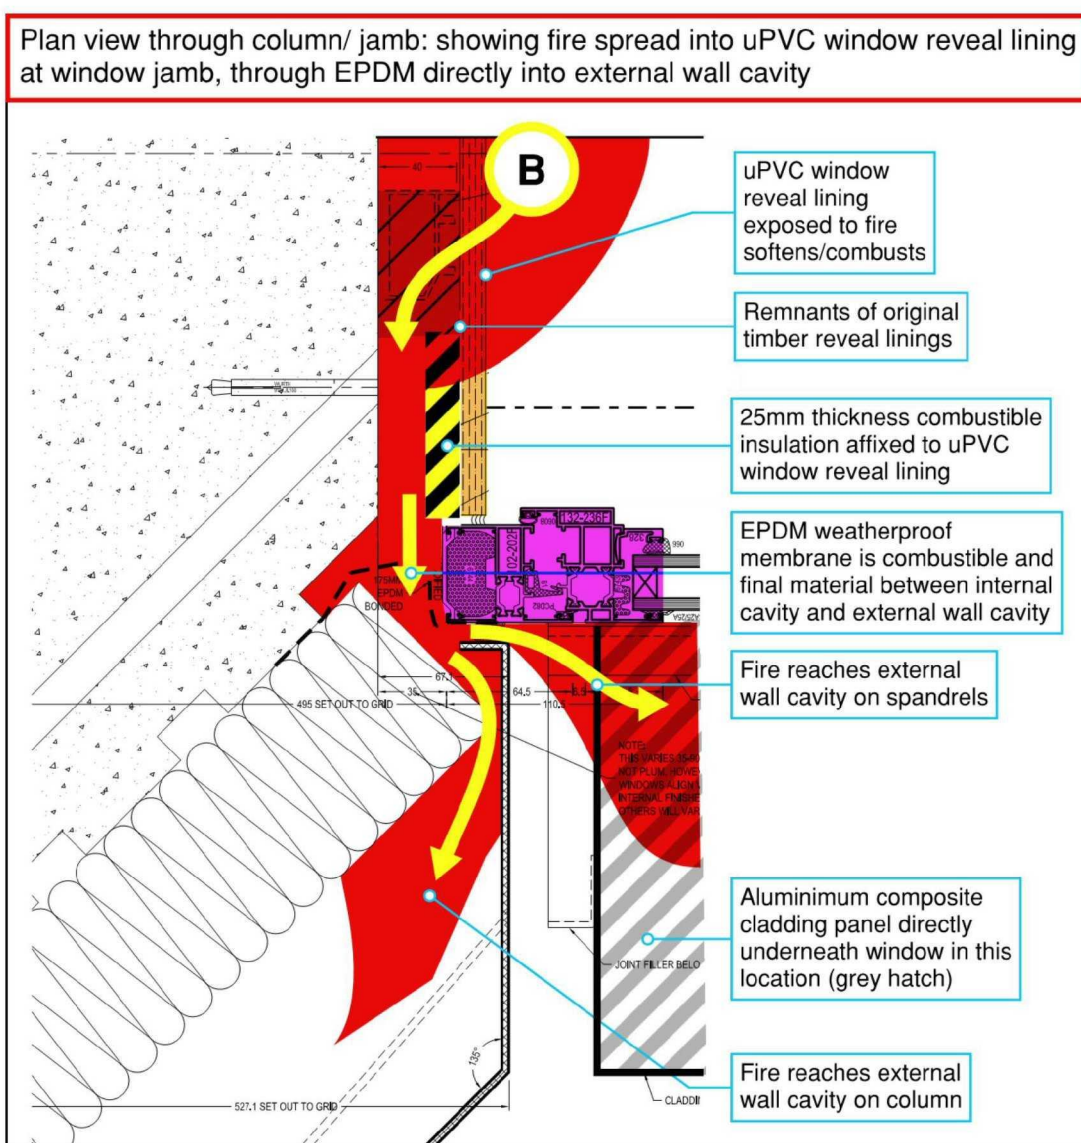
9.3.16 In this position, radiative heat, hot gases or burning particles from the fire could impinge on the vertical materials lining the window jamb. First the uPVC surface lining, then the 25mm combustible insulation affixed to the underside of the uPVC and the retained timber batons from the original window frames.

9.3.17 Once the fire is within the vertical cavity behind the window jamb it can spread directly to the column external wall cavity through the combustible EPDM weatherproof membrane'

Figure 9.14: Diagram of route B originating from a localised fire adjacent to window jamb (HAR00008902).

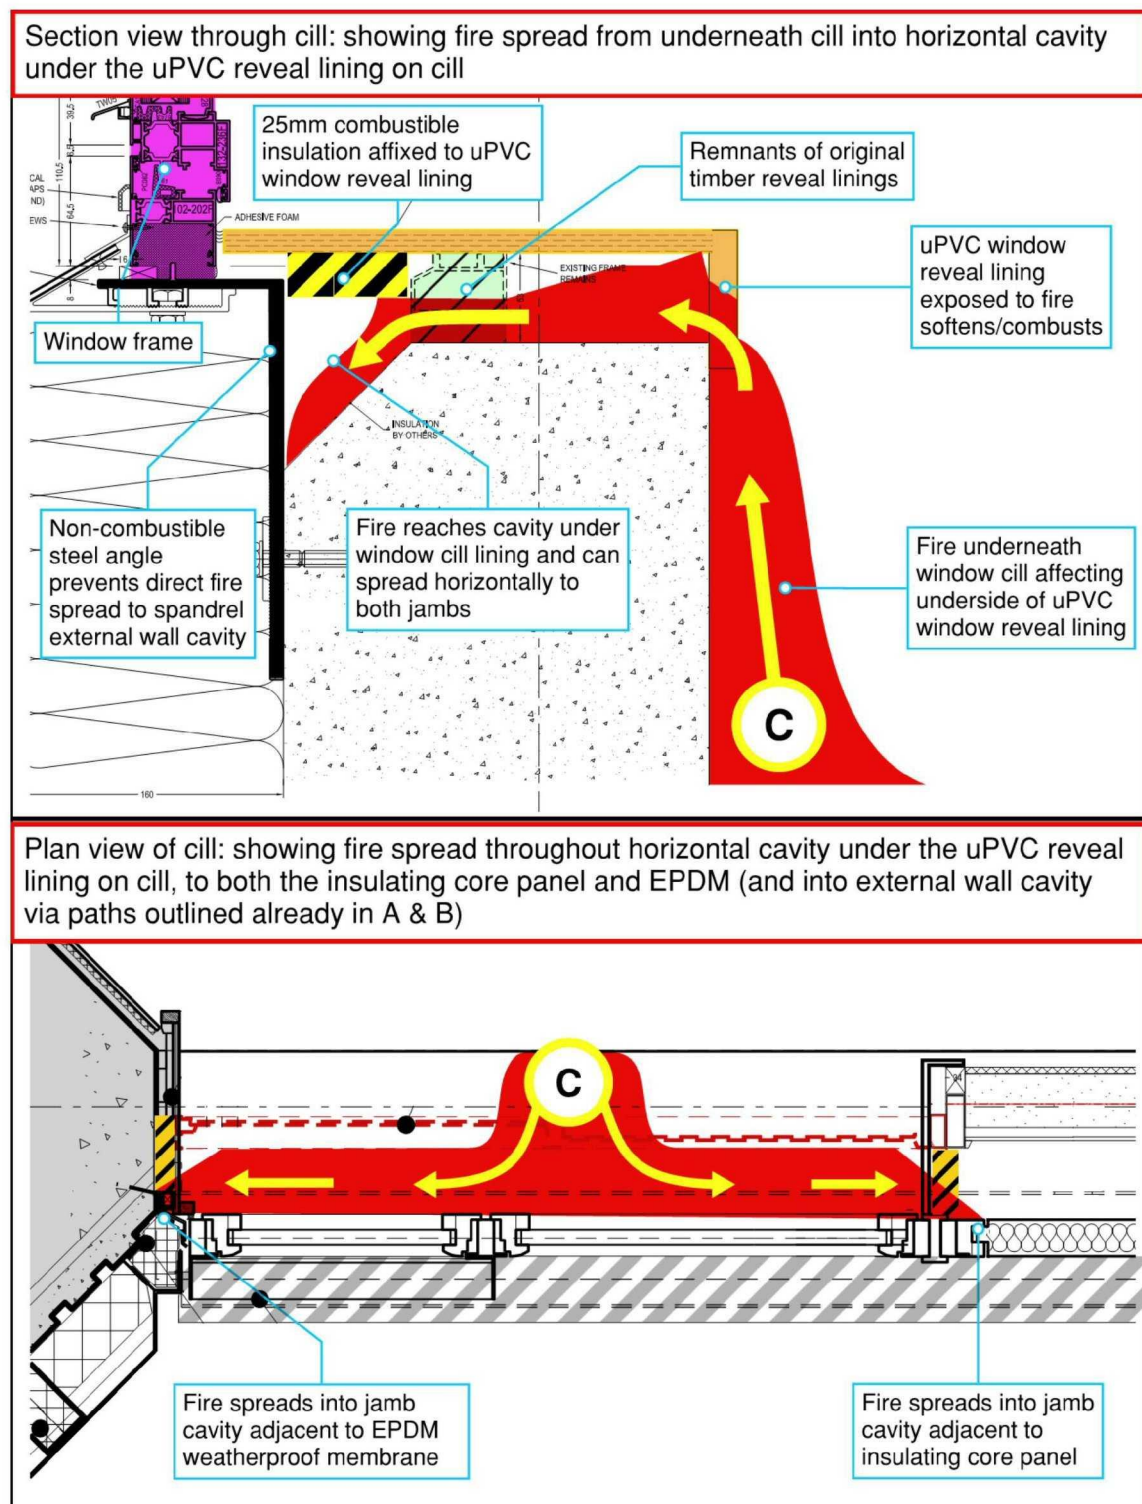
- 9.3.24** As per route A, once failure of the insulating core panel occurs the fire can spread into the external wall cavity on the spandrel above, and below. This route is illustrated in Figure 9.15.

Figure 9.15: Diagram of route C (in two parts) originating from a localised fire underneath cill and spreading into cill internal cavity, with onward spread to behind both jambs and using the remainder of routes A & B to reach the external wall cavity (HAR00008879, SEA00013045).

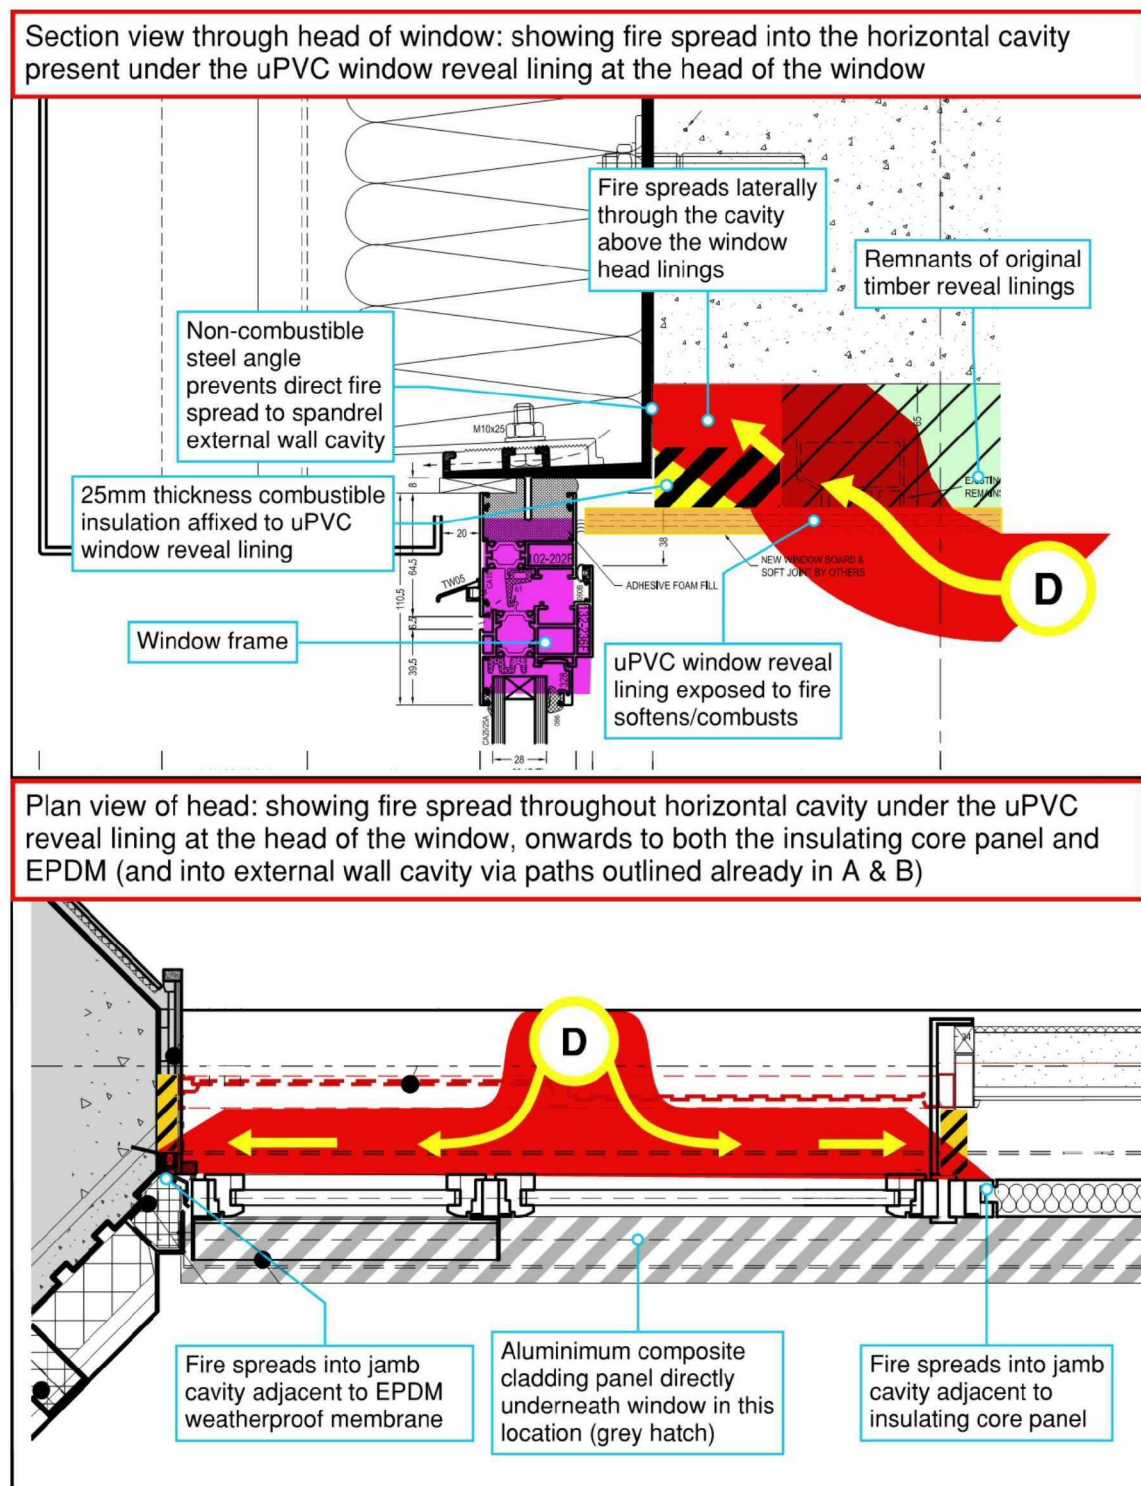
9.3.26 In Figure 9.16 I have illustrated the route of fire spread where a localised fire is at or near the head of the window and travels to the column external wall cavity. In this position radiative heat, hot gases or burning particles from the fire could impinge on the horizontal materials lining the window jamb. First the uPVC surface lining, then the 25mm combustible insulation affixed to the underside of the uPVC.

9.3.28 As for a localised fire at or adjacent to the window cill, once a fire is within the window head cavity, it is separated from the external wall cavity by a non-combustible steel shelf angle. The fire must therefore spread laterally towards either the column or the new insulating core panels. Once the fire is in the head cavity it could spread laterally along the cavity until it reaches the EPDM weatherproof membrane at either the column jamb or the XPS filled insulating core panel located between the windows.

Figure 9.16: Diagram of route D (in two parts) originating from a localised fire on or adjacent to cill, or from a fire remote to window with ceiling plume. Onward spread to behind both jambs and using the remainder of routes A & B to reach the external wall cavity. (HAR00008901, SEA00013045).

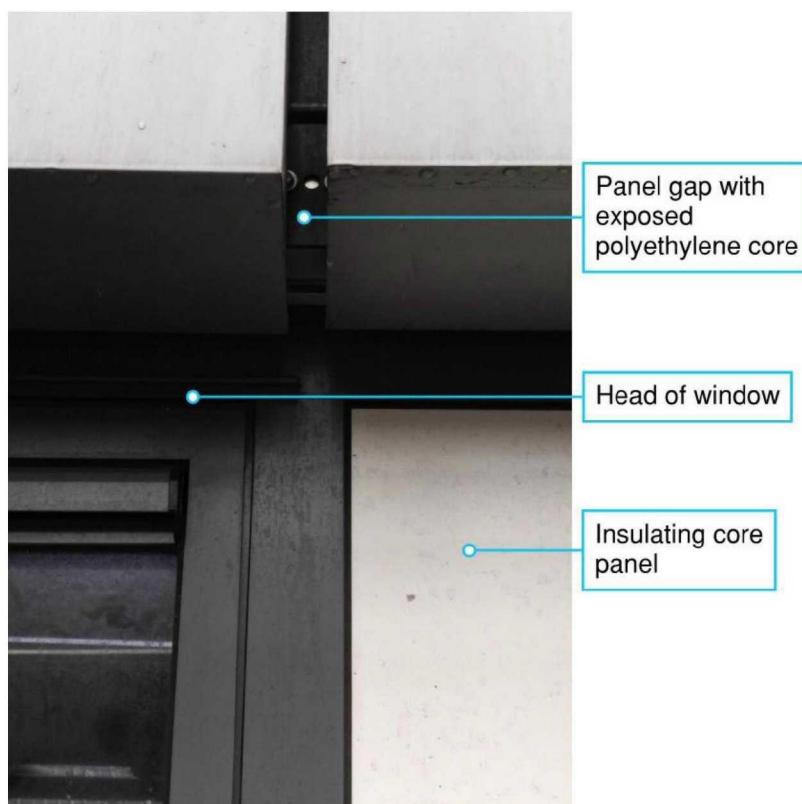
Once flames from the fire are able to penetrate the window by any one of the three scenarios described above, the heat and smoke from the fire could impinge directly on the ACP overlapping on the vertical column and also on the ACP overlapping located above and below the window. Flames can enter both the horizontal and vertical rainscreen cavities through ventilation gaps between the aluminium composite rainscreen panels (Figure 9.22) and also cause ignition of the exposed PE core, shown in Figure 9.19.

Figure 9.19: External wall photograph showing proximity of panel gaps to window and insulating core panel

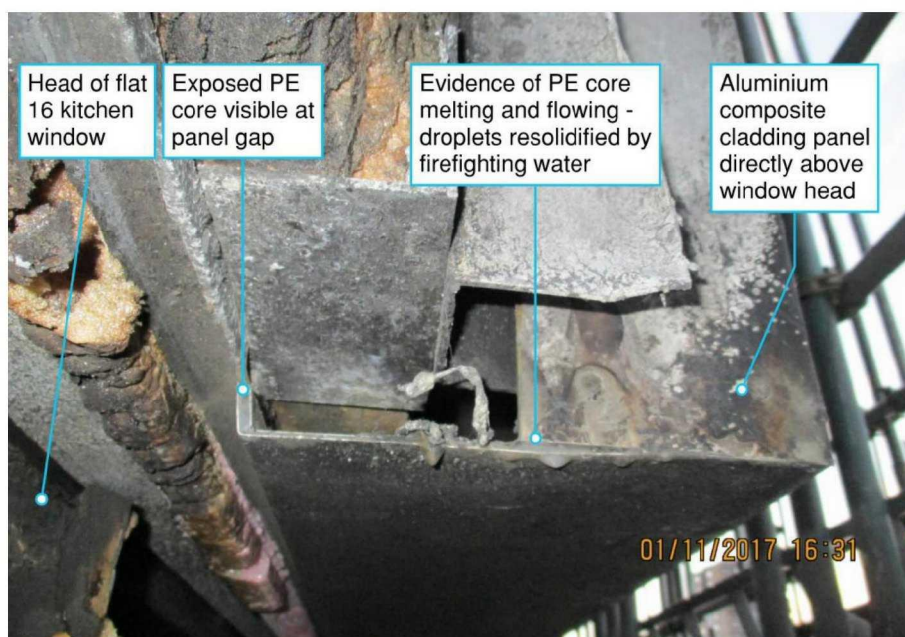
9.3.33 The polyethylene core was exposed along the sides of the panels in this location, as indicated by Figure 9.20. My onsite observations confirm it was exposed and also that it had melted, as shown in Figure 9.21:

Figure 9.21: Photograph of cladding panel directly above flat 16 kitchen window

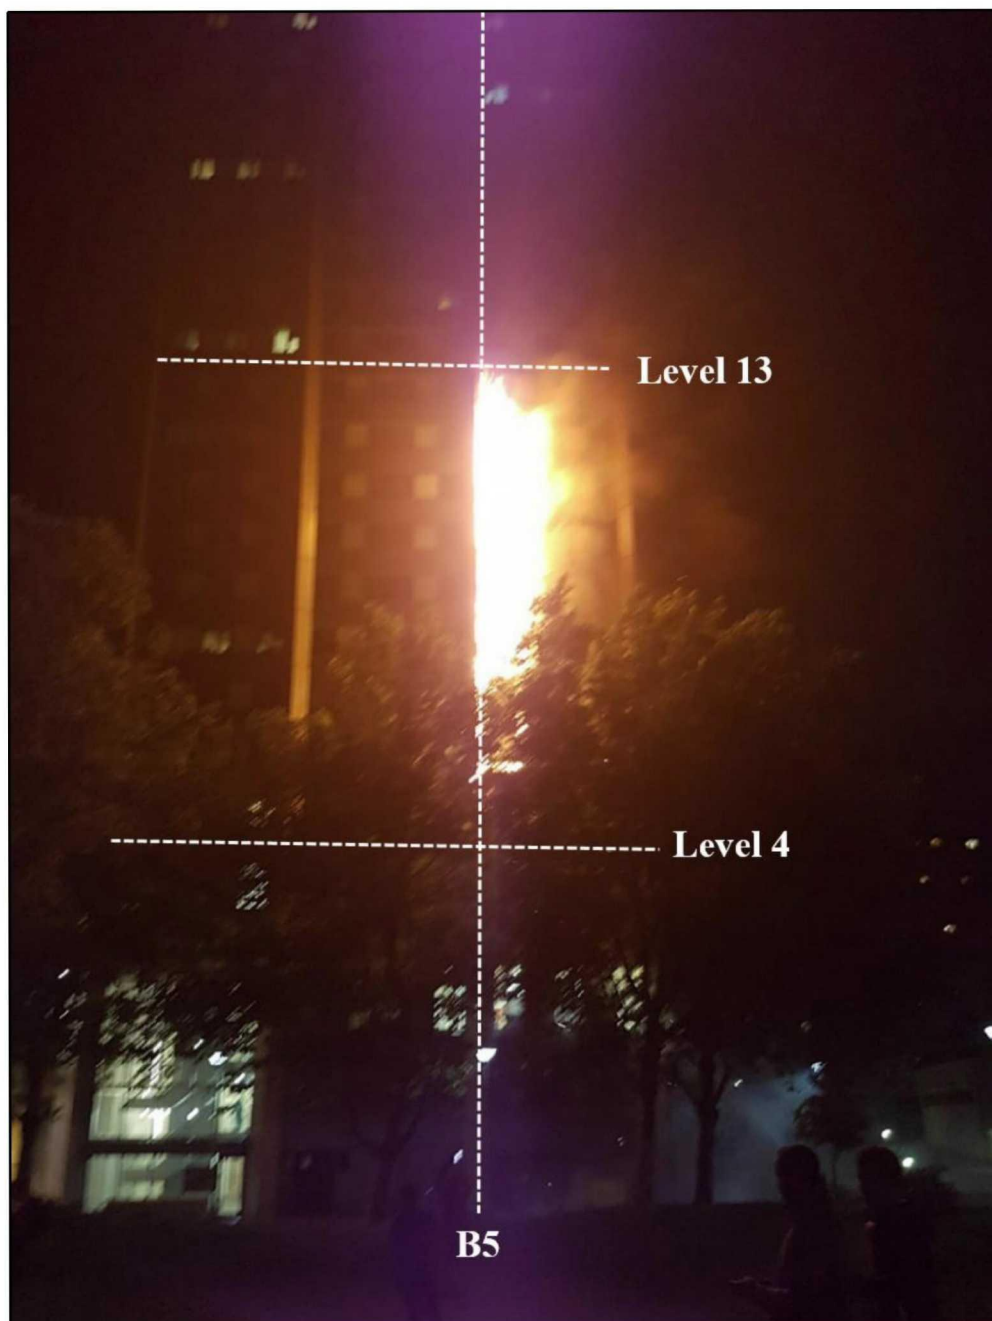
9.4.6 As I have explained in Section 5 of my report, there was rapid flame spread observed up the columns of Grenfell Tower on the 14th June 2017. Figure 9.23 is replicated from Section 5 to visualise this spread.

Figure 9.23: Evidence of flame spread up column at 01:22 (approx)¹

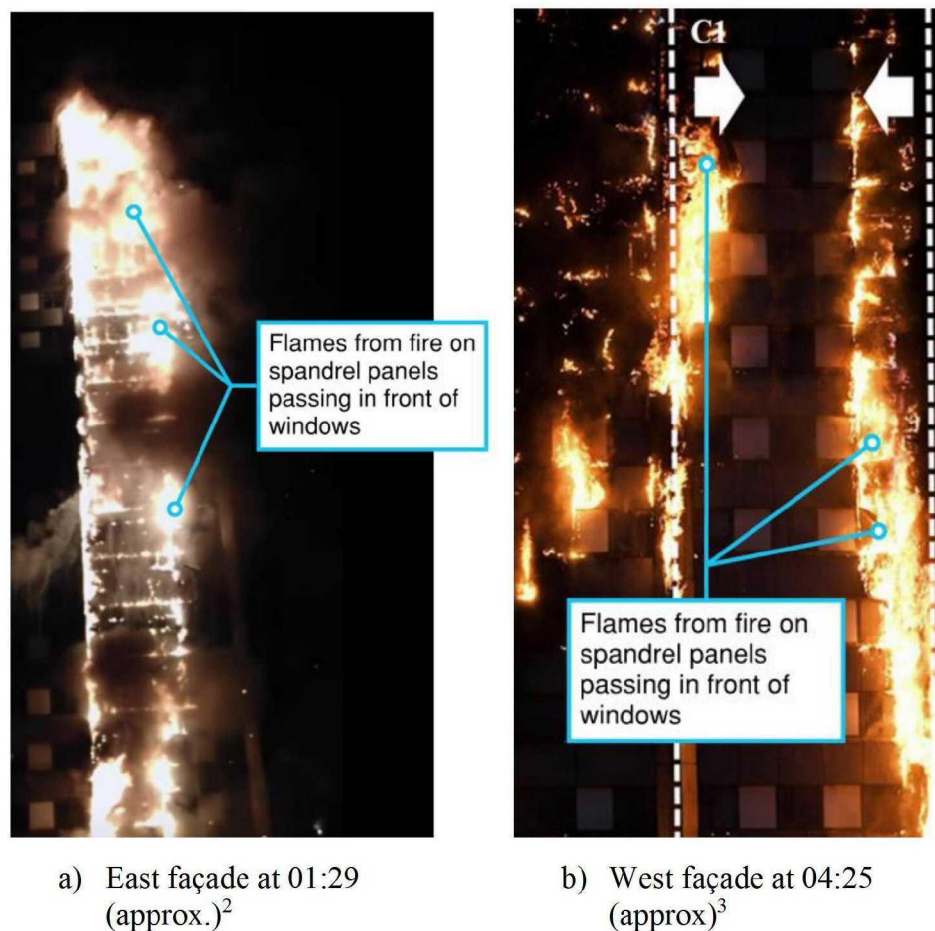
9.4.11 Figure 9.24 presents evidence from the fire on the 14th June 2017 and shows that flames coming from burning spandrel panels were able to engulf some or all of the windows directly above.

Figure 9.24: Evidence of fires from spandrels causing flame fronts in front of windows
