**Grenfell Tower – fire safety investigation:
The fire protection measures in place on the night of the fire, and conclusions as to:**

Phase 1 Report – Section 9

Routes for fire spread out through the window openings

24th October 2018

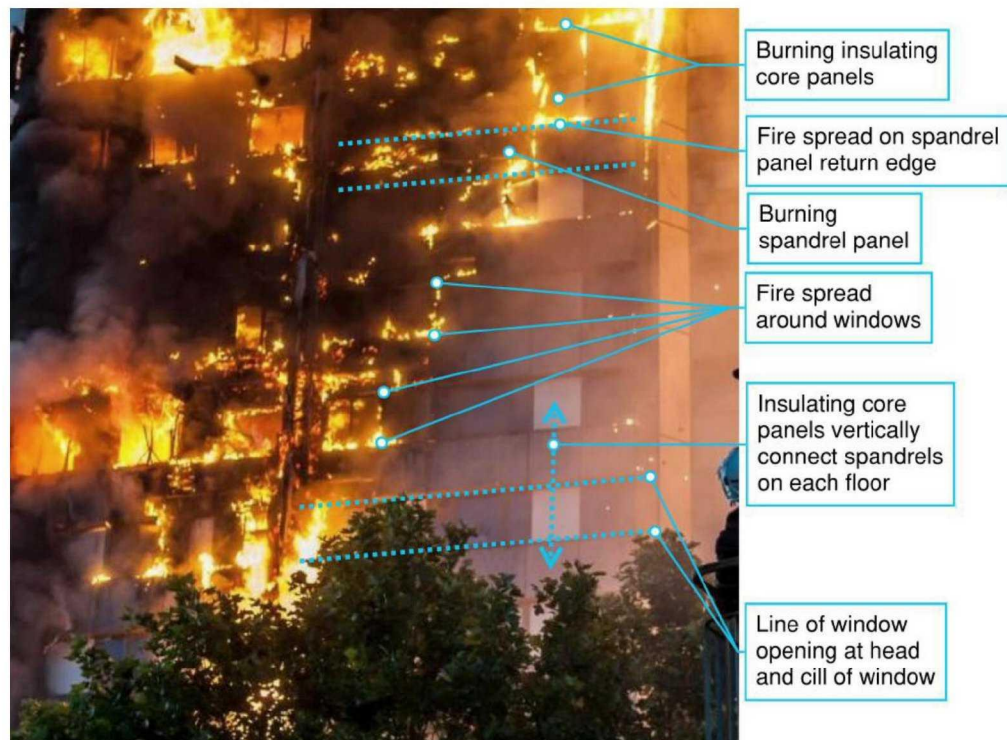
9.4.16 Figure 9.25 below, presents evidence from the fire on the 14th June 2017 of horizontal fire spread along the head and cills of the windows.

Figure 9.25: Example of Pathway C (replicated from Section 10)⁴

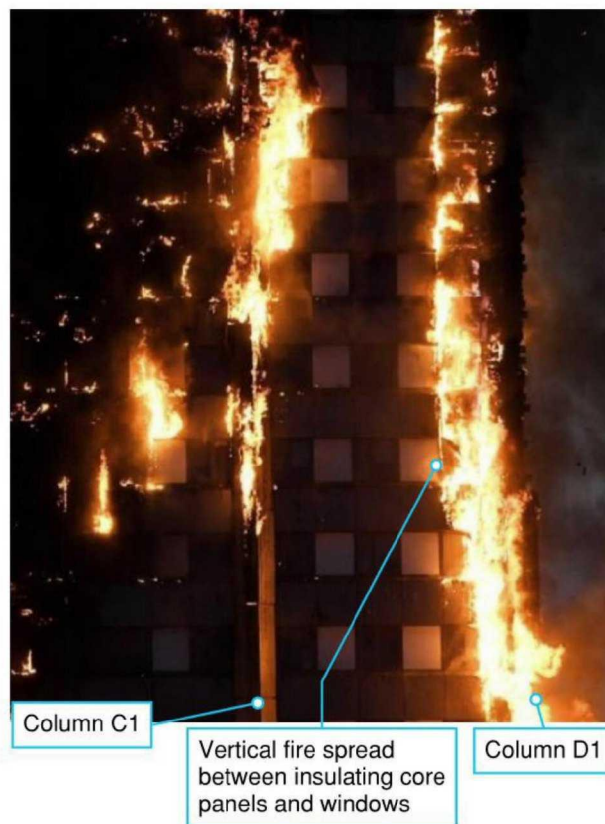
Figure 9.26: Photo evidence of vertical fire spread at the junction between the insulating core panels and windows⁵

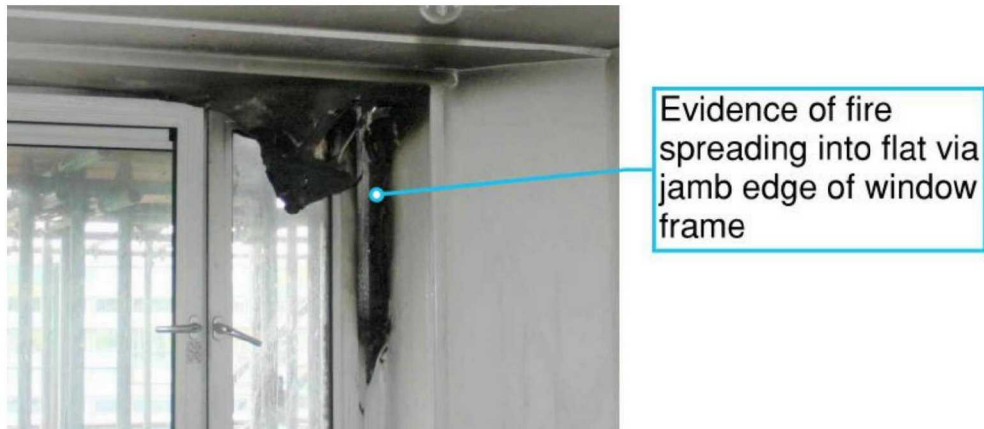
9.4.9 The photograph in Figure 9.29, discussed in Section 9.5.1, illustrates that this was a feasible route for fire spread into the flat.

9.5.2 In my inspection of Flat 15 on Level 4 (Figure 9.28), I observed that there was a window exhibiting evidence of fire spread from outside the building to the inside, shown in Figure 9.29. The evidence of fire spread showed that the entry route for the fire was in the top corner of the window, adjacent to the column, consistent with the mechanism of fire spread presented in Section 9.4. That is a fire being able to penetrate from outside the building, into the cavity behind the new uPVC reveal linings via the EPDM weatherproof membrane (route B).

Figure 9.29: Fire spreading into flat from outside (Flat 15 bedroom)

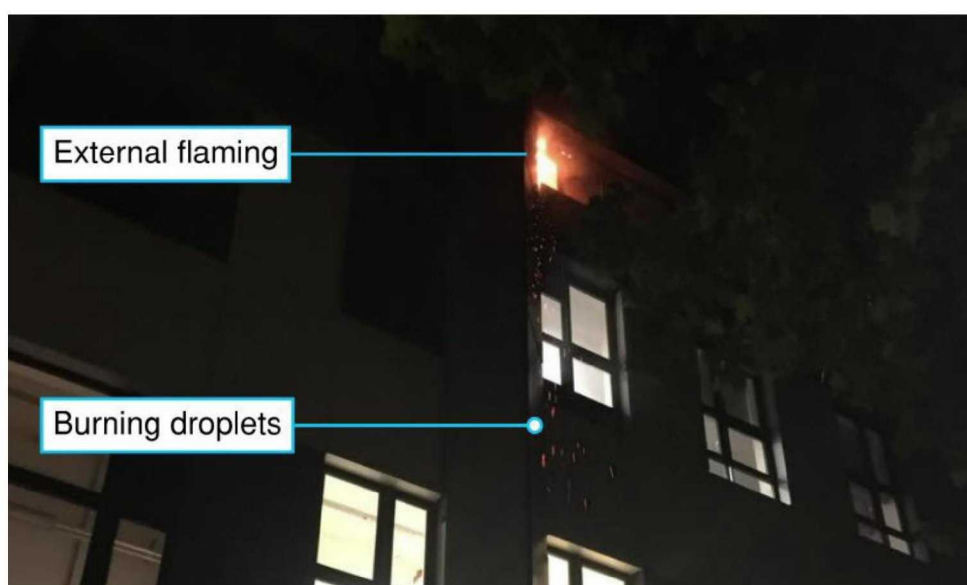
9.5.15 Additionally, Figure 9.35 identifies that burning droplets began falling outside the building at around 01:08.

Figure 9.35: Photograph at 01:08 submitted by witness (IWS00000051)

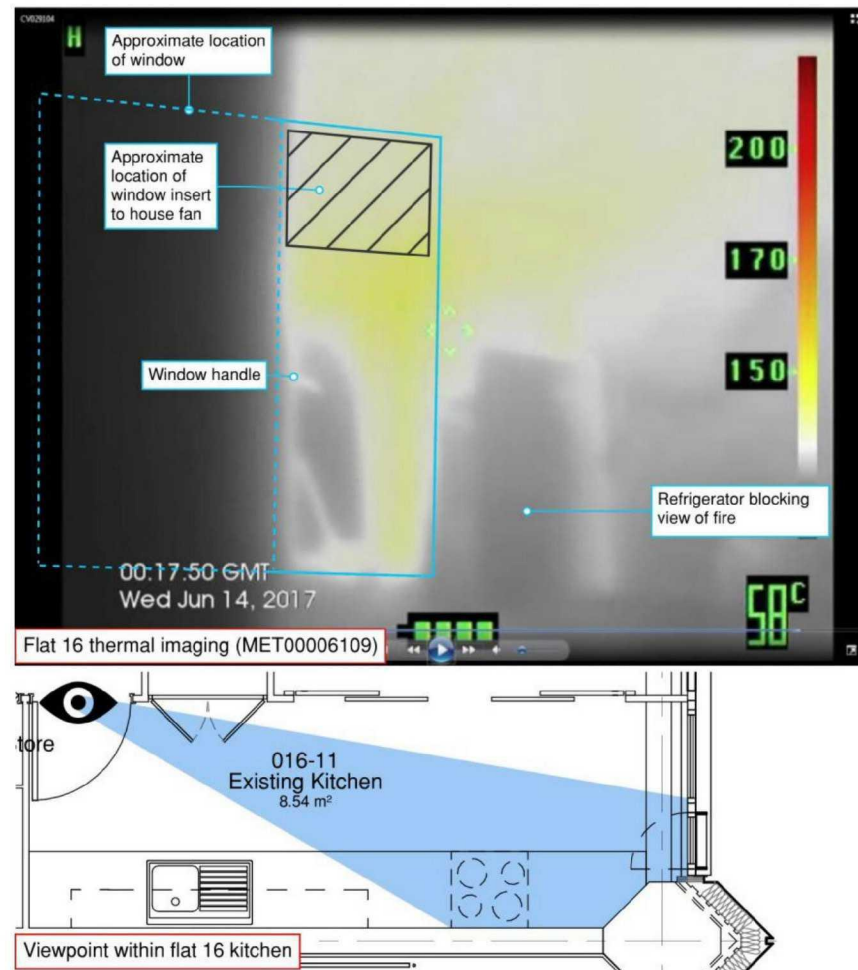
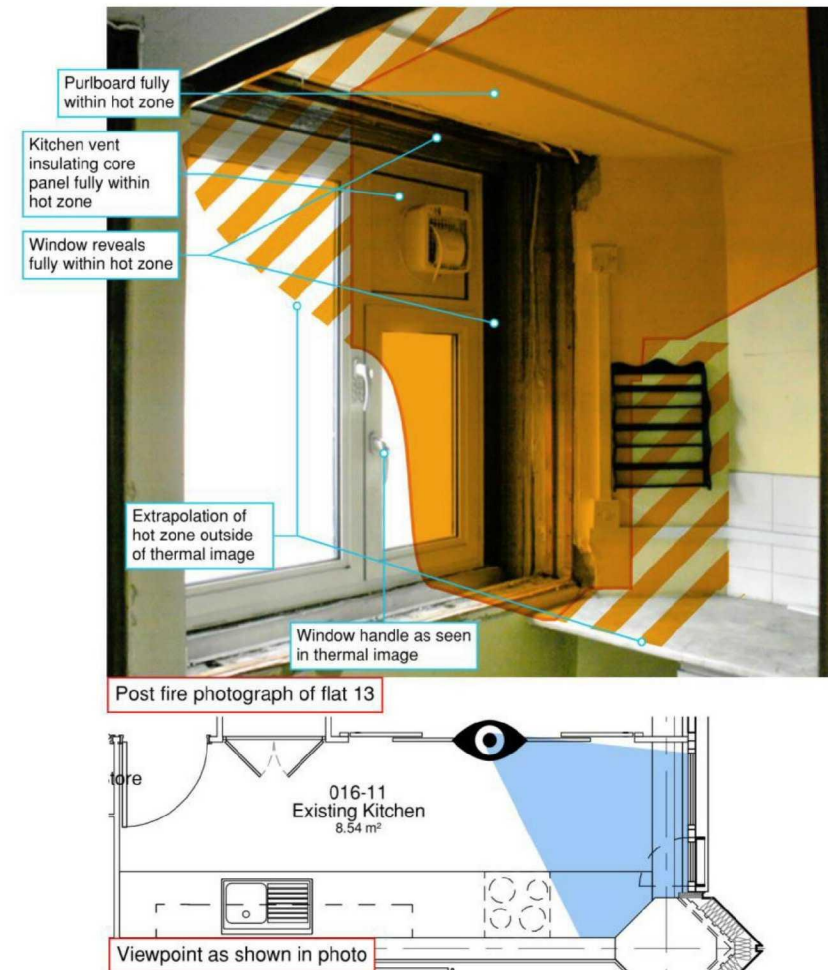
- 9.5.18** Figure 9.38 shows the extent of the area that was subjected to the hot plume observed within the flat 16 thermal imaging camera footage. This therefore also shows the extent of materials that were exposed to the heating from the initial fire, and the possible routes available for fire spread into the external wall cavity.

Figure 9.38: Comparison figure of the area exposed to the hot fire plume observed in thermal imaging from flat 16 (plans: SEA00010474)

- 9.5.19** Therefore, using Figure 9.38, the exposure from the hot zone could lead to the fire reaching the external wall cavity **by either routes B (via jamb/EPDM), or E (directly through the window glazing/kitchen vent panel):**

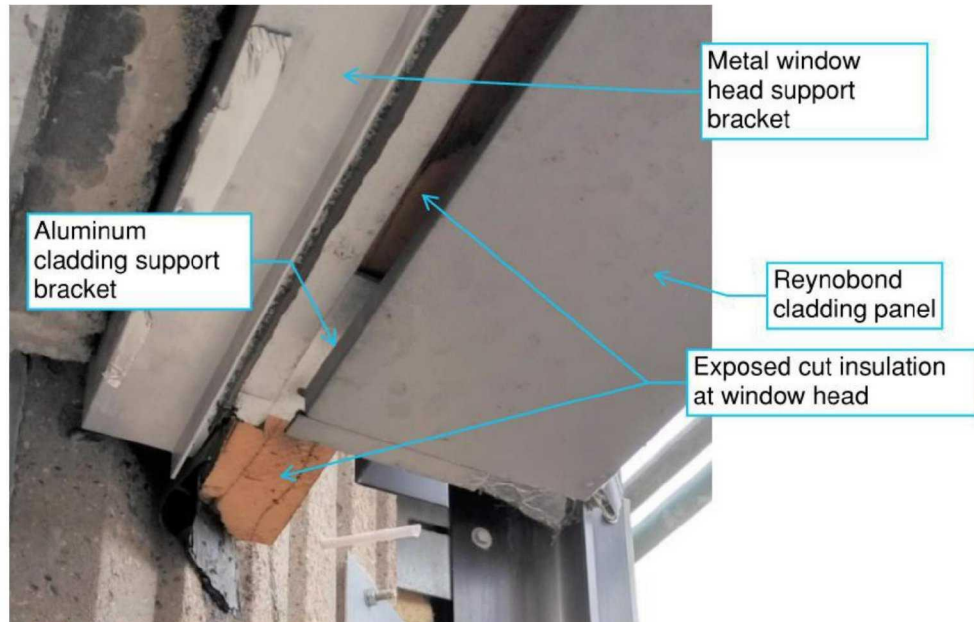
Figure 9.39: Evidence of cut insulation edge above window head

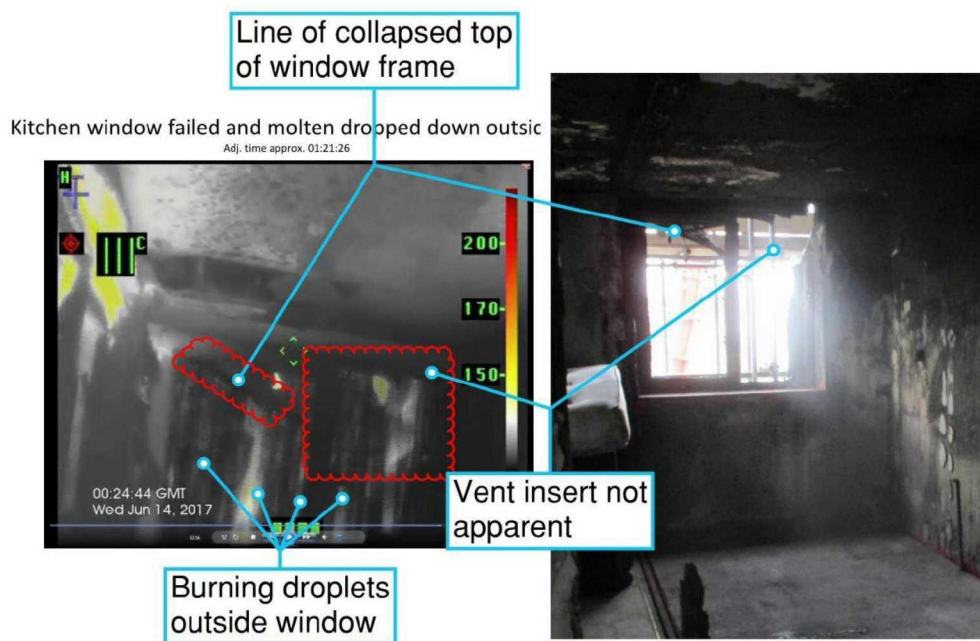
- 9.5.20** Figure 9.40 includes a still taken from LFB thermal imaging camera of the first fire fighter to enter the kitchen of Flat 16 on the 14th June 2017 timestamped 01:21. The right hand side of this image shows a view out of the kitchen window. Burning droplets are apparent, falling outside the window. Furthermore, the kitchen vent insulating core panel does not appear to be visible, indicating that it had already been affected by fire and fallen away (as discussed in route E).

- 9.5.21** The site photograph included in Figure 9.40, taken in Flat 16 on the 8th November 2017, corroborates this evidence by indicating that the worst damage to the kitchen window in Flat 16 was in the top corner where the vent insert was originally positioned. Please refer to Figure 9.38 showing the original window configuration with the vent insert in the top right corner.

Figure 9.40: Evidence of loss of vent insert (MET00006109), compared with post-fire photograph of Flat 16 kitchen window
