Grenfell Tower – fire safety investigation:
The fire protection measures in place on the night of the fire, and conclusions as to:
the extent to which they failed to control the spread of fire and smoke;
the extent to which they contributed to the speed at which the fire spread.

Phase 1 Report – Section 10

Routes for vertical and horizontal fire spread throughout the building envelope

Dr Barbara Lane FREng FRSE CEng

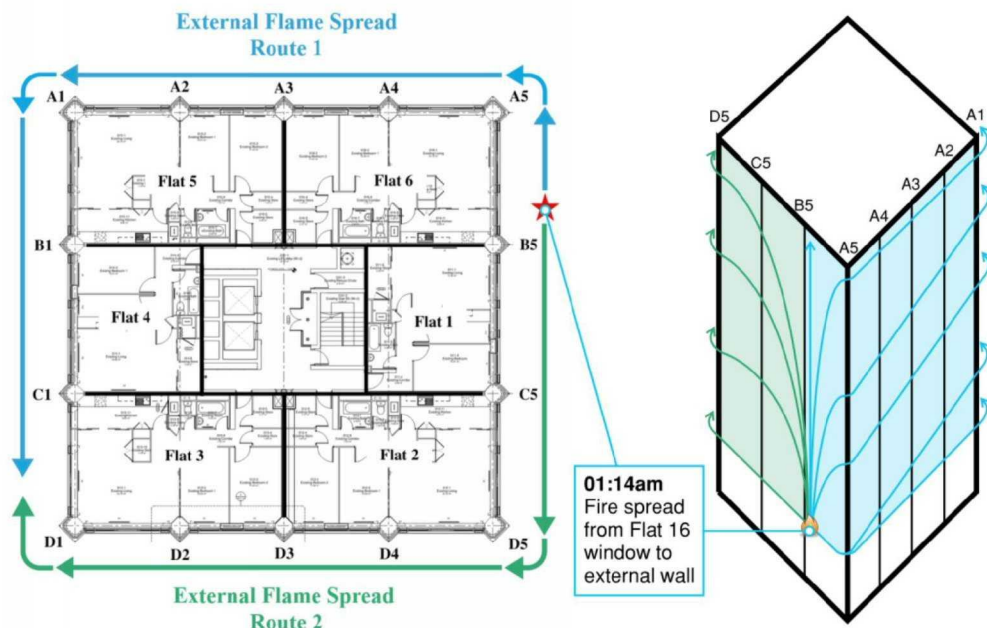
10.1.3 In Section 5 of this report I provided Figure 10.1 setting out on the plan drawing of the 4th floor, a diagram summarising the primary direction of the observed fire spread routes during the Grenfell Tower fire. Figure 10.1 also shows a schematic of the fire spread in 3 dimensions on an isometric representation of Grenfell Tower.

Figure 10.1: Plan (based on SEA00010474) and isometric views of Grenfell Tower showing fire spread observed and column references for orientation

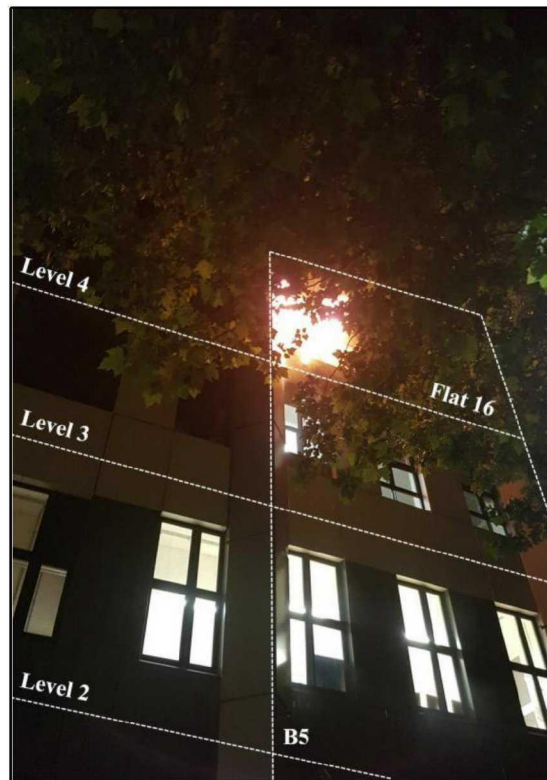
10.3.3 Figure 10.7 and Figure 10.8 show the origin and subsequent fire spread vertically up the column as a Pathway. This occurred on several other columns during the fire, and fire spread down the columns was also observed for example as shown in Figure 10.9.

Figure 10.7: Earliest image of external fire observed on Level 4, at 01:14 on 14 June 2017 (MET00006589)

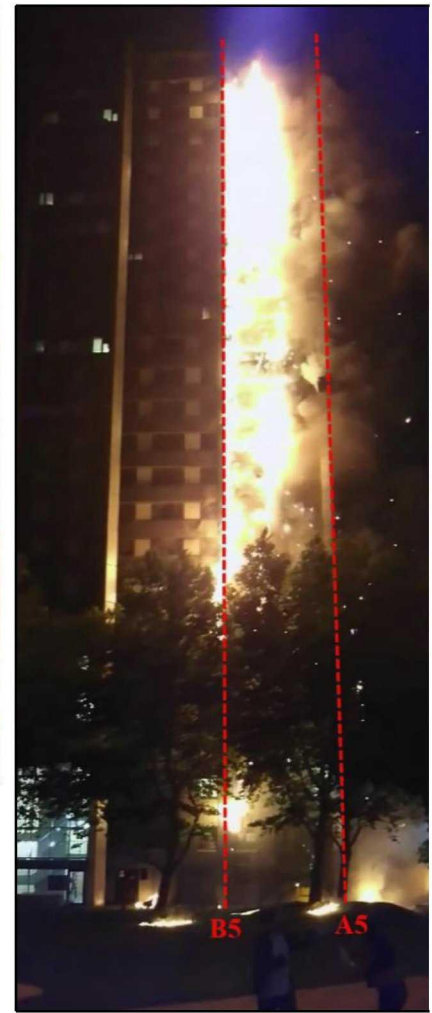
Figure 10.8: Fire on the full height East elevation of the building envelope on 14 June 2017, estimated time 01:26³

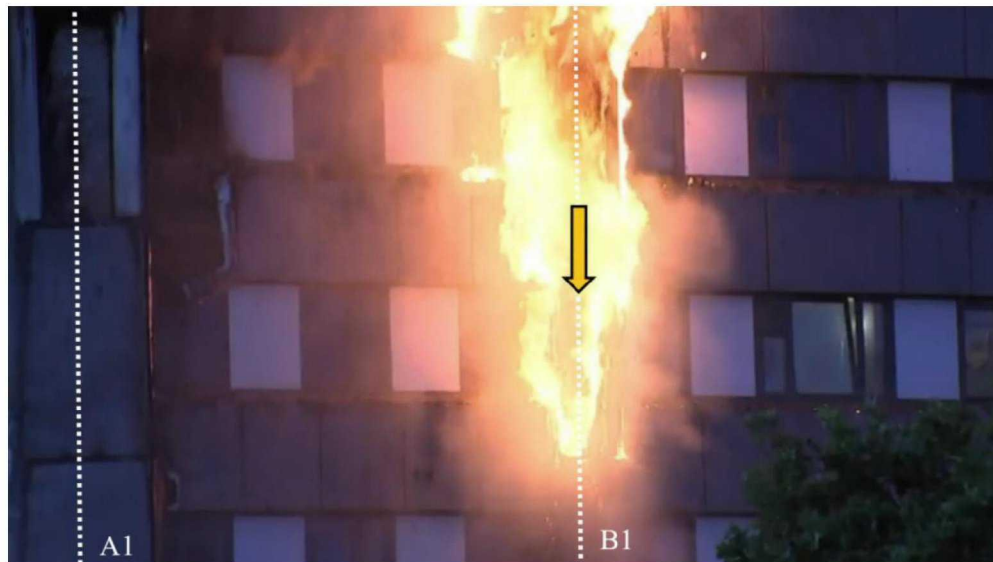
10.3.4 Figure 10.9 shows fire spread vertically down a column as a Pathway.

Figure 10.9: Downwards fire spread along column B1 on the West elevation⁴

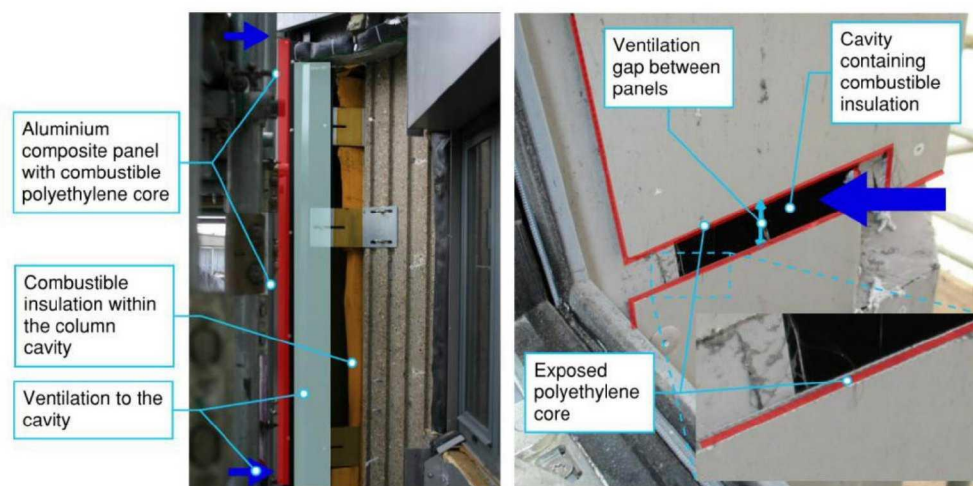
10.3.13 Figure 10.10 shows photographs taken of the column outside Flat 13 (left) and the column outside Flat 11 (right). In the left hand image, the rainscreen panels and insulation have been removed from the nearest half of the column, to show the layers on materials on the other half of the column. Figure 10.10 also identifies routes for air to pass into the cavity behind the Reynobond rainscreen cladding panels. The right hand image shows the construction of the panels featuring the exposed PE core material around all edges of each panel.

Figure 10.10: Images of available fuel and ventilation within column cavities from Grenfell Tower site inspection (left image – Flat 13, right image – Flat 11)

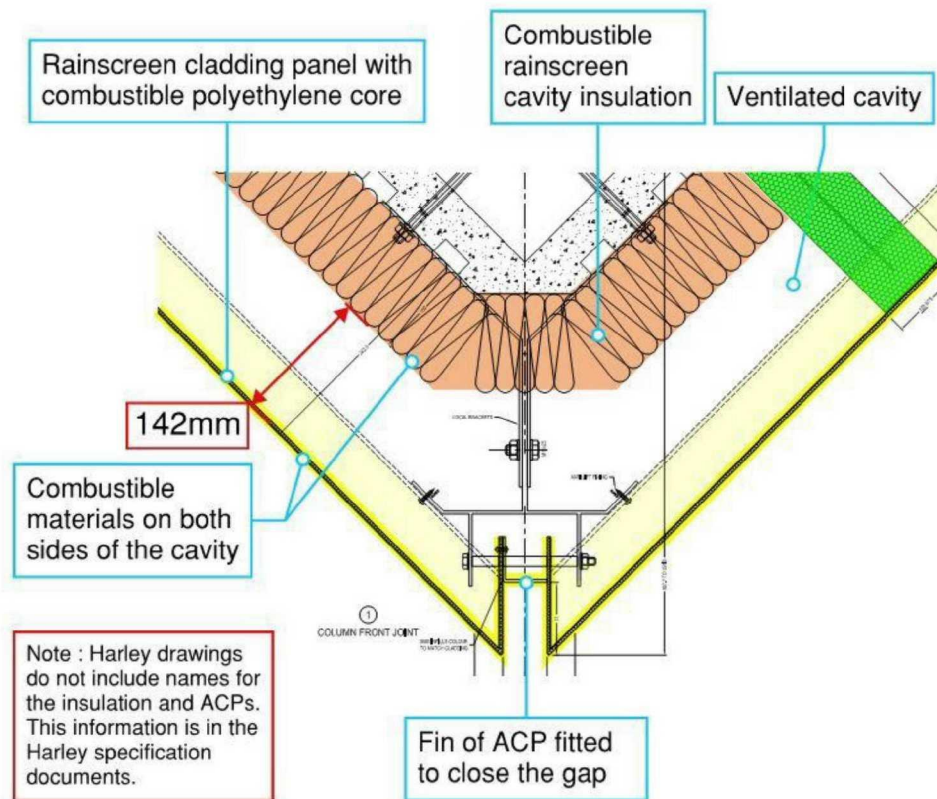
10.3.14 Figure 10.11 shows a marked up horizontal section drawing through a column identifying each of the components, and the resulting cavity between the face of the Celotex RS5000 insulation and the rear of the Reynobond 55 PE rainscreen cladding panel. This was approximately 140mm in depth. This image also shows the construction of the panels at the column nose, where the panels fold over and a separate fin of ACP is fitted to close the gap.

Figure 10.11: Harley design drawing showing column in plan view showing that both interior surfaces of the cavity contain combustible materials (Based on HAR00008902)

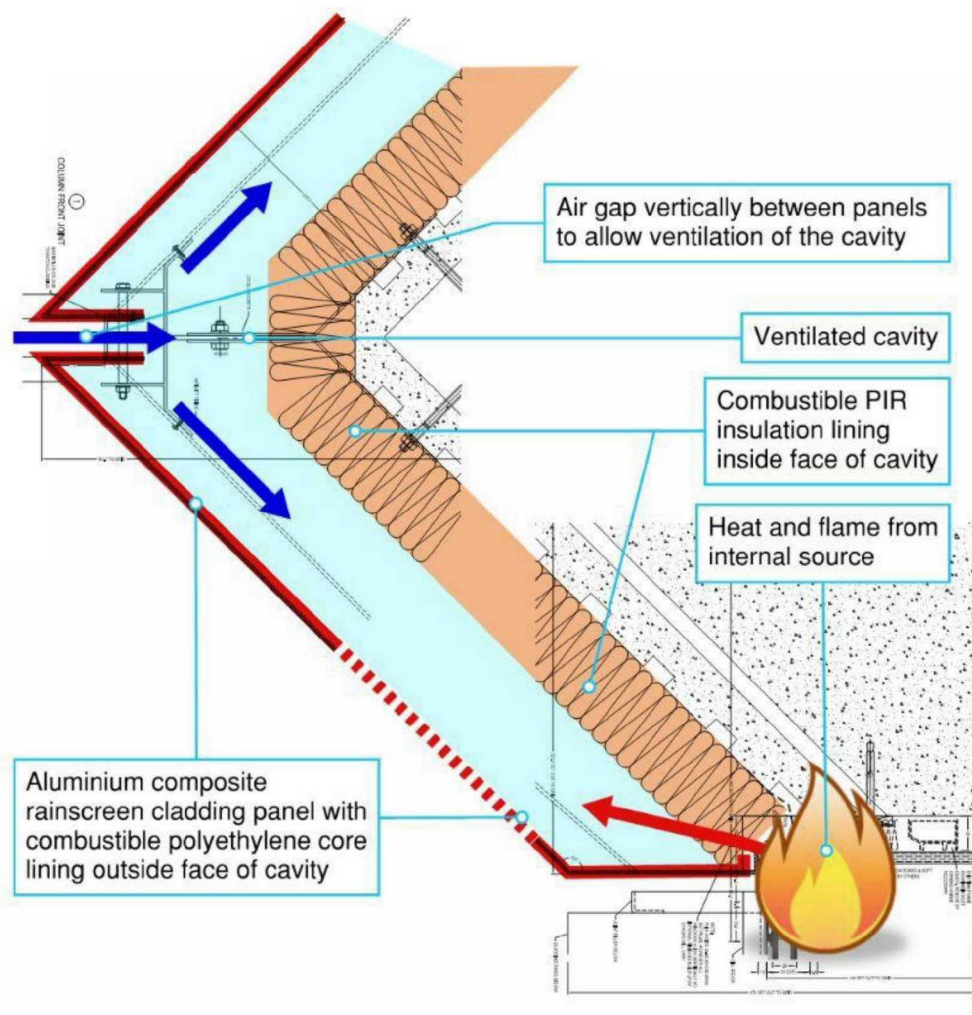
Figure 10.12: The fuel, ventilation and heat available within the column cavity of Grenfell Tower adjacent to Flat 16 (based on Harley drawings HAR00008880 & HAR00008902) to support combustion (dotted line denotes continuation of panel between underlying drawings)

10.3.26 In summary, the vertical fire spread observed up and down the columns, was caused by:

- The presence of fuel (the combustible polyethylene core of the Reynobond panels, the combustible Celotex insulation and the combustible EPDM weather proof membrane);
- The presence of oxygen entering the rainscreen cavity through the specifically designed air gaps;
- Heat from a fire within a flat passing into the cavity via the window construction described in Section 9; and
- Polyethylene from the Reynobond panels melting and running down the building, while ignited.

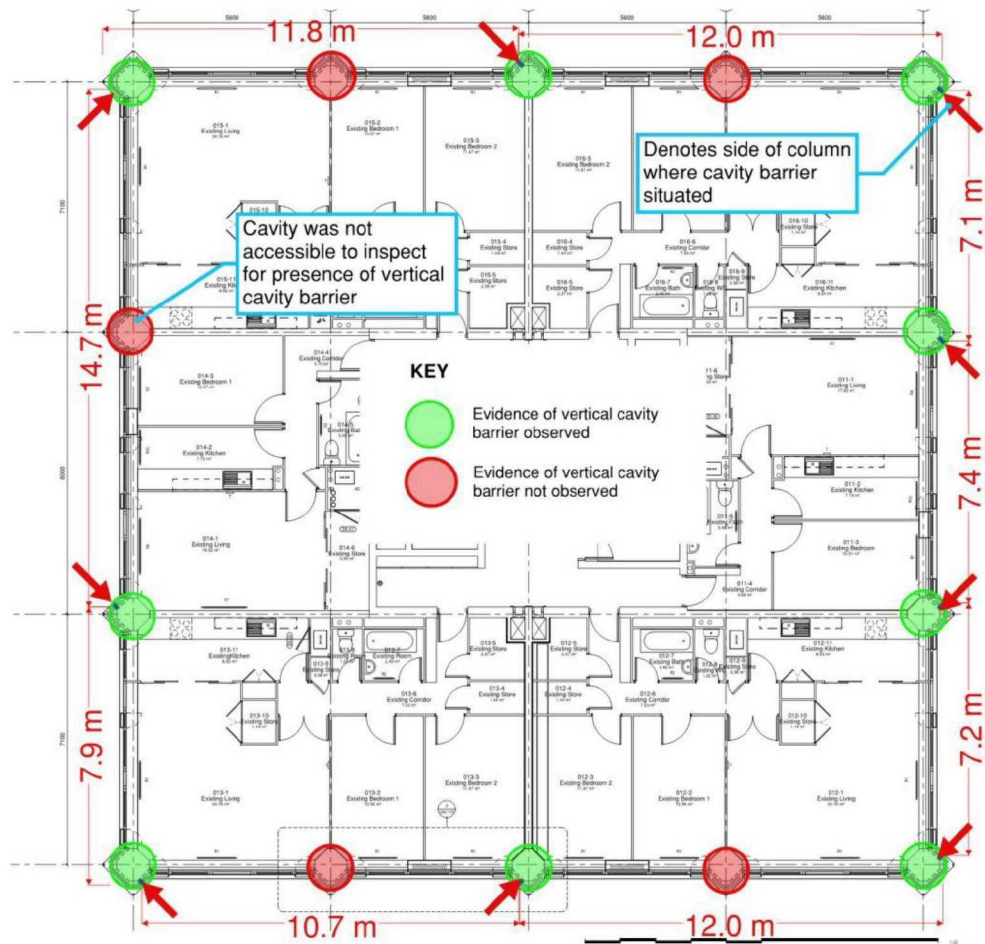
- 10.3.31** As explained in Section 8, these vertical fire stops were not the specific vertical cavity barriers/fire stopping product specified by the designer, they were the horizontal cavity barriers/fire stopping product inserted in a vertical orientation. I observed the presence, or remains of, vertical cavity barriers/fire stops on each corner column, and each column adjacent to party walls. At column B1 I saw no remnants of a vertical cavity barrier on the upper levels inspected and I was not able to inspect the remaining cavity at Level 4 (See Note Figure 10.14).

Figure 10.14: Location and separation (as measured from plan) of vertical fire stops as identified during post fire inspection (SEA00010474)

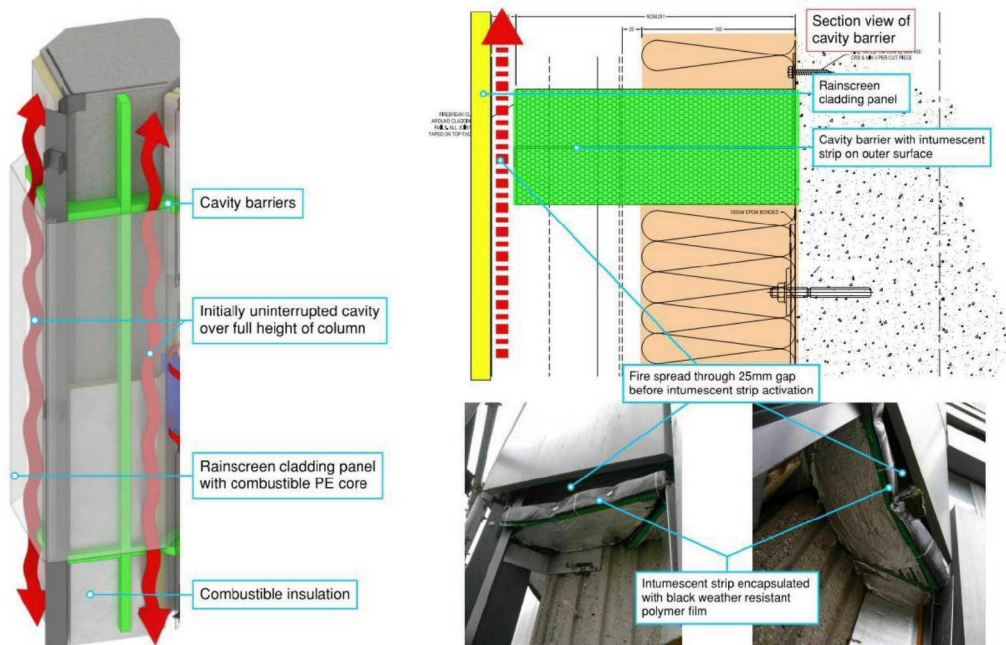
10.3.37 **Horizontal cavity barriers** - The initial condition of the cavity is that it is continuous up the full height of the column, prior to activation of the intumescent coating (Figure 10.17):

Figure 10.17: Continuity of the cavity within the column rainscreen over cladding system and evidence of 25mm gaps at locations of cavity barriers (Photos external of Flat 14). (HAR00008901)

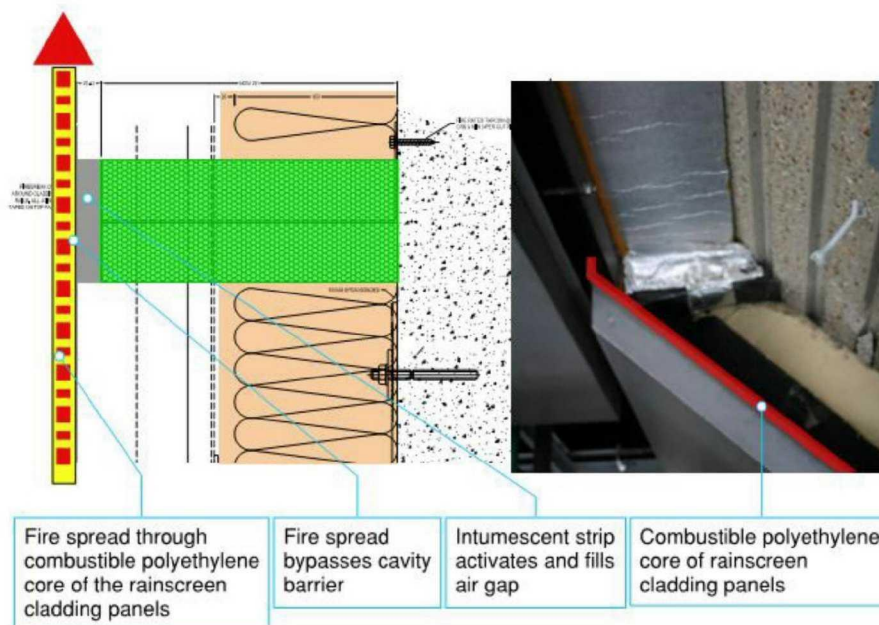
10.3.38 Horizontal & vertical barriers – The combustible polyethylene core of the rainscreen cladding panel itself provides a route of fire spread, bypassing the cavity barriers (Figure 10.18):

Figure 10.18: Fire spread through the combustible rainscreen cladding panel core (Photo external of Flat 14) (HAR00008901)

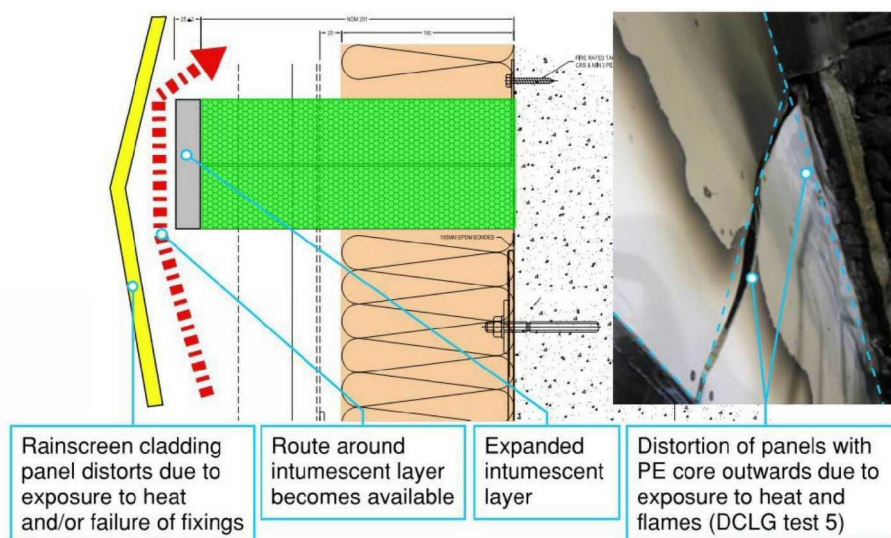
10.3.39 Horizontal & vertical barriers – Rainscreen cladding panels can distort when heated, either through heating of the panel itself or by failure of the supporting fixtures. This can allow further gaps between the cavity barriers and the rainscreen cladding panels to form (Figure 10.19):

Figure 10.19: Integrity failure of rainscreen cladding (HAR00008901) (photo: CLG00016837)

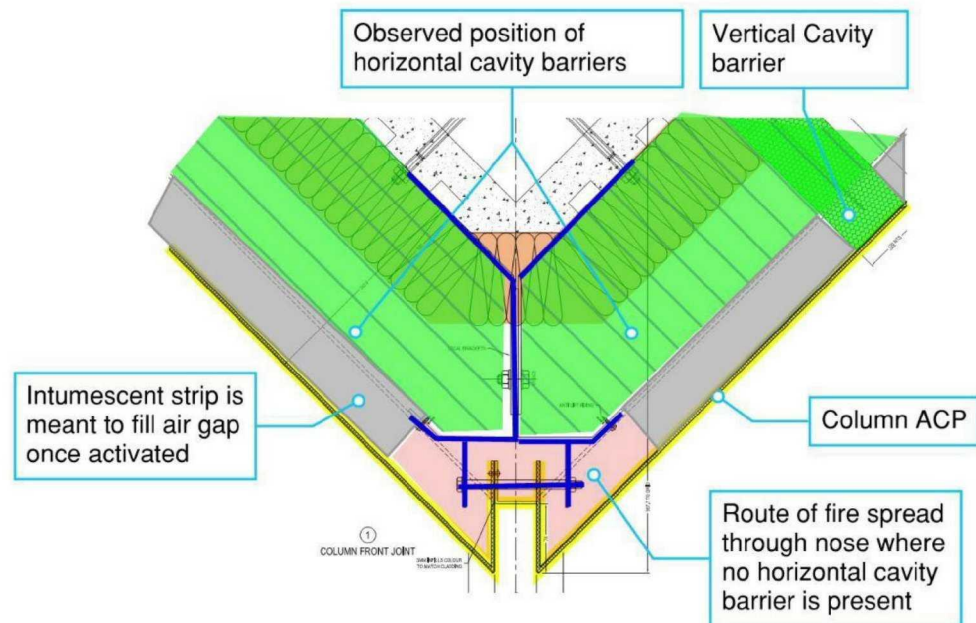
- 10.3.40** The performance of the cavity barriers in restricting the spread of fire was also compromised at the nose of the column, due to the specific geometry of the ACP and support bracket. As illustrated in Figure 10.20, a gap where the horizontal cavity barrier was not present existed at the nose, which provided another route of fire spread past the horizontal cavity barriers.

Figure 10.20: Harley design drawing showing column in plan view showing a gap where the horizontal cavity barrier was not present at the nose of the columns (Based on HAR00008902)

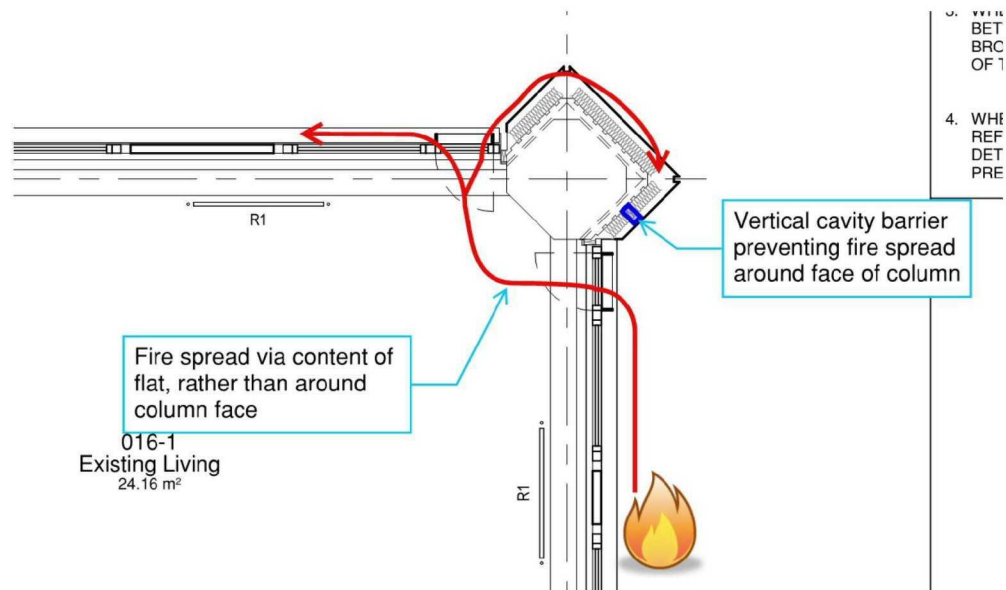
- 10.3.41 Columns with no vertical cavity barriers** – In this case the column contains no impediment to the horizontal spread of fire around the building envelope (For example Column A2, A4, D2 and D4).
- 10.3.42 Corner columns with vertical (and horizontal) barriers** – as described in Section 9, the materials and construction of the window installations also provide a Pathway for fire to spread rapidly between the flats and the rainscreen cavity (from inside to outside, and vice versa). This introduces a further avenue for bypassing the vertical cavity barriers situated on the corner columns (Figure 10.21):

Figure 10.21: Route for fire to bypass corner column cavity barrier (based on SEA00010474)

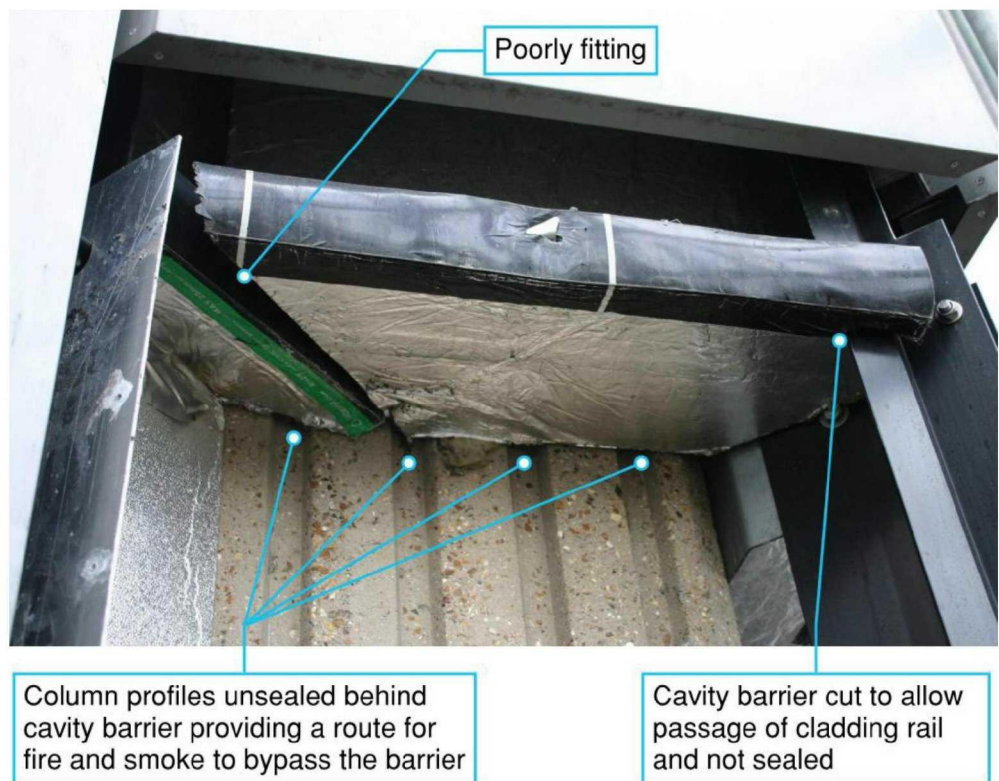
- The same product (Siderise RH25 with an intumescent strip) used for horizontal cavity barriers was used for the vertical cavity barriers, with the intumescent strip facing the concrete.

Figure 10.23: Horizontal cavity barrier in column cavity - floor 4, external Flat 12.

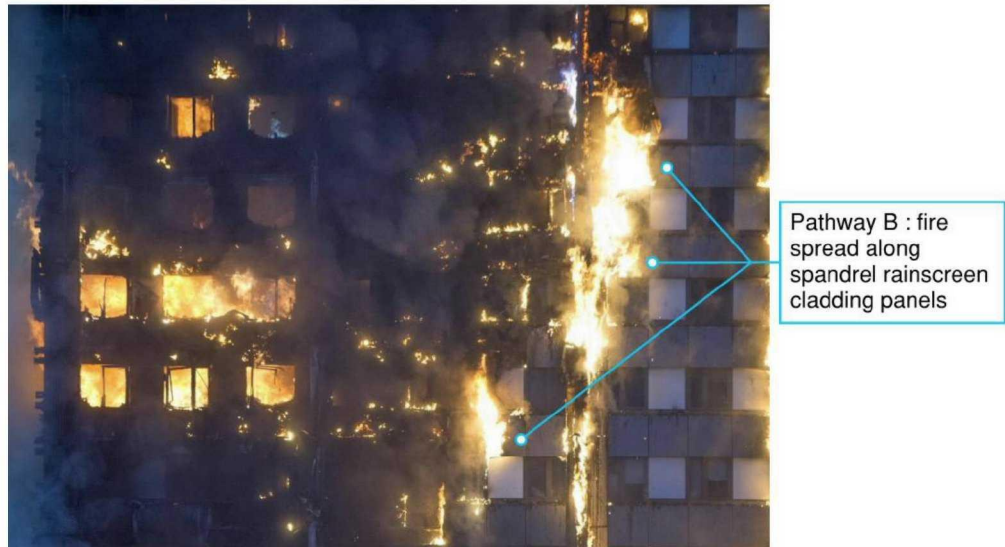
Figure 10.24: Evidence of fire spread along Reynobond panels⁵

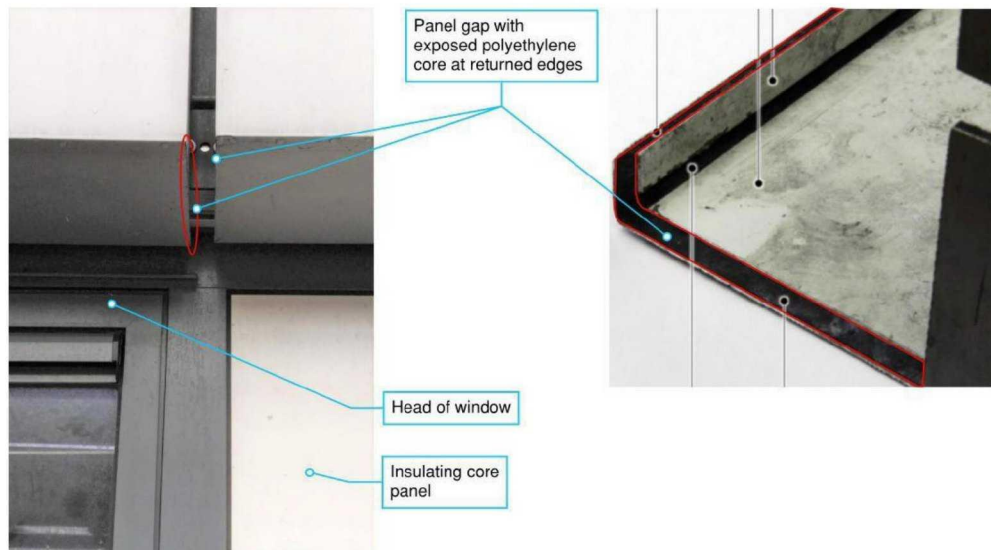
Figure 10.26: Photograph outside Flat 10 showing gaps (with combustible PE core exposed at panel edges) permitting air into the cavity (also refer to Figure 10.2) (Prof. Bisby's phase 1 report figure 20)

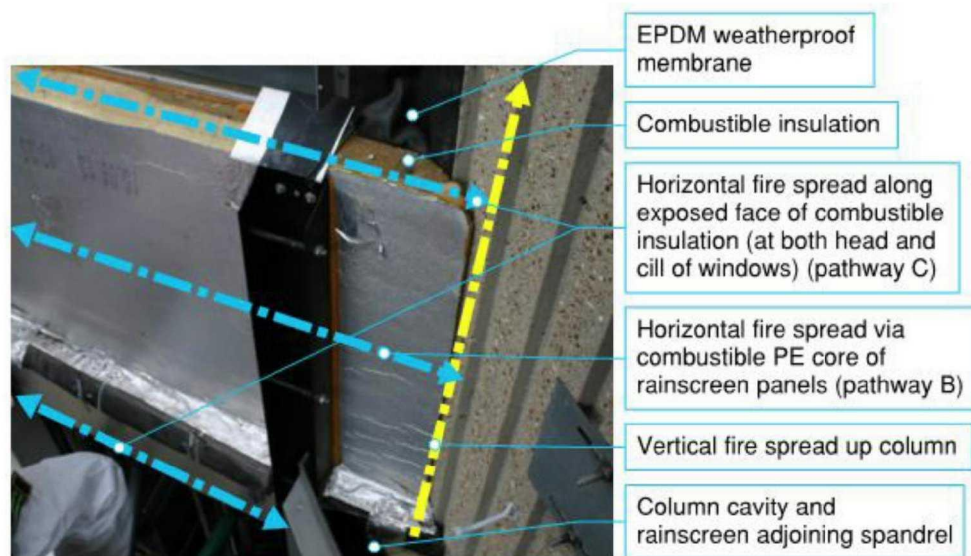
As identified in Figure 10.28, the exposed edges of the insulation support flame spread to a greater extent than if the edges had been covered in aluminium foil taping. PIR or PF insulation covered by aluminium foil has a higher resistance against flame spread compared to the uncovered material. This is because the aluminium foil covering acts to reflect radiant heat, and to prevent flames from reaching combustible gasses being released as the PIR heats up. However, this protection only lasts until the thin layer of aluminium is damaged or destroyed by the fire. So in the early stages of fire spread across the material, the cut edges will be more prone to support flame spread.

Figure 10.28: Exposed insulation in spandrel panel rainscreen cavity (External Flat 14)

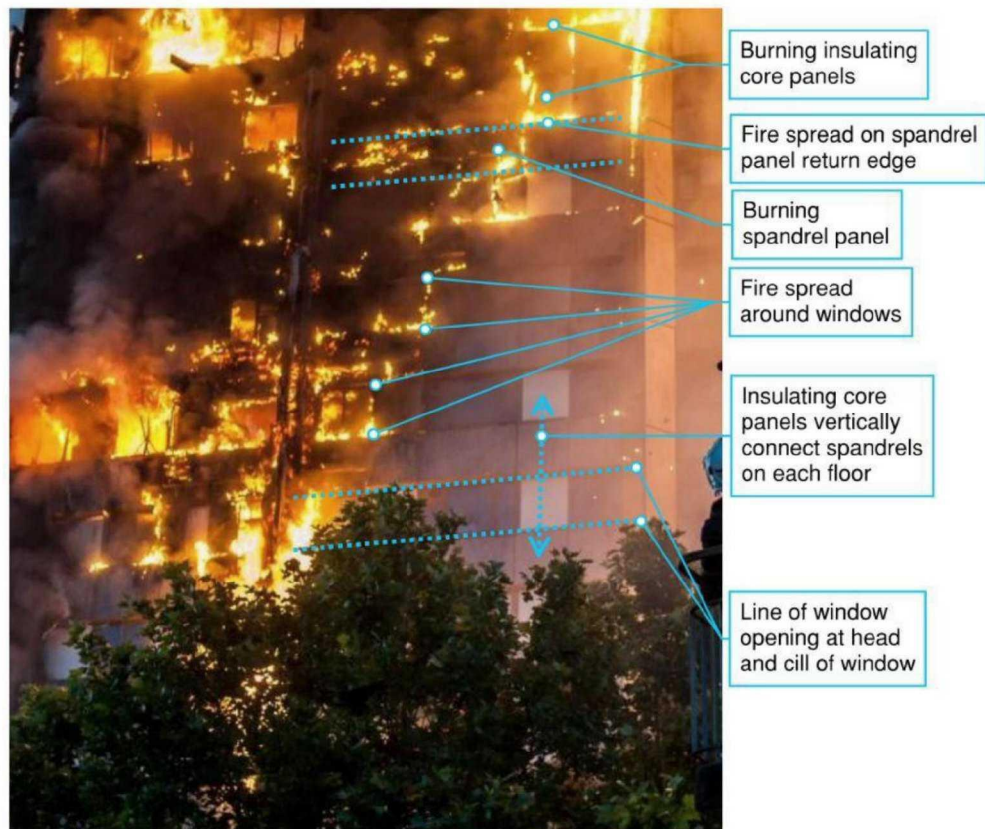
10.5.2 Fire spread was observed along the line of the window openings (all sides), as shown in Figure 10.30, and along the edges of the infill panel:

Figure 10.30: Photo evidence of fire spread observed along the line of window openings, at head and cill⁶

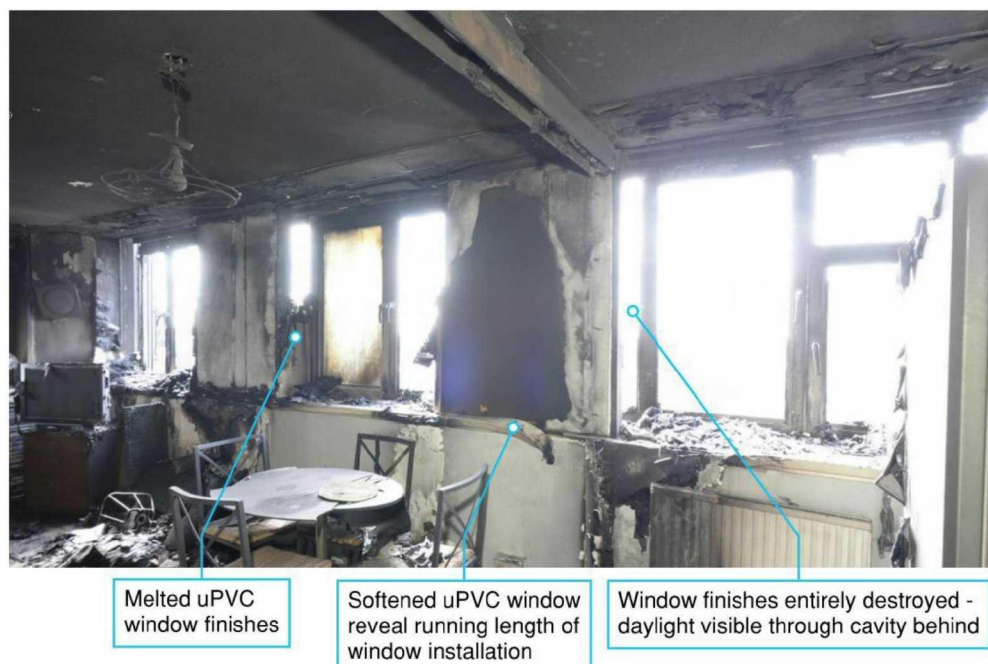
Figure 10.32: Internal example showing the uPVC cill reveal spanning the length of the window internally, passing by the inside of the original in-fill panel

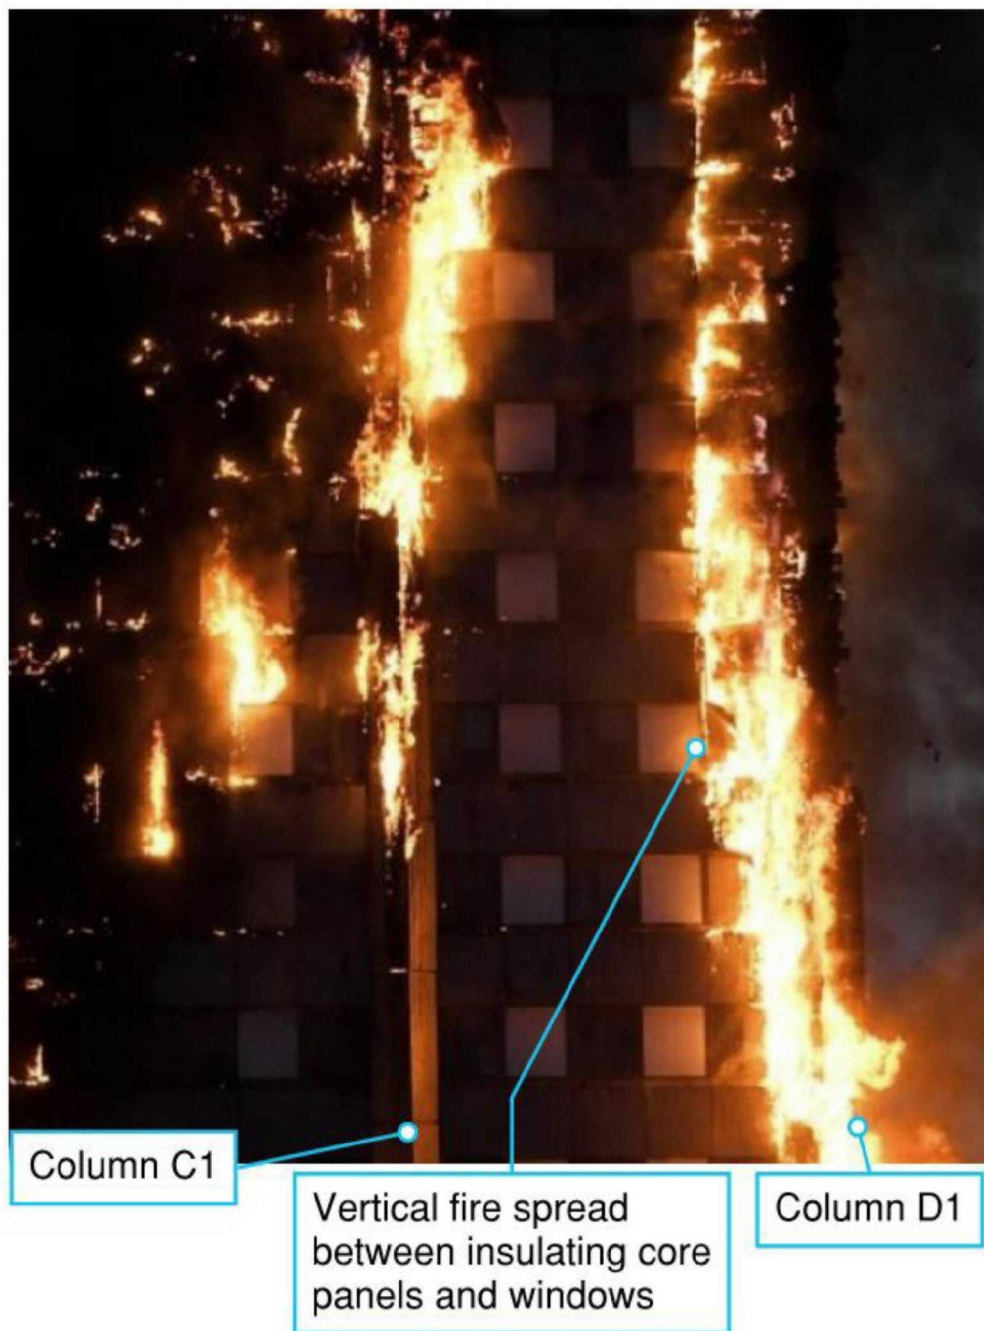
10.6.2 Figure 10.34 provides evidence that fire spread vertically along the edges of the window and the edges of the infill insulating core panel. Figure 10.34 shows external fire spread observed between columns C1 and D1, where Route 1 and 2 (Figure 10.1) met on the West elevation.

Figure 10.34: Photo evidence of vertical fire spread at the junction between the insulating core panels and windows⁷

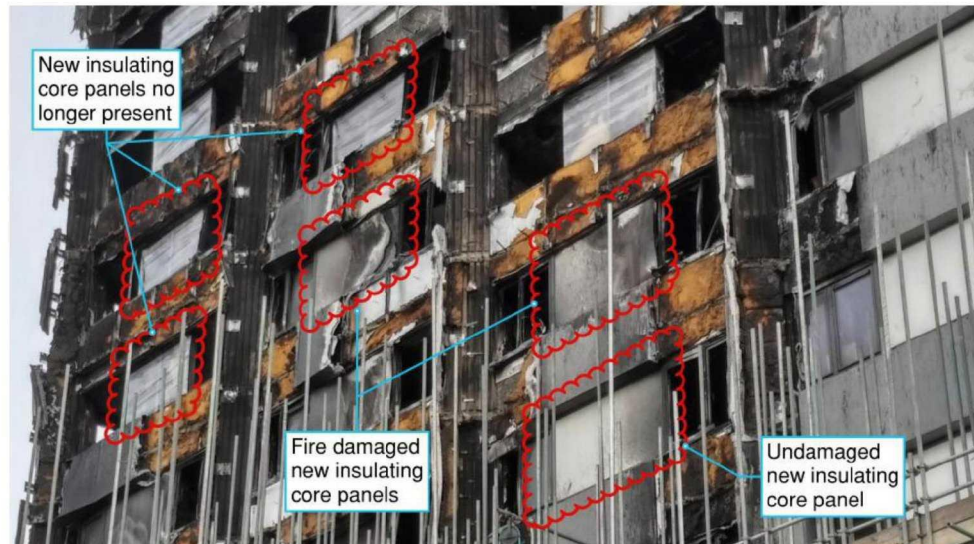
10.6.9 It can be seen in the case of the fire damaged panels that the aluminium skin has failed and revealed the 25mm Styrofoam XPS core, allowing oxygen in the air to access the fuel surface.

Figure 10.35: Evidence of fire damage to new insulating core panels

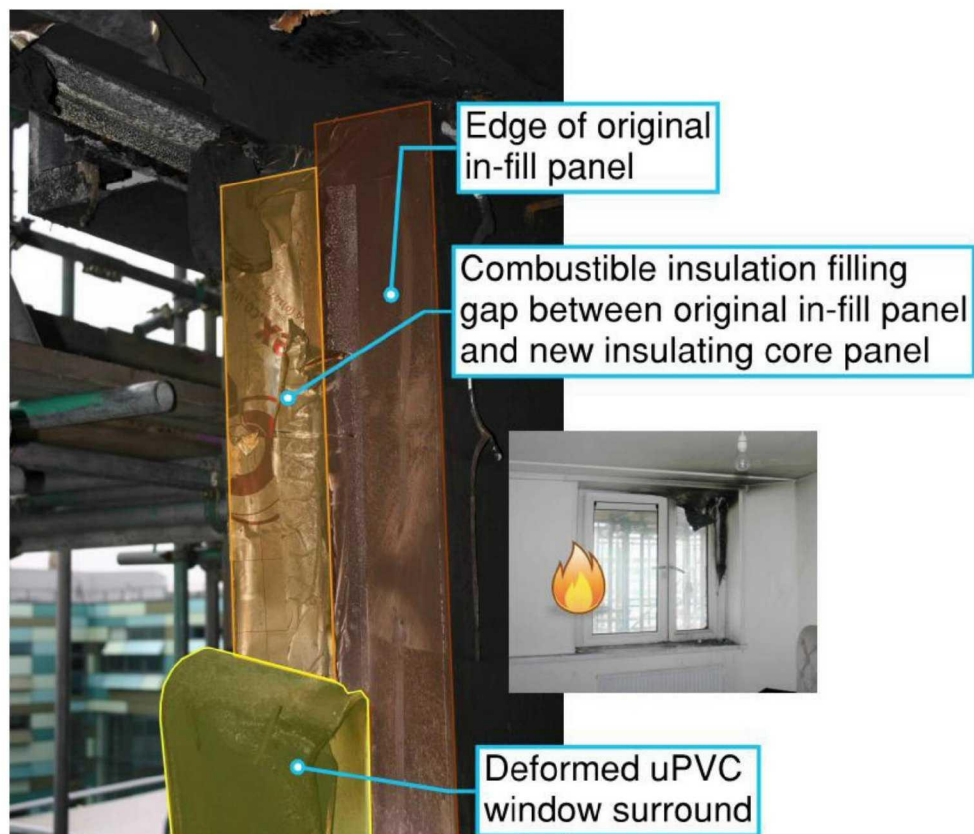
Figure 10.36: Effect of fire on the infill panel side of the window (Flat 16 living room window) with example location inset

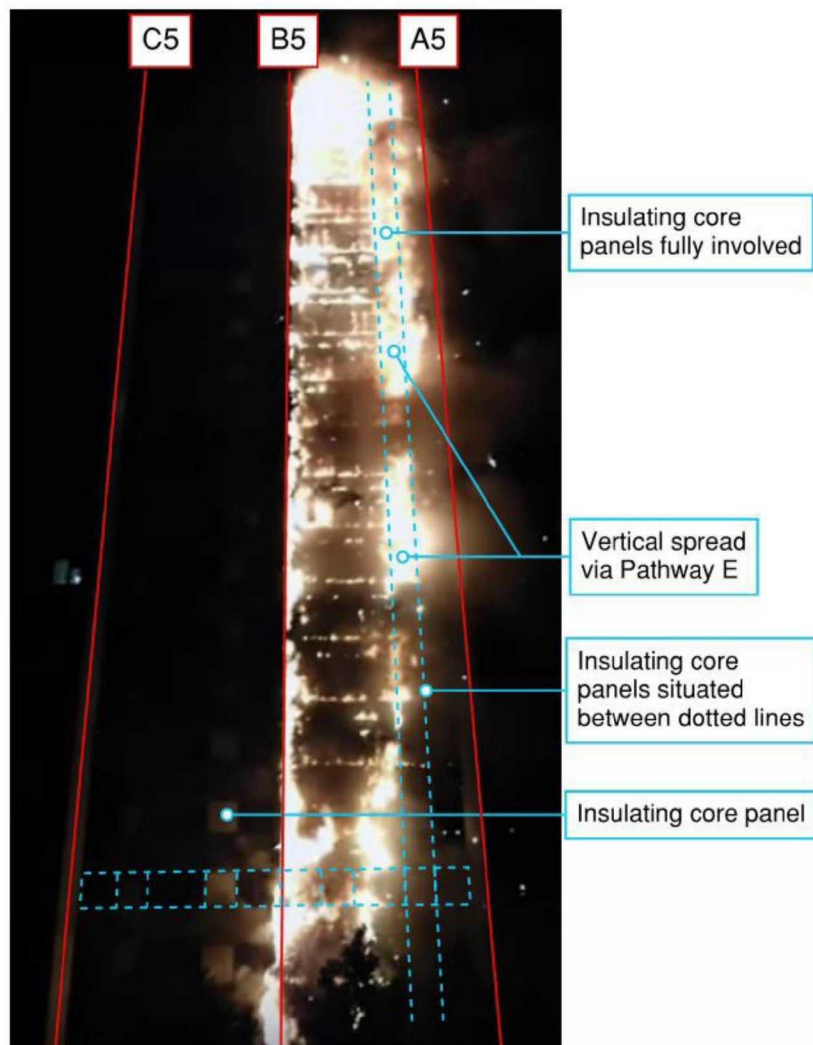
Figure 10.37: Photo evidence of vertical fire spread up insulating core panels, estimated time 01:26⁸

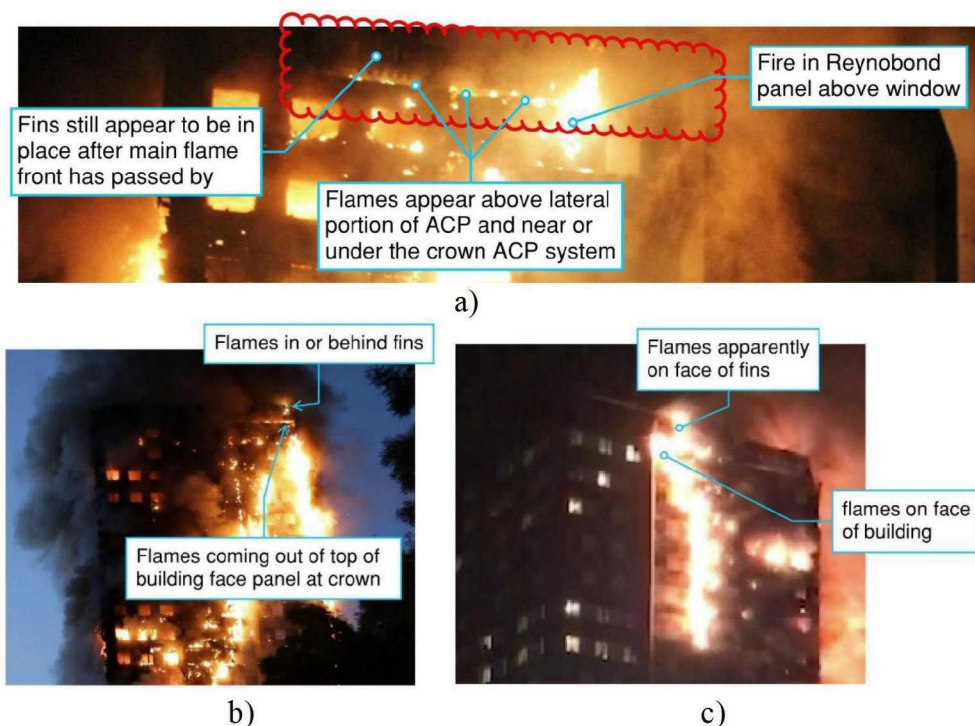
10.8.2 Fires were observed to be burning in and around the crown cladding construction, as shown in Figure 10.39.

Figure 10.39: Fire in the crown construction (see Video 5 accompanying Prof. Bisby's supplemental Phase 1 report)^{9, 10}

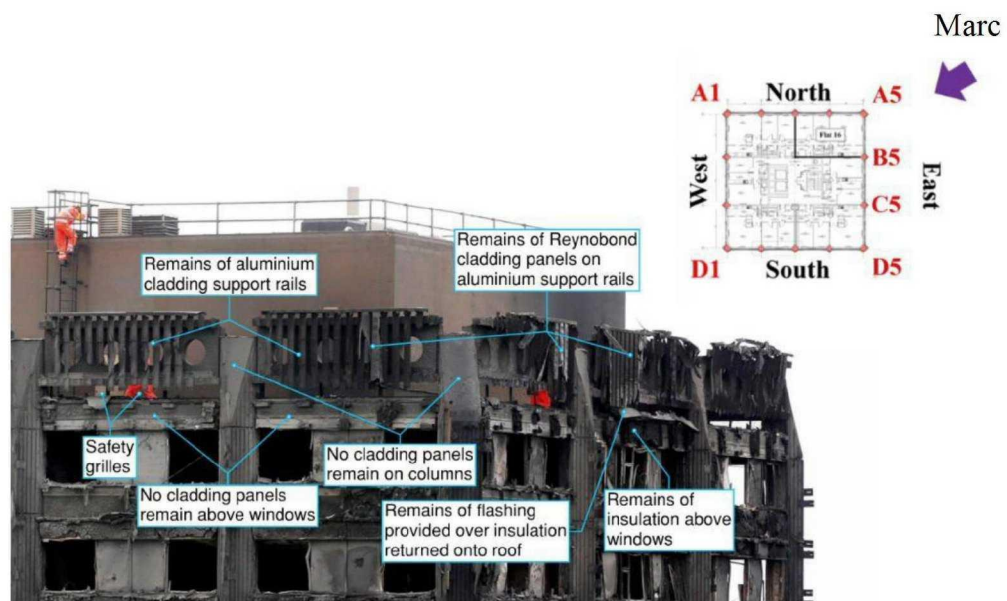
Figure 10.40: Post fire remains of crown cladding¹¹ (Plan drawing: SEA00010474)

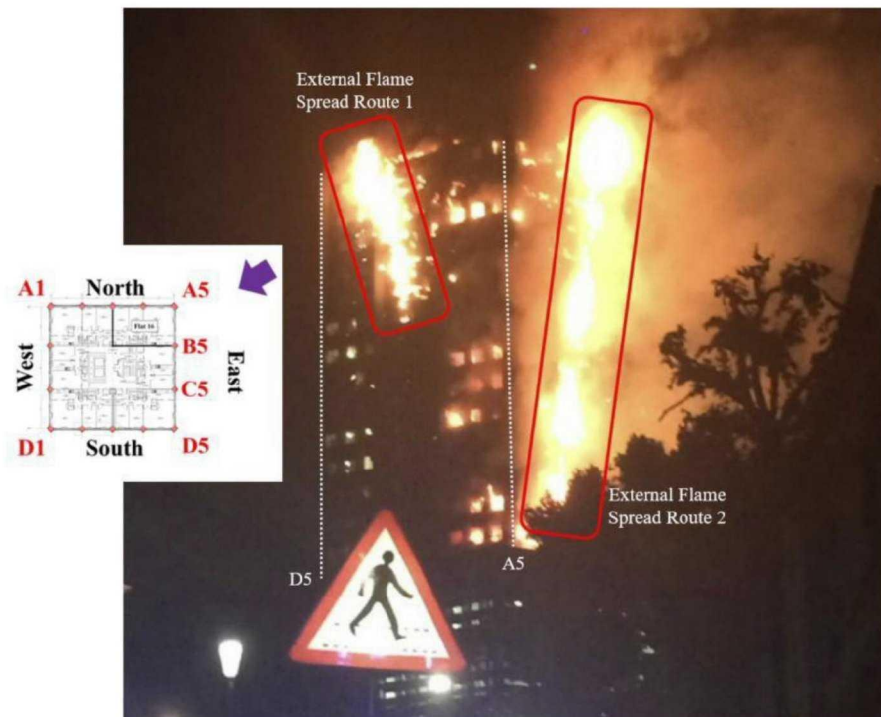
- 10.8.9** In most of the photographic and video evidence I reviewed of external fire spread after 02:08, I observed a consistent diagonal pattern of fire spread along both External Flame Spread Route 1 and 2, as shown in Figure 10.41, Figure 10.42 and Figure 10.43. The most advanced point of fire spread along the diagonal at any one time is located at the Crown.

Figure 10.41: Diagonal pattern for External Flame Spread Routes 1 and 2 at 02:08 on 14th June 2017 (MET00012593) (SEA00010474)

- 10.8.10** This consistent diagonal pattern of flame spread indicates that fire advanced laterally along the crown before it spread to lower levels. In Section 10.10.14, I will describe the effect of the fire spreading at crown level before lower levels.
- 10.8.11** Behind the balustrade is the roof top plant room as well as a walking area; refer to Figure 10.45.
- 10.8.12** Figure 10.44 and Figure 10.45 identify that there is no evidence of fire spread over the surface of the roof. Damage and debris are largely present only at the perimeter of the roof.

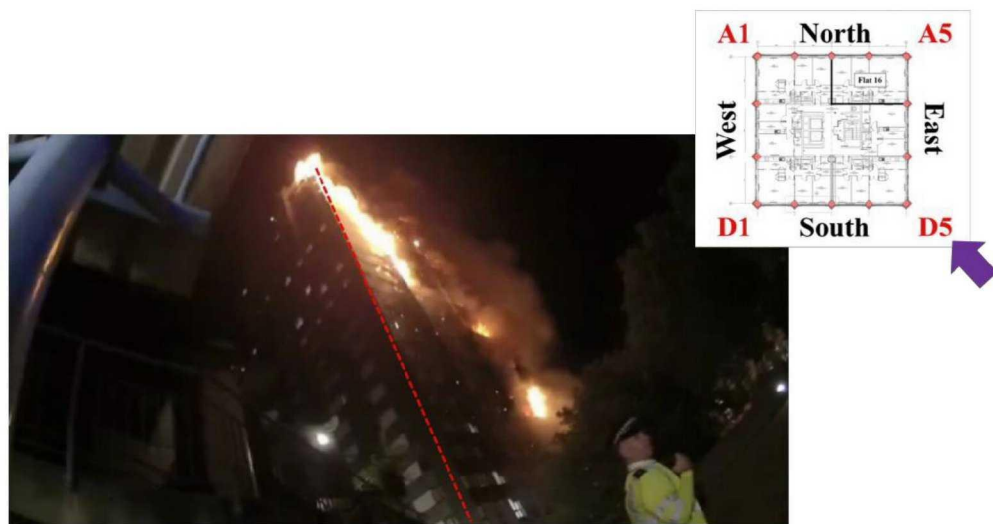
Figure 10.42: Diagonal flame front along External Flame Spread Route 2, that is, around column D5 (southeast corner of building), from East elevation to South elevation of the building envelope at 02:33 on 14 June 2017 (MET00012593) (SEA00010474)

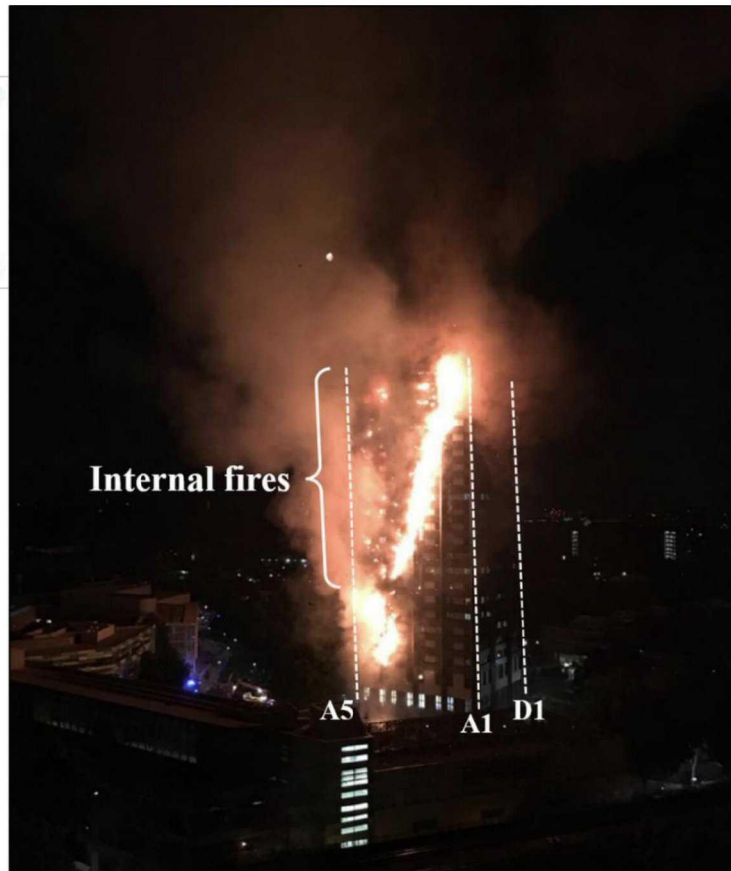
Figure 10.43: Diagonal flame front along External Flame Spread Route 1, that is, on the North elevation of the building envelope at 02:34 on 14 June 2017 (MET00012593) (SEA00010474)

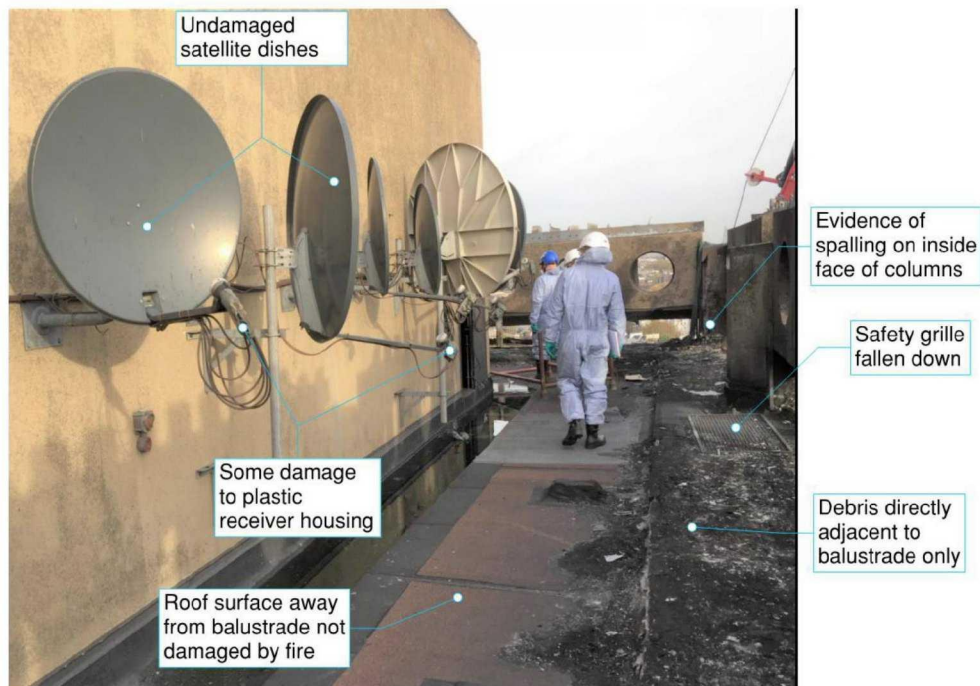
Figure 10.44: Evidence of post-fire condition along the South of the roof taken during my inspection [South]

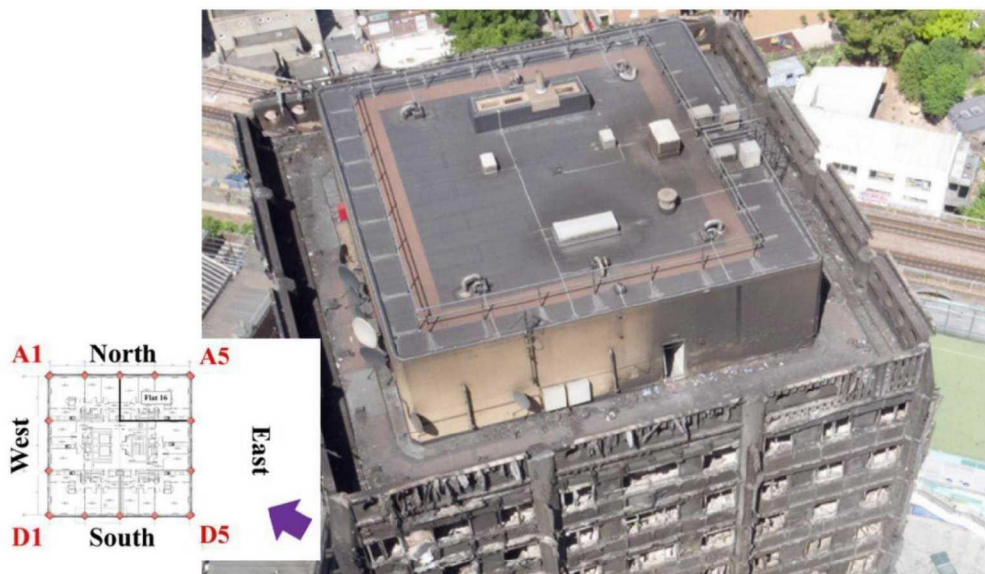
Figure 10.45: Aerial view of overall roof conditions post-fire [East] (MET00012593)
