Grenfell Tower – fire safety investigation:
The fire protection measures in place on the night of the fire, and conclusions as to:
the extent to which they failed to control the spread of fire and smoke;
the extent to which they contributed to the speed at which the fire spread.

Phase 1 Report – Section 10

Routes for vertical and horizontal fire spread throughout the building envelope

Dr Barbara Lane FREng FRSE CEng

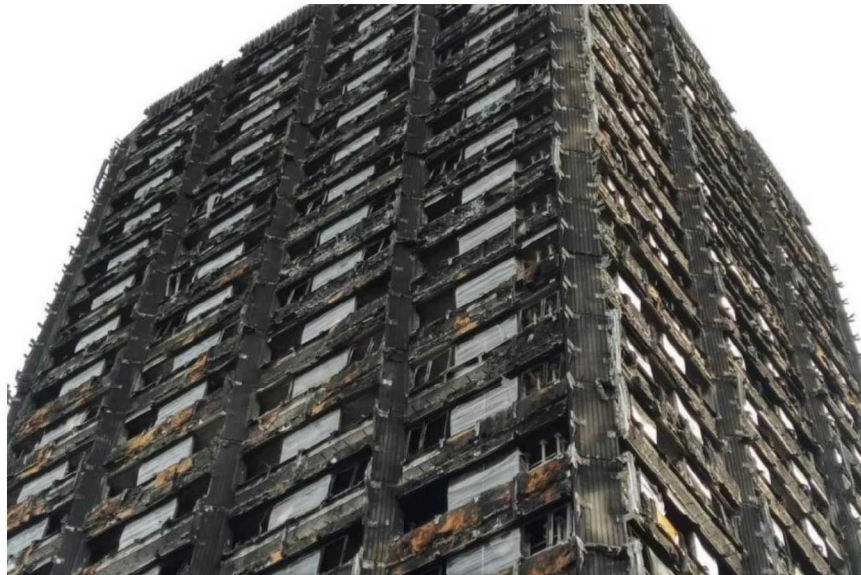
Figure 10.50: Reynobond 55 PE panels and Styrofoam XPS insulating core panels destroyed in all areas

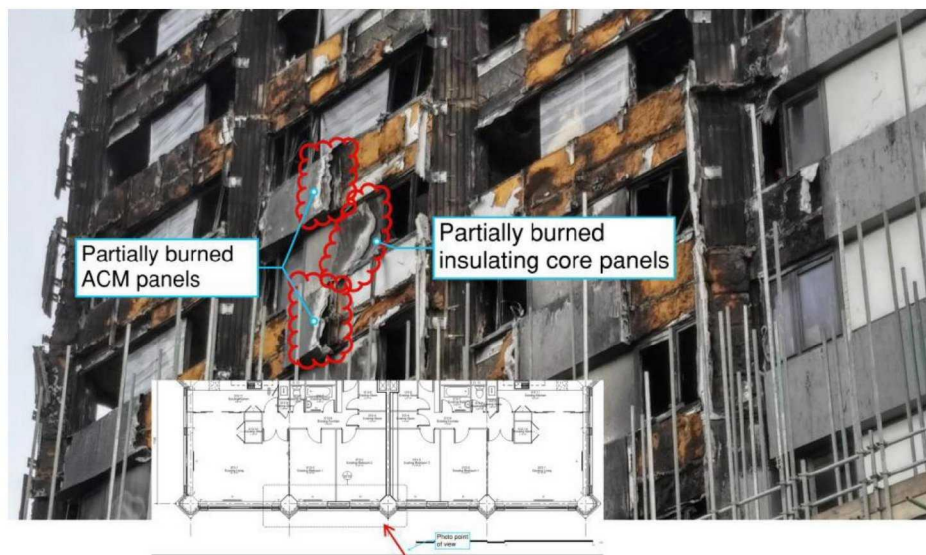
Figure 10.51: Partially burned Reynobond 55 PE panel and Styrofoam XPS insulating core panel on South façade on lower levels

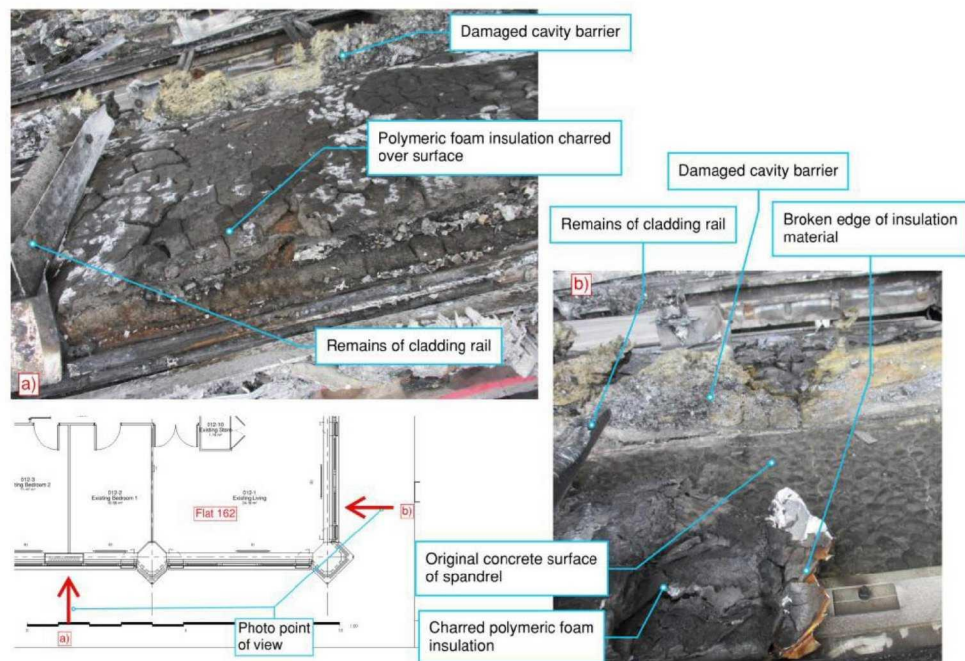
Figure 10.52: Charred polymeric foam insulation on the outside of Flat 162 (photos taken looking down out of window)

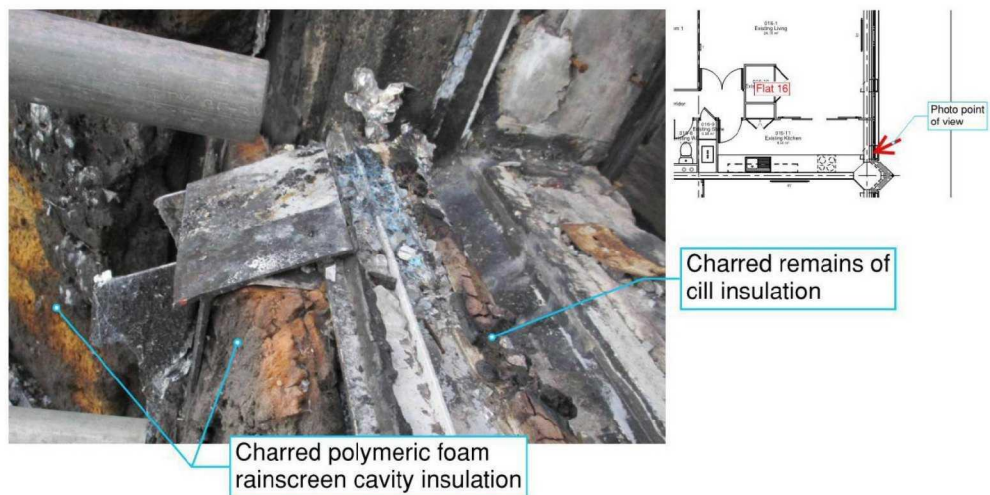
Figure 10.53: Charred polymeric foam insulation in cill cavity and in rainscreen cavity

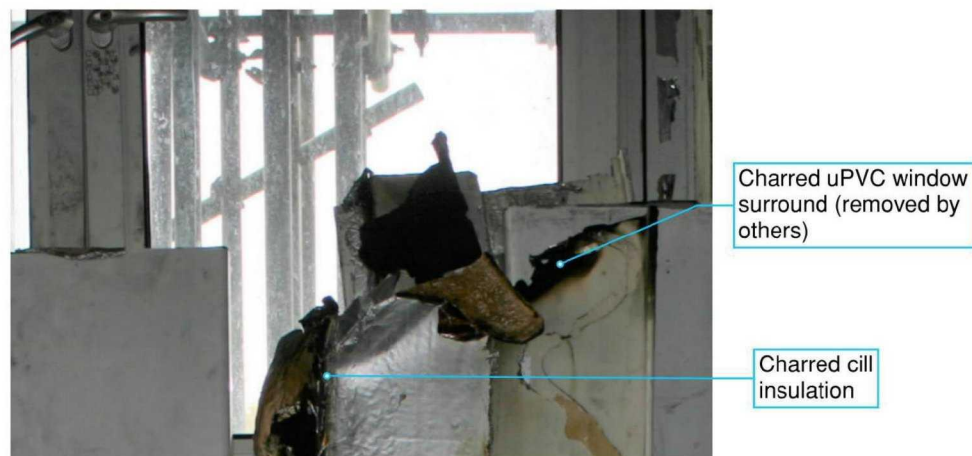
Figure 10.54: Evidence of burned uPVC and cill insulation in Flat 15

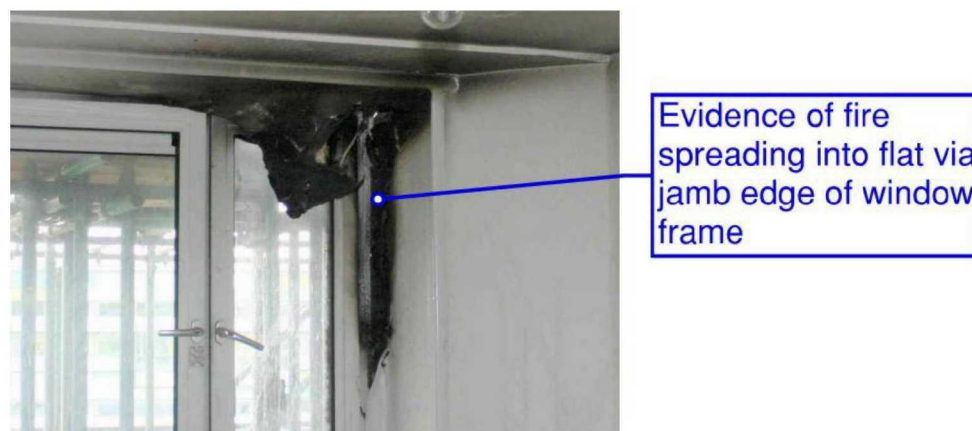
Figure 10.55: Burned uPVC frame in Flat 15

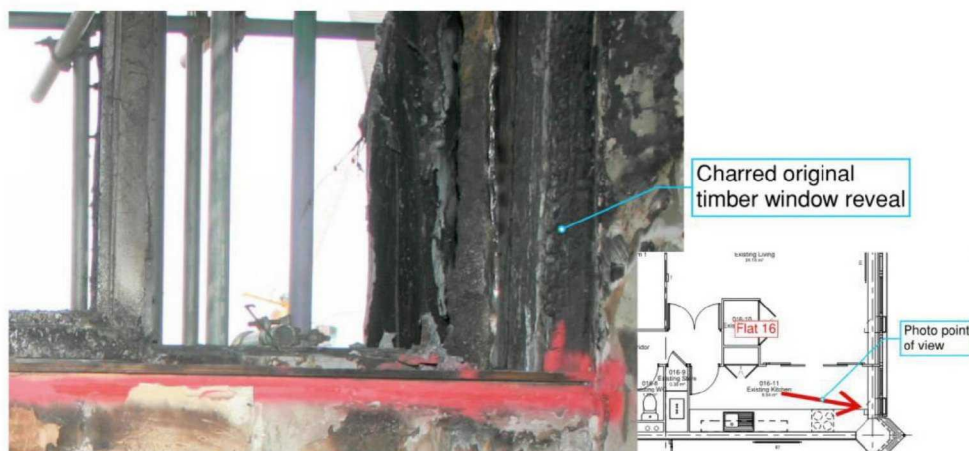
Figure 10.56: Charred timber reveal in Flat 16

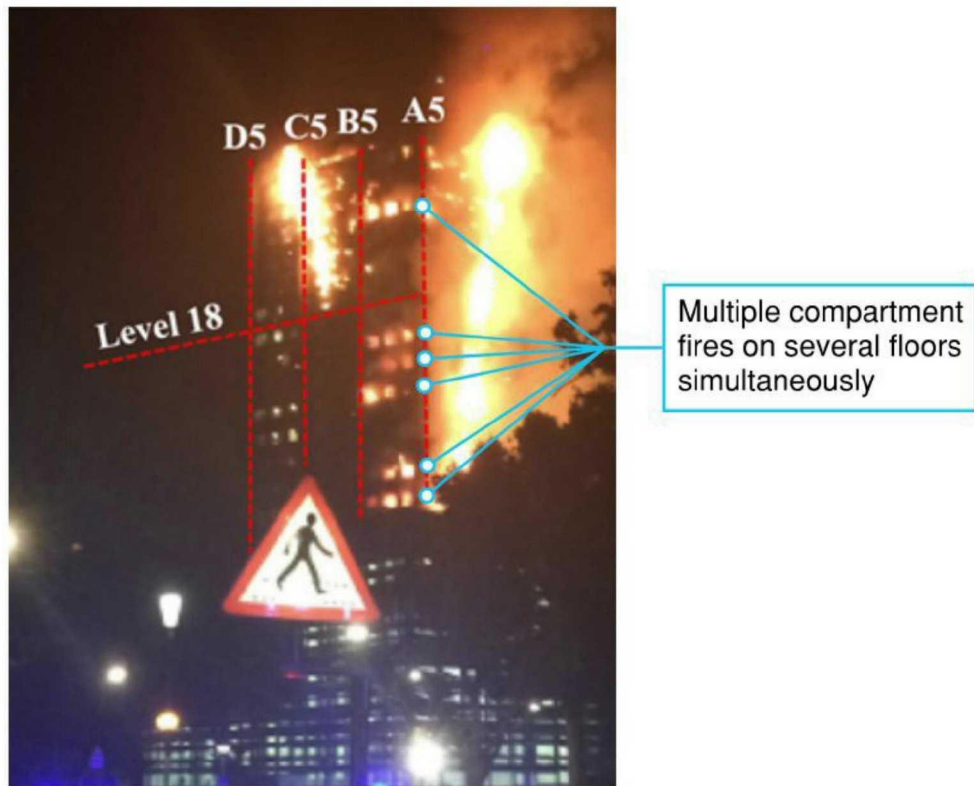
- 10.10.8** On this basis the scenario of multiple compartment fires developing on multiple floors, and soon after the initial fire spread, was made possible and in fact occurred. Multiple compartment fires on several floors burning simultaneously can be seen in Figure 10.60, which is a photograph of the East elevation of the building at 02:08.

Figure 10.60: Multiple simultaneous compartment fires (as external flaming from several windows observed on multiple floors) at 02:08 (MET00012593)

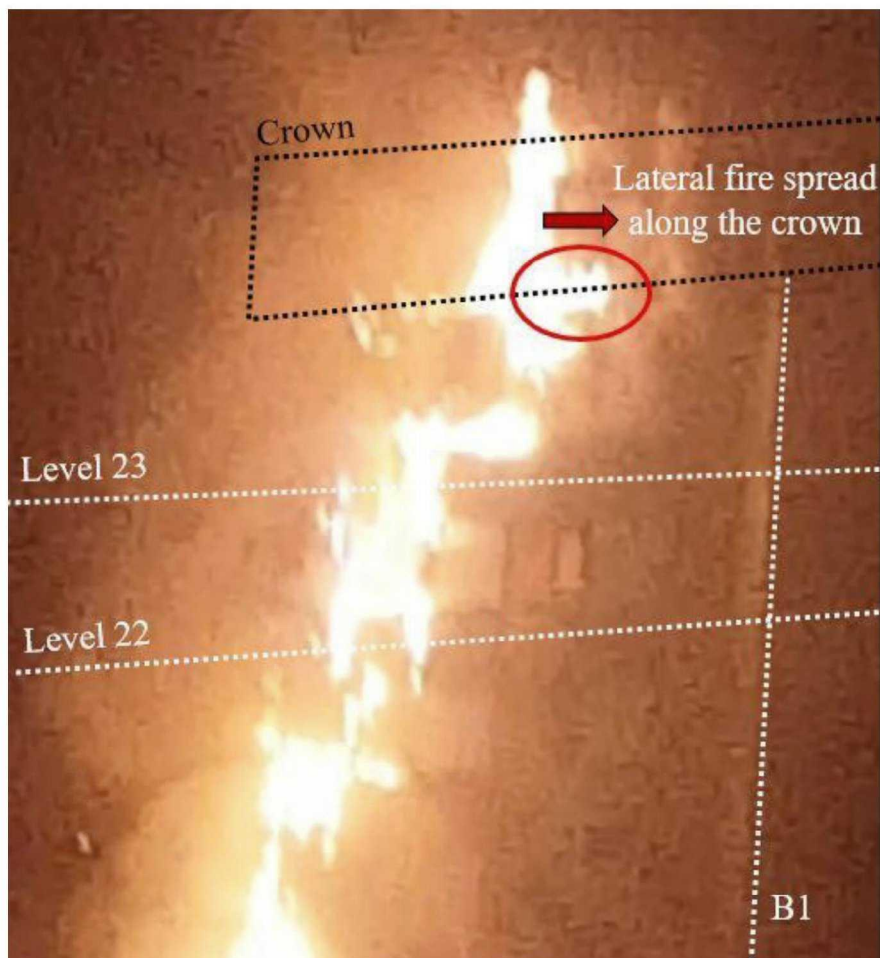
Figure 10.63: Lateral fire spread along the crown on the West elevation at 03:03 on 14th June 2017 (see Video 3 accompanying Prof. Bisby's supplemental Phase 1 report.)

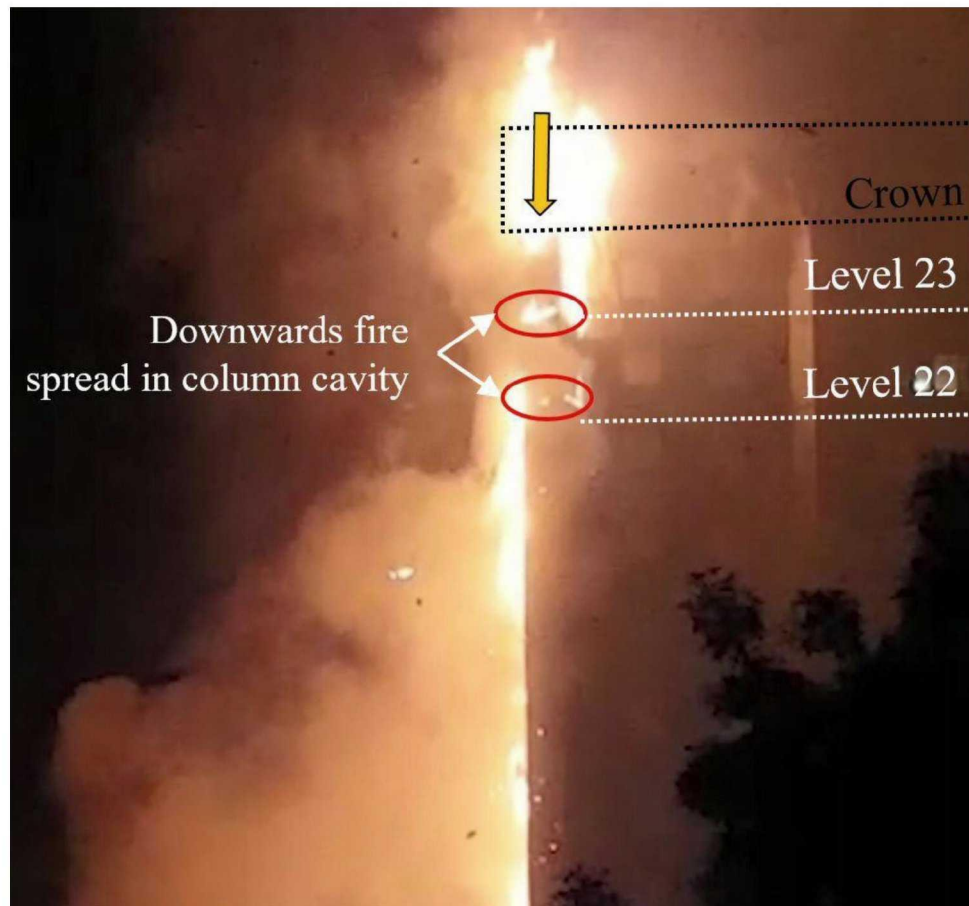
Figure 10.64: Fire spread down the Northwest column (A1) and within the column cavity at 02:51 on 14th June 2017 (see Video 3 accompanying Prof. Bisby's supplemental Phase 1 report)

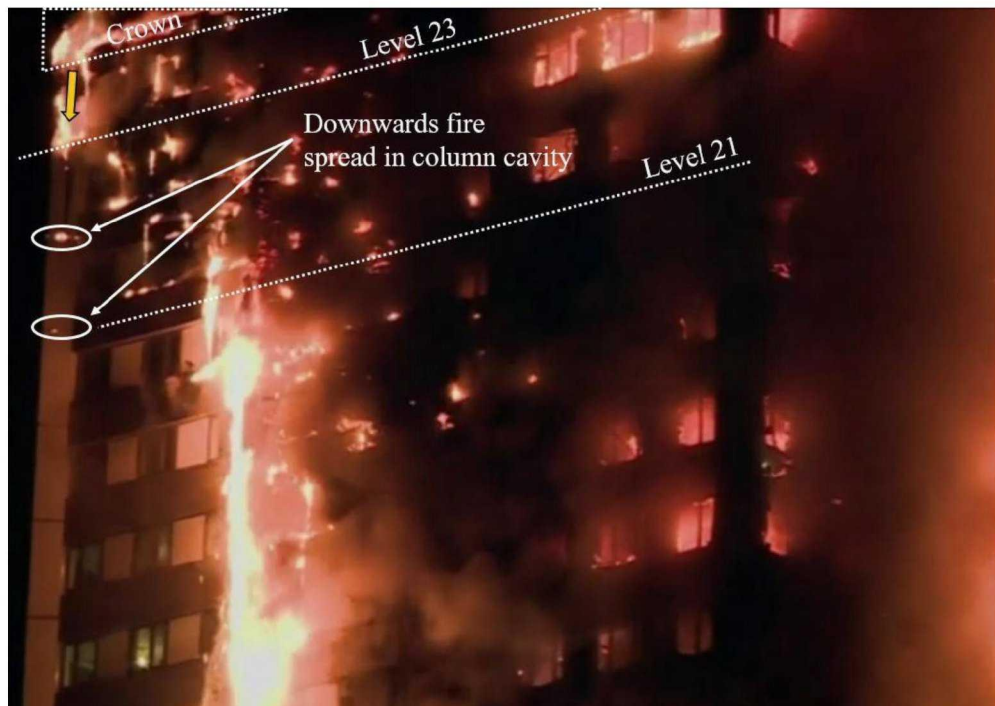
Figure 10.65: External fire spread along the exterior of the Southeast column (D5) and within the column cavity¹⁶

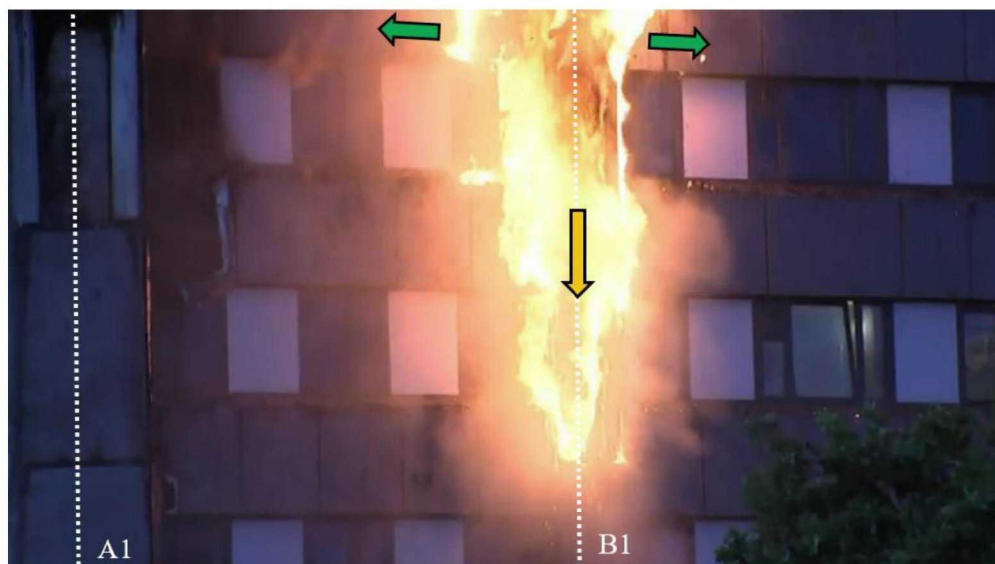
Figure 10.66: Downwards fire spread along column B1 and lateral fire spread in both directions from the column on the West elevation¹⁷

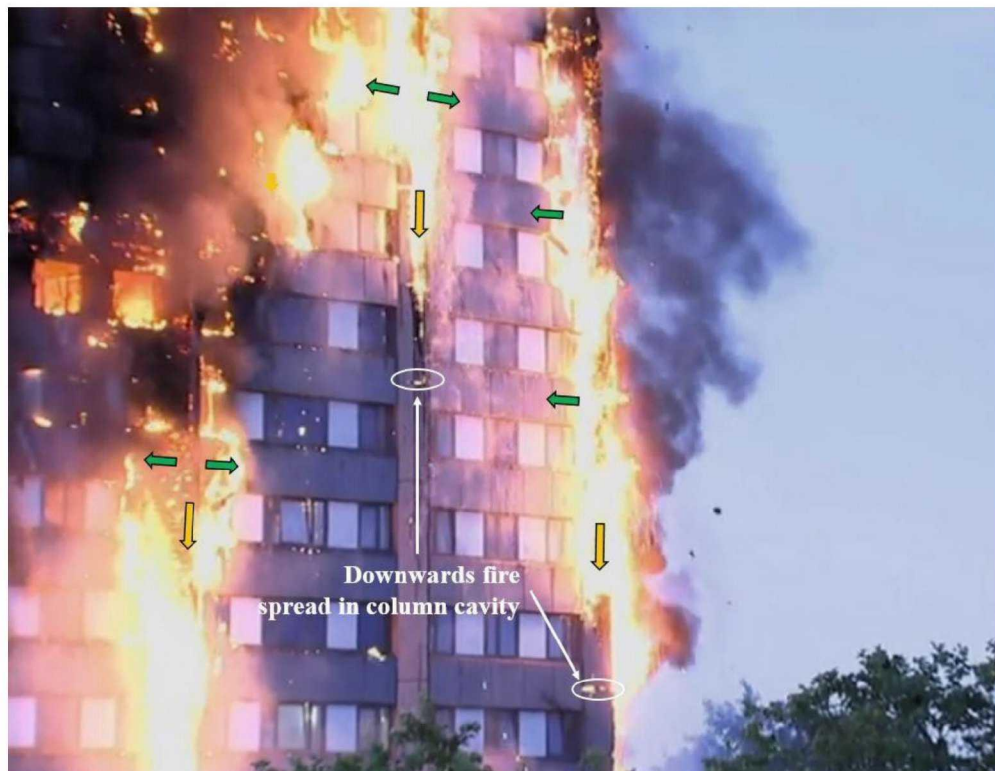
Figure 10.67: Downwards flame spread along columns on the West elevation.¹⁸

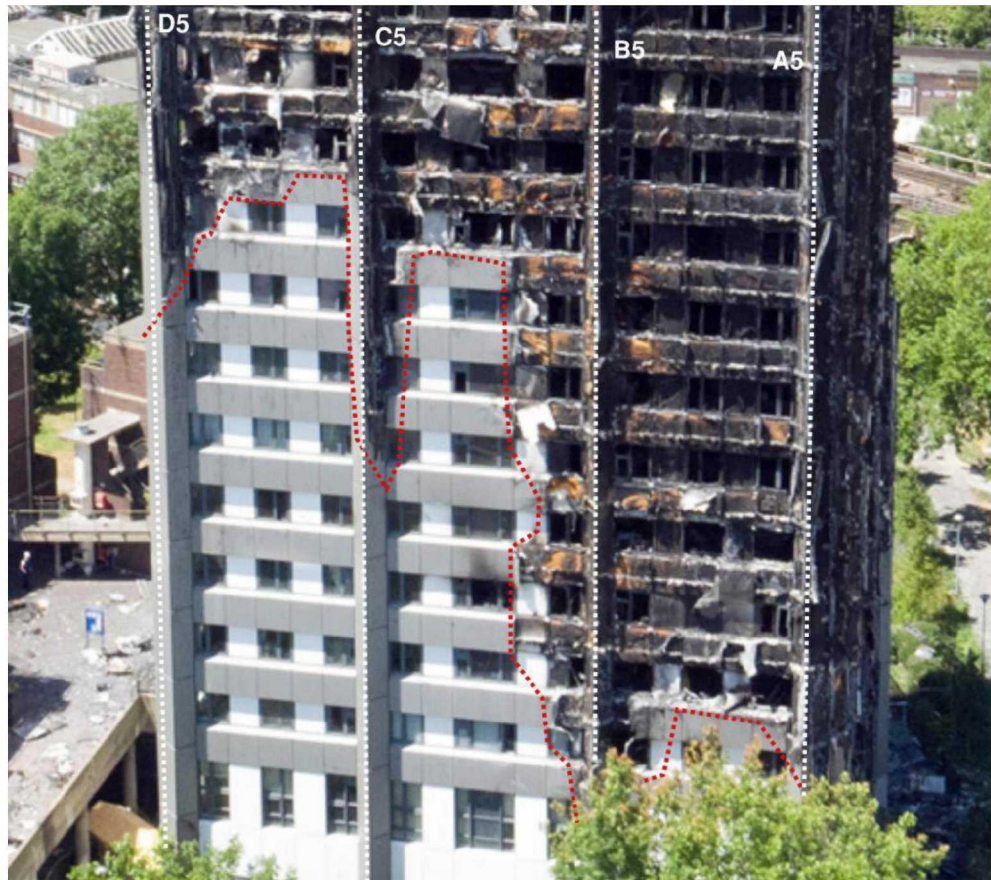
- 10.10.25** I observed a V-shaped pattern on the photographs of post-fire damage shown in Figure 10.68 through Figure 10.71. This V-shaped pattern is centred on each column on each elevation of Grenfell Tower, except for Column B5, which the column the fire spread up initially. These final damage patterns are further evidence that fire spread down the columns (step 2 described in Section 10.10.22) and then laterally away from the column in both directions (step 3 described in Section 10.10.22).

Figure 10.68: Post-fire damage on East elevation of Grenfell Tower (METS00020589)

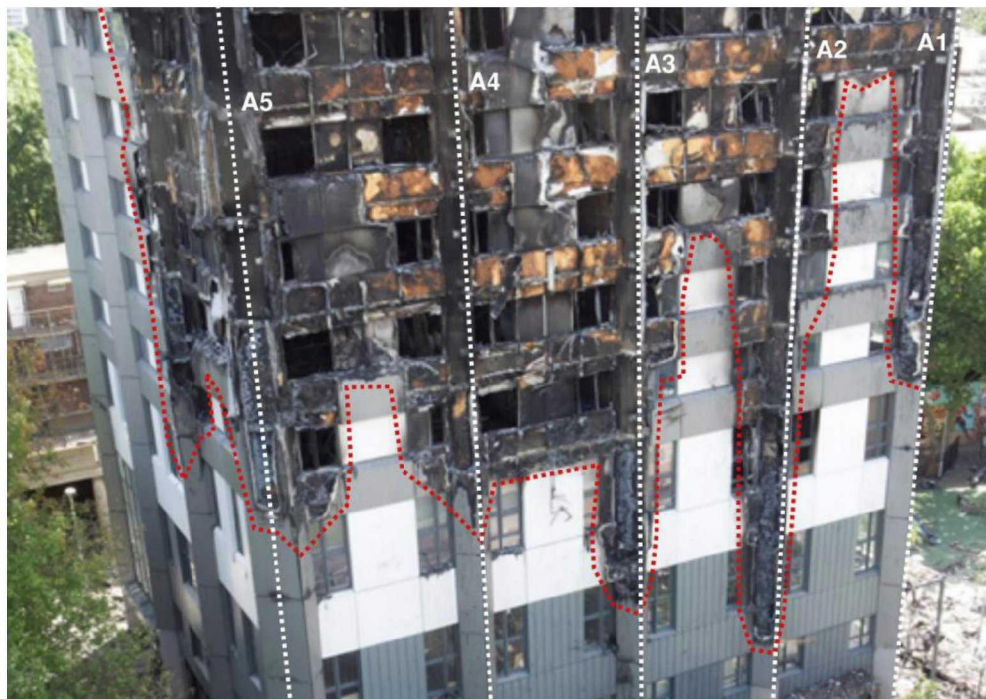
Figure 10.69: Post-fire damage on North elevation of Grenfell Tower (METS00020592)

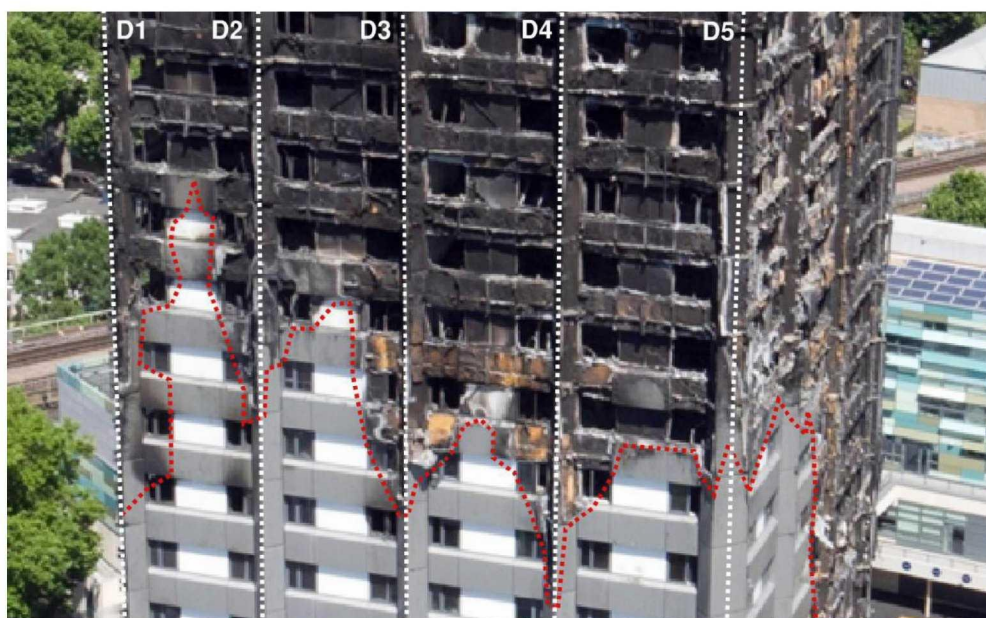
Figure 10.70: Post-fire damage on South elevation of Grenfell Tower (METS00020582)

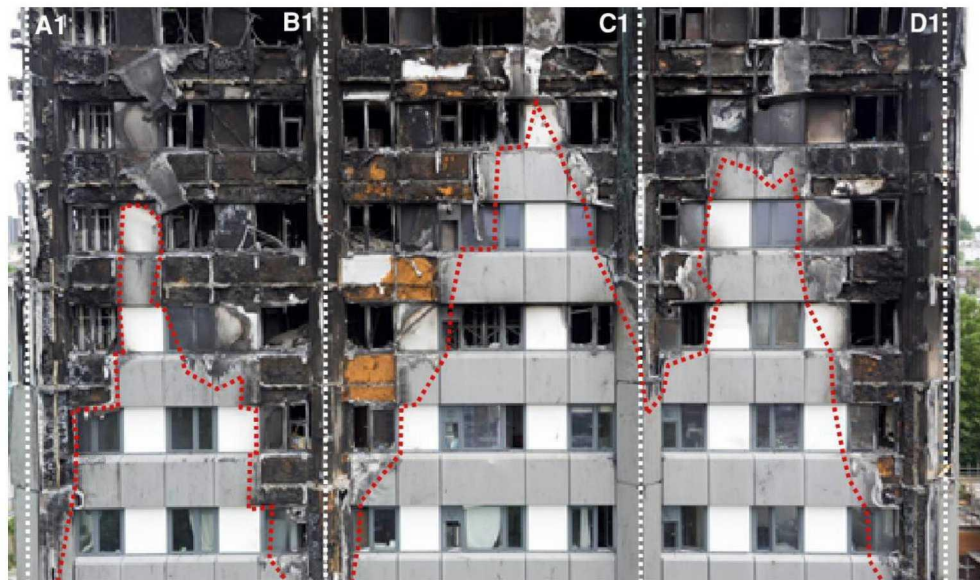
Figure 10.71: Post-fire damage on West elevation of Grenfell Tower (METS00020661)

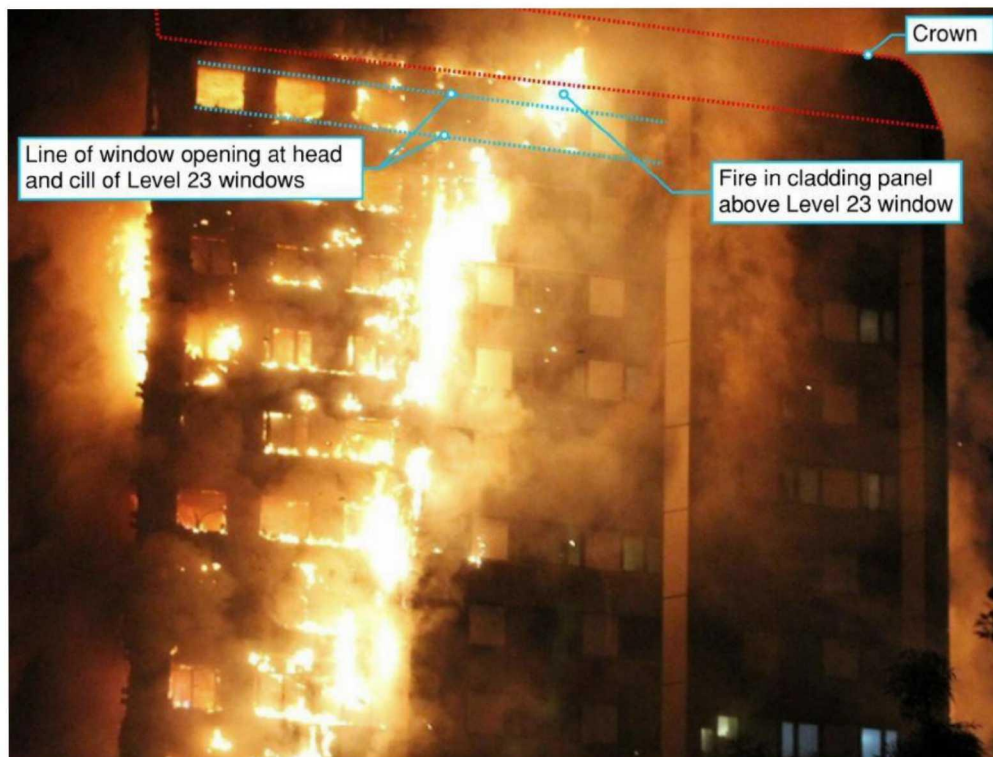
Figure 10.74: Fire in cladding panel above ¹⁹

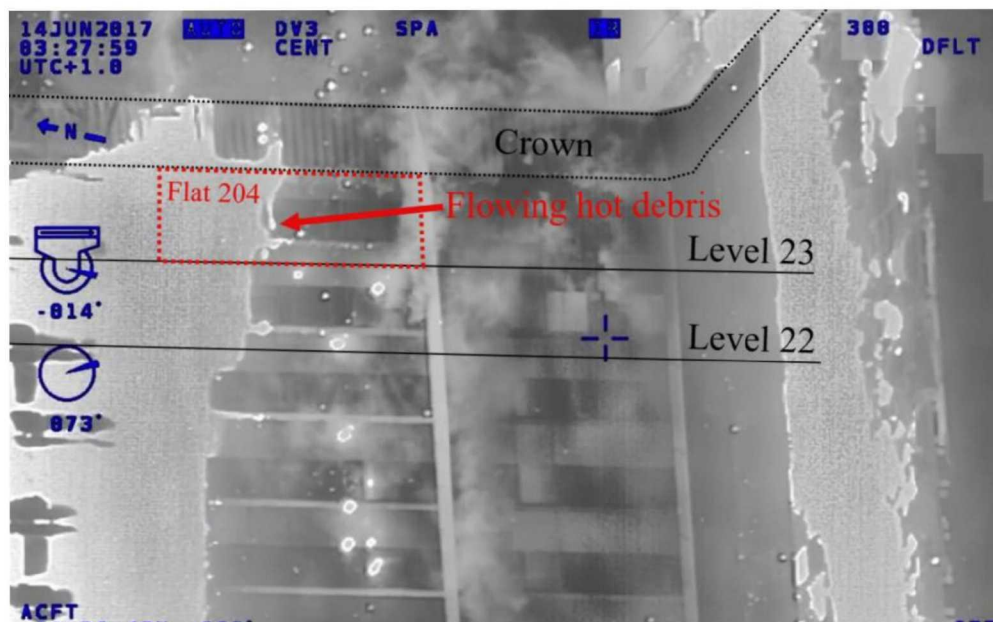
Figure 10.75: Thermal image showing flowing hot debris falling from panels above Level 23 windows on the West elevation of Grenfell Tower at 03:27 on 14th June 2017 (see Video 5 accompanying Prof. Bisby's supplemental Phase 1 report)
