External fire spread – Part 1 Background research

By Ciara Holland, Dr David Crowder and Martin Shipp

External fire spread – Part 2 Experimental research

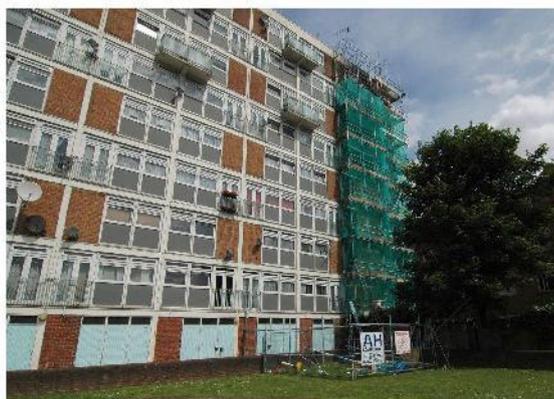
Case study 1 – June 2008

A fire occurred in a first floor flat of a 1960s nine-storey block of maisonettes. The external walls of the flats incorporated uPVC window and door units (Figure 1) and some of the lower window panels had been replaced with painted metal panels (comprising two sheets of painted metal, possibly aluminium, and a thin layer of adhesive holding the two together). The fire melted the frames of the window units, allowing flames to extend up the exterior of the building. These flames were sufficient to melt the frames and break the window panes of the floors/flats above the flat of fire origin and caused fire and smoke damage within the flats from the third to the sixth floors of the block.

Figure 1 – Block of flats showing undamaged window sets; the fire damage is behind the scaffolding

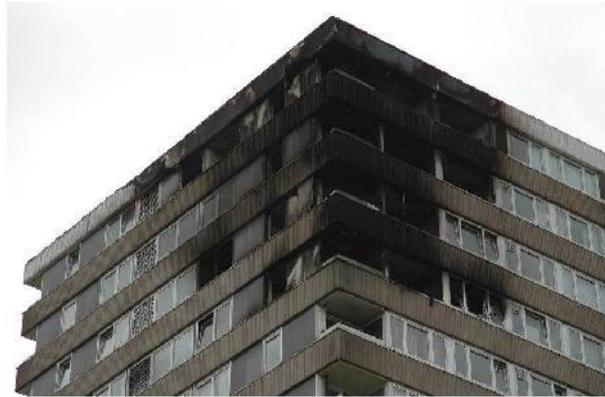
Case study 2 – July 2010

A fire started on the balcony of a 12th floor flat of a 16-storey residential block of flats constructed in the 1960s. As can be seen from Figure 2, the fire spread from the balcony of origin to the 15th floor and the roof of the building. Several features of the building were attributed to the extent of fire spread including combustible insulating panels (which were clad onto the underside of all of the balconies), cladding panels (which had been installed onto the outer surface of the exterior wall and comprised a mineral fibre board face supported on timber batons, behind which there was a fibrous combustible insulation material) and plastic drain pipes (which were installed at each corner of the building and passed through the concrete floor slab on each floor). There was no evidence of any fire stopping, proprietary seal or sleeve where the pipe passed through the floor slab and which should have been provided to maintain the level of fire resistance afforded by the concrete floor slab.

Figure 2 – Block of flats showing extent of fire damage caused by holes in compartmentation on balconies

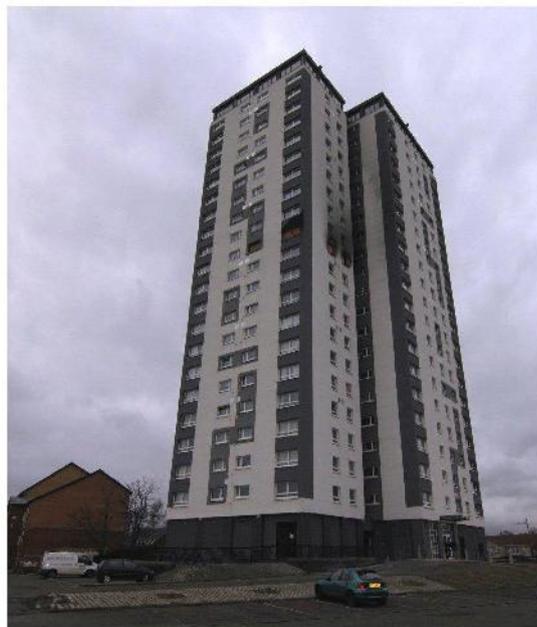
Case study 3 – February 2008

A fire occurred in a flat on the 11th floor of a 22-storey block of flats built during the 1960s and refurbished in 2006/7. This refurbishment included the fitting of a new cladding system to the exterior of the building which comprised an insulated render, the insulation for which was mineral wool and had been tested to and passed BS 8414-1. The fire developed to fully involve the flat of origin and broke out of the windows. The damage to the façade was localised to the immediate vicinity of some of the windows but beyond this the damage appeared to have been limited to surface charring and sooting (Figure 3).

Figure 3 – Block of flats showing limited damage to the non-combustible cladding system after a fire

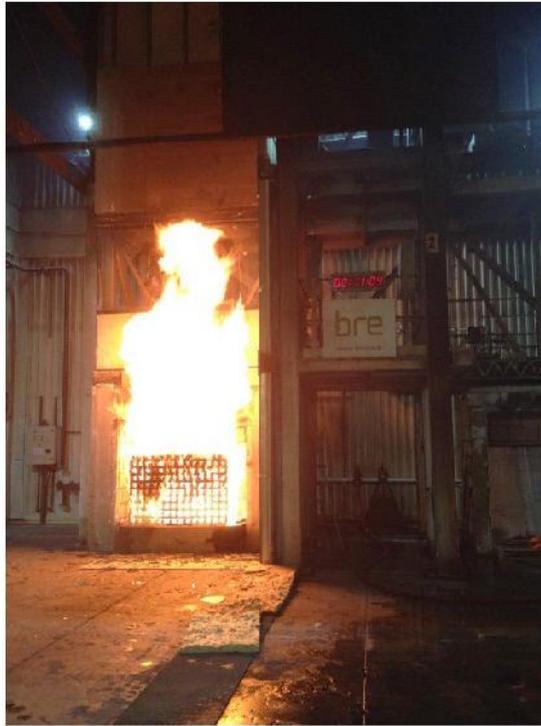
The maximum flame length for all three experiments was estimated at 3.3 metres from the underside of the hearth i.e. to the top of the glazing (Figure 4). The glazing failed in all three experiments.

Figure 4 – Image showing maximum achieved flame length of approximately 3.3 m

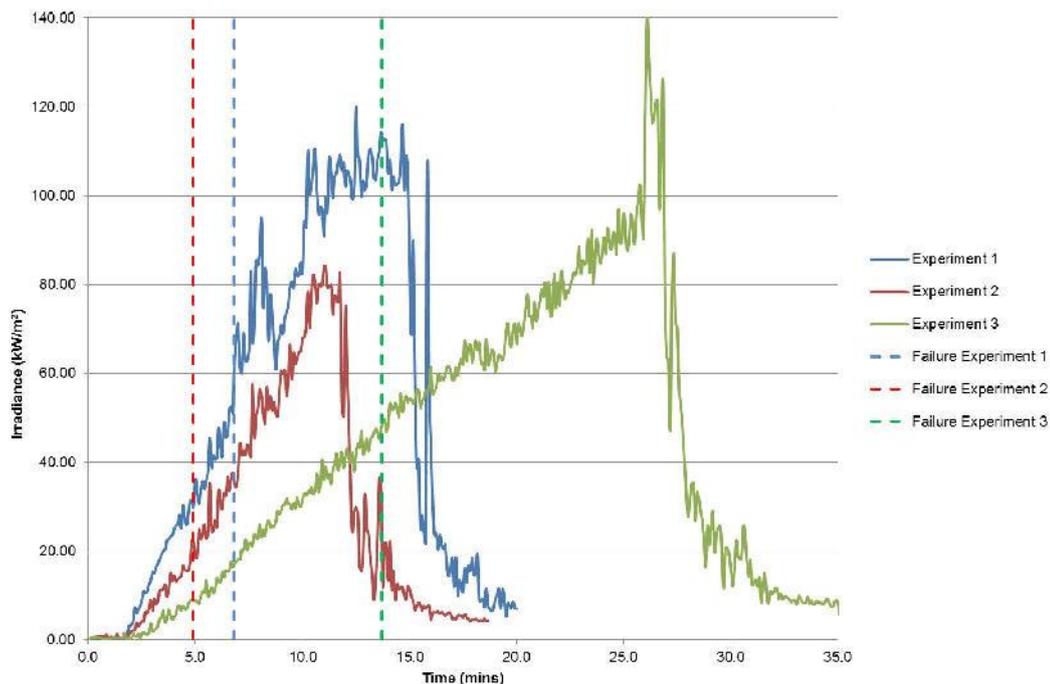
As shown in Table 2, the glazing in Experiment 2 failed earlier than in the other experiments. Given that, as shown in Figure 5, the rate of fire growth for Experiments 1 and 2 are comparable, the reason for this earlier failure of the glazing is, in our opinion, due to the involvement of and eventual burn through of the “Class 3” spandrel panel contributing to and changing the local dynamics of the fire. That is, the involvement of the spandrel panel in Experiment 2 may have changed the angle of trajectory of the fire plume relative to location of the heat flux meter in the return wall resulting in the difference of recorded data.

Figure 5 – Comparison of heat flux against time for the return wall for all three experiments showing the first failure point of glazing at vertical dashed lines
