**Lakanal Fire
Investigation -
Questions Posed by the
Crown Prosecution
Service**

Prepared for: Metropolitan
Police Service

30 April 2012

Client report number 278607

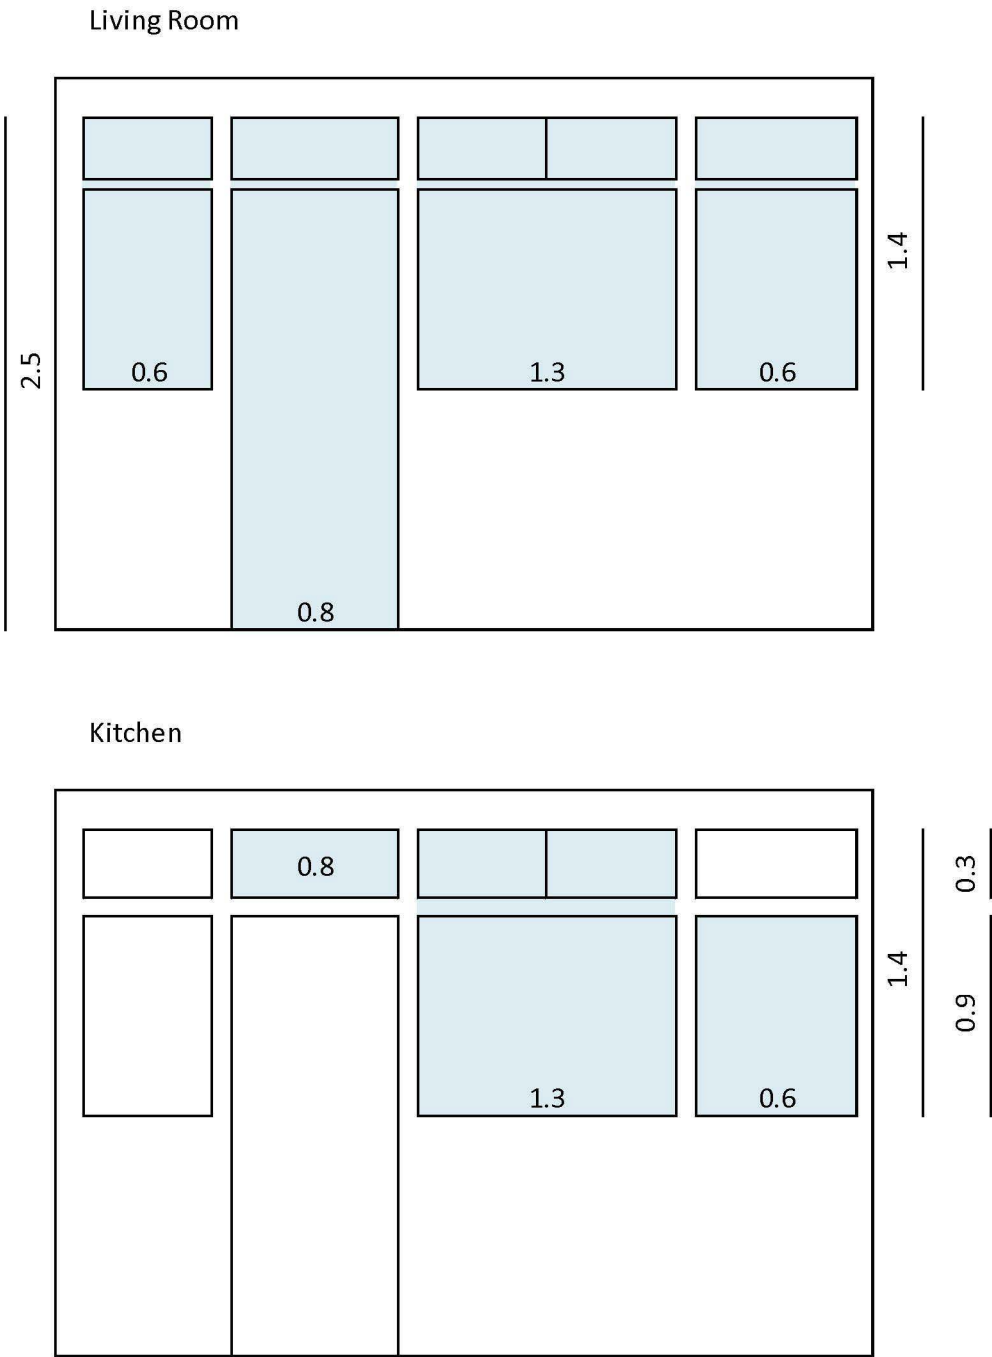
Figure 1 – Ventilation openings in upper floor of Flat 65. The ventilation openings shown in blue are those which remain when spandrel panels are fire resisting and a fire resisting door is installed between the kitchen and escape balcony. Dimensions are in metres

- 41 The area of ventilation openings, A_v , had the correct fire resistance panels been used, is reduced to only the glass components of the façade. This corresponds to an area of 8.1m^2 . The dimensions used can be found in Figure 1.

- 45 The height of the openings, h , is taken to be the average of the heights of the openings, corrected by the proportion of the overall opening width occupied by each height; $((0.6 + 1.3 + 0.6) \times 1.4 + 0.8 \times 2.5 + 0.6 \times 0.9 + 1.3 \times 1.4 + 0.8 \times 0.3) \div (0.6 + 0.8 + 1.3 + 0.6 + 0.8 + 1.3 + 0.6) = 1.35\text{m}$.

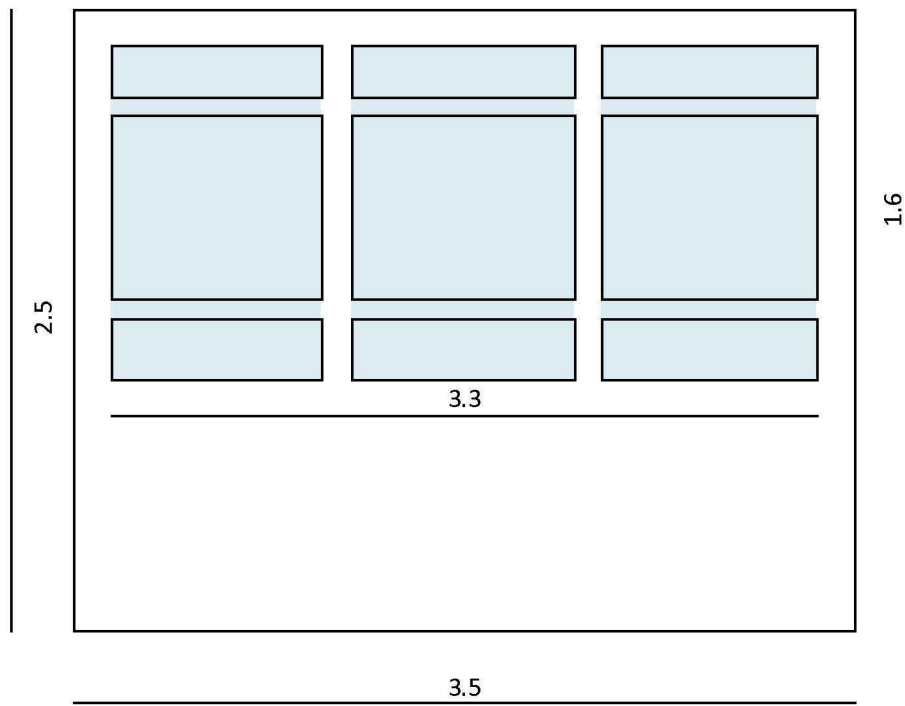
Figure 2 – Ventilation openings in bedroom 1 of Flat 65. Dimensions are in metres

51 The area of ventilation openings A_w , had the correct fire resistance panels been used, is reduced to only the
glass components of the façade. This corresponds to an area of 5.3 m^2 . The dimensions used can be found
in Figure 2.

55 The height of the openings, h , is taken to be 1.6m .
