The performance in fire of structural insulated panels

BD2710

BRE

December 2010
Department for Communities and Local Government

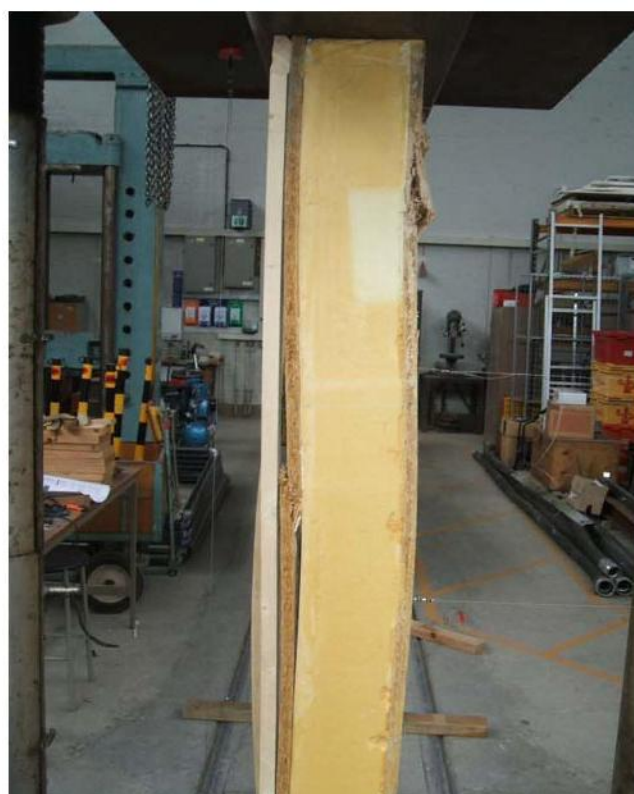
In all cases failure was through a fracture of the oriented strand board skin. Some de-lamination was also observed in the region close to the failure surface, see Figure 28.

Figure 28 De-lamination between skin and core around fracture surface

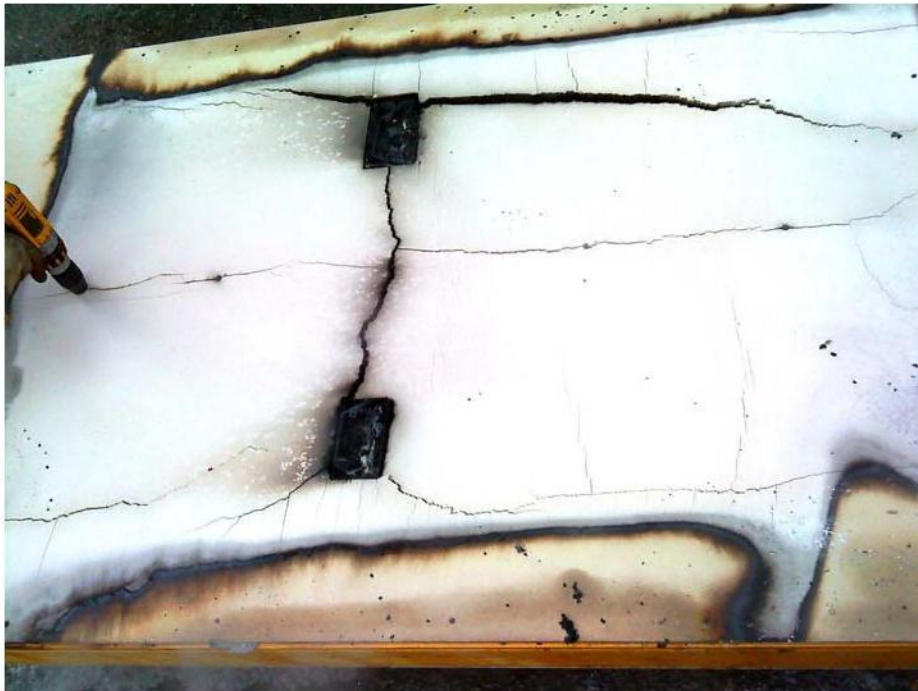
Figure 32 Panel on removal from the furnace for Test 1

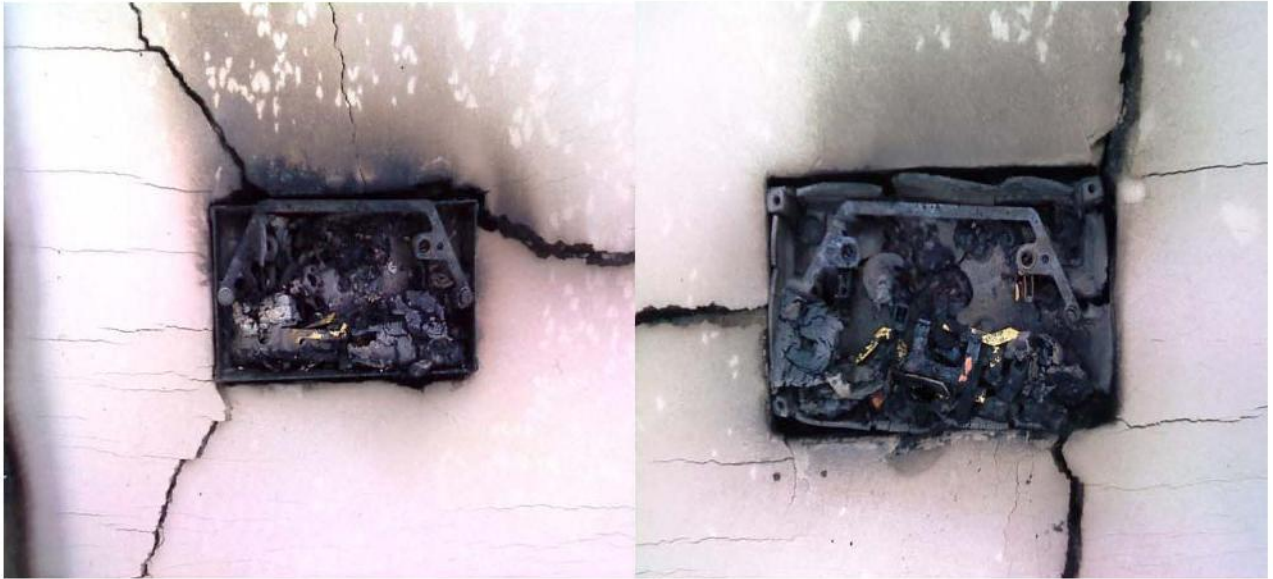
Figure 33 Damage to boxes for Test 1

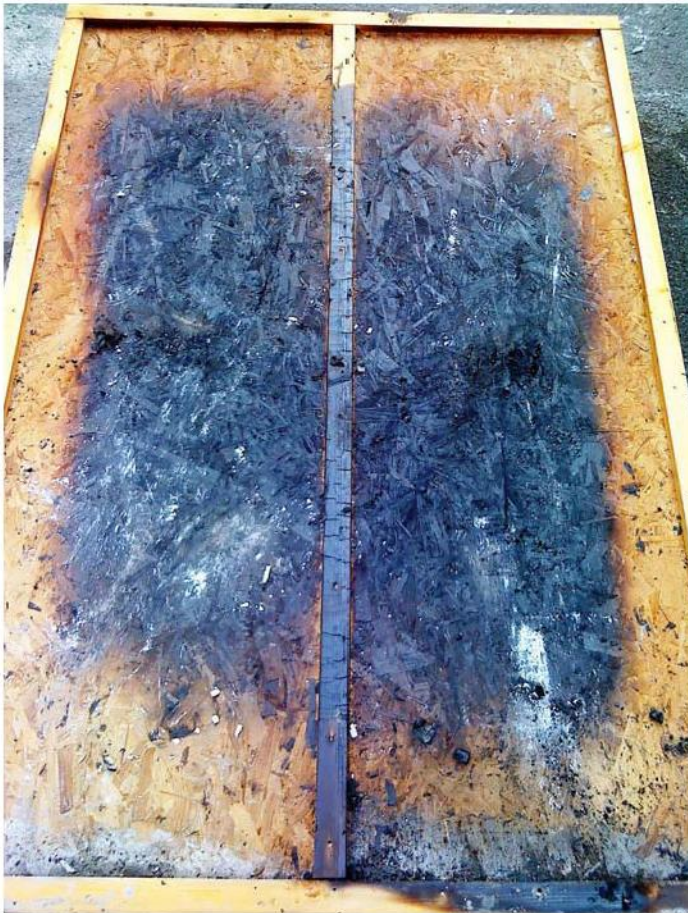
Figure 34 Damage to panel for Test 1

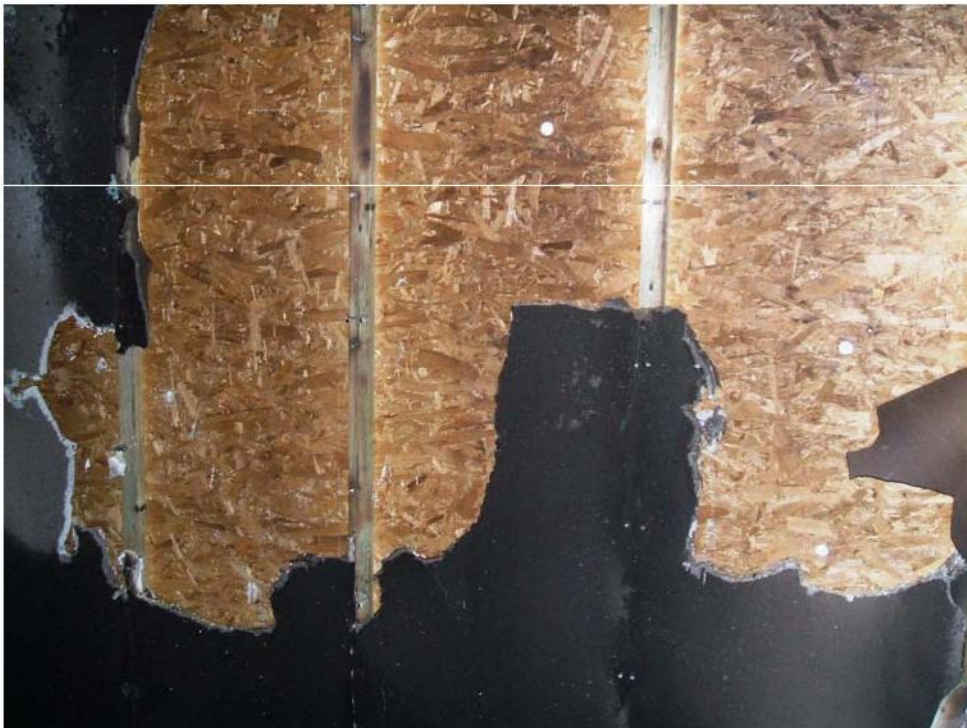
Figure 71 Condition of party wall (gridline E) – post-Test F1

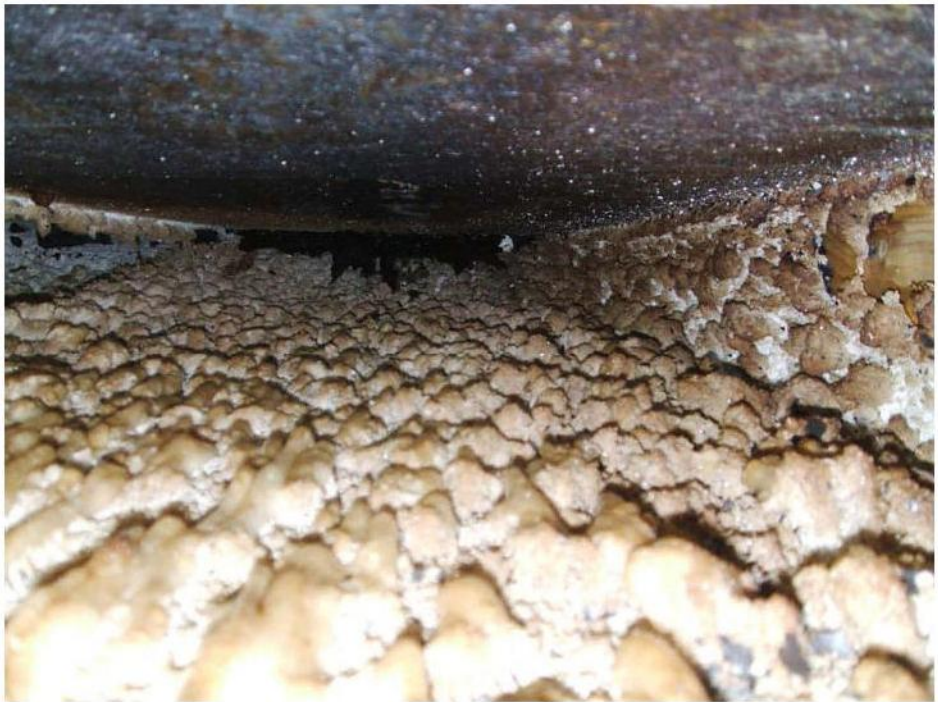
Figure 74 View down damaged structural insulated panel to the floor – Test F1

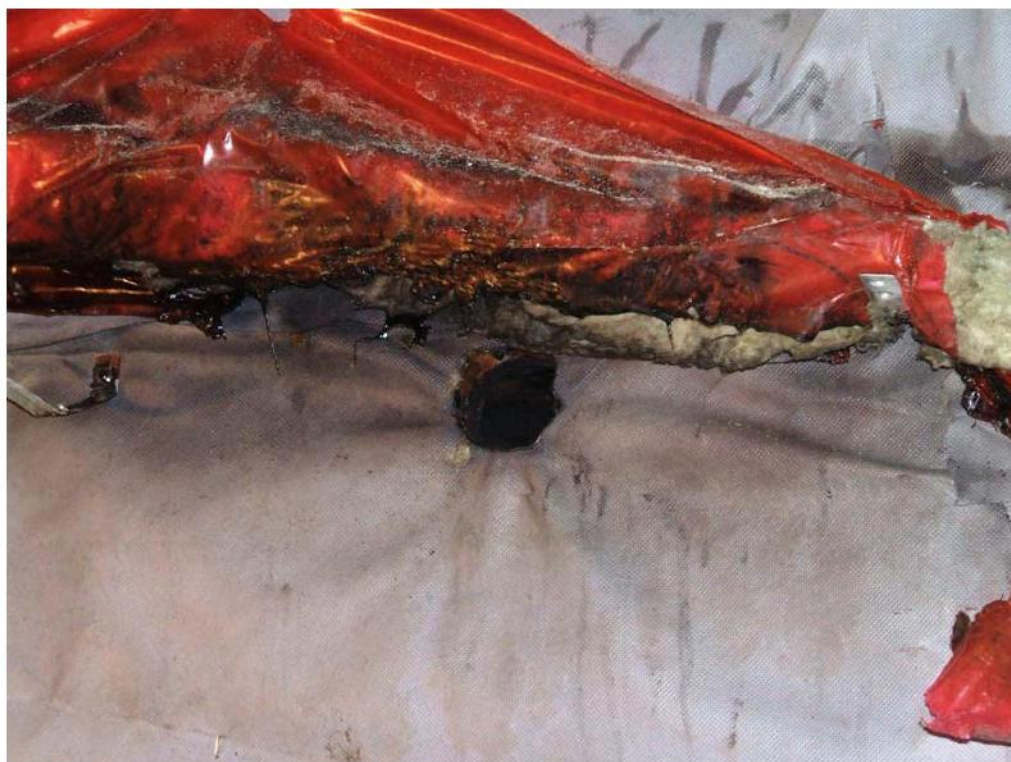
Figure 76 Damage to cavity barrier – Test F1

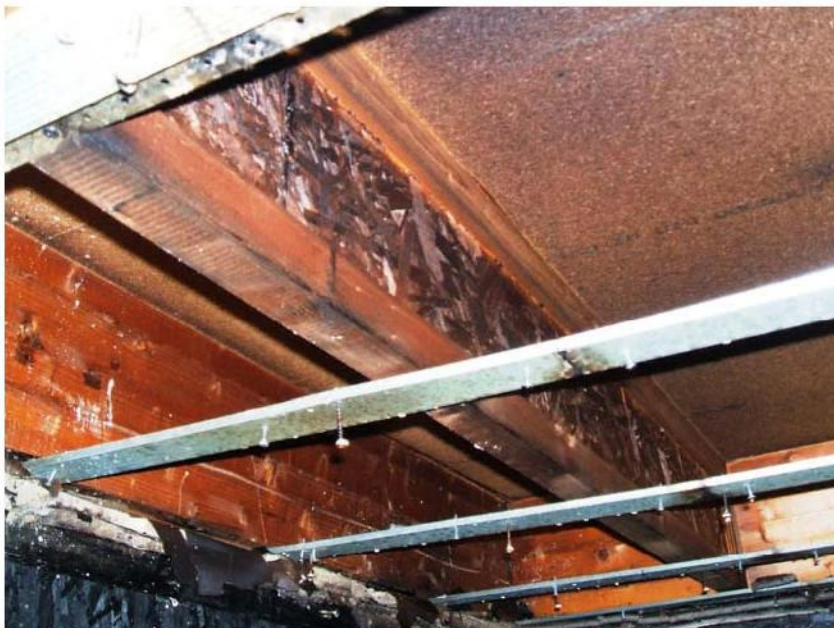
Figure 100 Limited damage to floor system –Test F3

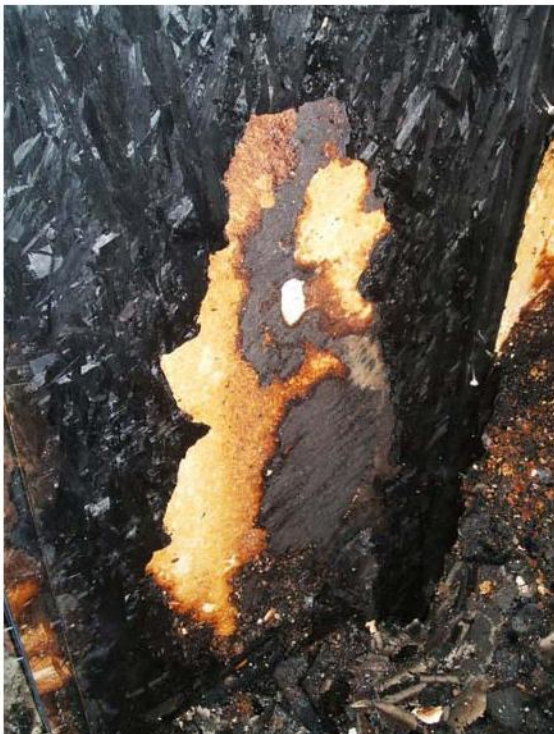
Figure 102 Localised damage to polyurethane core – Test F3

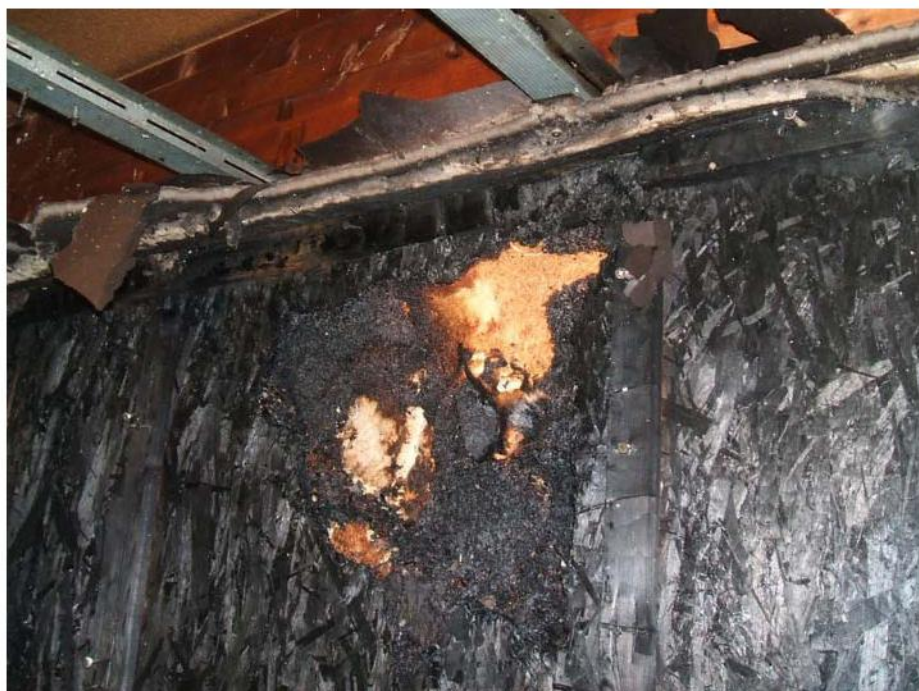
Figure 103 Localised damage to polyurethane core – Test F3

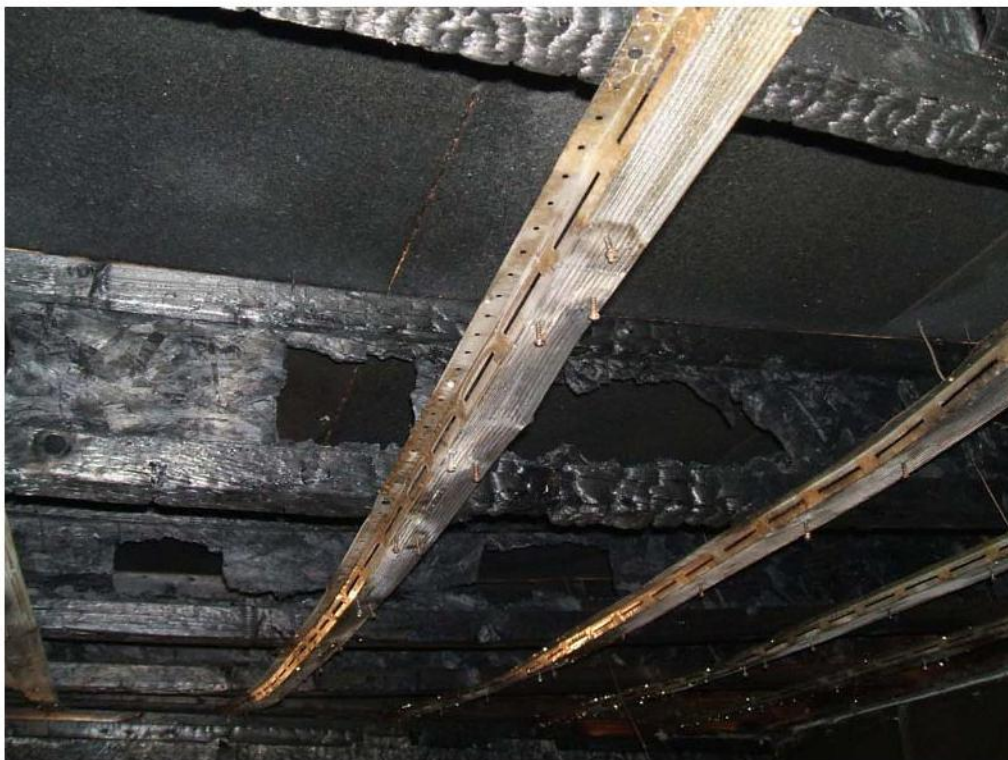
Figure 114 Damage to floor system – Test F4

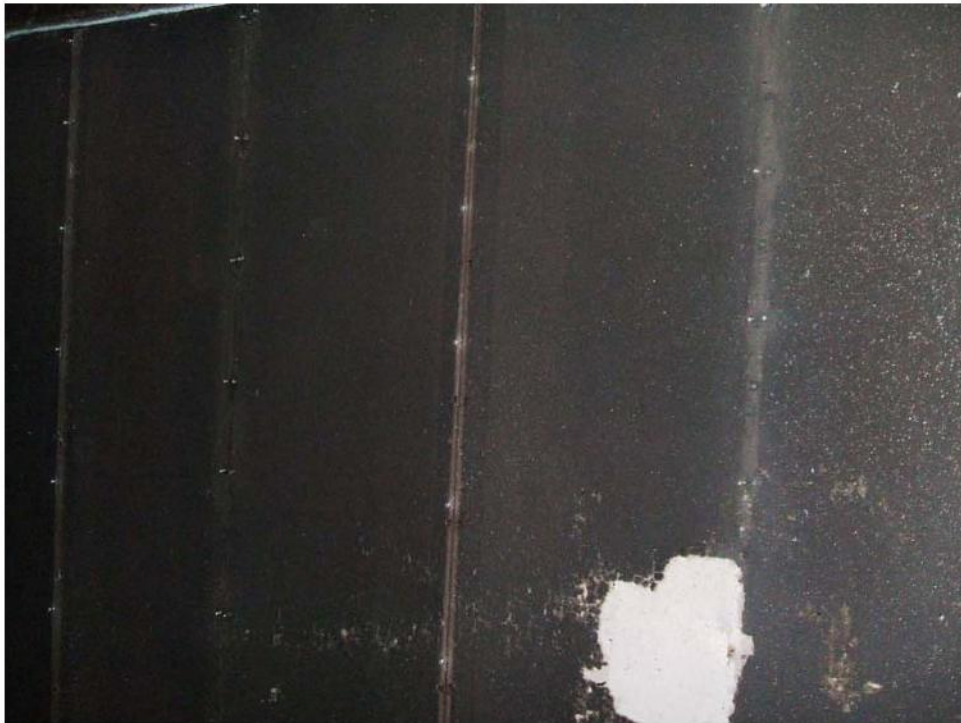
There was little visible damage to the party wall with the lining remaining intact, see Figure 115. However, there was extensive damage to the remaining (30 minute) walls (Figure 116). During the test, the panels adjacent to the window openings were seen to be contributing to the fire development. At the end of the test, much of the plasterboard had fallen into the compartment. Fire-fighting operations removed all remaining boards making the identification and suppression of localised hot spots much easier.

Figure 115 Limited damage to party wall – Test F4

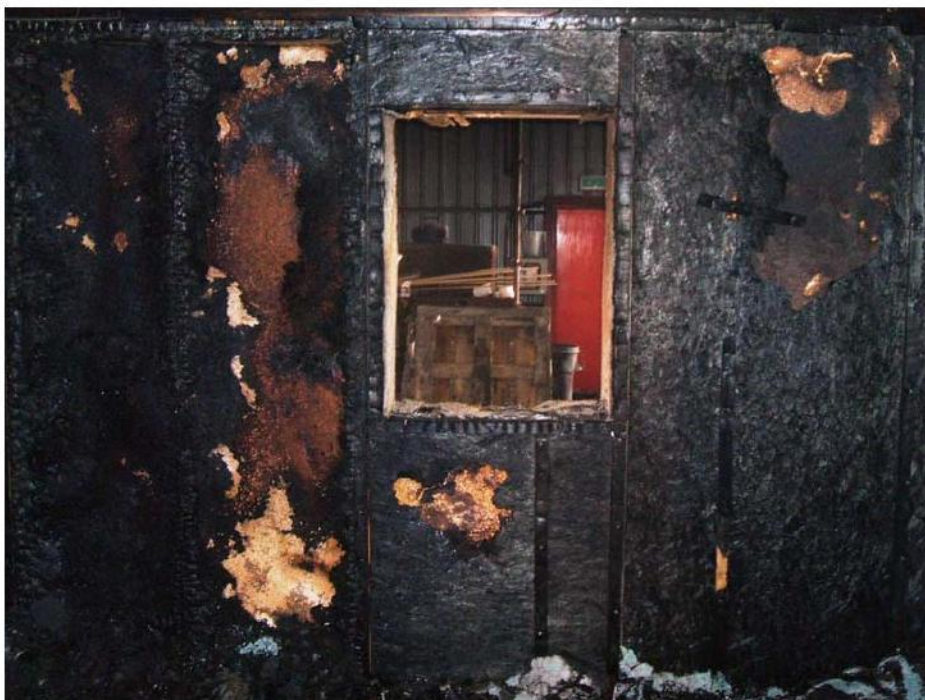
Figure 116 Damage to front wall – Test F4
