**Fire at Garnock Court, Ir.....**  
**11.06.99**  
**Phase 2 Fire Tests on GRP cladding**

Prepared for:  
**North Ayrshire Council**

Prepared by:  
**Penny Morgan**  
**Fire Protection Systems Centre**

**April 2000**                      **81310**

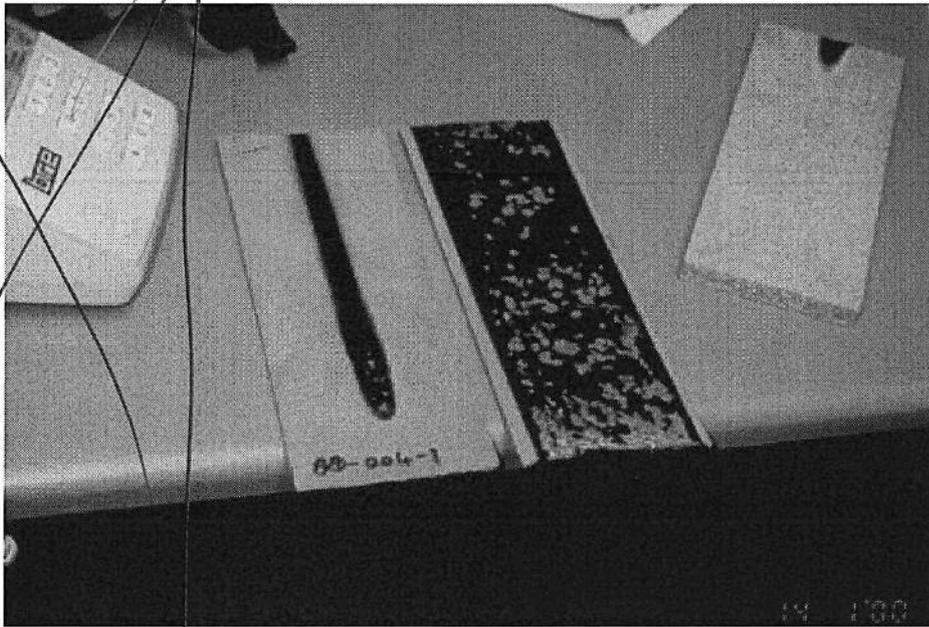
**Plate 1** Sample tested in prEN ISO 11925-2, front face on the left, rear face on the right

These tests were done to both test the GRP sample and the brand new test equipment. The results are in Annex 3. The small flame is applied to either side of the material and performed well indicating a good surface spread of flame classification, Plate 1. However when the edge test was done where the flame is applied to the shorter edge of the sample, see Plate 2, ignition was rapid with the evolution of much black smoke. The six tests each of the two samples gave very similar results and the new apparatus has been truly fire hardened. This test result will be a crucial indicator in the future as to the possible involvement of materials where the broad flat surface resists flame spread but the cut edge does not.

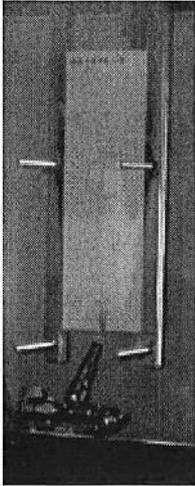
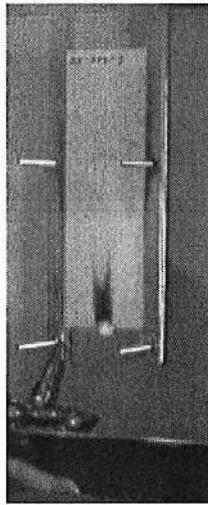
**Plate 2** Edge test, prEN ISO 11925-2, stages in ignition to flaming

3. The poor fire performance would not have manifested itself until the circumstances of such a fire as in June of 1999 where a serious fire inside the block spread out of the window. Flames and hot gases from that fire were able to attack the exposed edges of the cladding material and ignite it. The design of the window pods and spandrel panels also contributed to this mechanism by affording a cut edge to be in the path of any flames and hot gases leaving a room on the inside of the cladding.

4. Fires in other parts of the building which were not overlaid in this way did not trigger this kind of spread.
5. It is recommended that the performance of any related material should be carefully assessed before it is used on high rise residential blocks. This is where the strength of the new European tests will lie as there is additional information to be gained from this test over the current BS 476 tests.

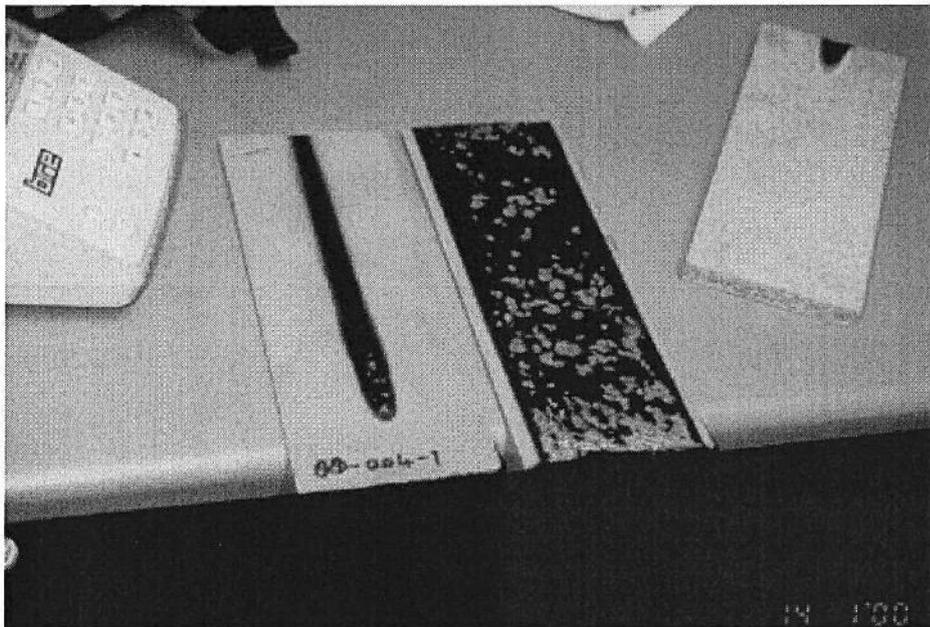
**Plate 1** Sample tested in EN front face on the left, rear face on the right

Phase 3 tests were done to both test the GRP sample and the brand new test equipment. The results are in Annex 3. The small flame is applied to either side of the material and performed well indicating a good surface spread of flame classification, Plate 1. However when the edge test was done where the flame is applied to the shorter edge of the sample, see Plate 2, ignition was rapid with the evolution of much black smoke. The six tests gave very similar results and the new apparatus has been truly fire hardened. This test result will be a crucial indicator in the future as to the possible involvement of materials where the broad flat surface resists flame spread but the cut edge does not.

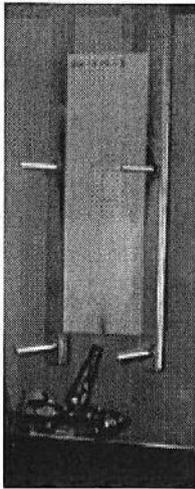
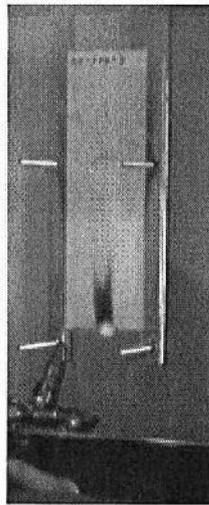
**Plate 2** Edge test, prEN ISO 11925-2, stages in ignition to flaming

These tests were done to both test the GRP sample and the brand new test equipment. The results are in Annex 3. The small flame is applied to either side of the material and performed well indicating a good surface spread of flame classification, Plate 1. However when the edge test was done where the flame is applied to the shorter edge of the sample, see Plate 2, ignition was rapid with the evolution of much black smoke. The six tests each of the two samples gave very similar results and the new apparatus has been truly fire hardened. This test result will be a crucial indicator in the future as to the possible involvement of materials where the broad flat surface resists flame spread but the cut edge does not.
