Composite Panels – PUR 25-09-01

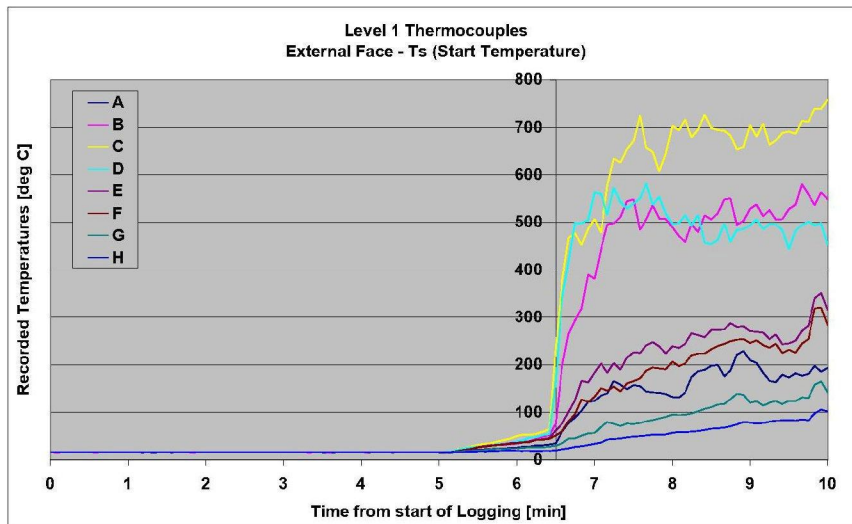
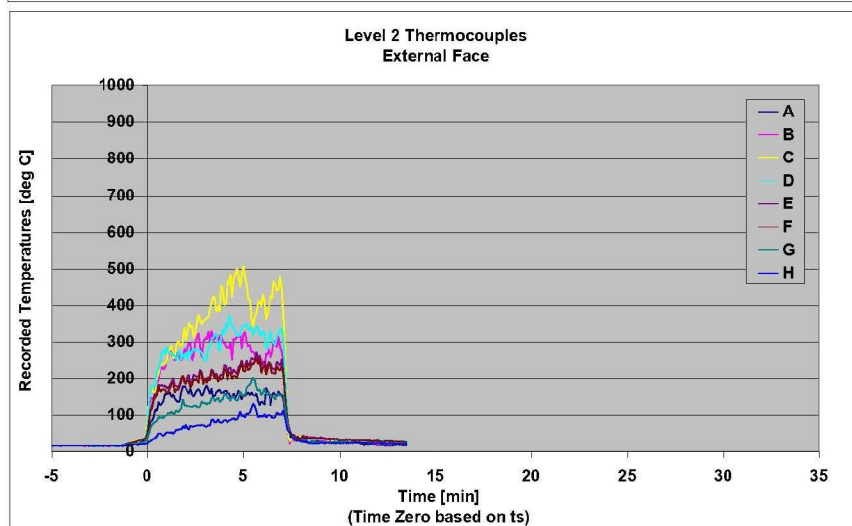
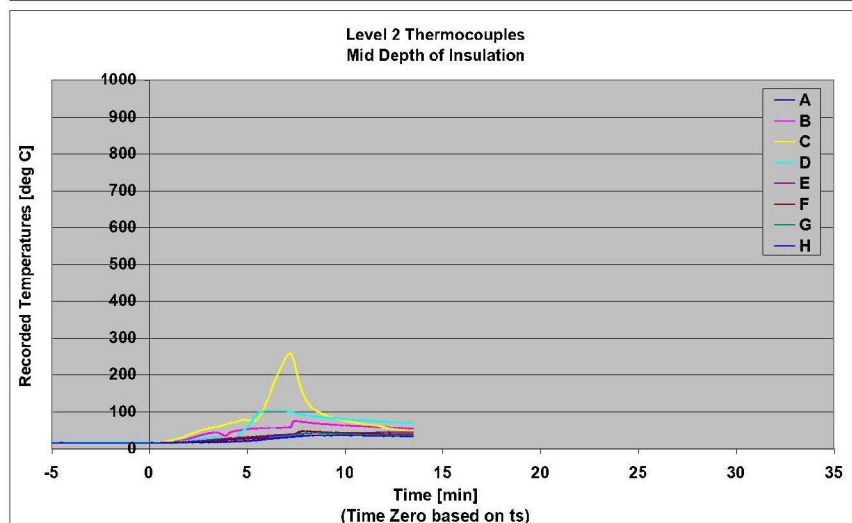
Panel joint penetrated 12:00 - Test terminated 13:30.

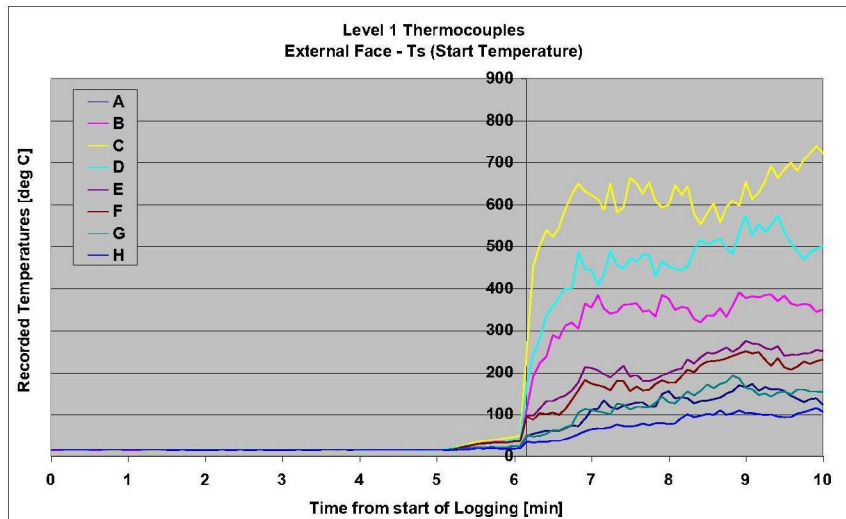
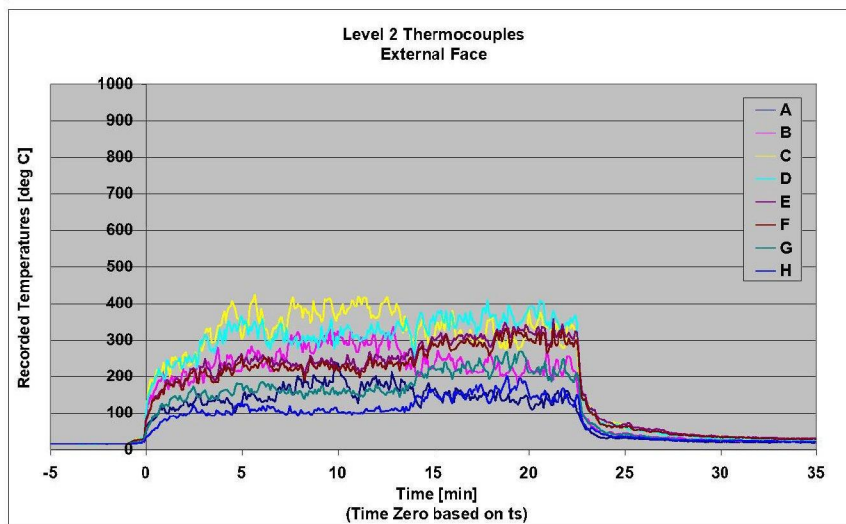
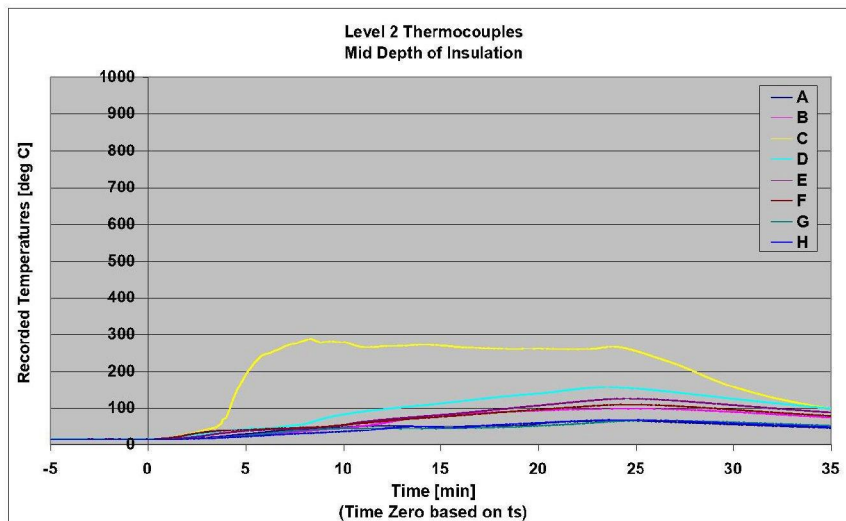
Composite Panels – PIR 25-09-01

Panel joint penetrated 14:15 - Test terminated 28:50

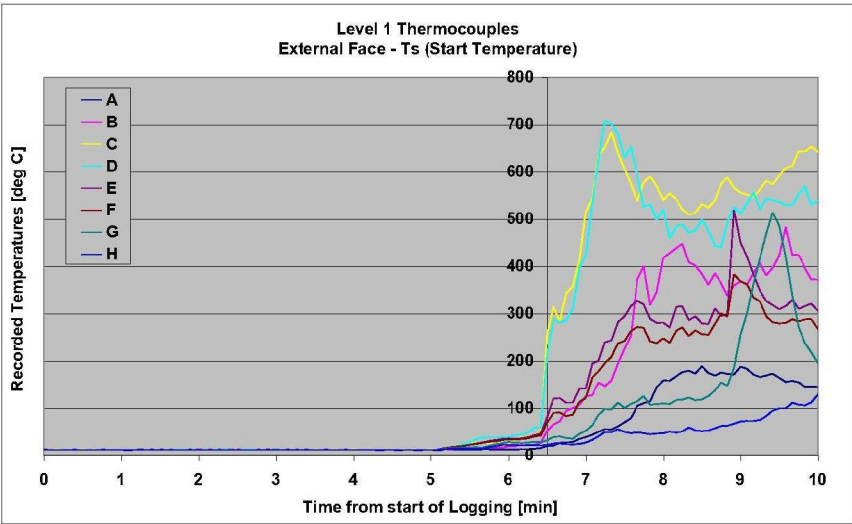
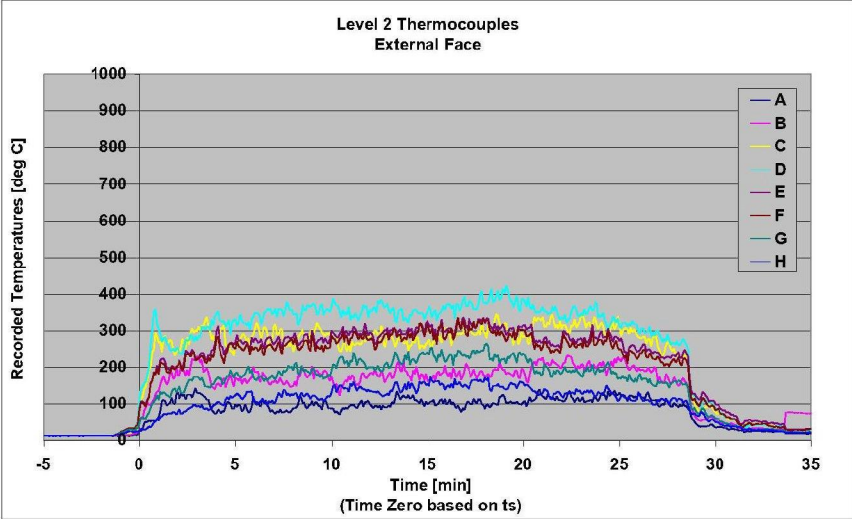
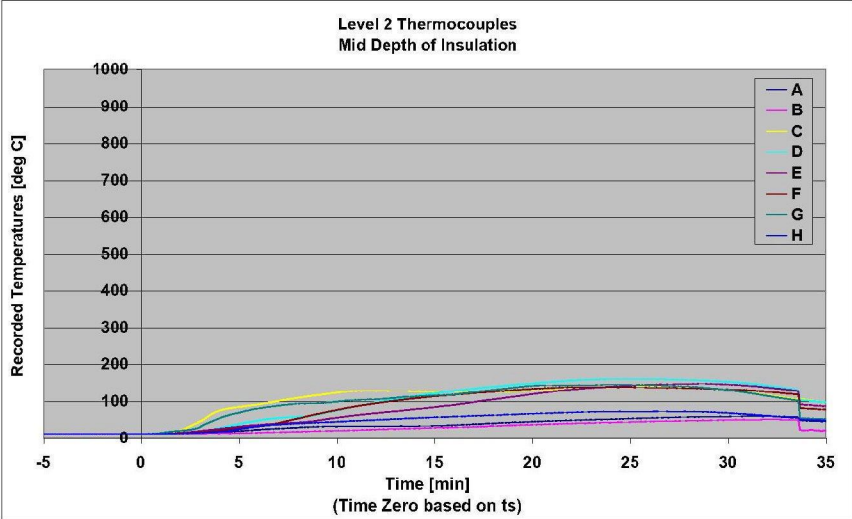
Composite Panels – Mineral Wool 25-09-01

No Panel joint penetration - Test terminated 35:00

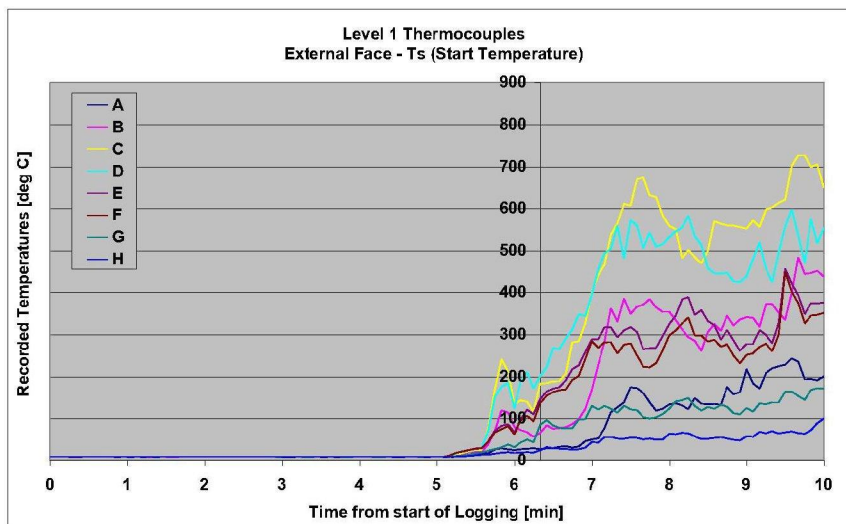
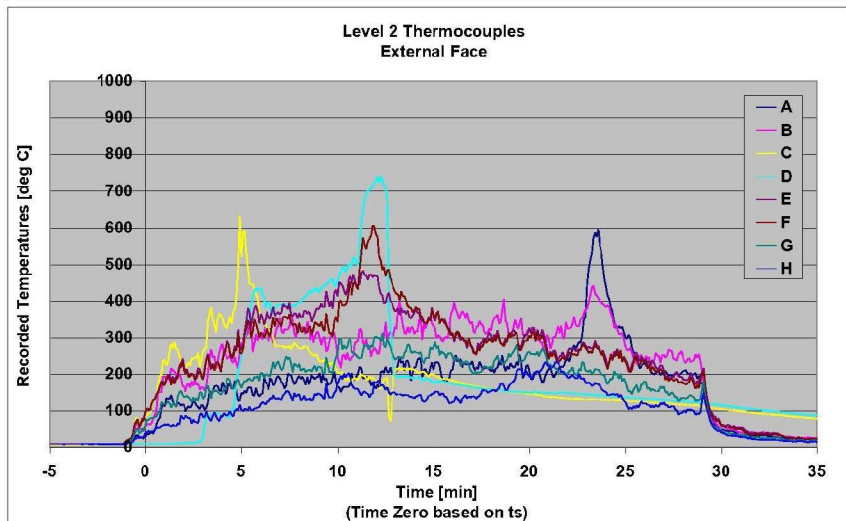
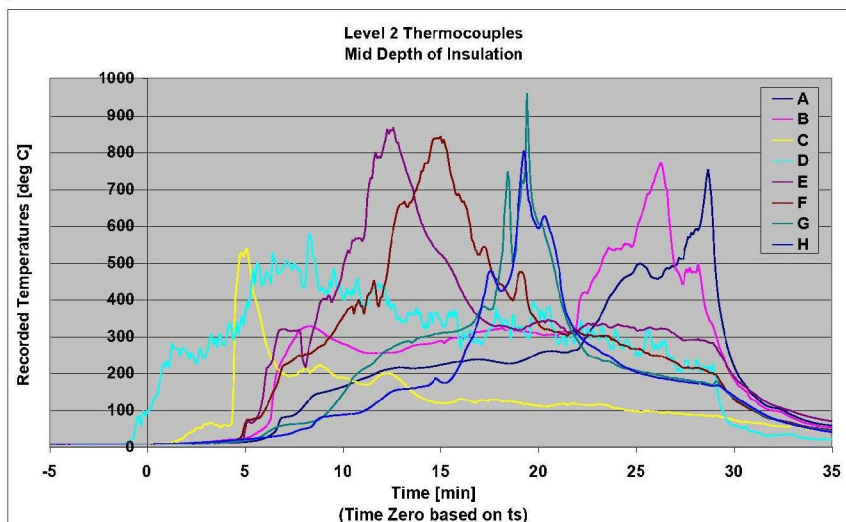
Composite Panels – EPS 14-11-01

Panel joint penetrated 9:45 - Test terminated 35:00

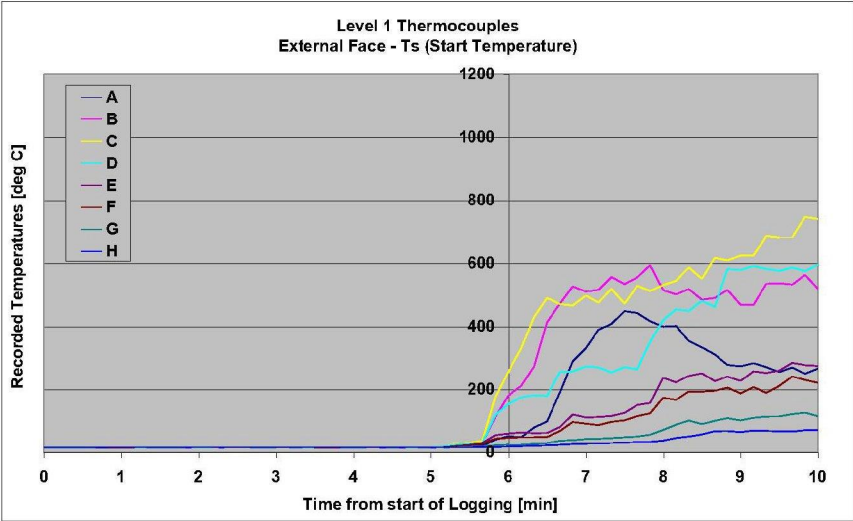
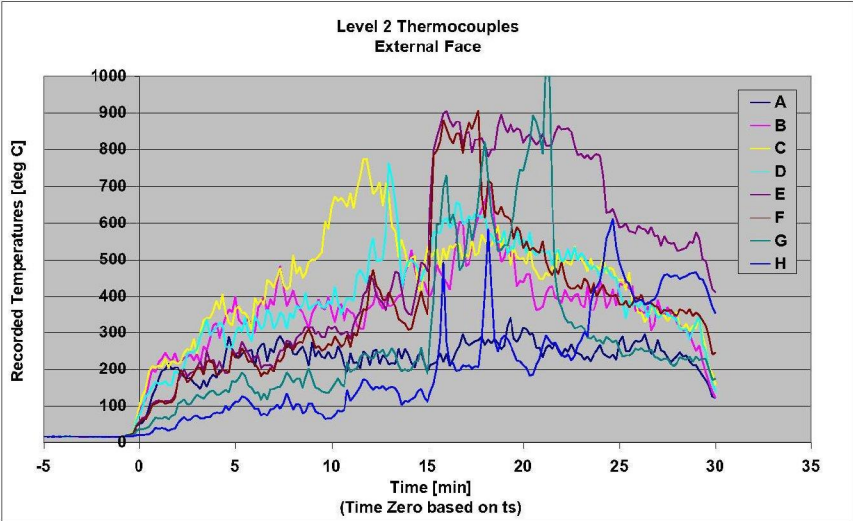
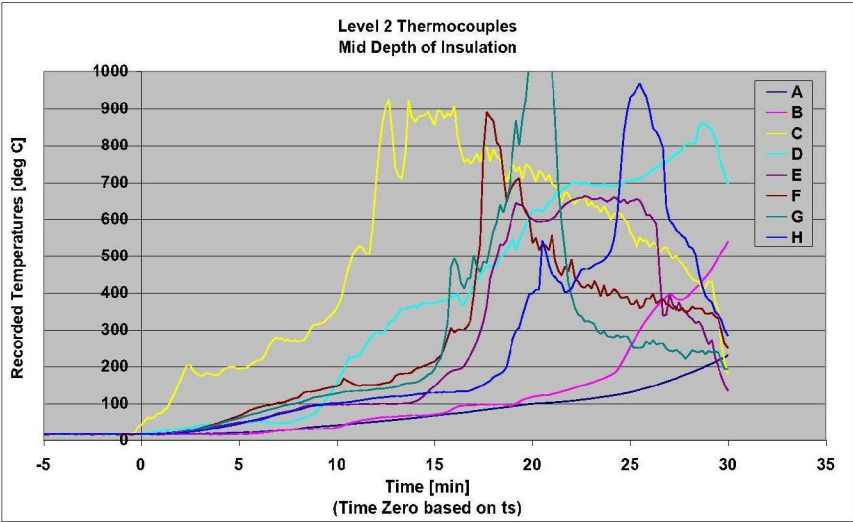
Rainscreen1 - Resoplan + Rockwool on timber no FB 31-05-01

Test terminated 35:00

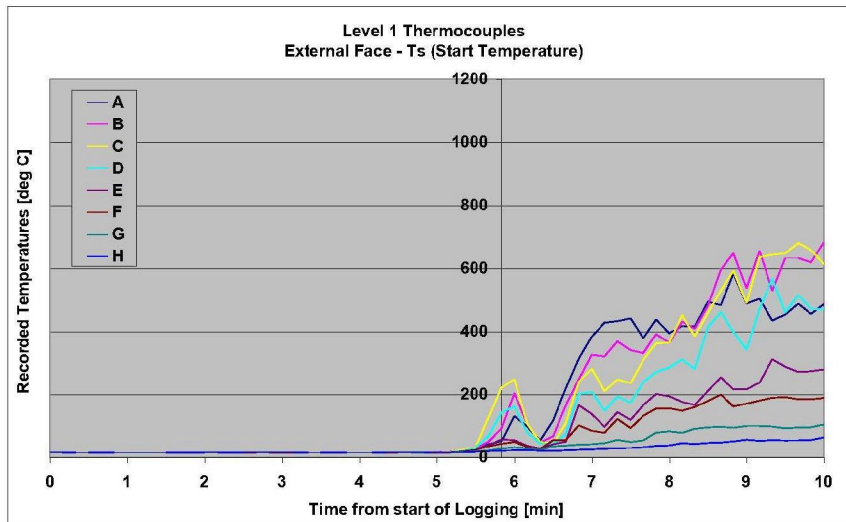
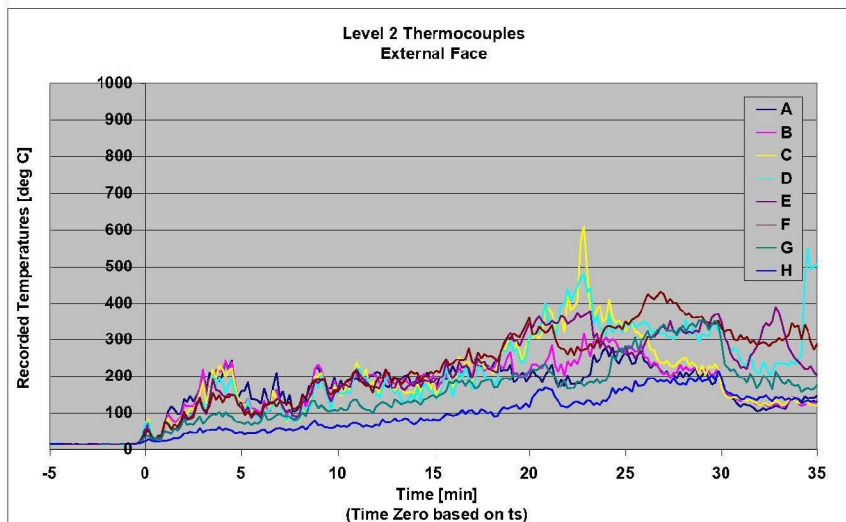
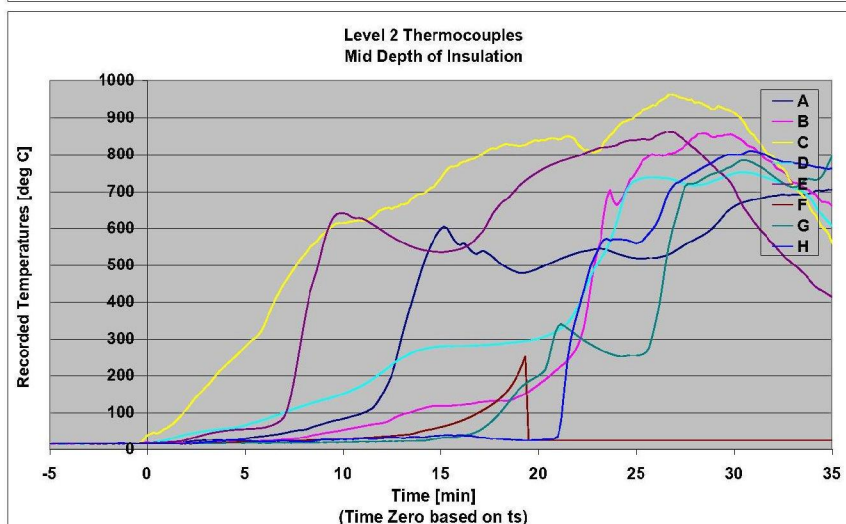
Rainscreen2 - Rockclad + Rockwool on timber no FB 31-05-01

Test terminated 35:00

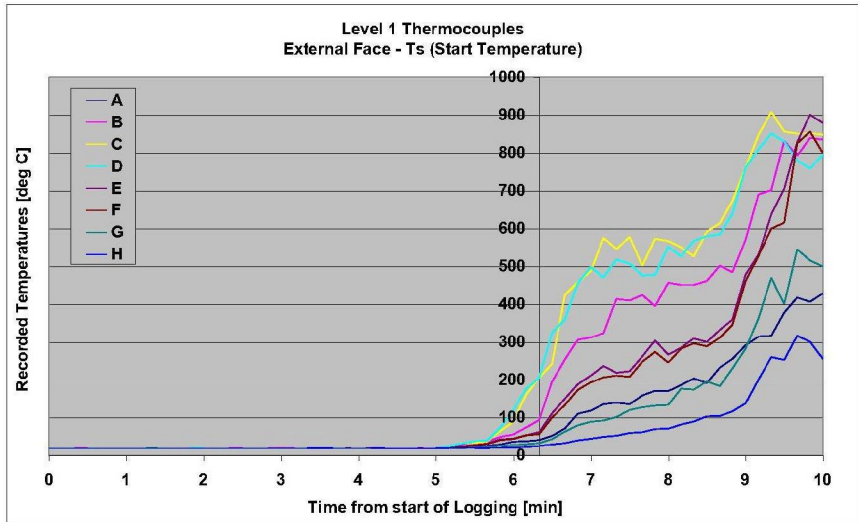
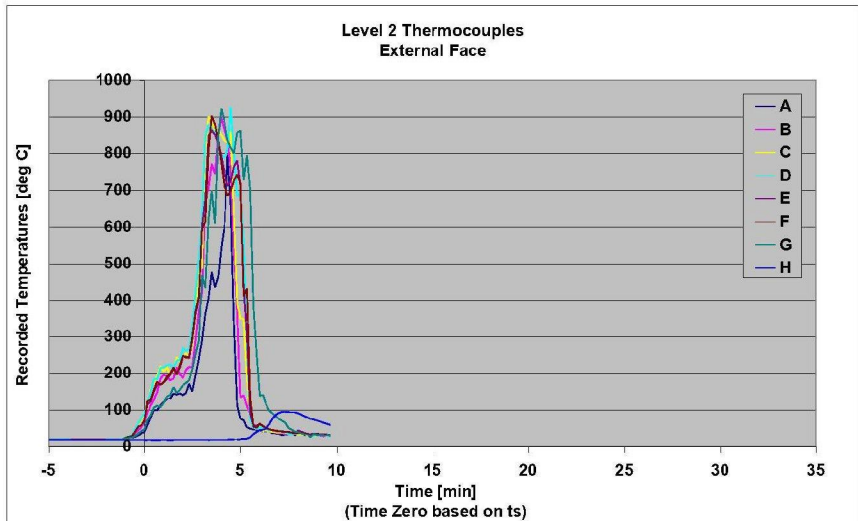
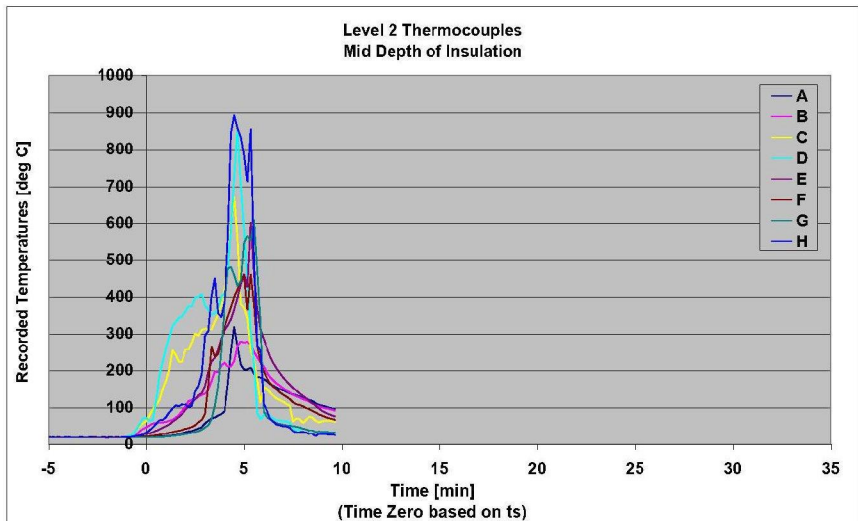
Rainscreen3 - Aluminium + Isowool on metal no FB 18-07-01

Test terminated 12:00

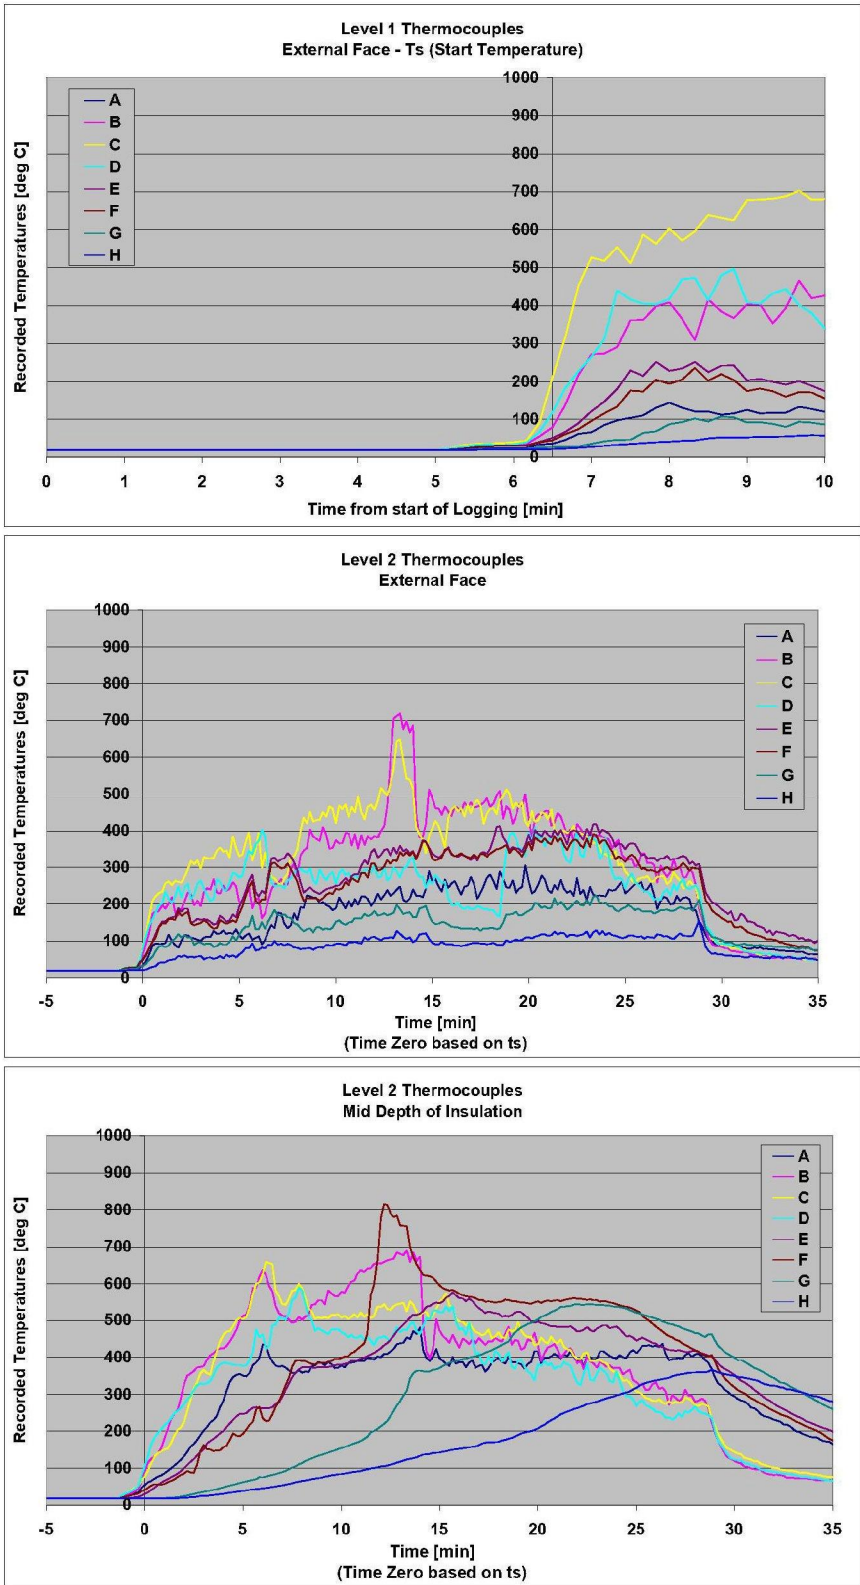
Rainscreen 4 - Rockclad + Isowool on metal no FB 18-07-01

Test terminated 35:00

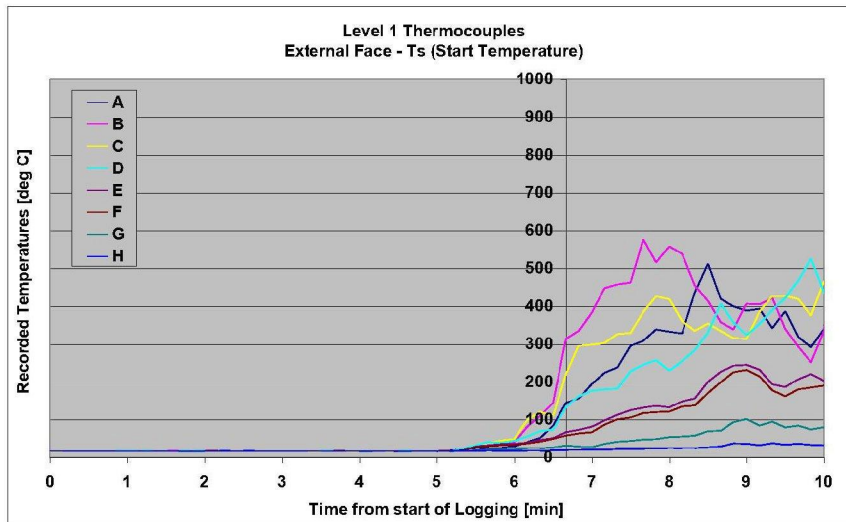
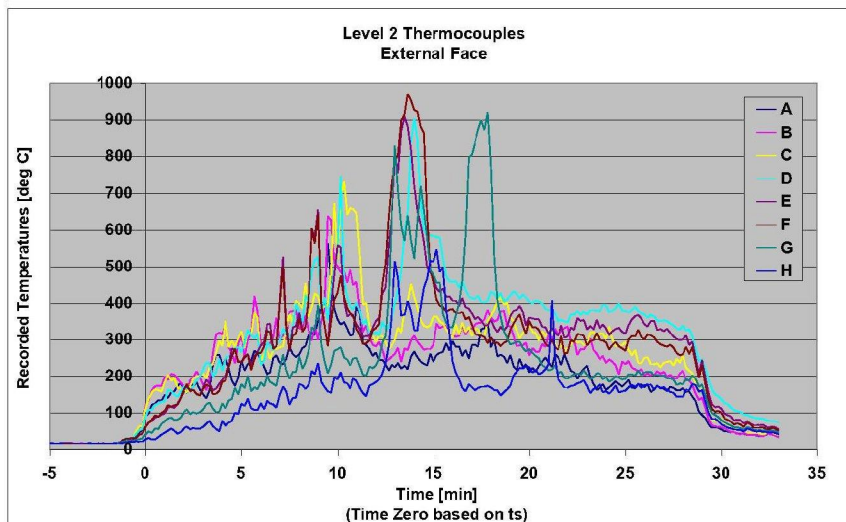
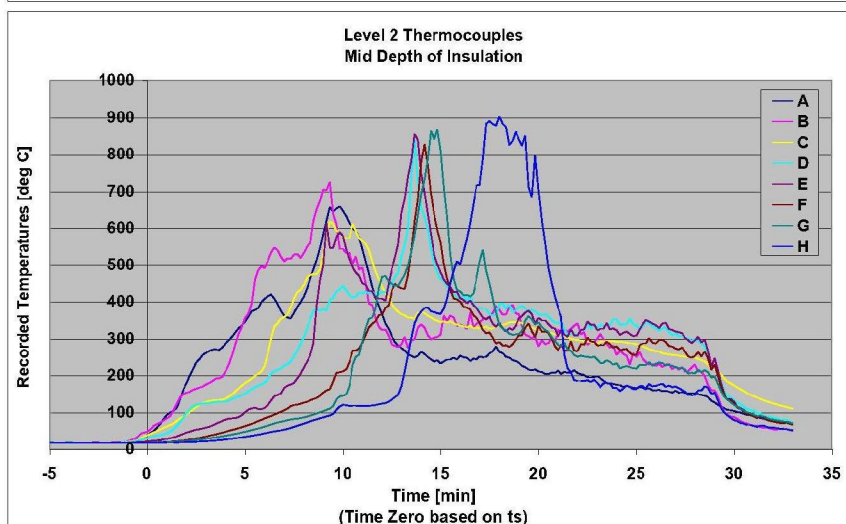
Rainscreen 5 - Resoplan + Isowool on metal + FB 18-07-01

Test terminated 35:00

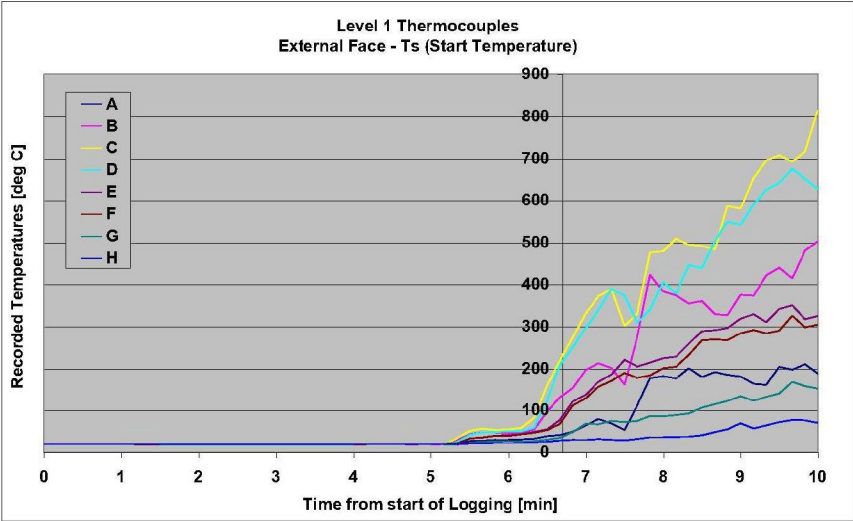
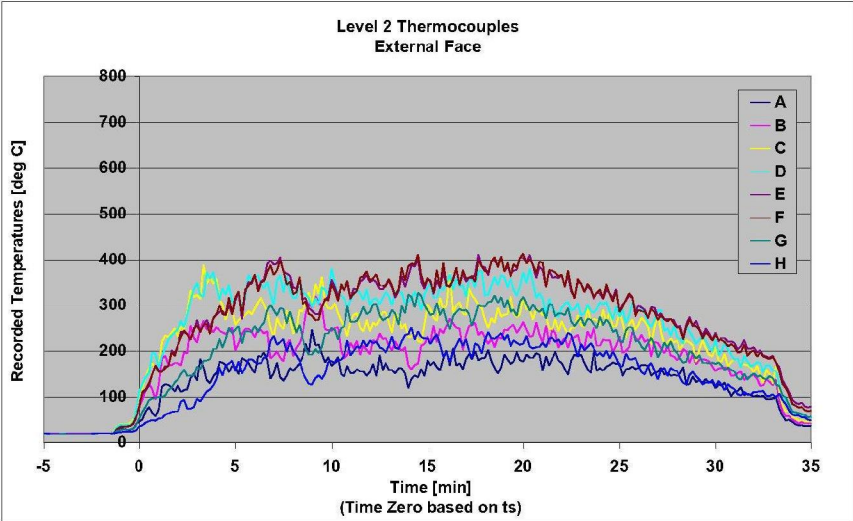
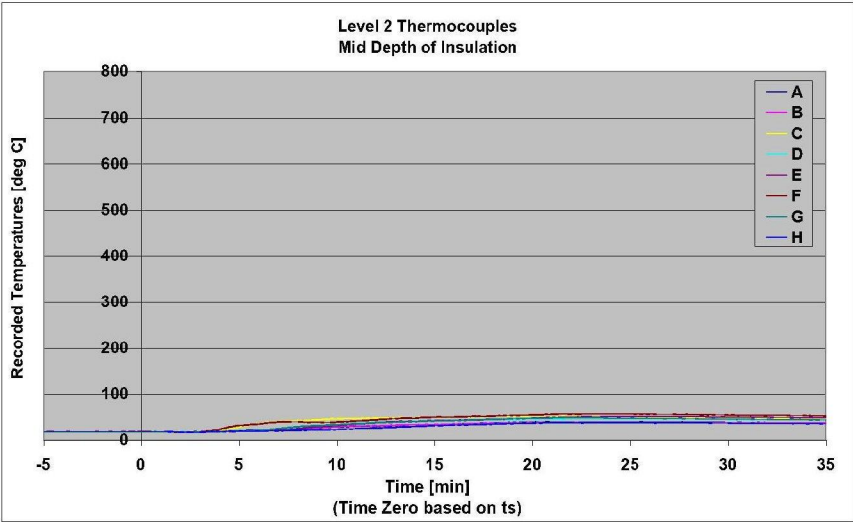
Render 1 - Rockwool 03-09-01

Test terminated 40:00

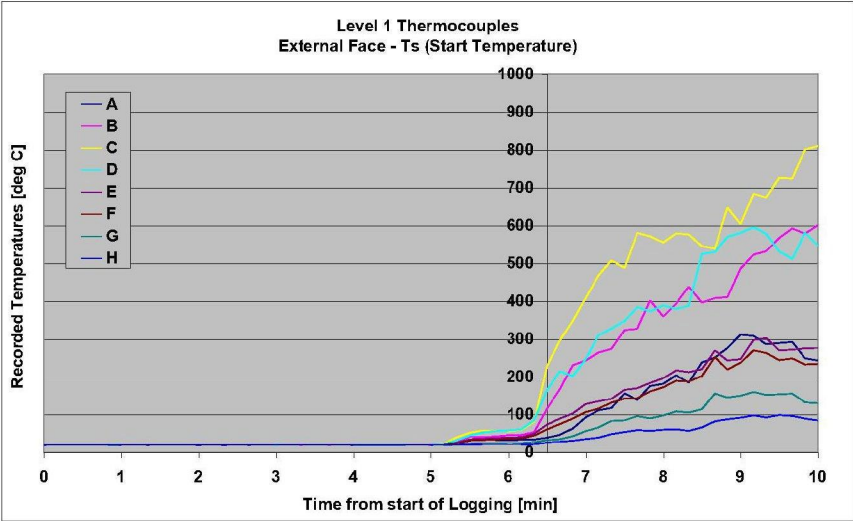
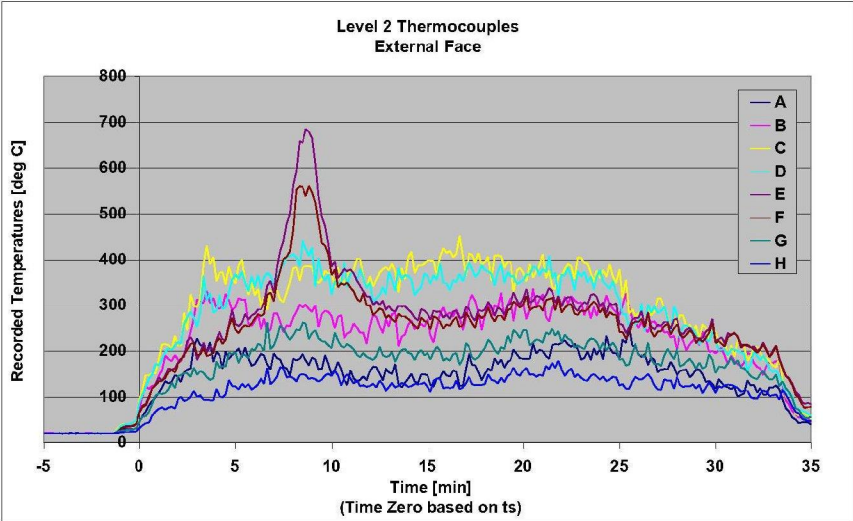
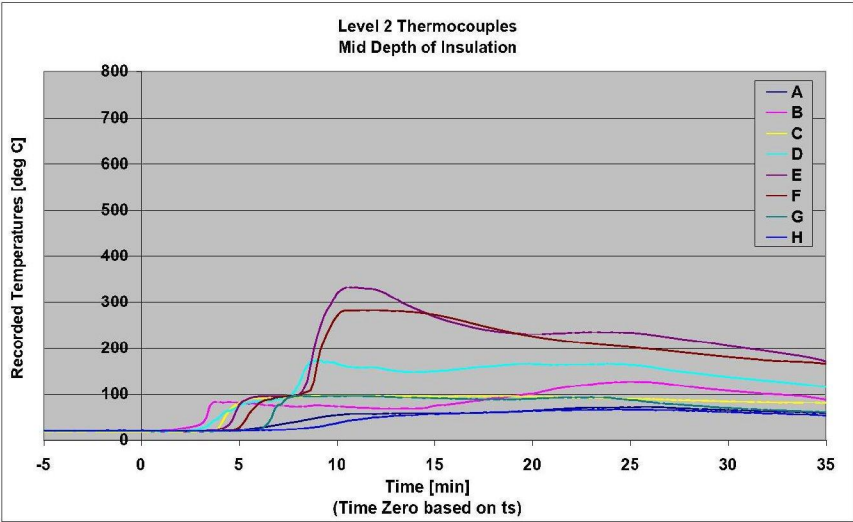
Render 2 - Phenolic 03-09-01

Test terminated 40:00

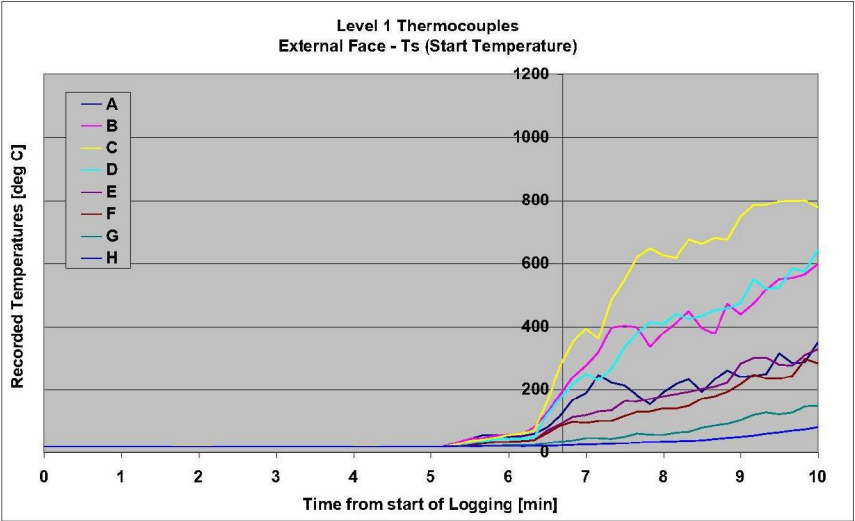
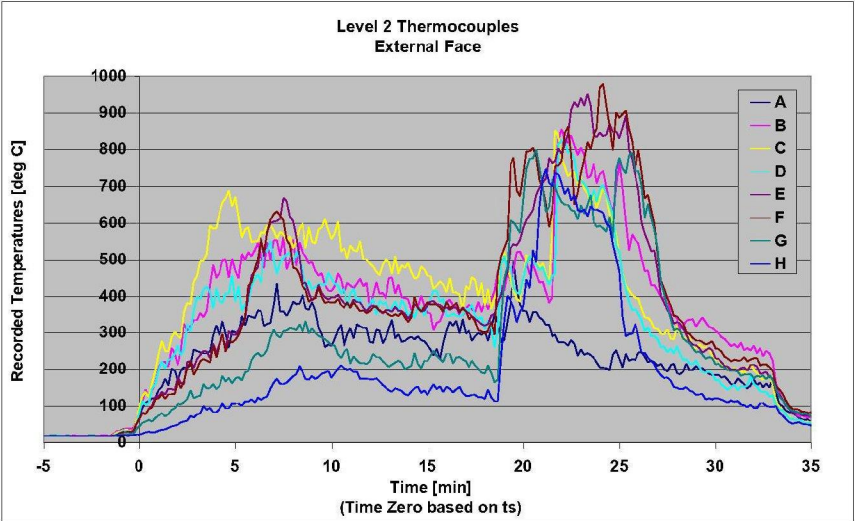
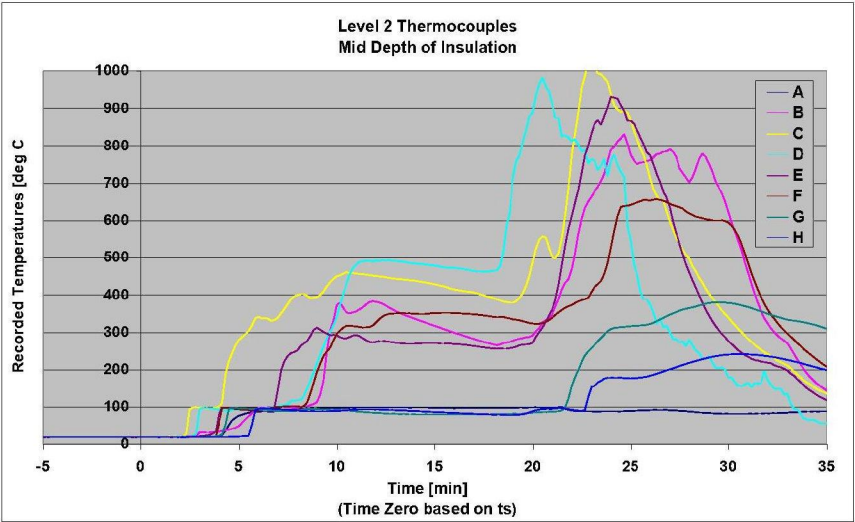
Render 3 - PUR 03-09-01

Test terminated 50:00

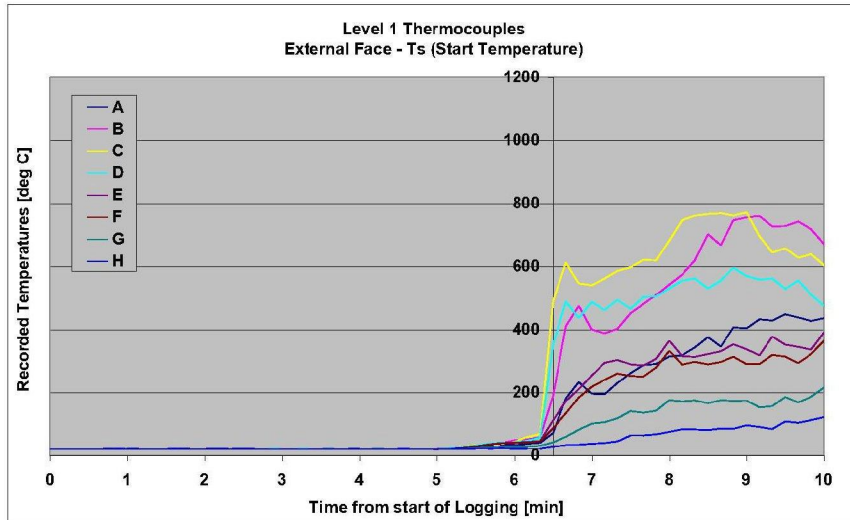
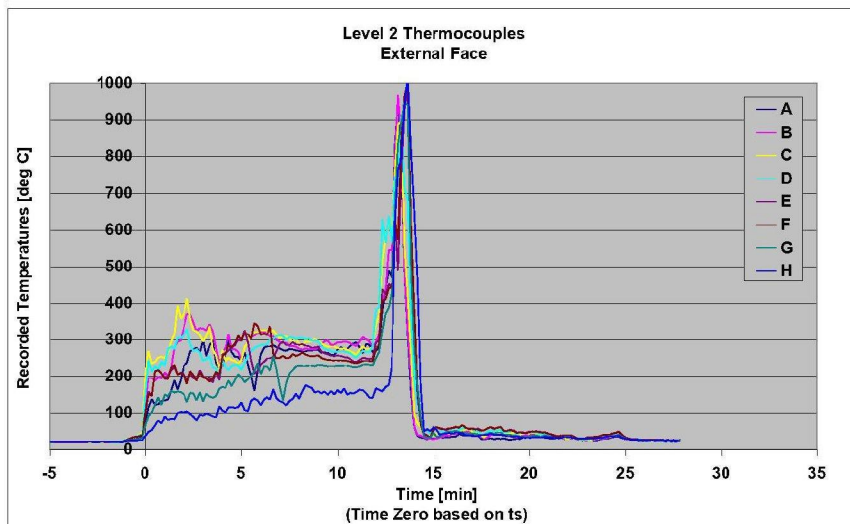
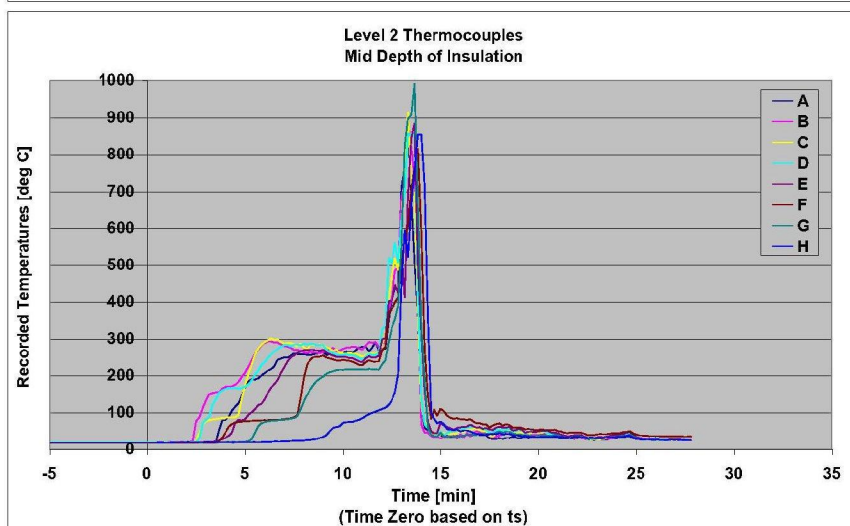
Render 4 - EPS 06-09-01

Test terminated 20:00

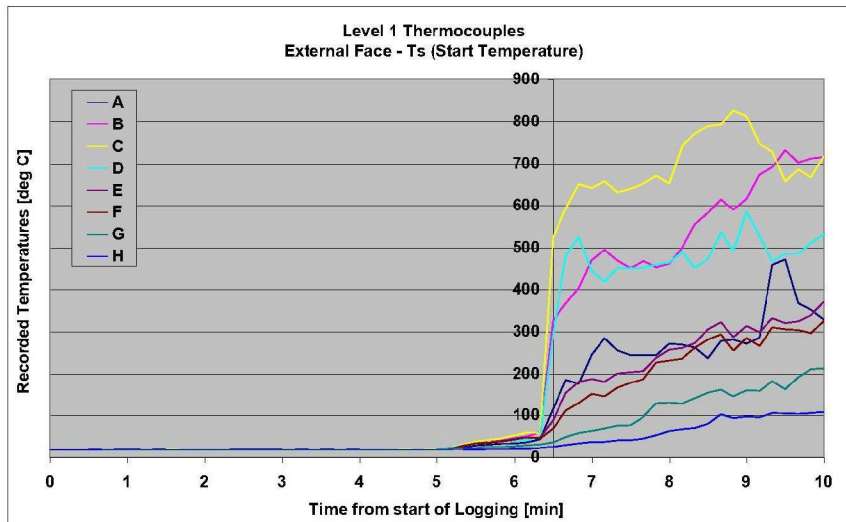
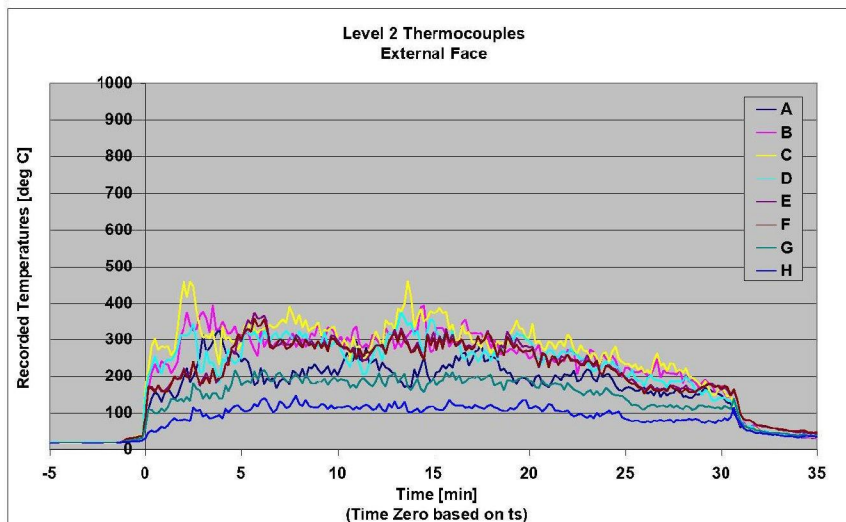
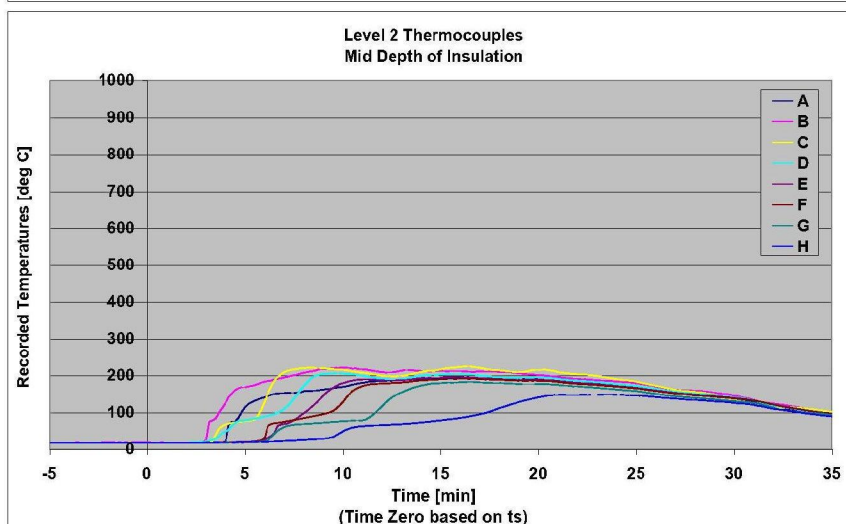
Render 5 - EPS with FB 06-09-01

Test terminated 37:00
