### **Exhibit JAH13**

1. The 4 x BIVs located at high level on the original 4" steel service pipe laid in 1974
2. The 3" IIV on the new 90mm Polyethylene (PE) gas service pipe
3. The ECV on the 10" steel gas service pipe

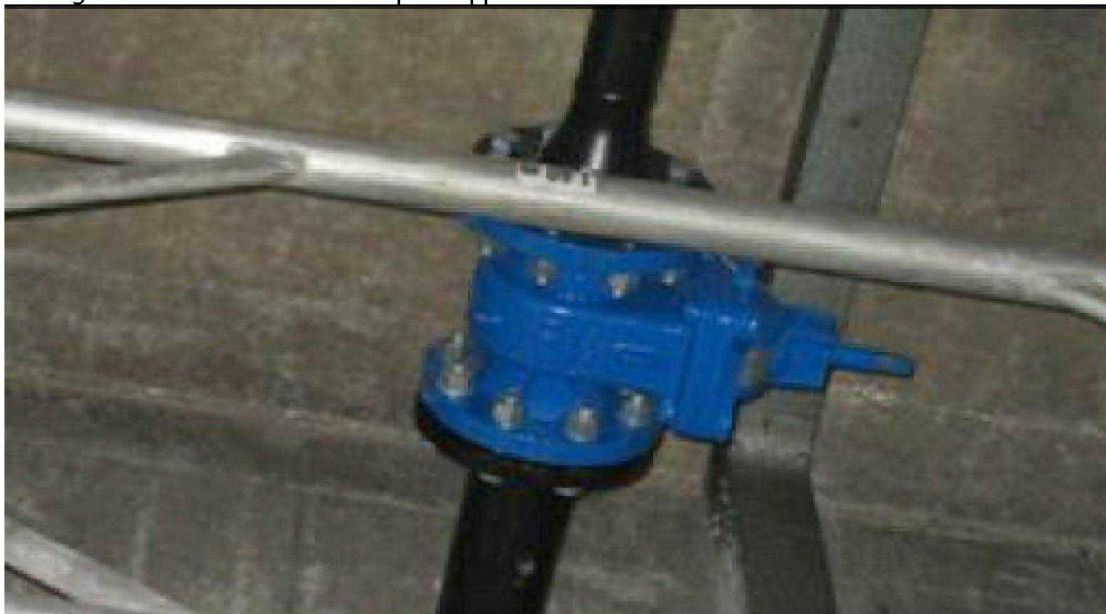
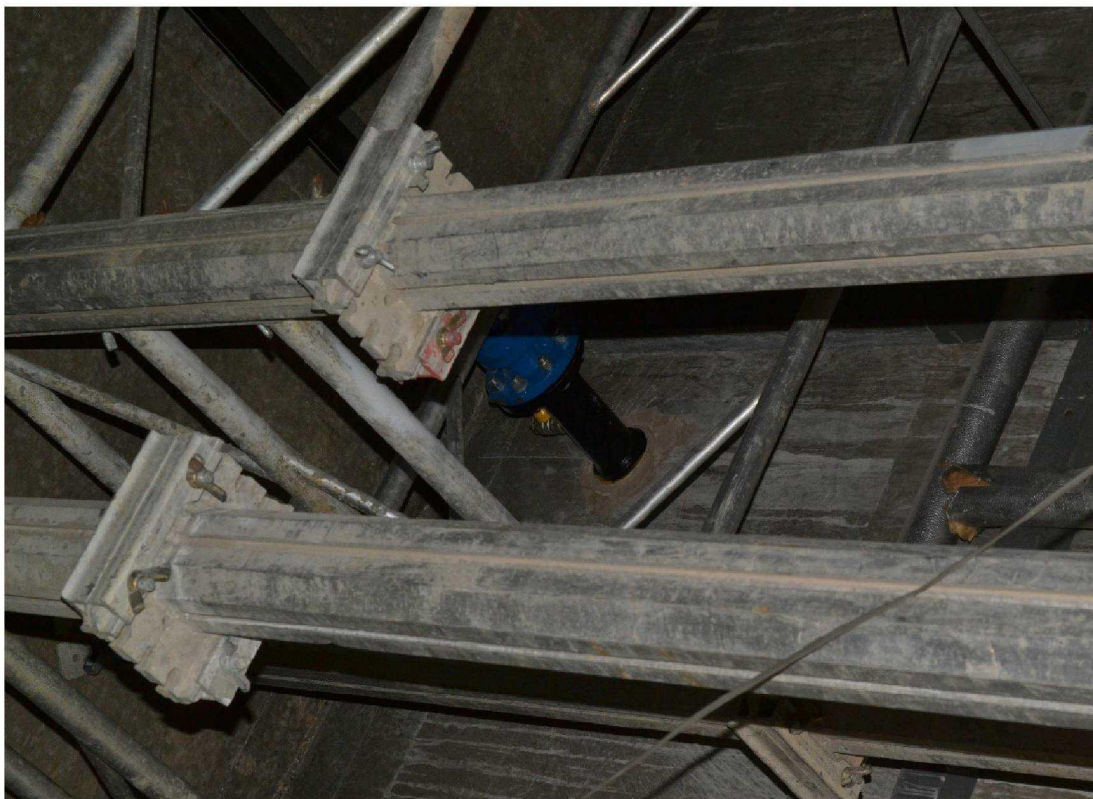
**2. The 3" IIV on the new 90mm Polyethylene (PE) gas service pipe**

Figure K18 from Dr Lane's report Appendix K
