BRE Global Test Report

BS8414-2 : 2005 Test on a Celotex RS5000 insulated system with a ventilated Eternit rain screen

Prepared for: Celotex Insulation Ltd

Report Number: 295369 Issue: 1

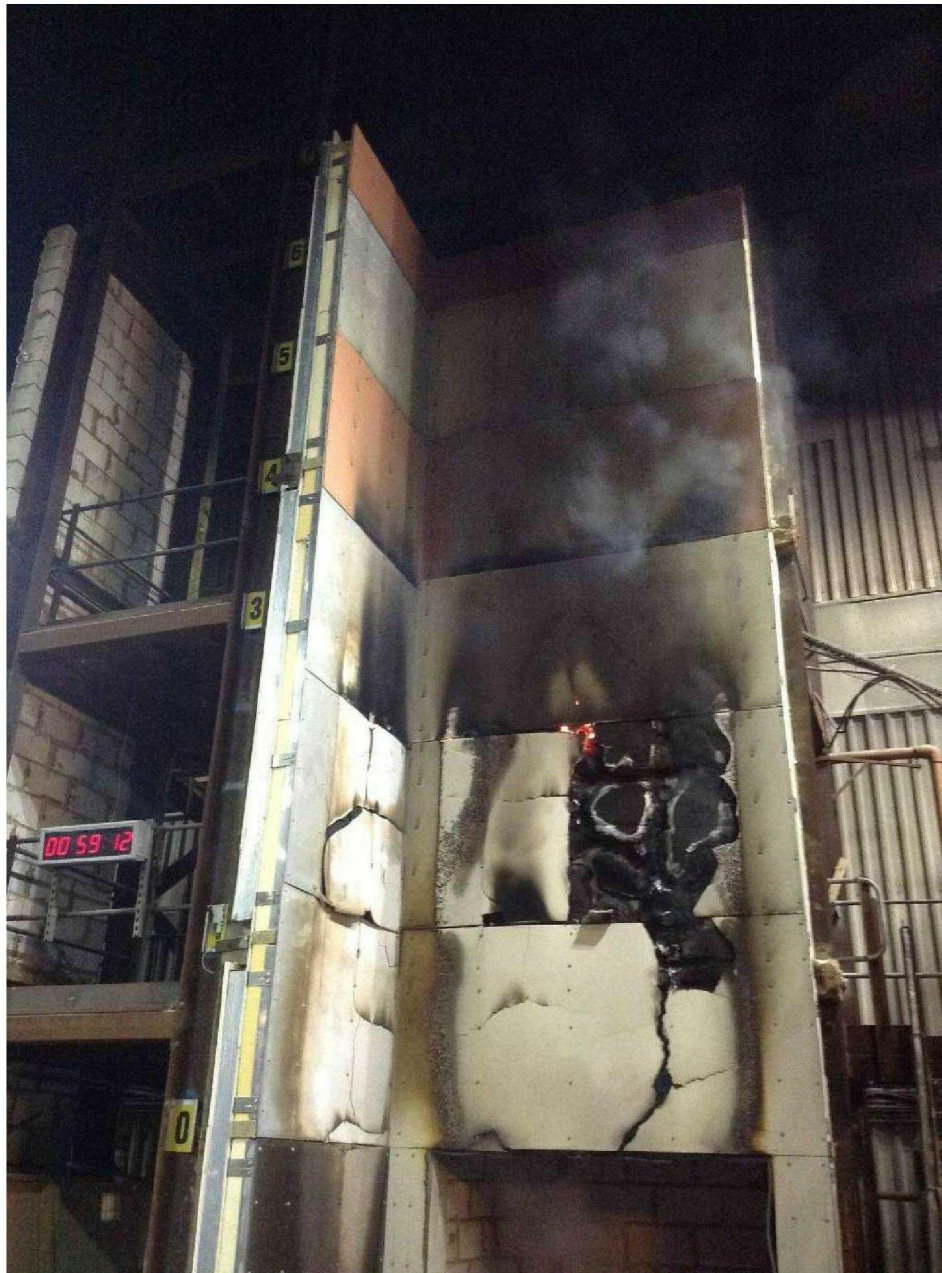
Figure 17. Photograph showing the condition of the cladding system post-test (Decorative Layer Full height).

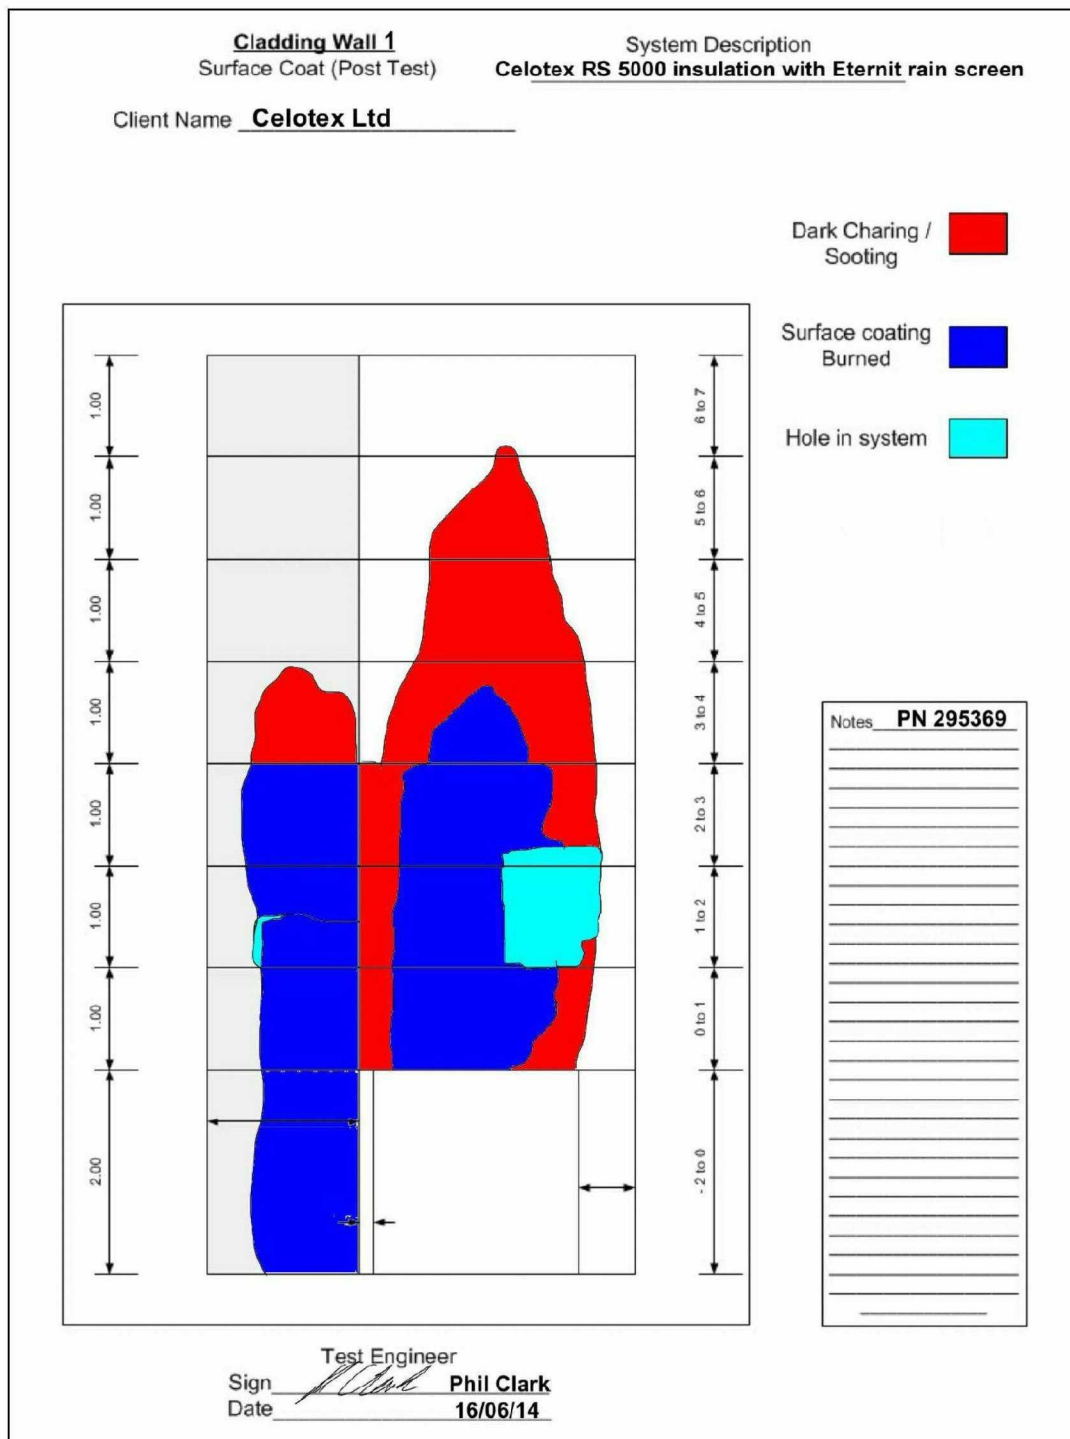
A schematic illustration of the damage to the system is shown in the condition of the cladding system after the test is shown in Figure 18. It was noted that the insulation layer continued to burn past the 30 minute with the flaming extinguished at 60 minutes.

Figure 18. Schematic of the condition of the cladding system post-test (Surface coat layer).

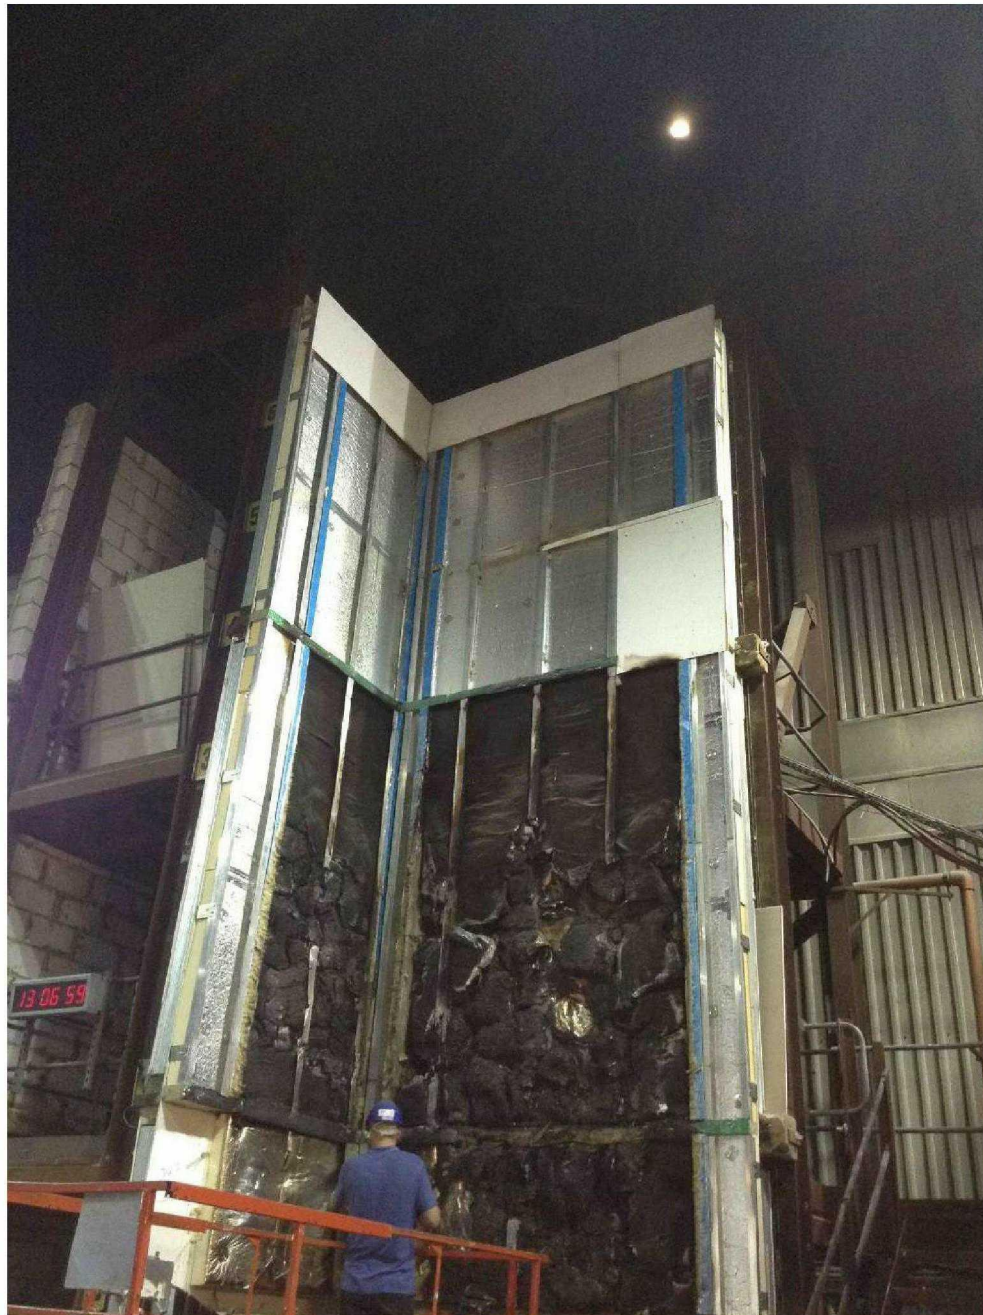
The condition of the panels after the test is shown in Figure 19.

Figure 19. Photograph showing the condition of the cladding system post-test (Insulation layer).

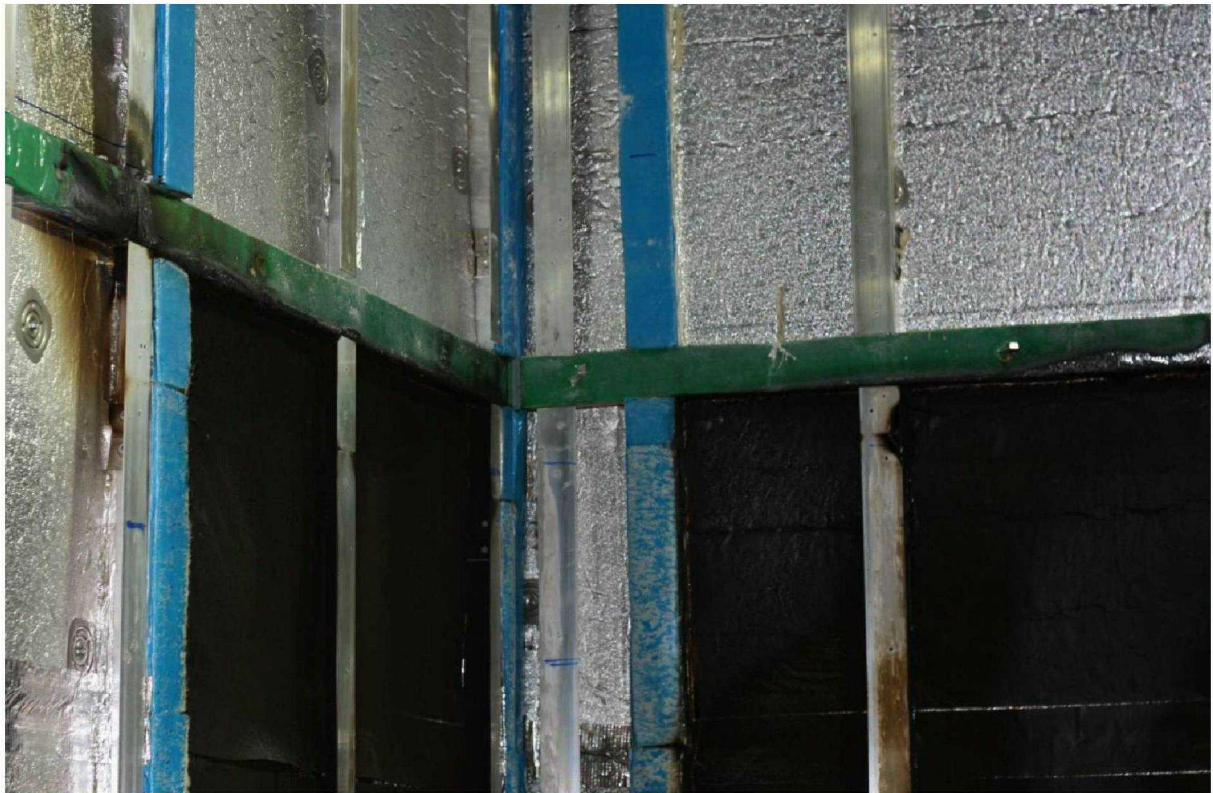
Figure 20. Photograph showing the condition of the cladding system post-test (Insulation layer) above and below the fire barriers.

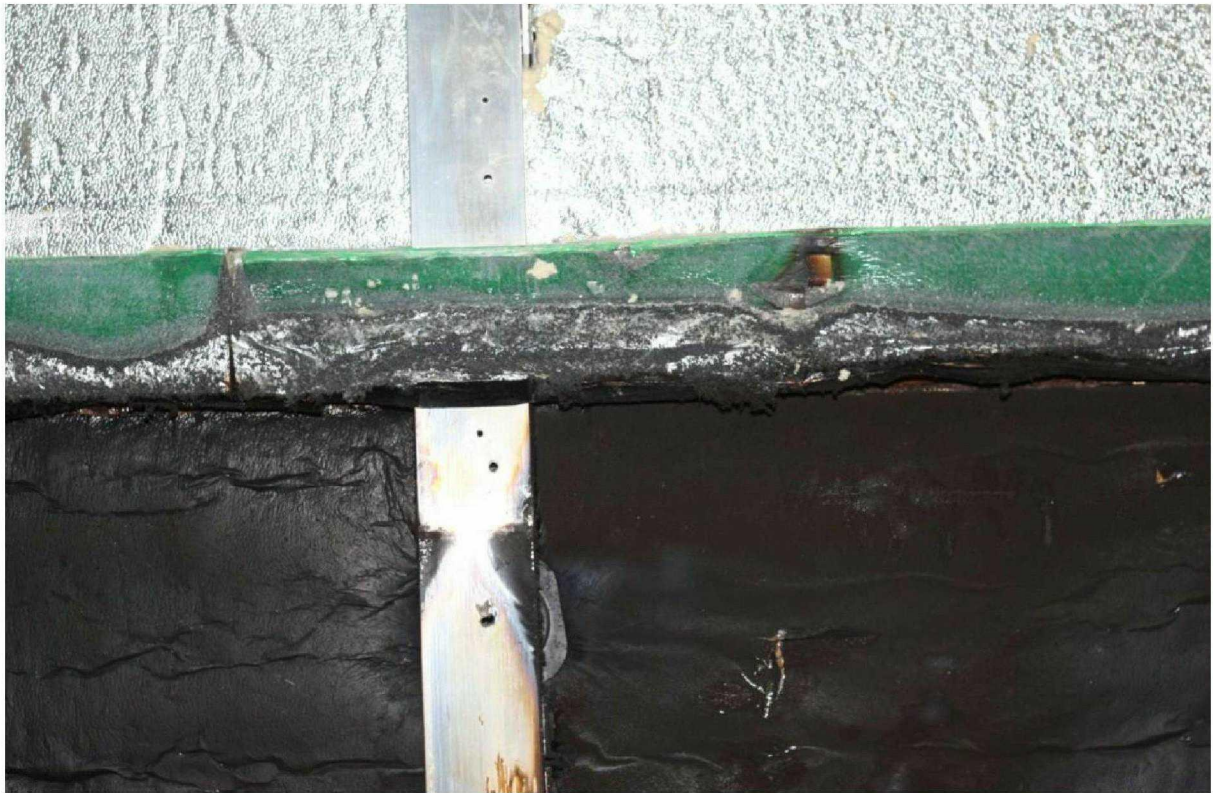
Figure 21. Photograph showing the condition of the ventilated fire barrier post-test.

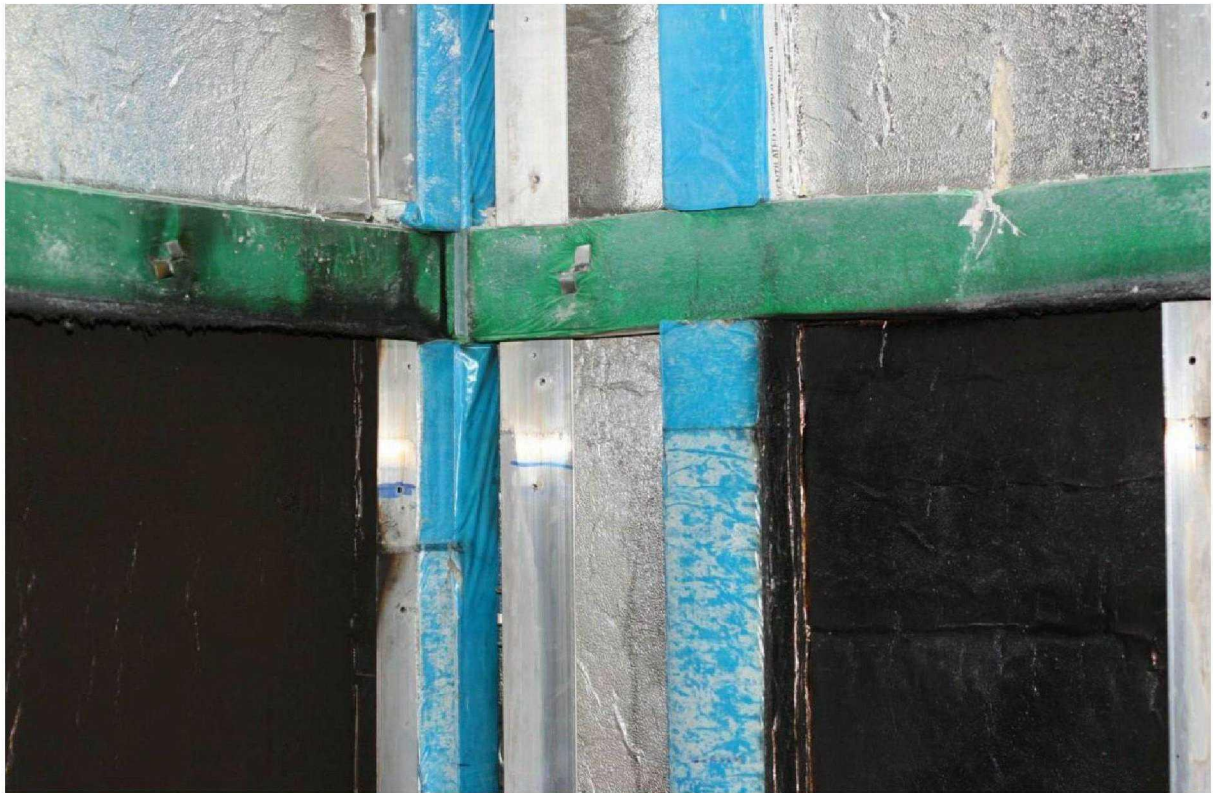
Figure 22. Photograph showing the condition of the fire barriers post-test.

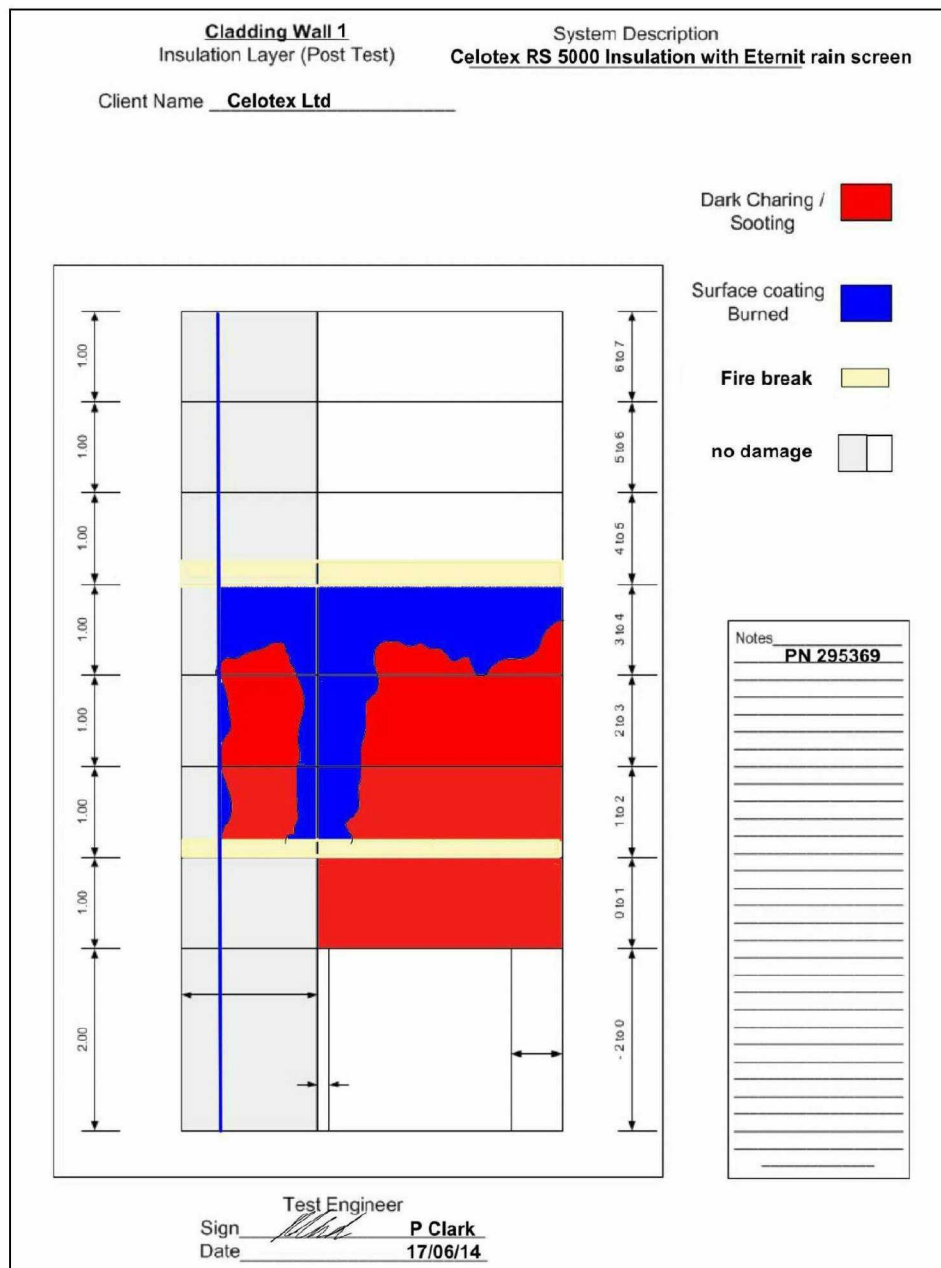
Figure 23. Schematic of the condition of the cladding system post-test (Insulation layer).
