**123 TAPLOW HOUSE
CHALCOTS ESTATE**

**FIRE DAMAGE REPORT FROM
ABSIEL SURVEY**

HARLEY CURTAIN WALL INCIDENT REPORT FORM 1

CONTRACT NO: C1031 Chalcots Estate
LOCATION: 123 TAPLOW HOUSE
RE: FIRE DAMAGE REPORT FROM ABSIEL SURVEY
DATE OF INSPECTION: TUESDAY 18th January, 2012

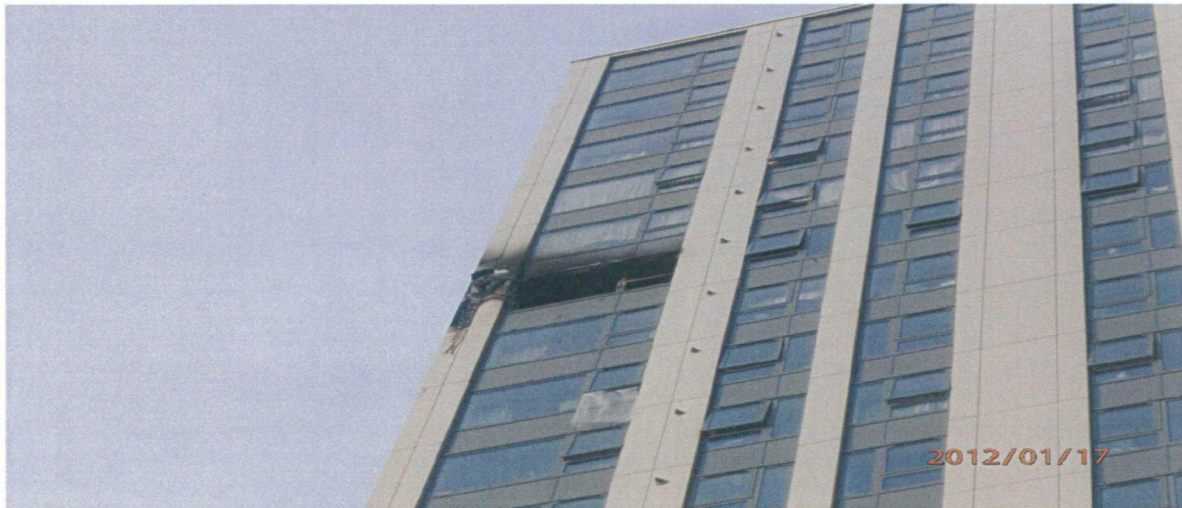
The South Elevation appears to have carried the brunt of the fire as shown on the photograph below. The extent of the fire also includes the flat above and below to the 16th and 18th floors. Temporary weather proofing will be required to prevent further damage by the weather as the design wind load for this project is said to be up to 2000pa.

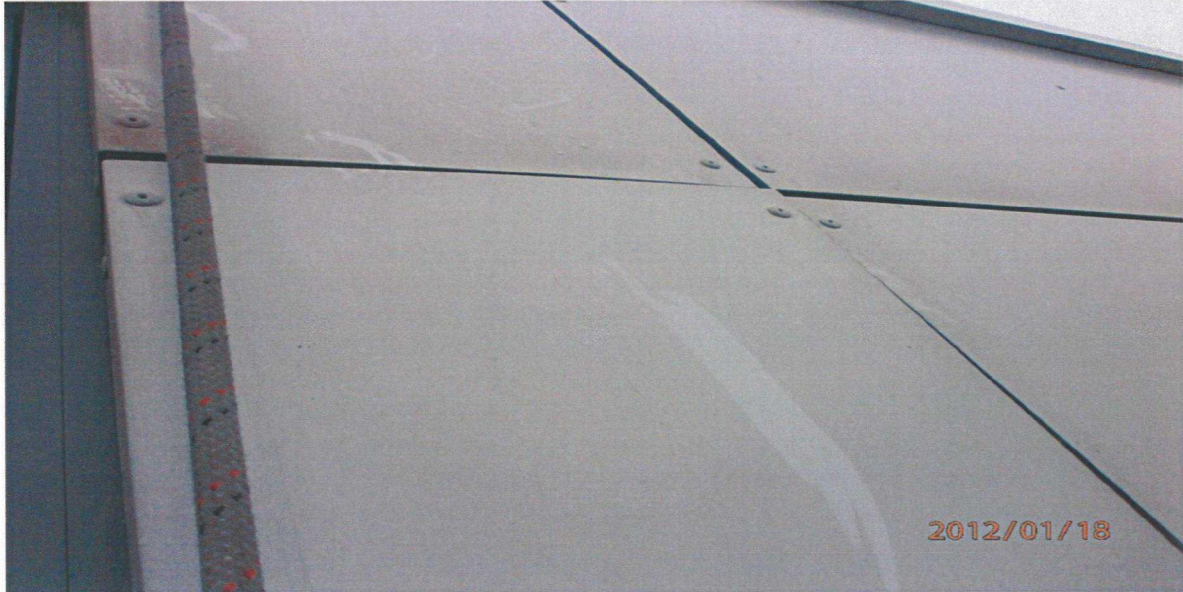
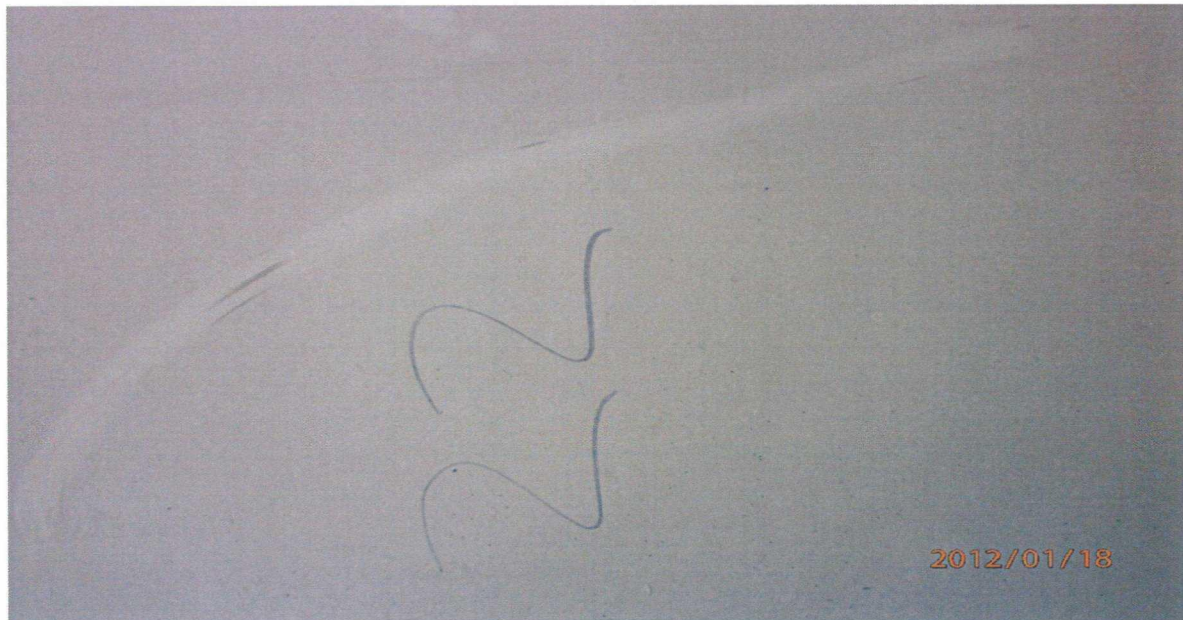
The Abseilers positioned their ropes on the roof and started their survey to the west elevation. As illustrated on the photographs below, the survey revealed damage to the cladding panels had extended up to the roof level, which could have been caused by the wind acting as a fan, moving hot flames and smoke. This has caused alignment issues with the panels and potential damage to the fixings and rails.

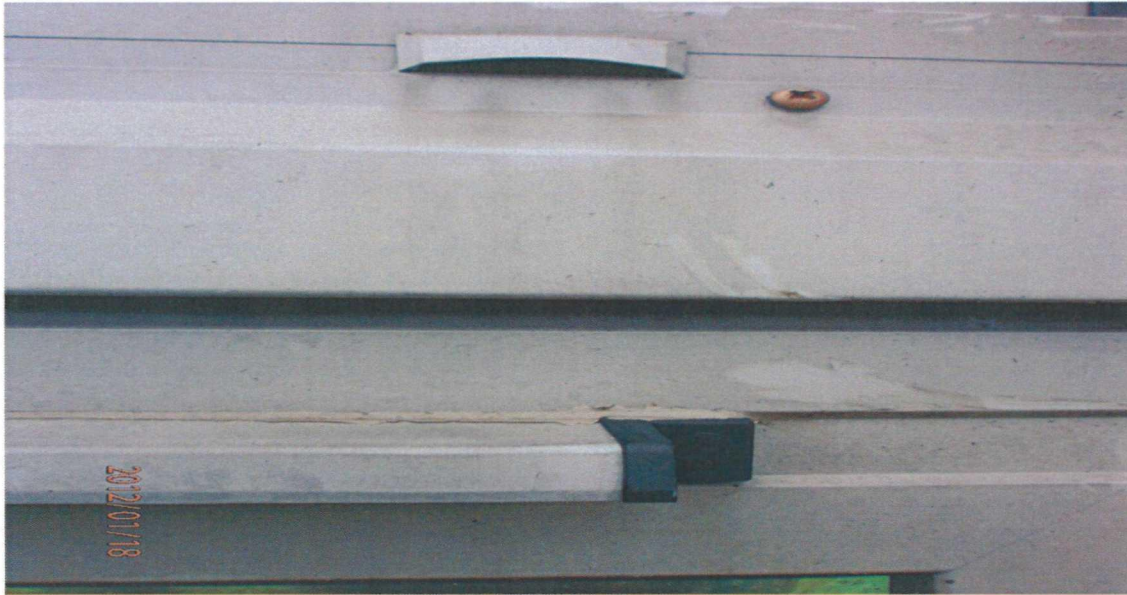
Smoke damage was evident to the windows on the 19th floor which has damaged the Active coating to the glass units and potentially the window fixings.

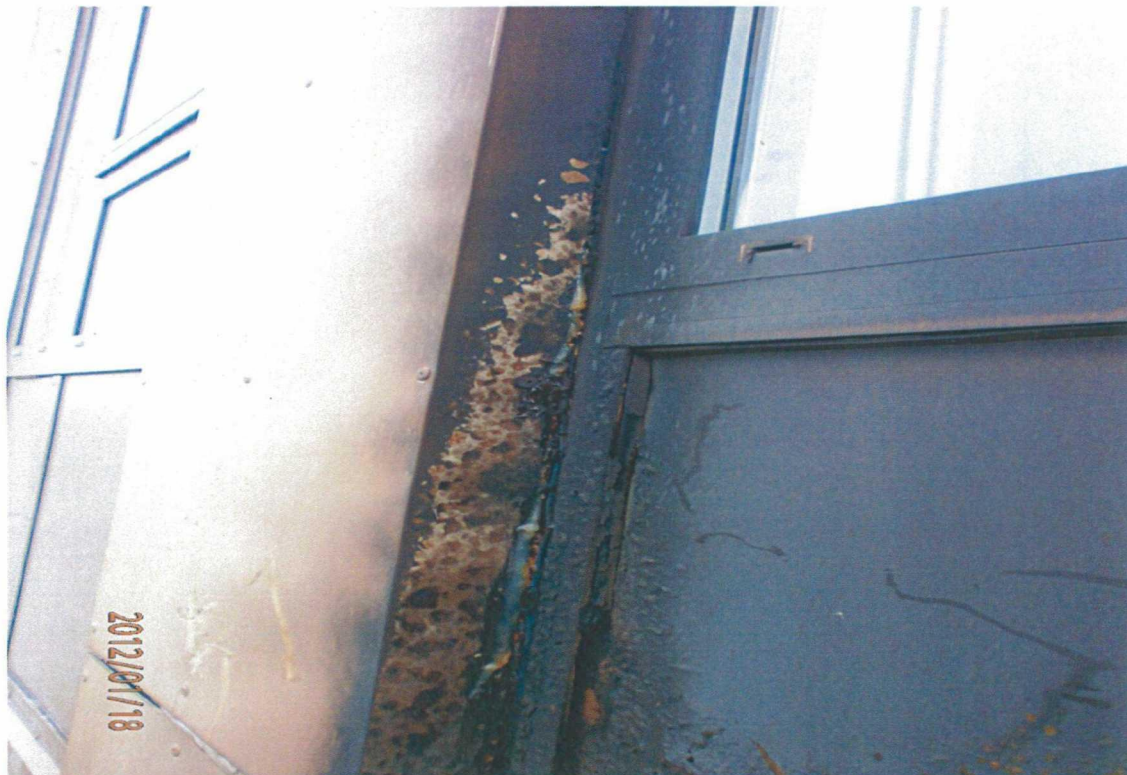
Visible damage to the flat above 123 Taplow House on the 18th floor, which shows damage to both the window and rainscreen cladding. It was also noted that Rydon's Maintenance division have replace the glass unit with a temporary replacement.

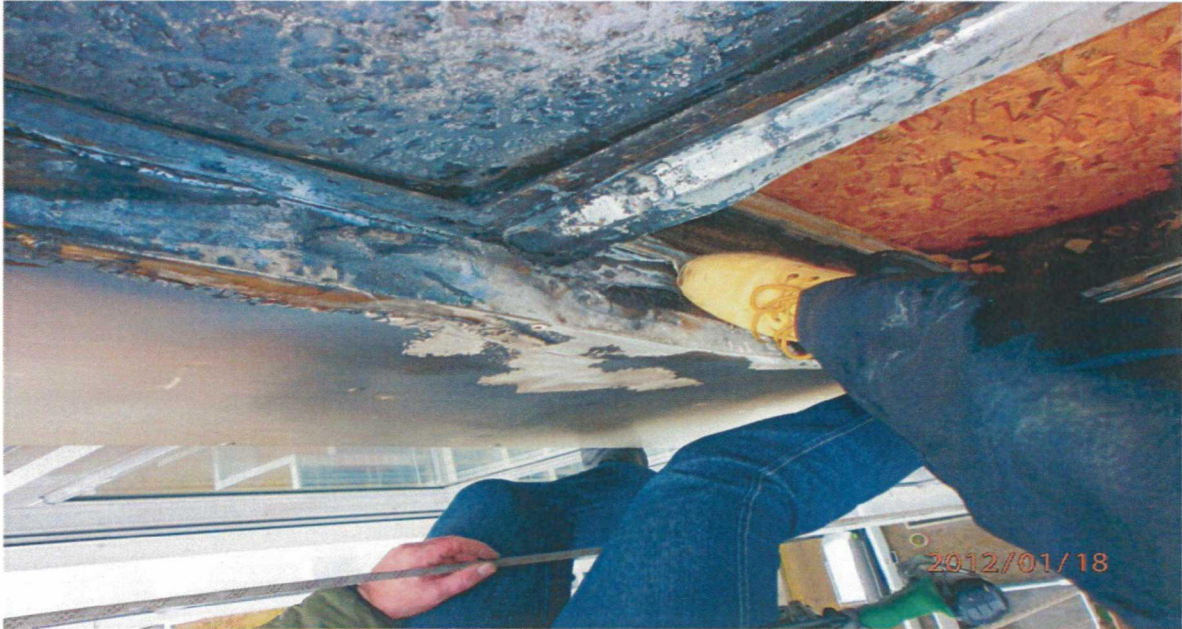
The area around the living room has clearly taken the brunt of the fire leaving serve damage.

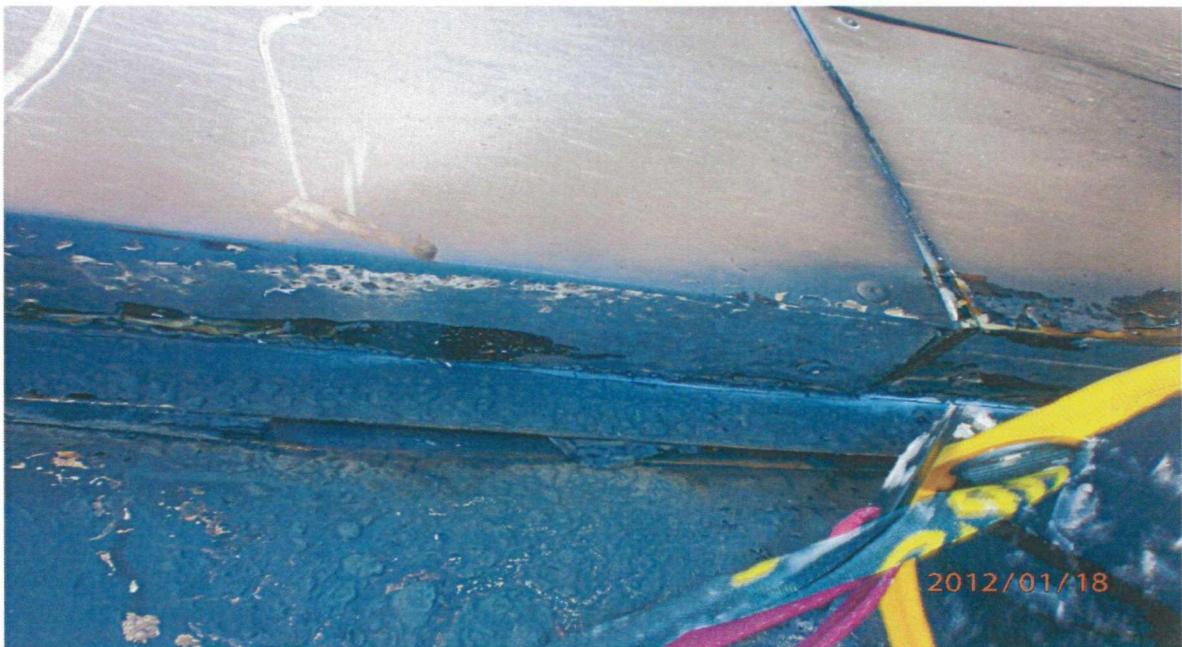
Extensive damage has also occurred to the left hand jamb section of the living room window, where the fire started. The damage includes the panels above and below the flat on the 17th floor and includes all panels on the west elevation as it meets the south elevation.

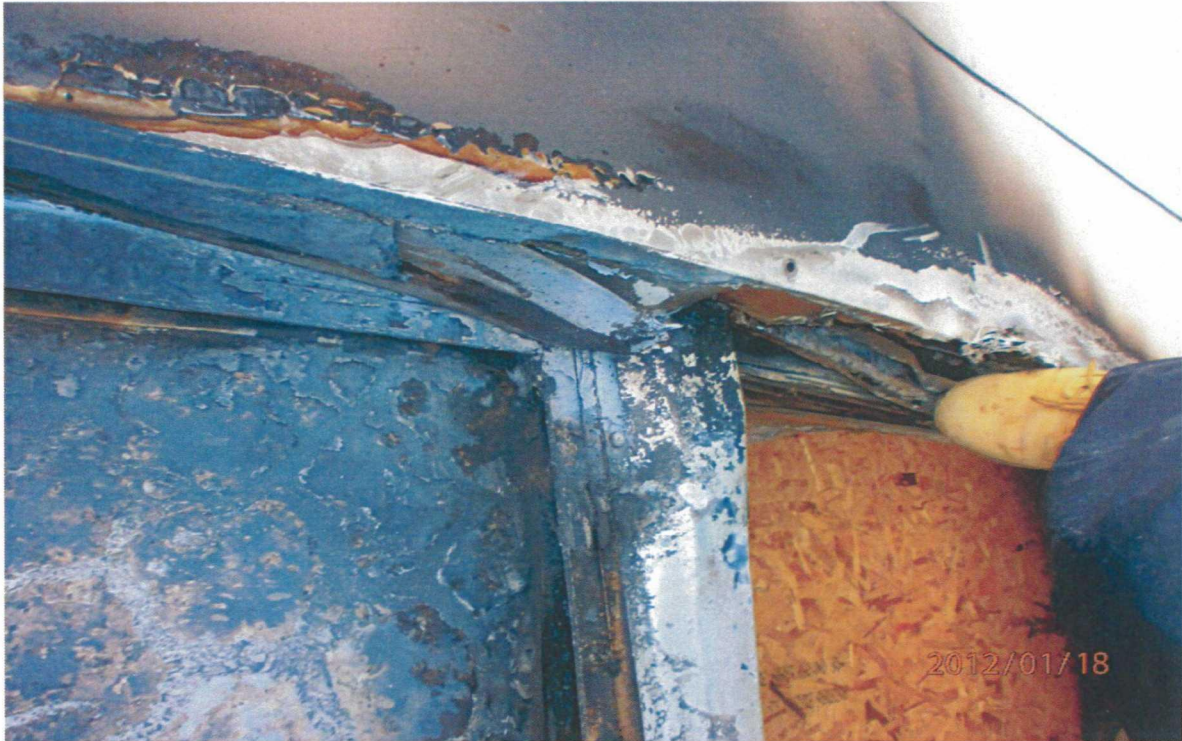
The photograph below which has been taken on the west elevation 18th floor looking down to the 17th floor where the fire broke out. Concrete repairs maybe necessary as the fire has damaged the reveals.

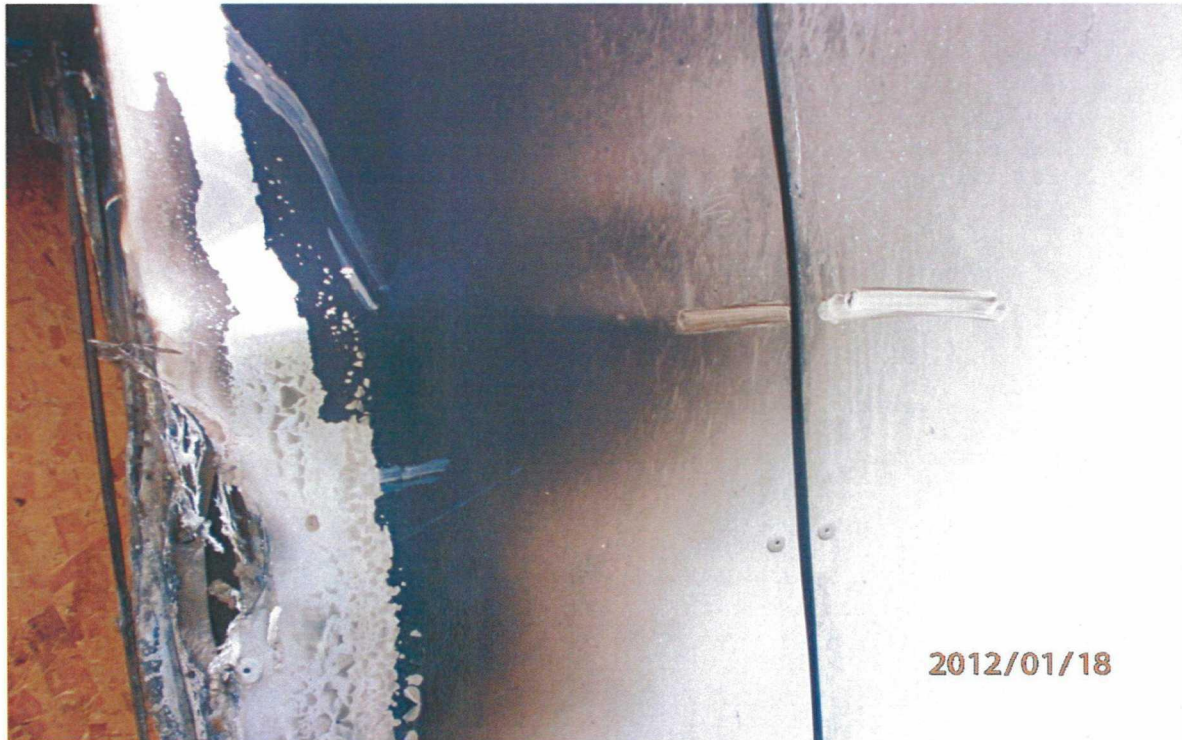
Photograph showing damage to the window vent location on the west elevation 17th floor, which has twisted the substructure and damaged the system.

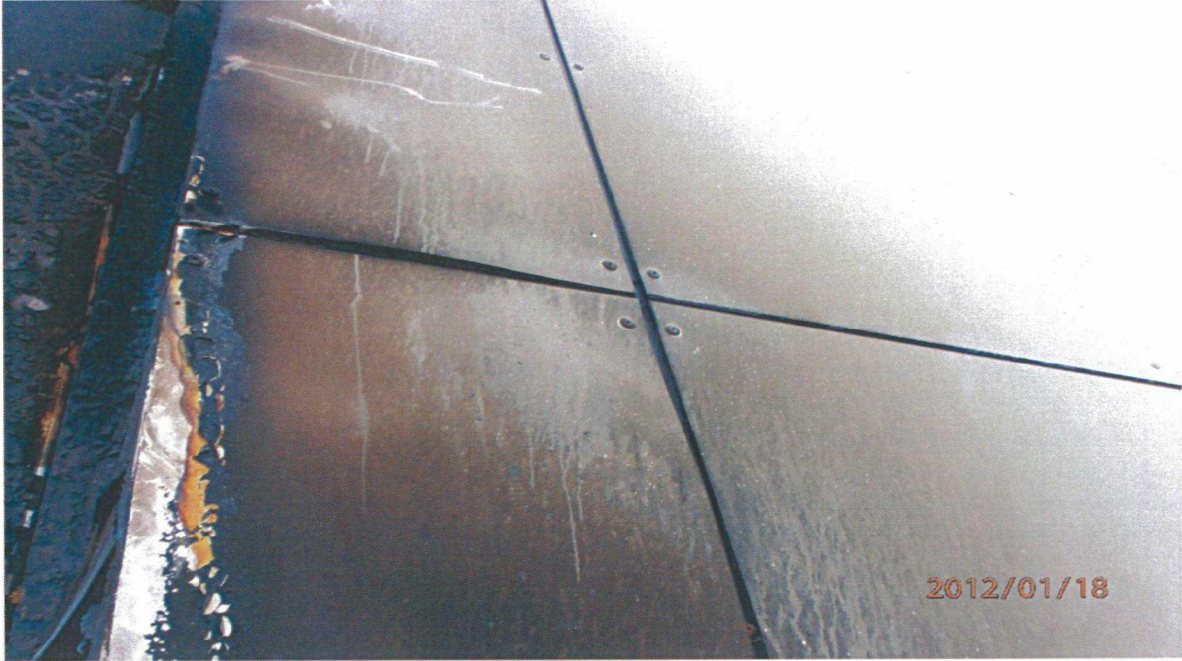
Opposite corner on the 17th floor west elevation which shows damage to the panels, and possibly the support structure behind.

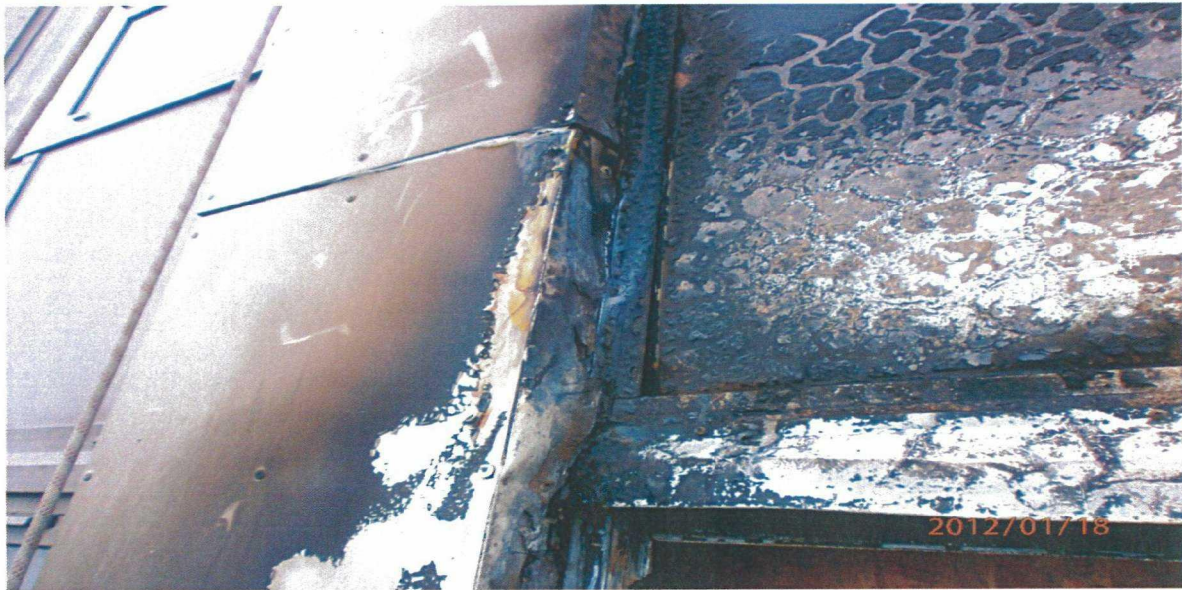
Photograph showing extensive damage to the 17th and 18th floors to the west elevation.

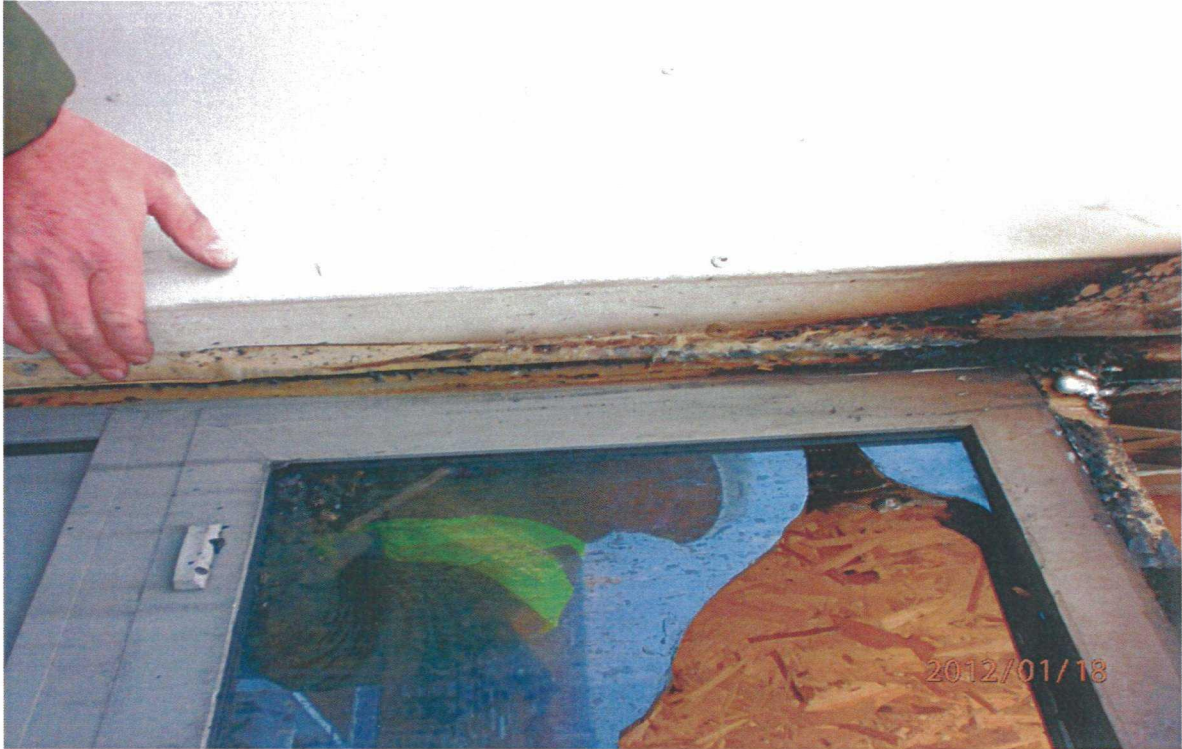
Visible damage to the bottom vent and the window reveal on the 17th floor to the west elevation. We would have concern as the integrity of the support structure.

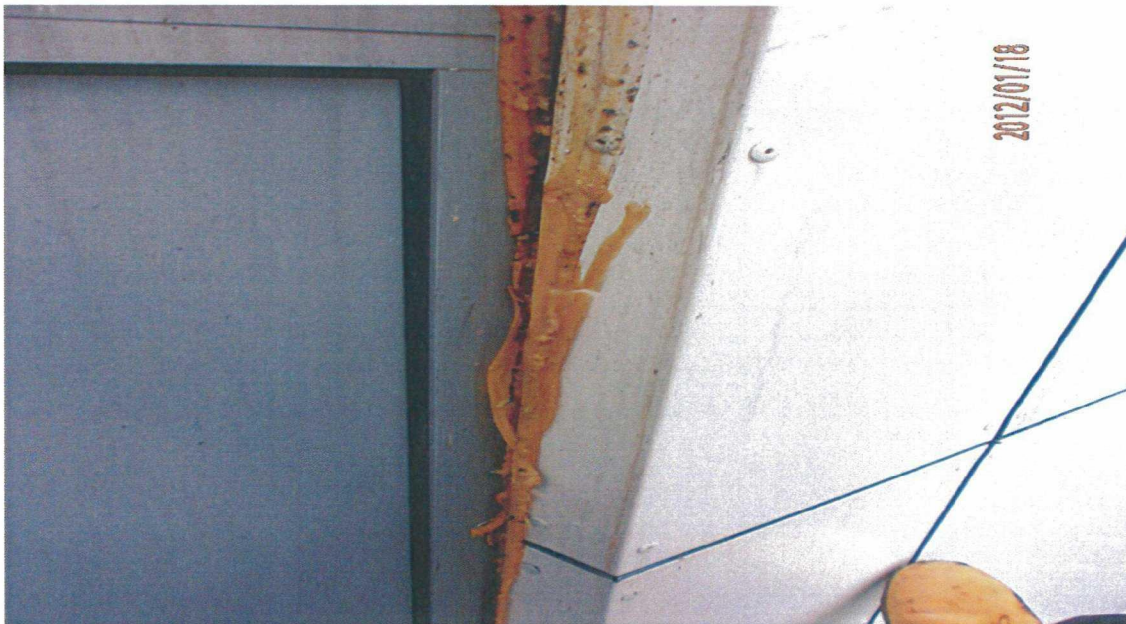
Damage to the window on the 16th floor below the fire damaged flat.

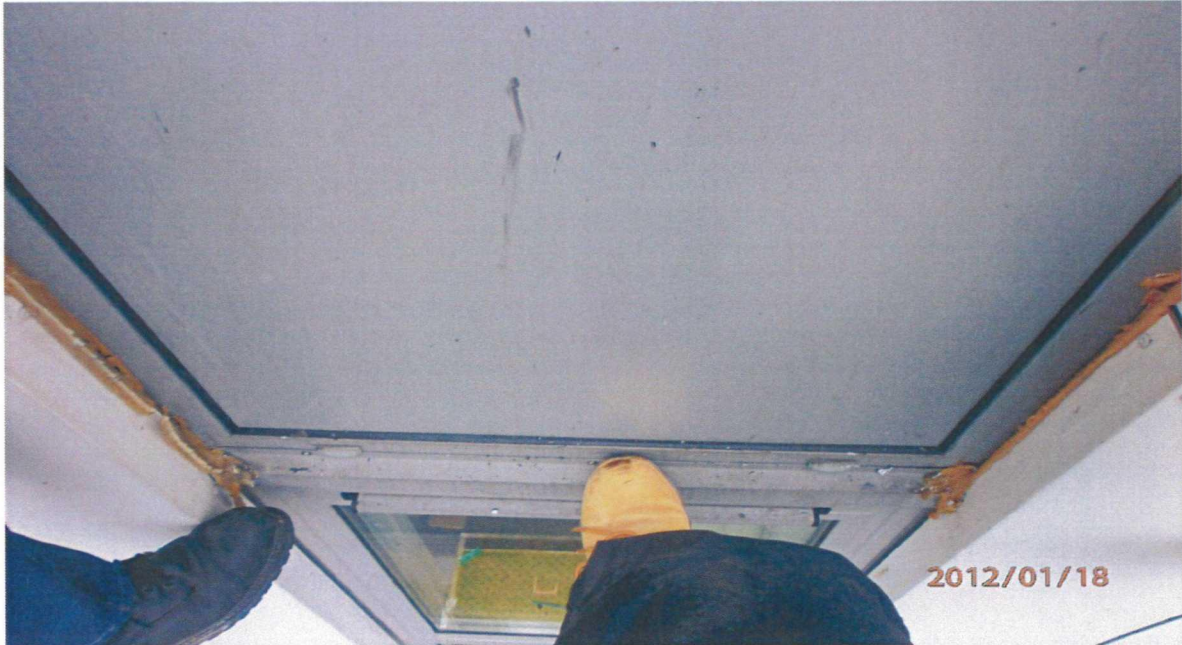
Windows viewed on the 15th floor west elevation which show residue of smoke damage and foam on the surface.

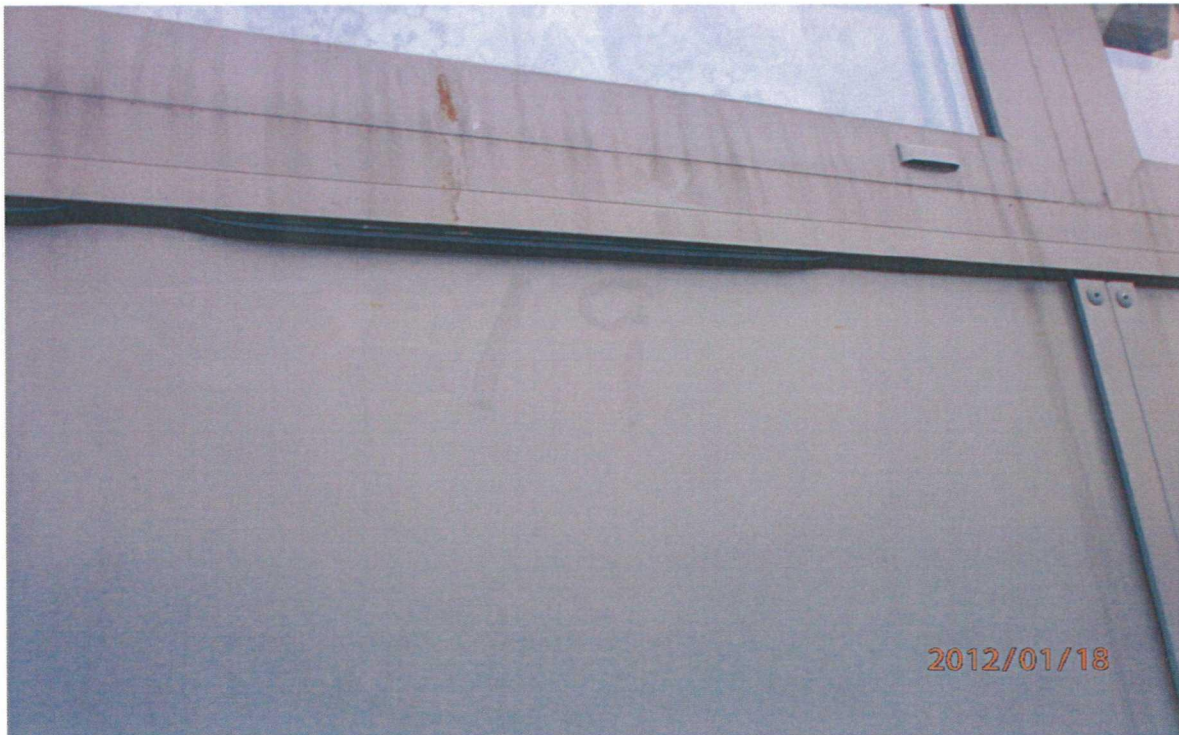
The fire damage to the south elevation appears to be more severe with damage evident on the 19th floor window, affecting both the powder coating and active glass coating.

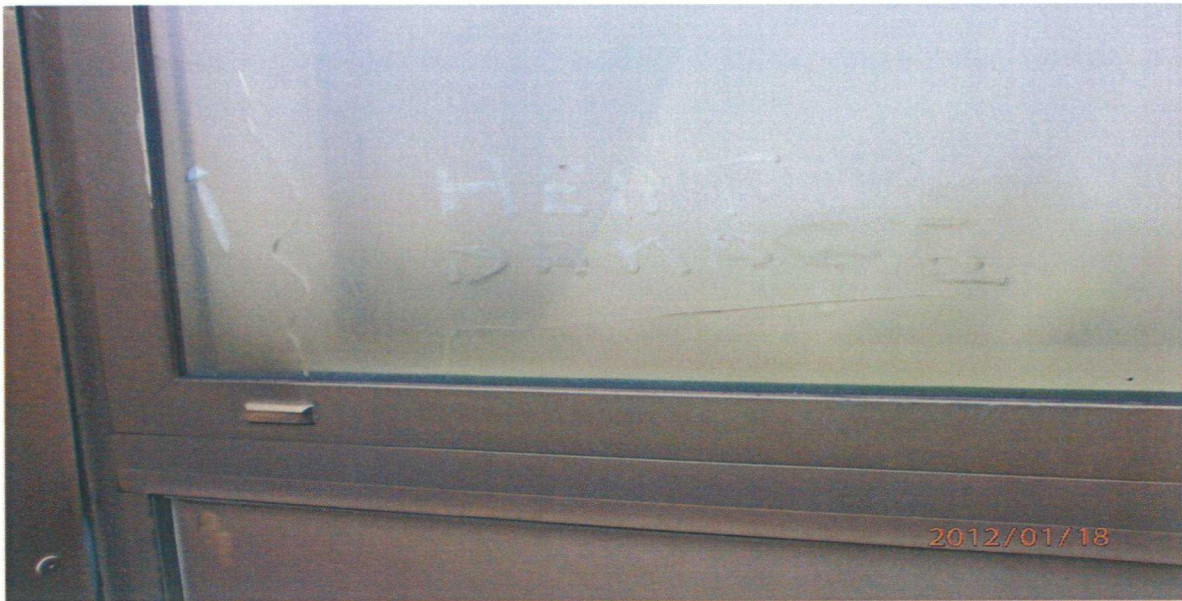
Damage to the window on the 18th floor south elevation above the fire damaged flat.

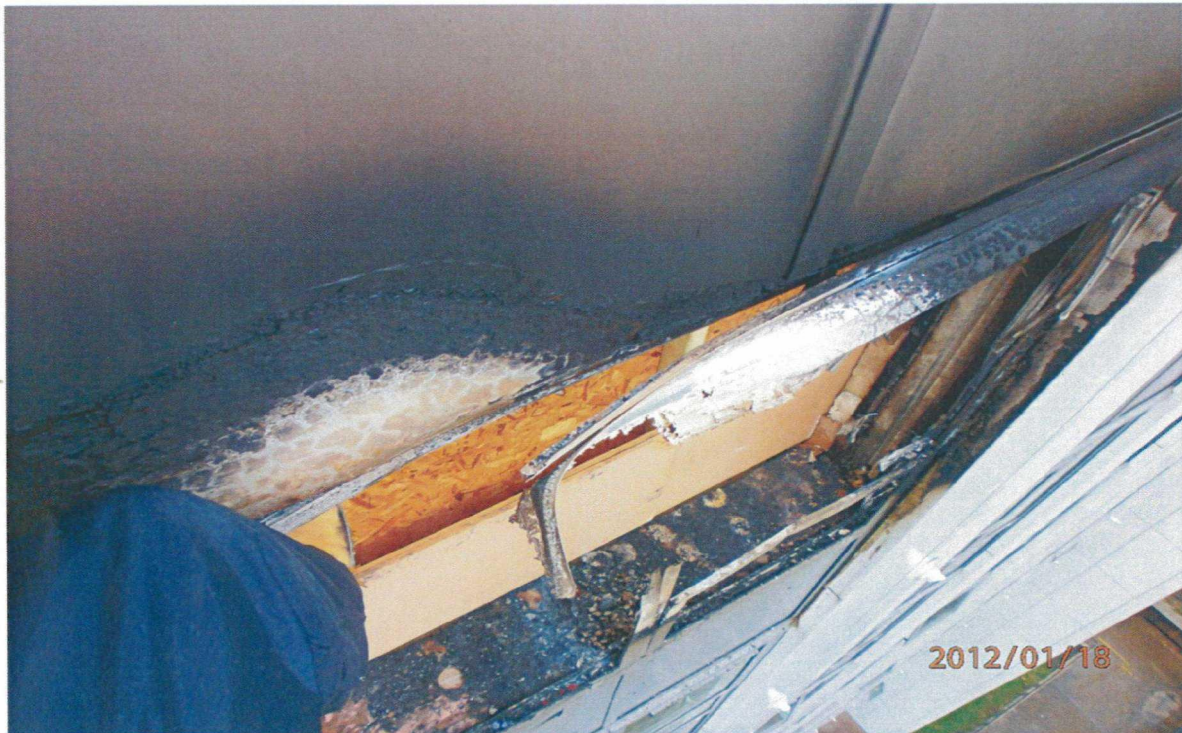
Damage on the 18th floor South Elevation looking down to the 17th floor flat where the fire occurred.

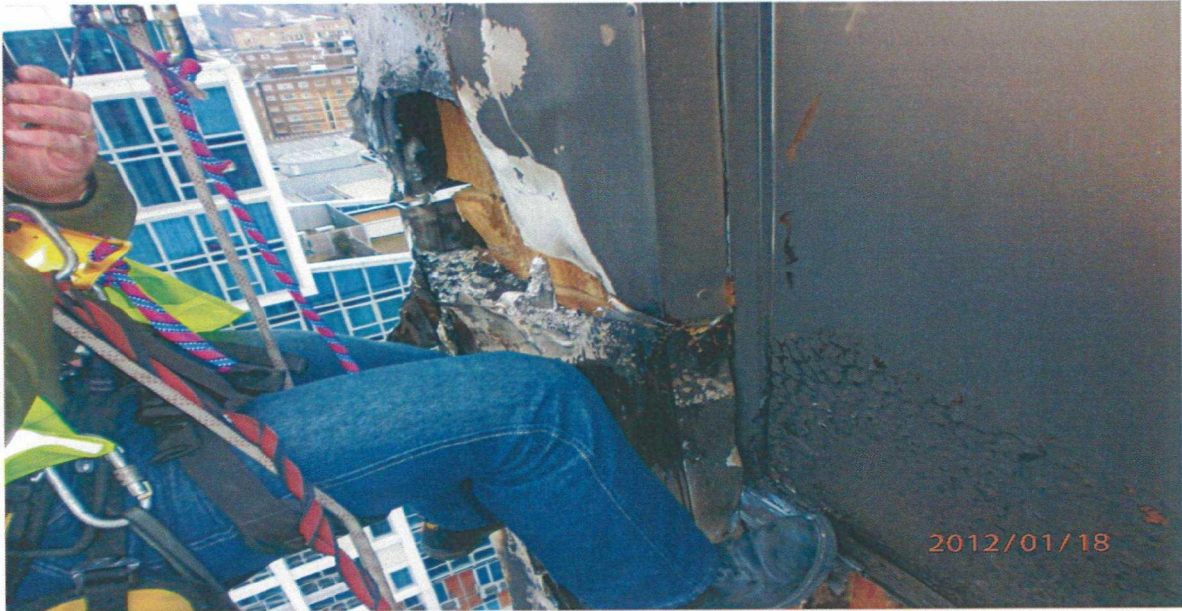
Photograph showing extensive damage to the south west corner on the 17th and 18th floors.

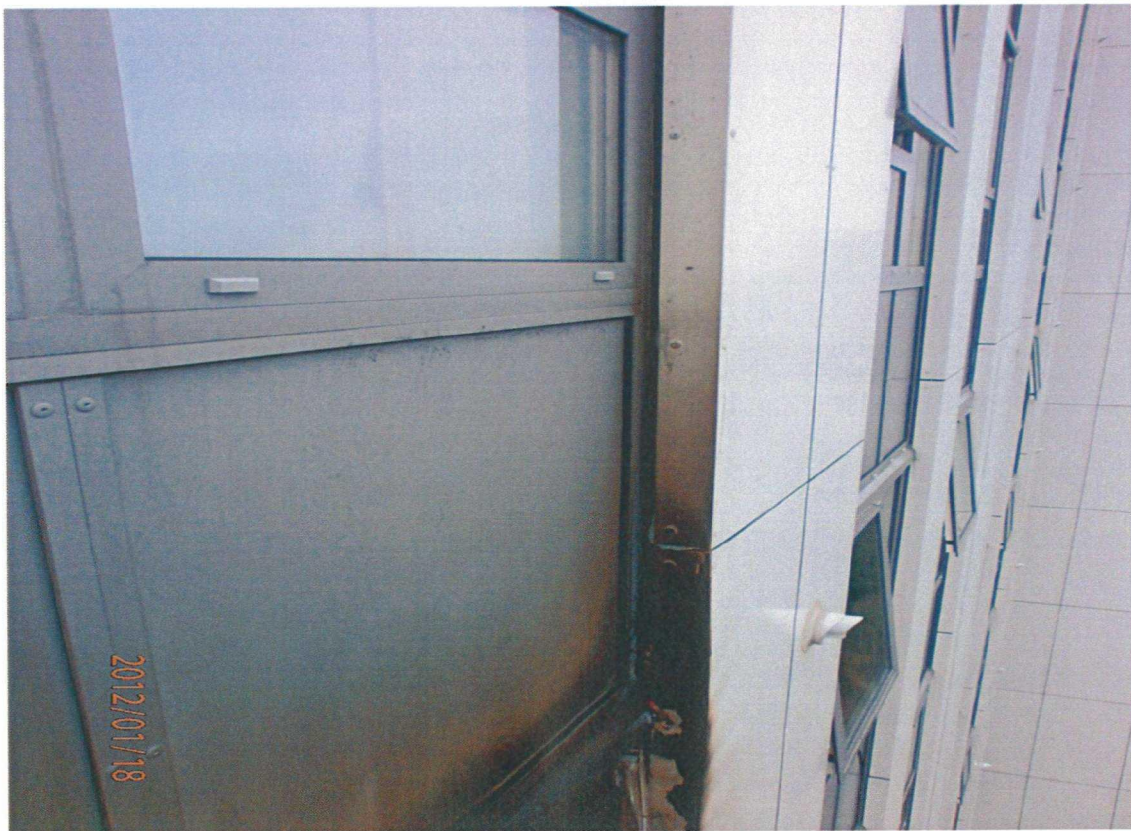
Damage to the bedroom window and surround panels and substructure on the 17th and 18th floors south elevation.

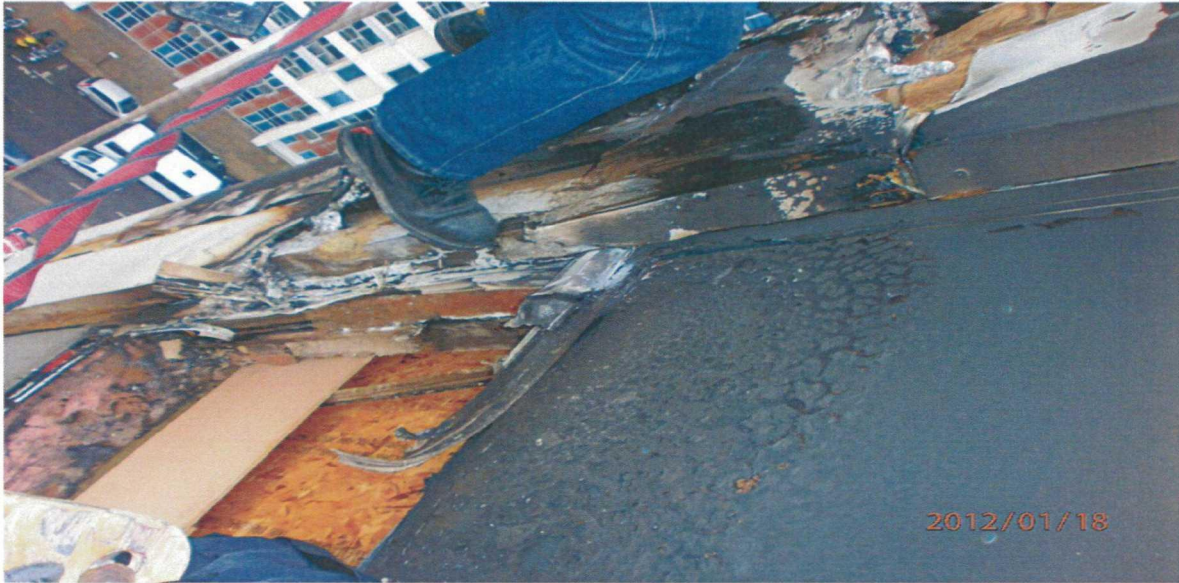
View from the south west corner on the 17th and 18th floors confirming damage to the flat directly above 123 Taplow House. However the fire barrier prevented the spread of fire into the internal space.

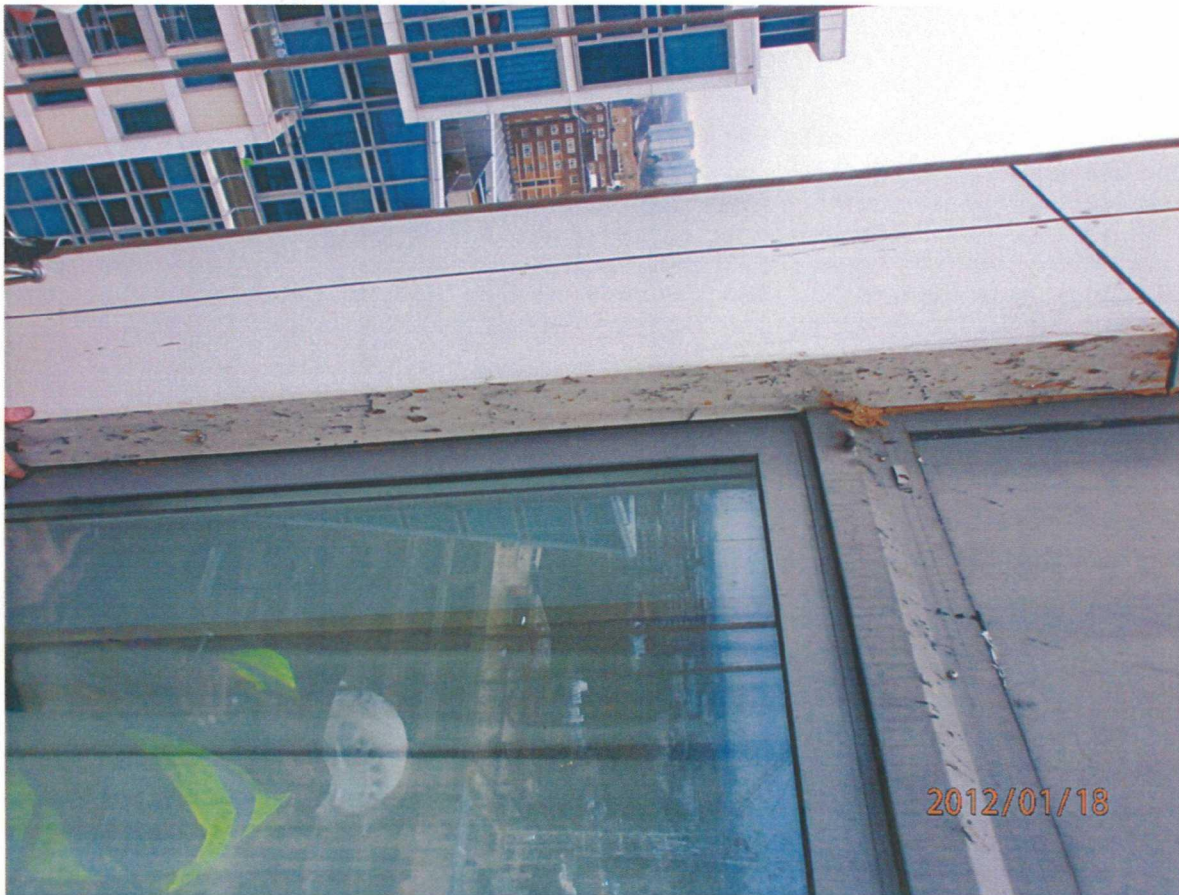
The hot residue from the burning flat has spread down to the 15th floor on the south elevation. This has stuck to the panels and burnt the PVDF surface
