Lakanal House, 3rd July 2009

FIRES OF SPECIAL INTEREST

FSIS Ref. No: 14/08-09

Address of fire: Lakanal House, Sceaux Gardens, Camberwell, London, SE5 7DN

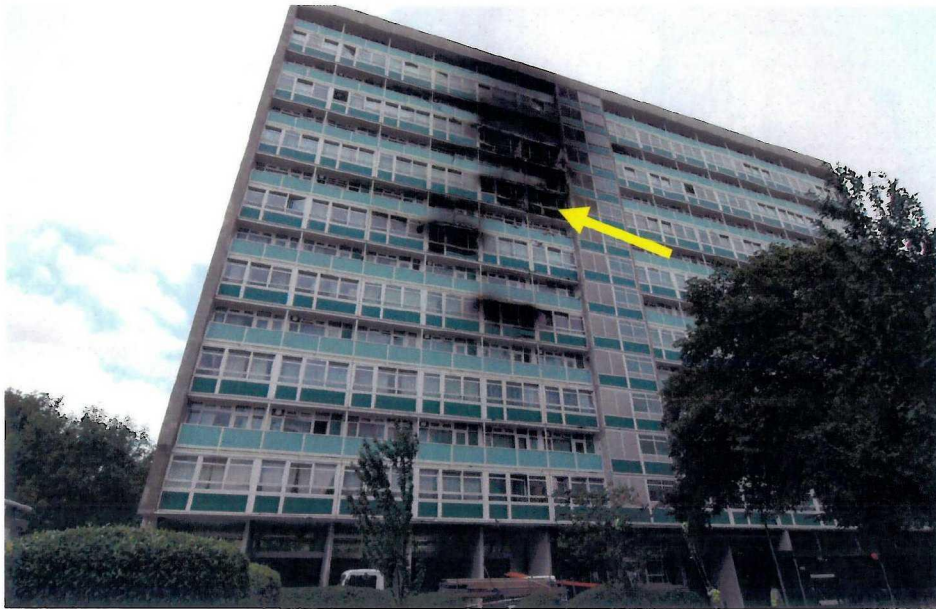
External Fire Spread – Yes. Fire initially spread up externally from flat of origin. Fire spread down due to burning material falling – possibly lodged in anti-pigeon wires. Also wind may have been significant in blowing fire through corridor (see Fig 8)

Figure 1 – West face of Lakanal House. Arrow indicates room of origin on 9th floor. Fire spread to floors below believed by LFB to be caused by drop down of flaming material from window frames.

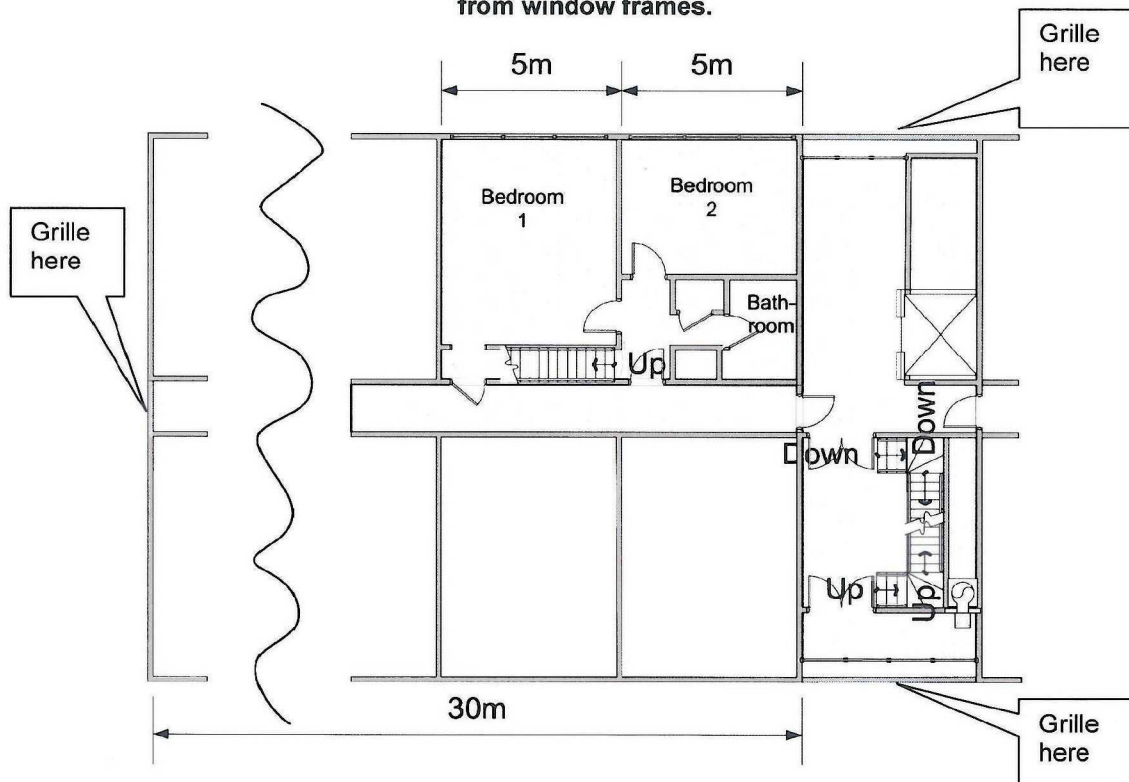
Figure 2 – Plan of odd numbered floor layout (lower floor of maisonettes). Flat volume highlighted in green, communal space highlighted red.

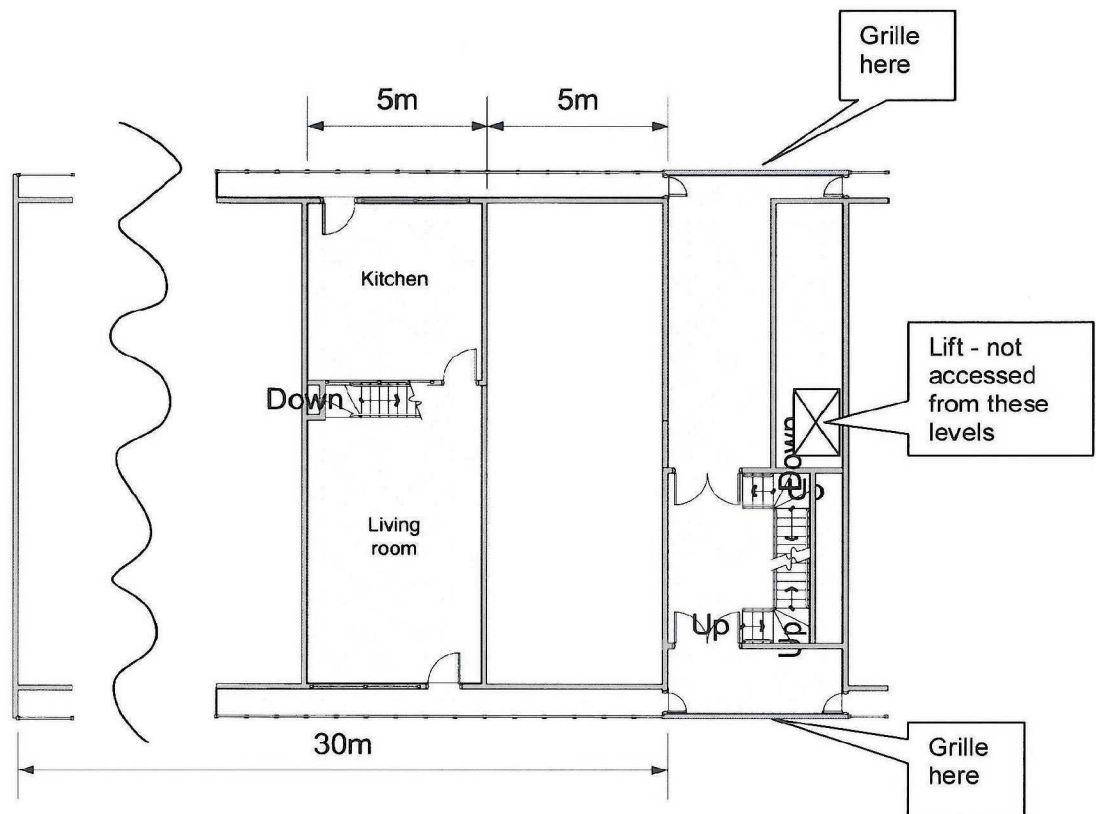
Figure 3 – Plan of even numbered floor layout (upper floor of maisonettes). Flat volume highlighted in green, communal space highlighted red.

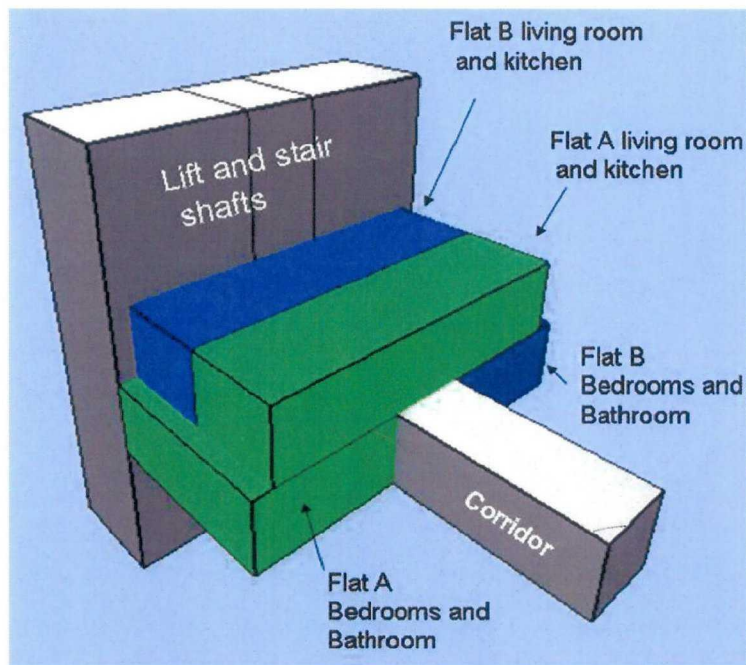
Figure 4 – Diagram showing interlocking of flats and corridor.

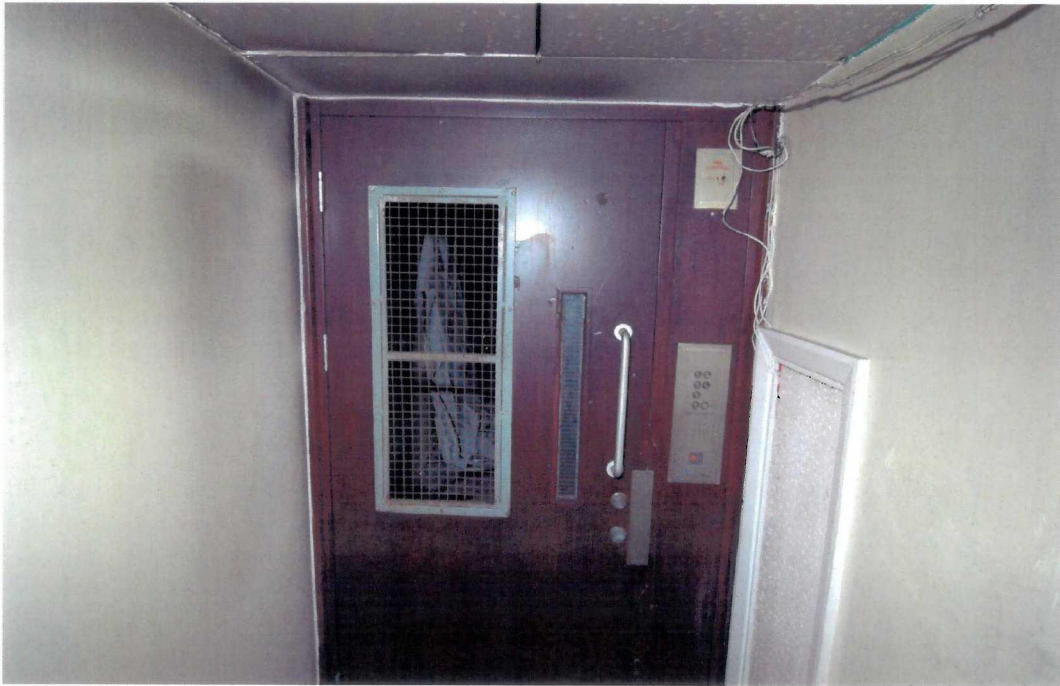
- Lobby doors modified with open grille (a new opening in the fire door, or in place of wired glass?). (see Fig. 5)

Figure 5 – Lobby doors with open grille.

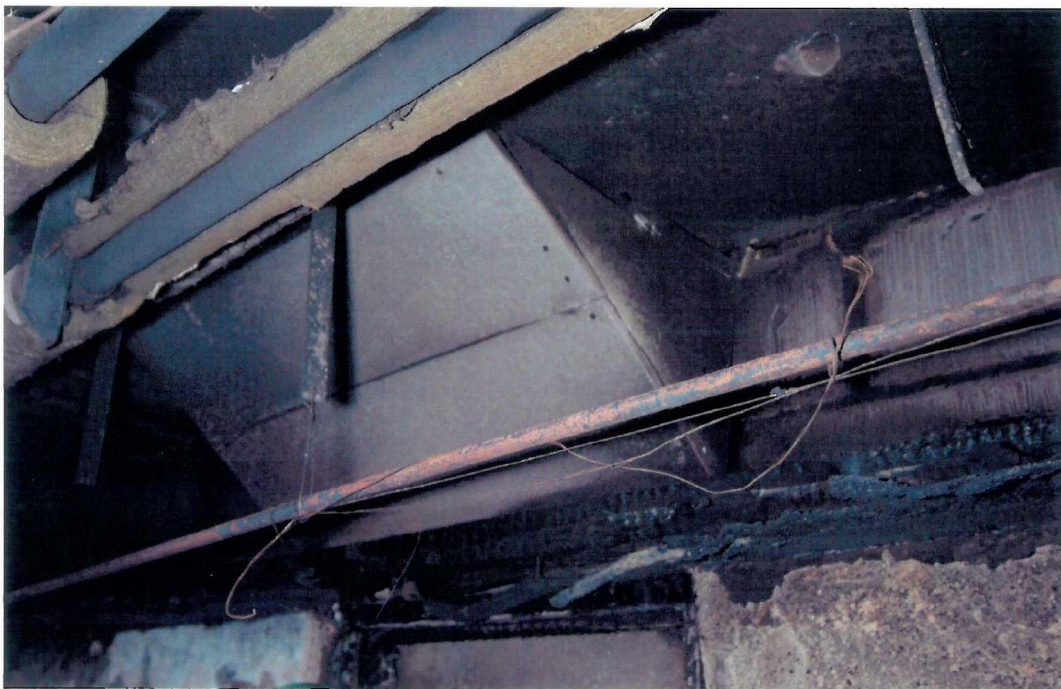
- Suspended ceiling (appears to be oriented strand board with polymeric laminate) above corridor concealing services. (See Fig. 7)
 - Maisonette timber staircases cut into the floor slab above the main corridor, protected using what appears to be mineral fibre board, although this was poorly fitted (figure 6 & 7)

Figure 6 – Mineral board covering staircase cut into corridor ceiling slab.

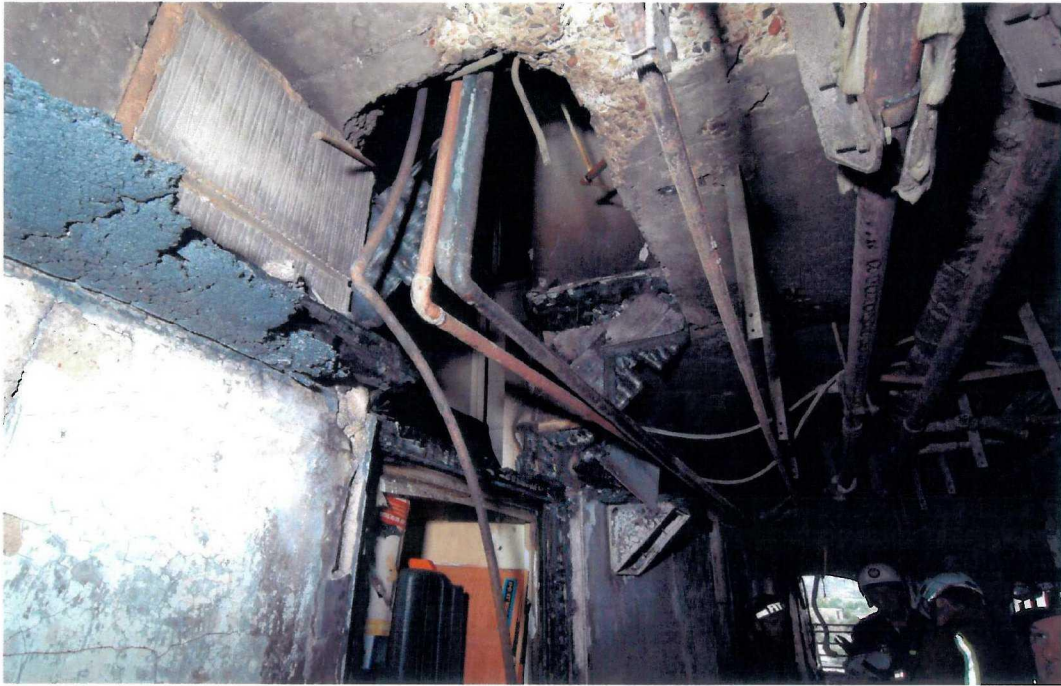
Figure 7 – Hole left by covering falling away and burnt staircase.

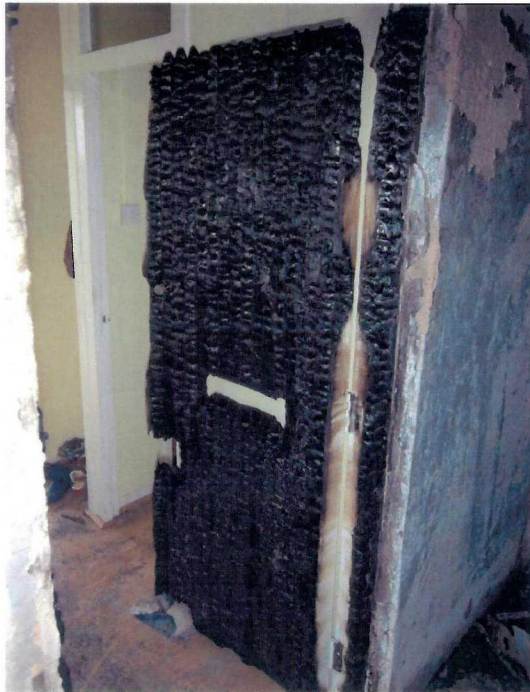
- Fire in bedroom 1 discovered by flat occupant following actuation of smoke alarm in their flat
- Occupant (briefly) attempted to fight fire but unsuccessful.
- Building occupants alerted each other to fire vocally.
- Fire spread through:
 - Interior of maisonettes (initially)
 - Flame spread up window façade (initially)
 - Burning droplets down window façade (source of droplets under consideration)
- Fire pulled through corridor by prevailing wind passing through vents, believed to have caused flaming throughout height of corridor, evidenced by charring to flat doors (figure 8).

Figure 8 – Heavy charring to flat. Note even depth of char throughout height of door.

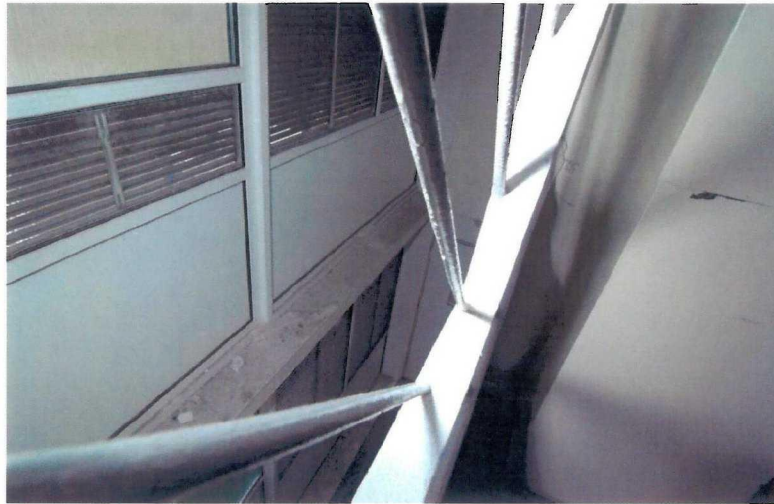
- Vinyl tiles on floor of corridor
- Ventilation grilles at ends of corridors and in lobbies. Lobby ventilation grilles span 2 floors such that smoke movement from one floor to the next is possible (see plans and figure 9).

Figure 9 – Lobby ventilation grilles and gap allowing air and smoke movement between floors.
