BRE Global Client Report

BS 8414-1:2015 + A1:2017 test referred to as DCLG test 2.

Prepared for: DCLG
Date: 3rd August 2017 (Issue 1.0)
12th September 2017 (Issue 1.2)
Report Number: B137611-1037 (DCLG test 2) Issue: 1.2

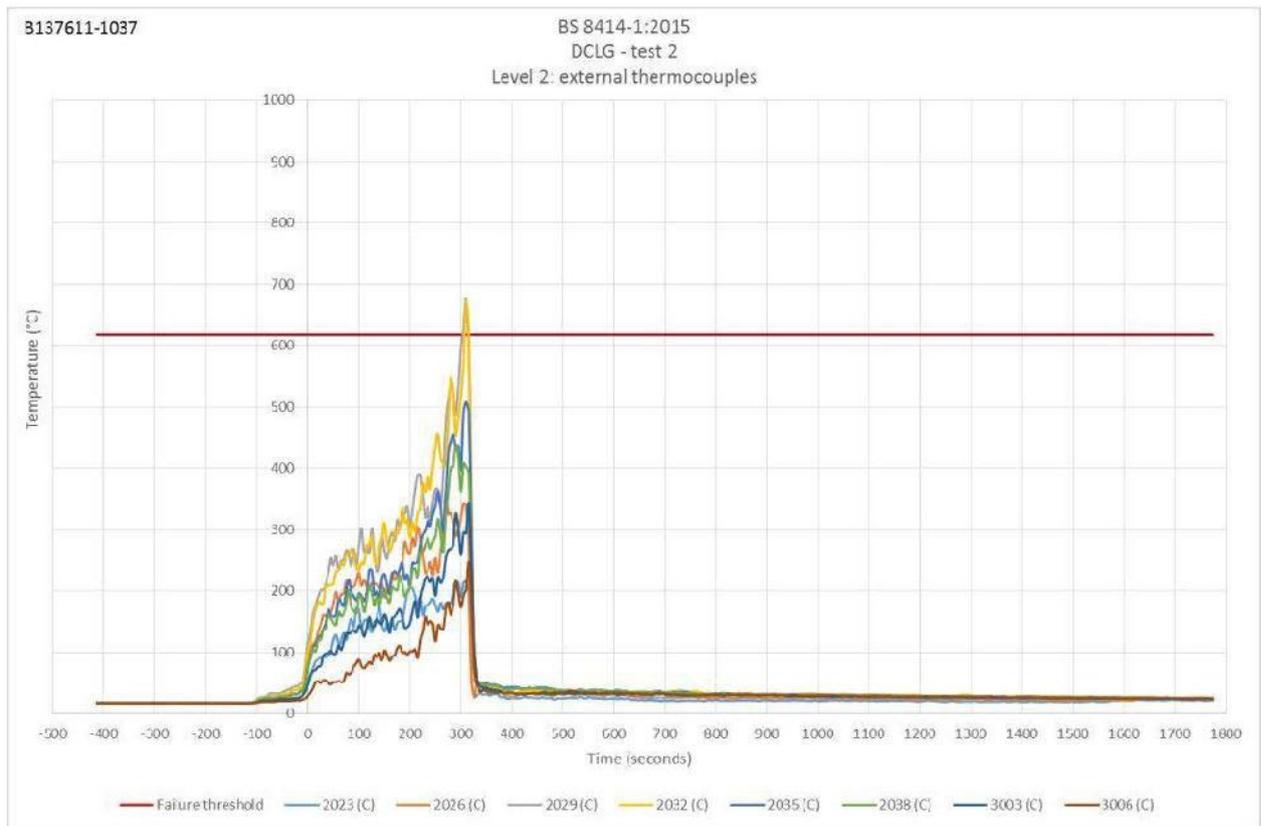
In addition, *Figure 18* shows that the level 2 external thermocouples having exceeded a 600°C temperature rise above T_s after 305s, would have sustained this temperature rise, for a minimum of 30s, within 15mins from test start time (t_s) had the test not been terminated early due to flame spread off the top of the cladding system.

Figure 18. Level 2 external thermocouples.

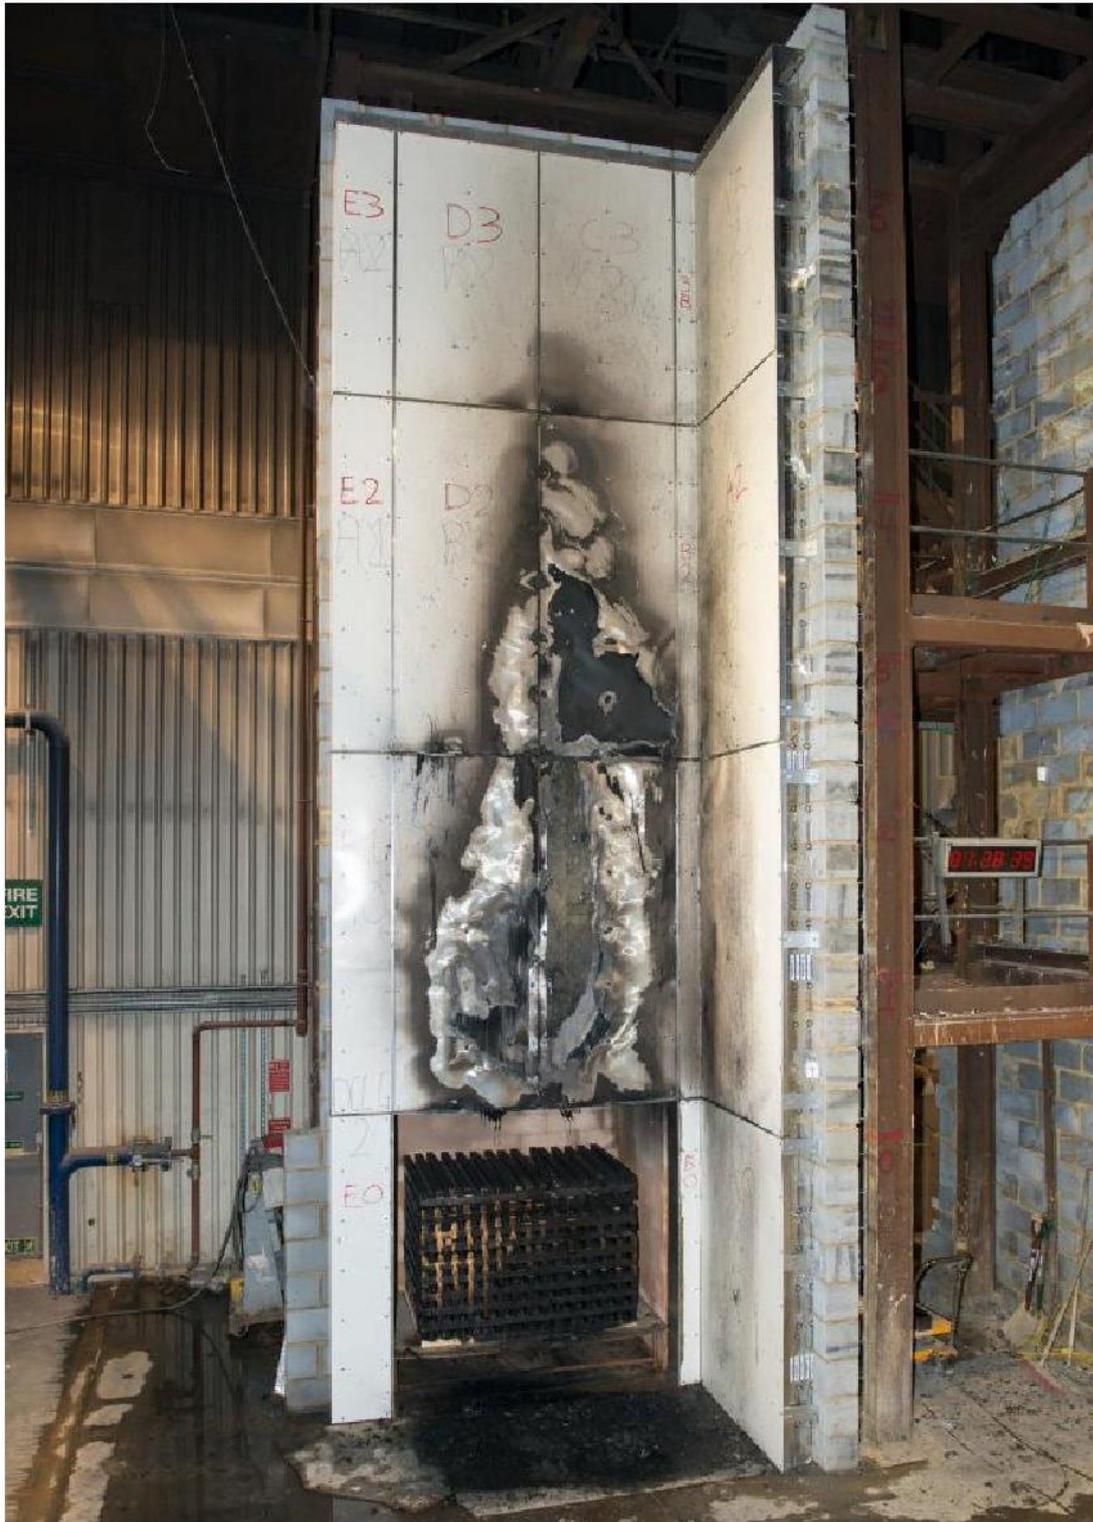
Figures 21-23 show that the main damage areas spanned the majority of the combustion chamber opening (2000mm-width) tapering to a point approximately 5000mm above, leaning slightly (approximately 300mm at the top) in the direction of the wing wall. The extent of the damage increased from black discolouration at the edges of the damage zone to complete consumption of sections of the ACM panels, a small amount of distortion to the rail substructure and some discolouration of the insulation at the centre of the main wall – see Figures 21-31. On the wing wall, slight distortion to ACM panels 1A&2A, either side of the panel joint and immediately adjacent to the main wall, was the only visible external damage on this face of the cladding - see Figures 21-23.

The surface finish of the panel was burnt away revealing a shiny metallic surface in a typically 300mm-wide strip adjacent to the consumed areas of the ACM panel which increased to approximately 1000mm at the tip of the flame impingement zone. Adjacent to the 'metallic' strip, a strip of dark discolouration, approximately 100mm-wide, which increased to approximately 1000mm at the tip of the flame impingement zone, extended to a height of 5000mm above the combustion chamber – see Figure 21.

Figure 21. Full height photograph of system soon after test termination.

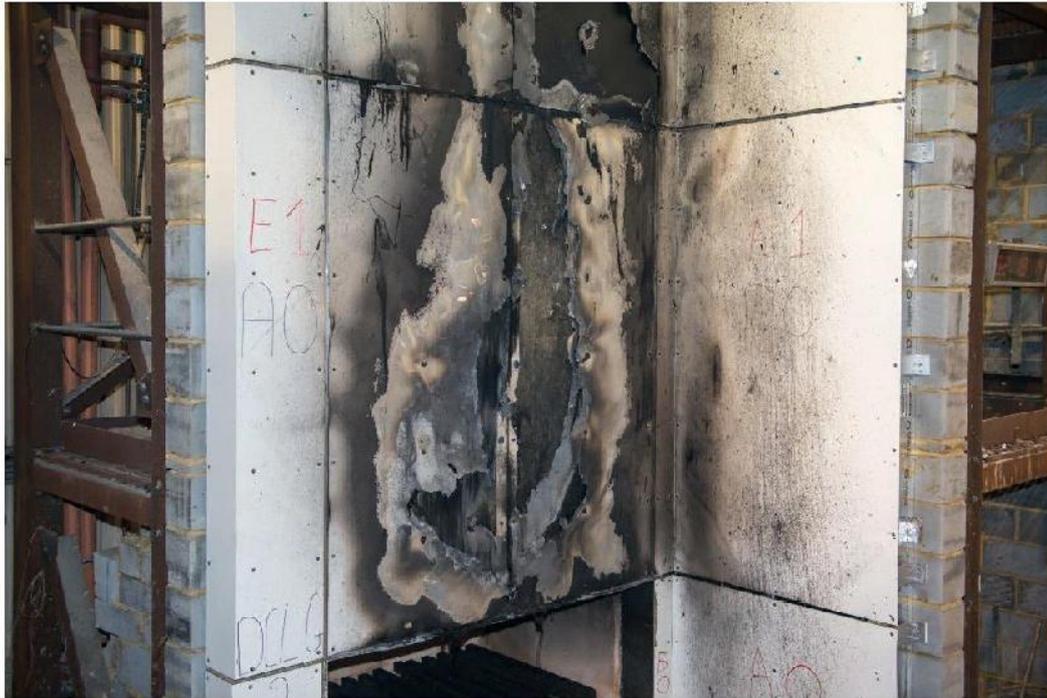
On the main wall, approximately 20% of ACM panel 1C was consumed - see Figures 1, 21&22. This damage was sustained in a strip approximately 250mm-wide×1800mm-high positioned directly adjacent to the centre line of the combustion chamber, and extended from 500mm above the opening to the height of the second cavity barrier – see Figures 21&22. Partial consumption (inner aluminium layer of panel remained intact) affected a 200mm-high x 450mm-wide strip at the base of the fully consumed section of panel 1C.

Partial consumption (inner aluminium layer of panel remained intact) of panel 1D affected approximately 15% of the surface area. The PE core was completely lost from this area and, where visible, between the distorted aluminium layers directly adjacent –see Figure 24. A small section (<0.05m²) of panel 1D had been fully consumed approximately 450mm above the combustion chamber opening – see Figure 22.

Slight distortion of the ACM panels was sustained on the wing wall, directly adjacent to the main wall, in the region approximately 2000mm-2500mm above the height of the combustion chamber opening – see Figures 22&23.

Figure 22. First row ACM panels (directly above combustion chamber).

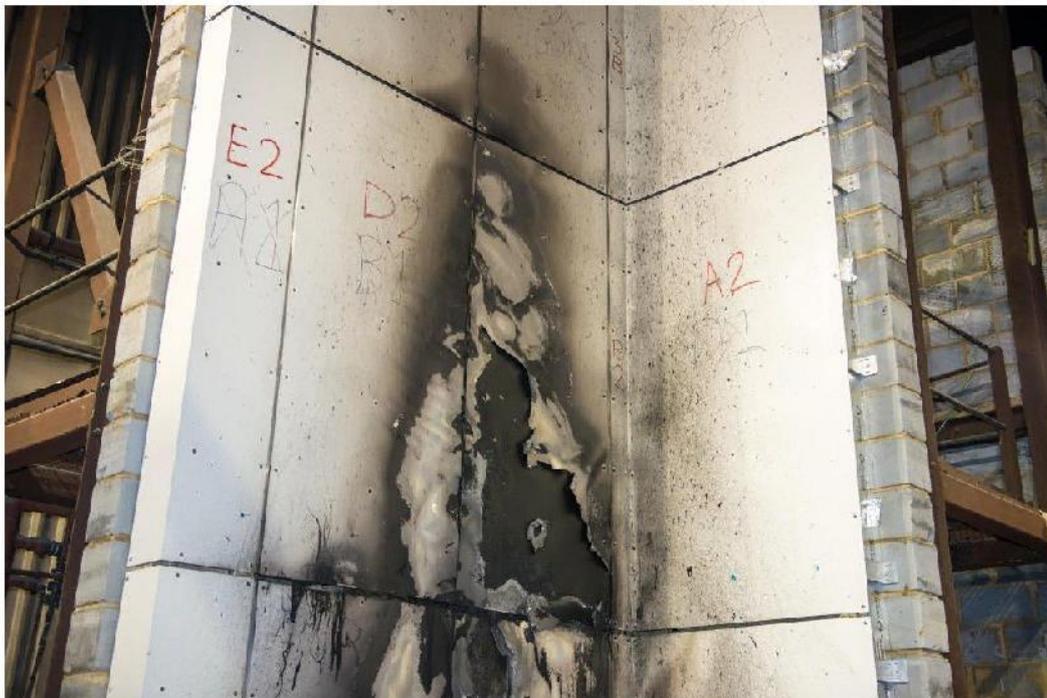
Partial consumption (inner aluminium layer of panel and some filler material remained intact) at the base of panel 2C affected approximately 30% of the surface area – see Figure 23. The PE core had been completely lost in a 100mm strip along the lower and central edges of this area but the majority, approximately 25% of the total panel surface area, remained intact and visible – see Figure 25.

Figure 23. Second row ACM panels (approximately 2300mm-4600mm above combustion chamber).

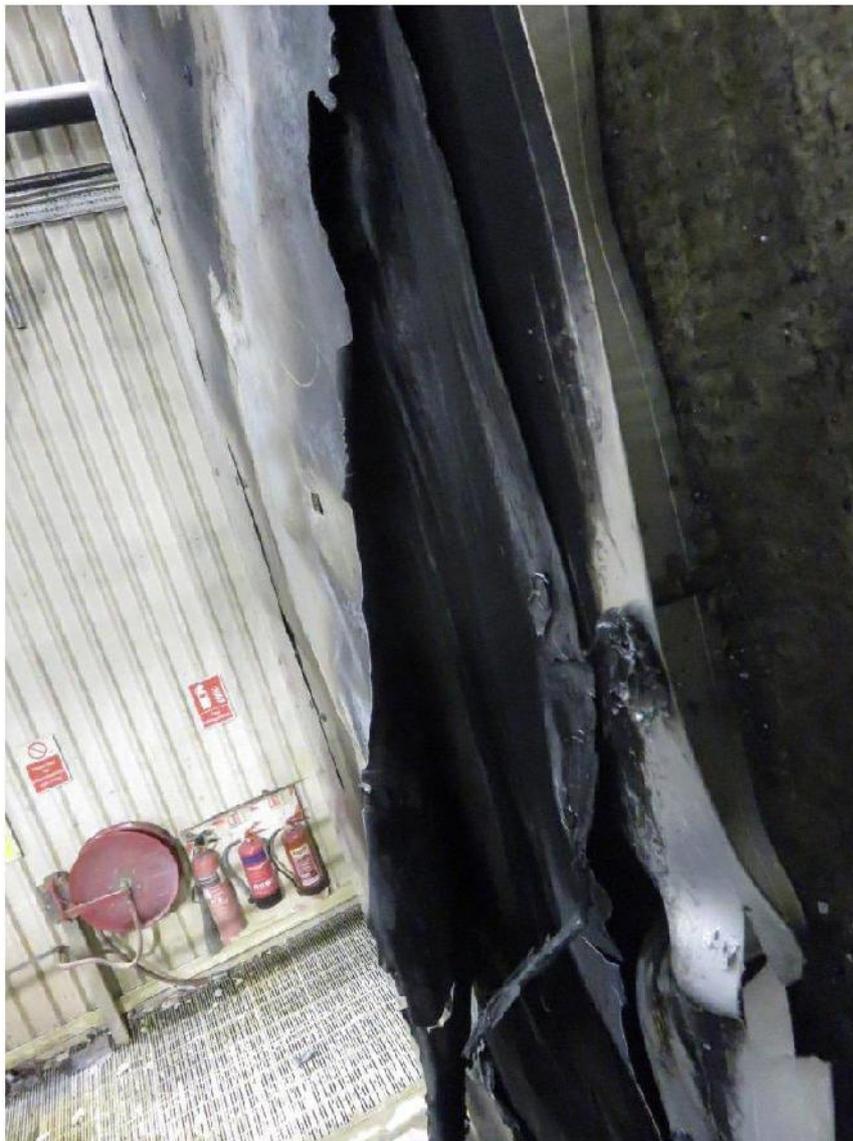
Figure 24. View between distorted aluminium layers of panel 1D (approximately 1000mm above the top of the combustion chamber) showing absence PE core material.

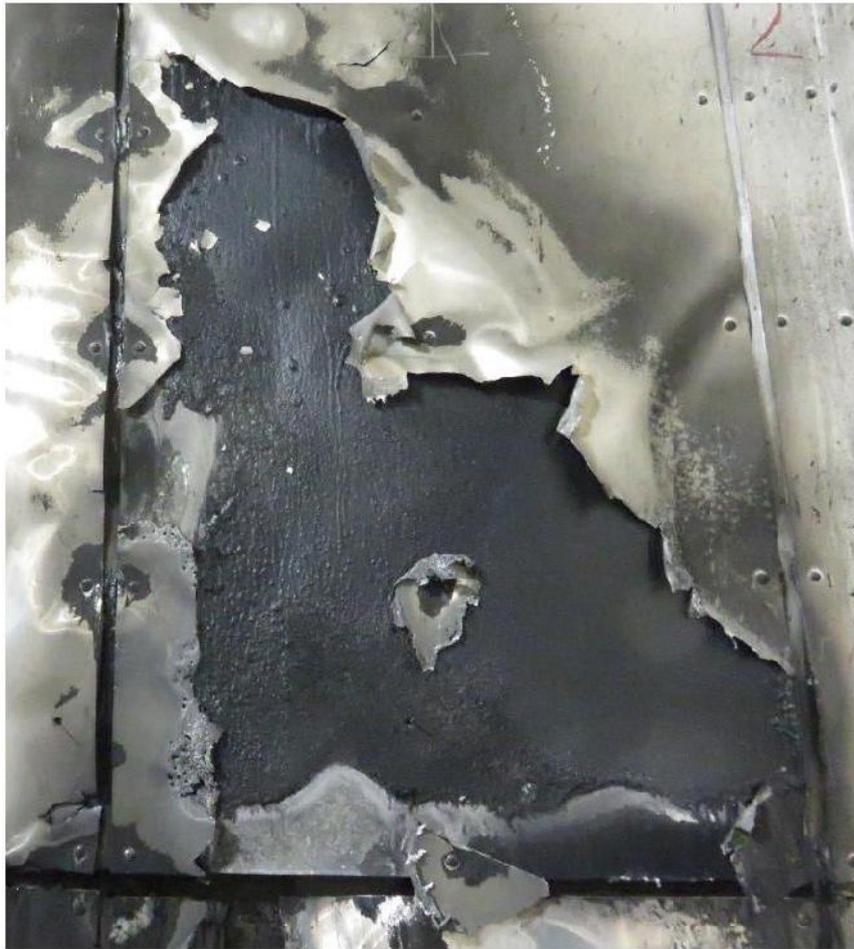
Figure 25. Close up of panel 2C (approximately 4600mm above the top of the combustion chamber) showing melted aluminium outer face with intact PE core material.

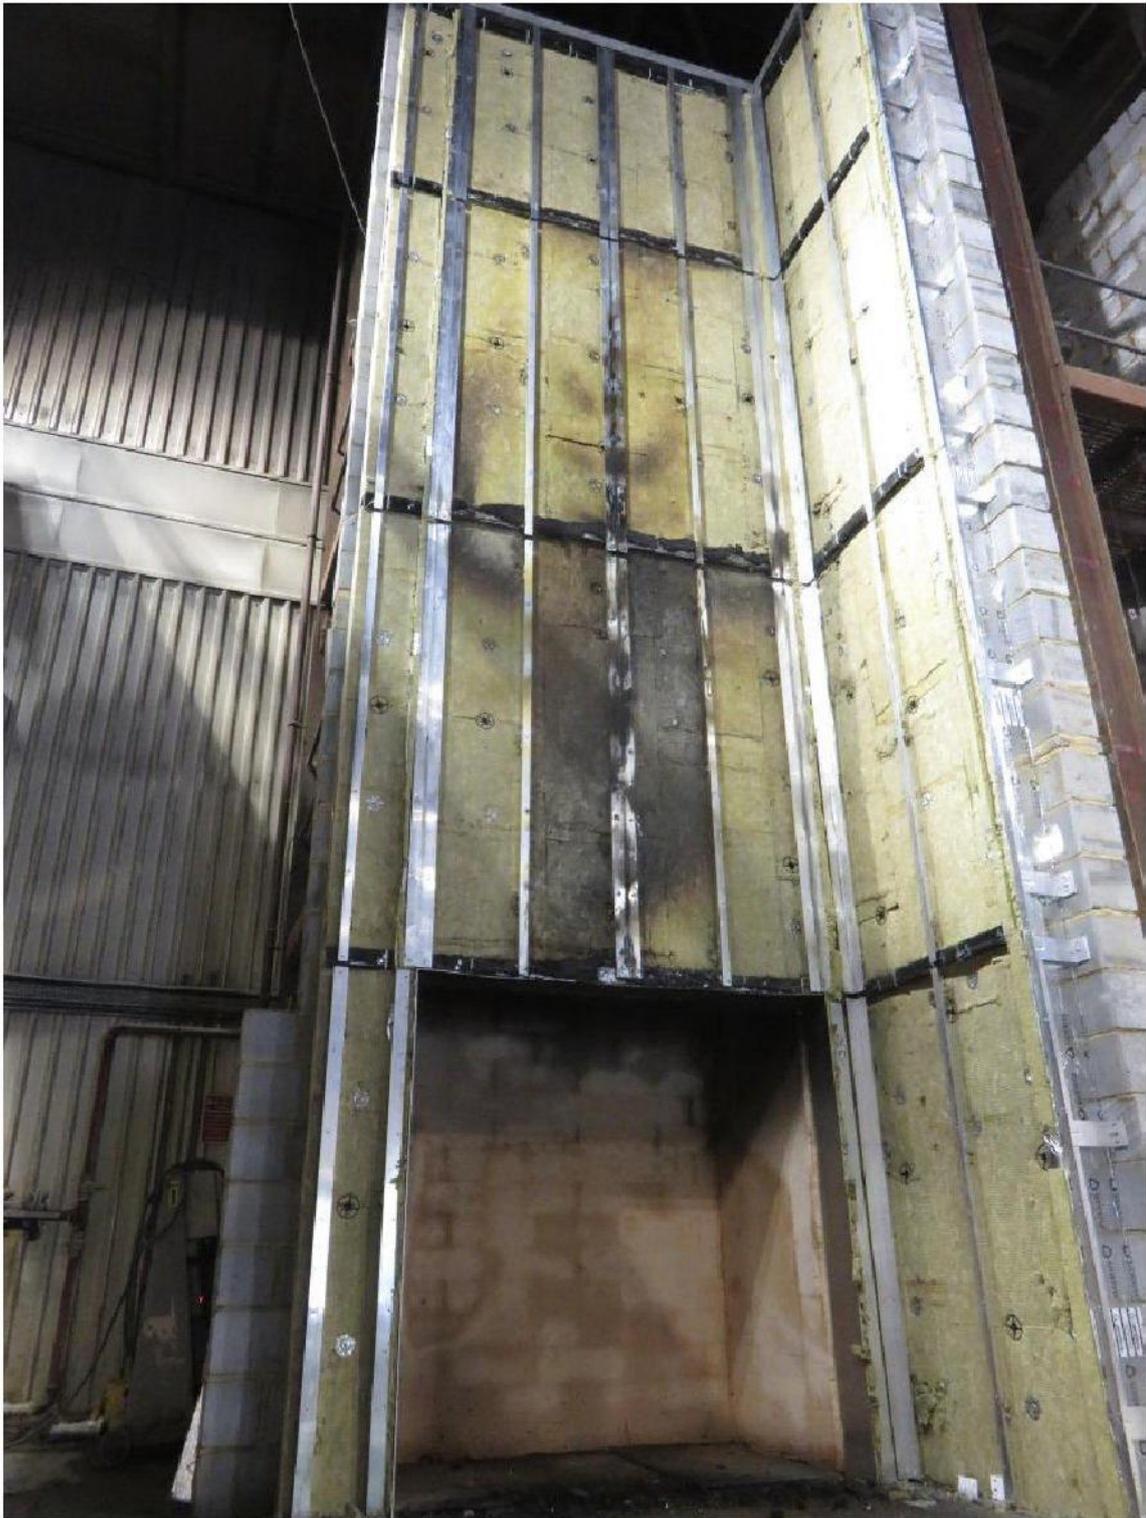
A 100mm-tall section of the central 'T' rail was distorted and partially melted at a height of 1000mm above the top of the combustion chamber – see Figures 26&27. This was the only structural damage observed to the rail substructure.

Figure 26. Full height photograph of cladding system following removal of ACM panels.

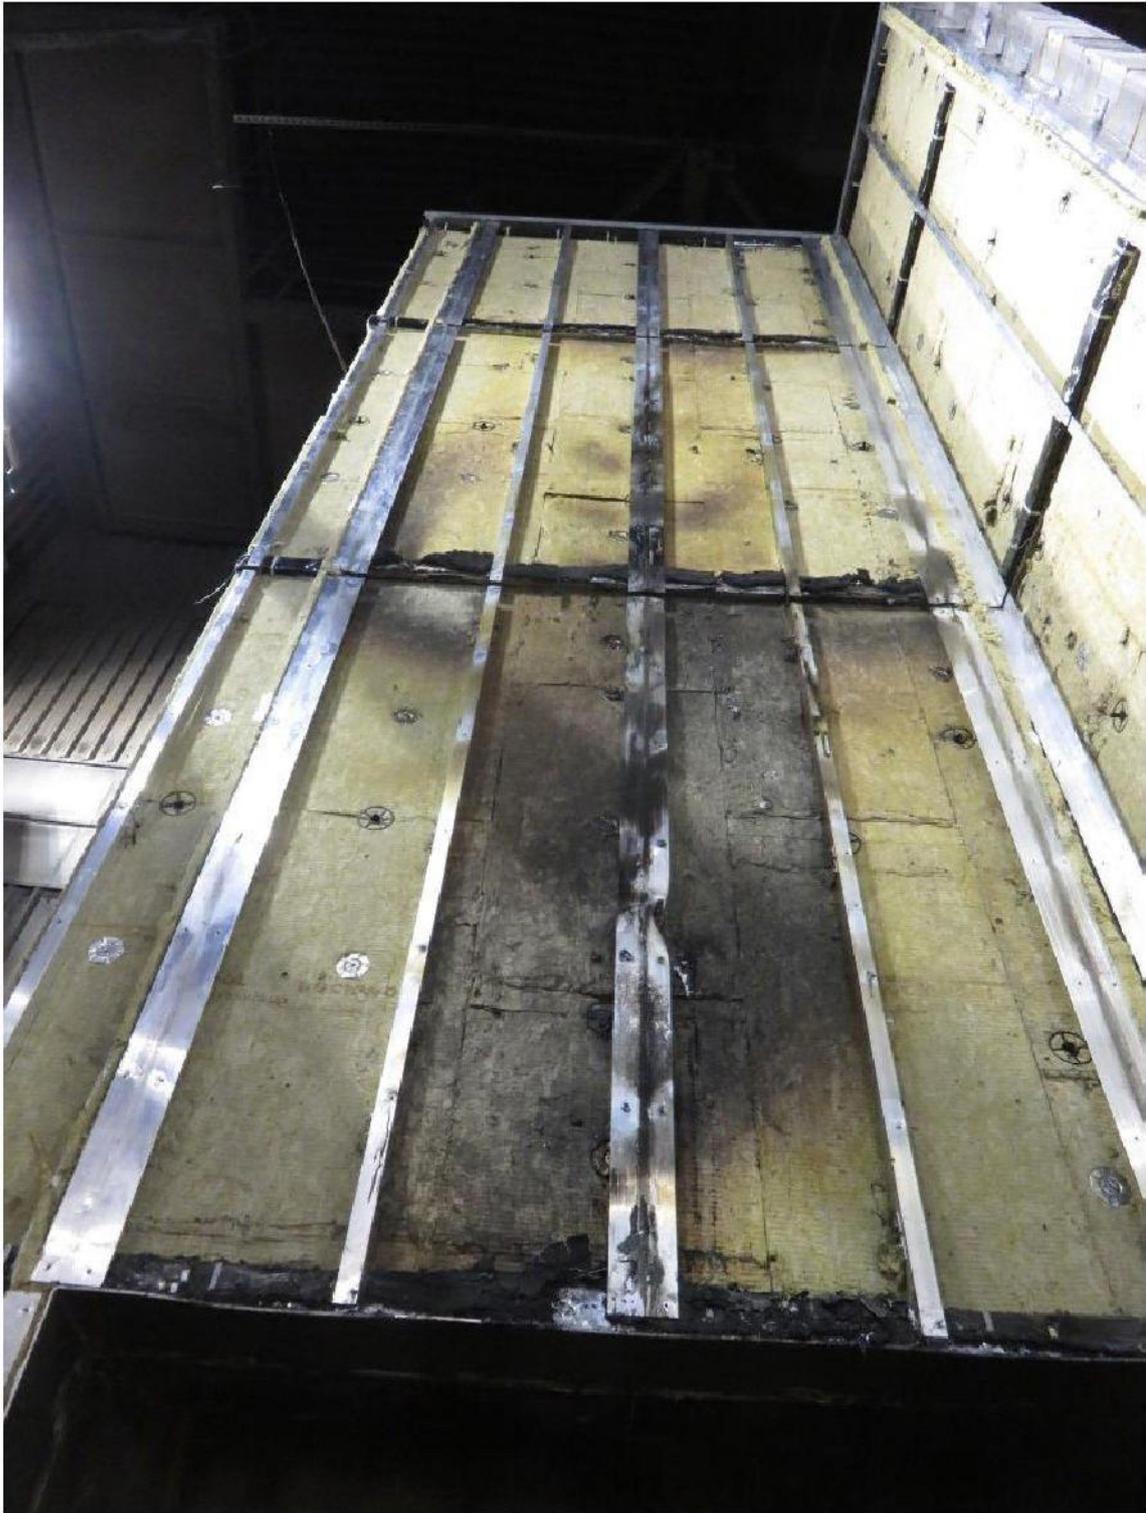
Figure 27. Damage to cladding system beneath ACM panels directly above the combustion chamber.

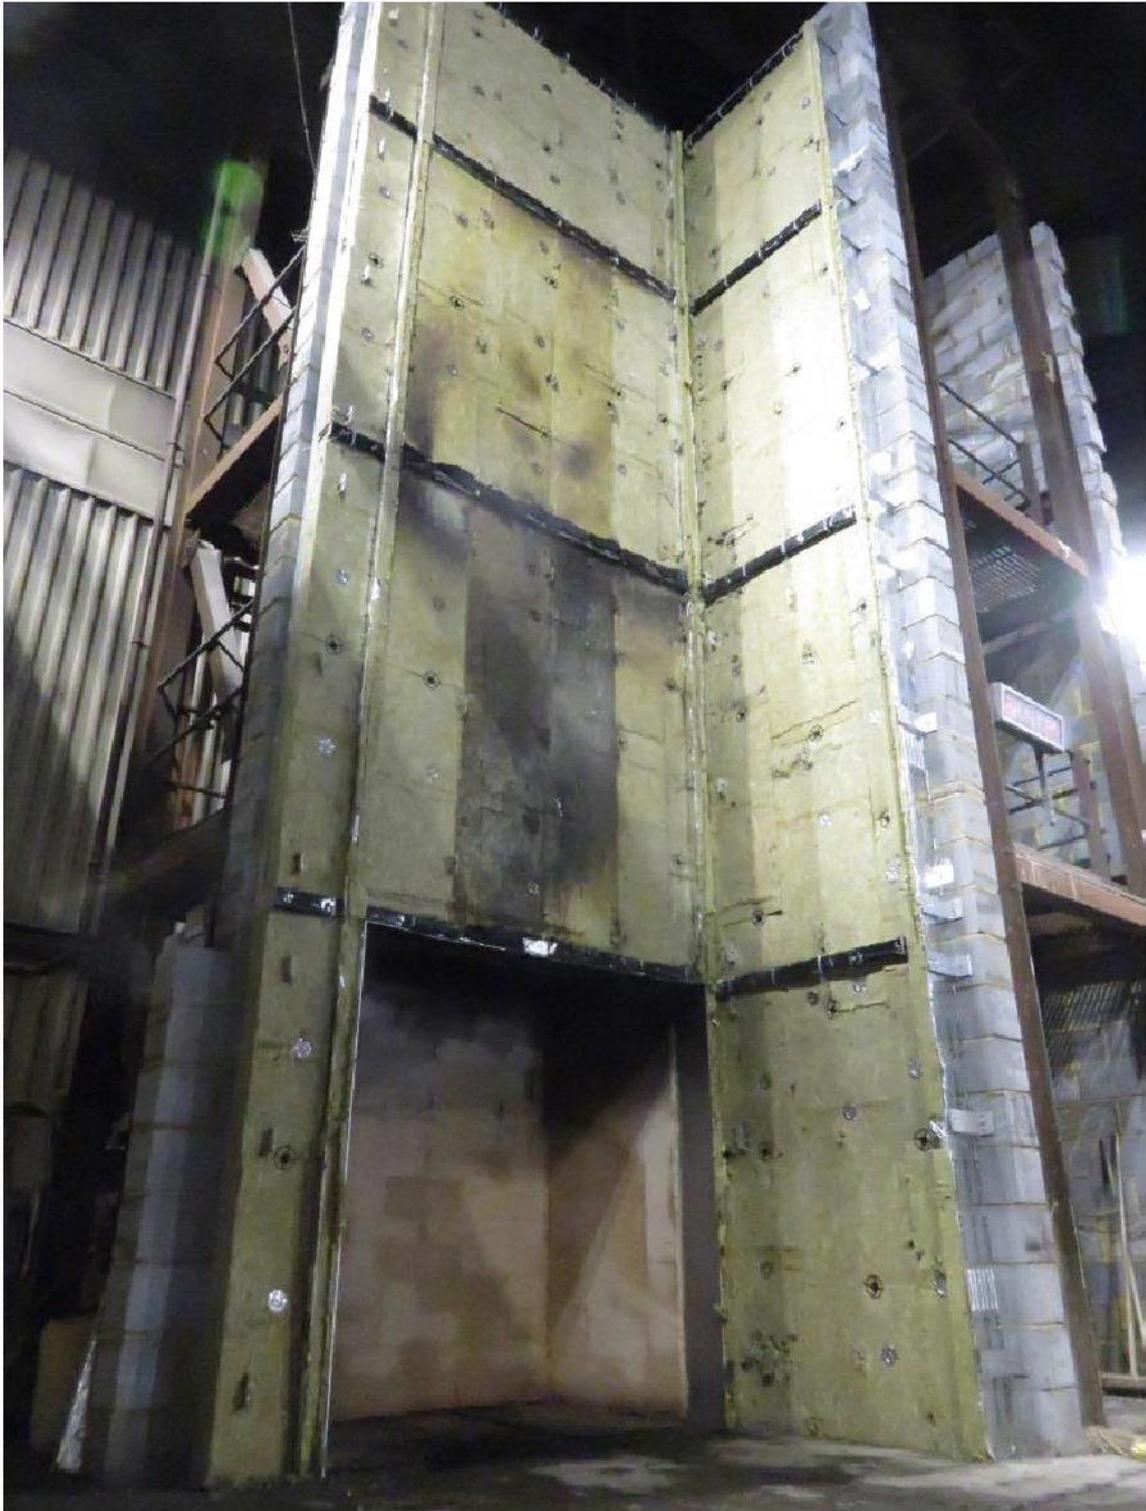
No damage was observed outside the bounds of the main wall vertical cavity barriers (including the full-height of the wing wall) or beyond the third row horizontal cavity barrier – see *Figure 28*.

Activation of the second row of horizontal intumescent cavity barriers occurred across the full width of the combustion chamber opening – see *Figures 28&29*.

The fire damage to the ACM panels and stone wool insulation was confined within the bounds of the vertical cavity barriers either side of the combustion chamber opening – see *Figure 28*. Minimal damage to the vertical cavity barriers was observed.

Figure 28. Full height photograph of cladding system following removal of ACM panels and rail substructure.

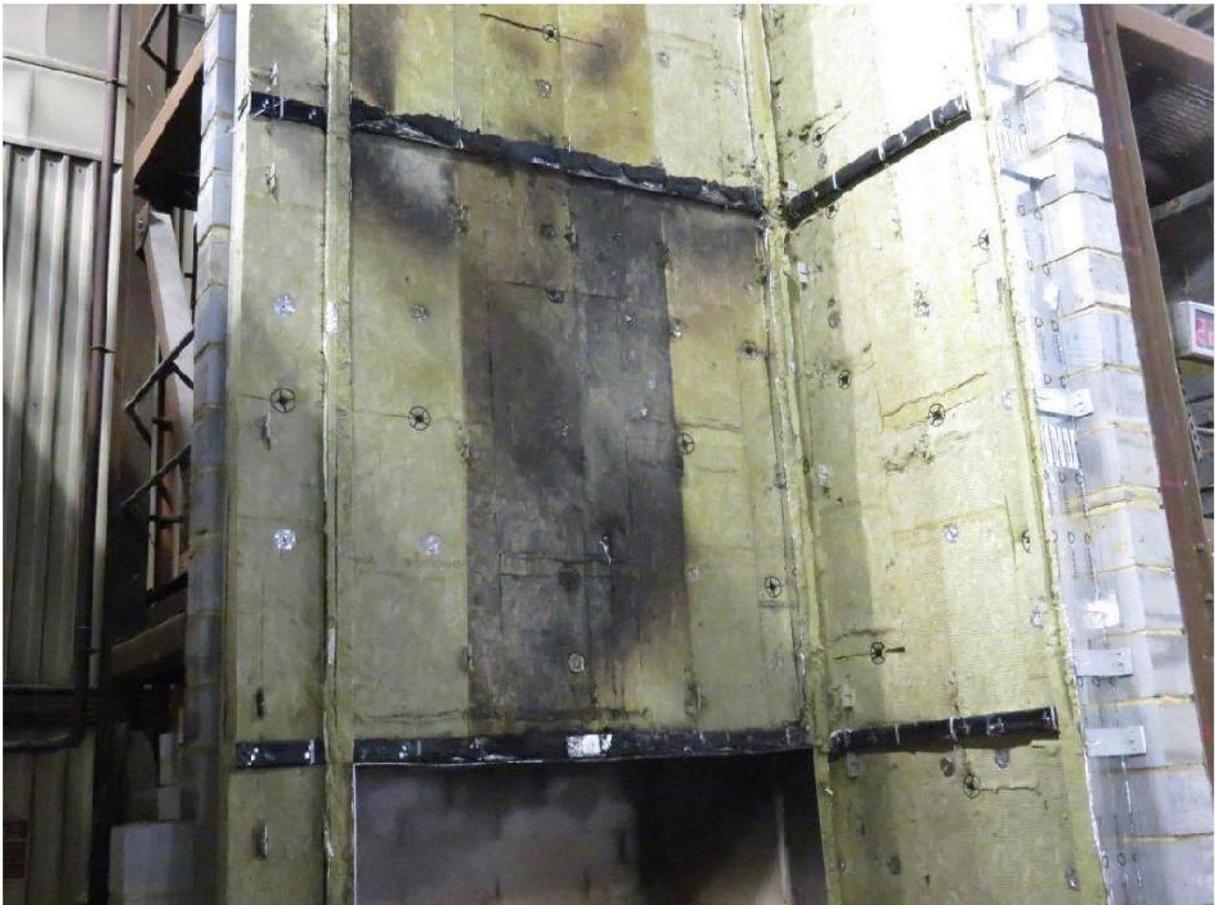
Discolouration of the stone wool insulation was observed in the central 1000mm-width above the combustion chamber which was contained by consecutive sections of 'L' rail, up to the height of the second row horizontal cavity barrier – see Figure 29. Lighter discolouration of the stone wool boards from

The first row of horizontal intumescent cavity barriers expanded across the central 1000mm of the combustion chamber width with initial signs of activation across the remainder of the opening – see *Figure 29*.

Figure 29. Cladding system beneath ACM panels and rail substructure between the first and second horizontal cavity barrier (approximately 0-2400mm above combustion chamber).

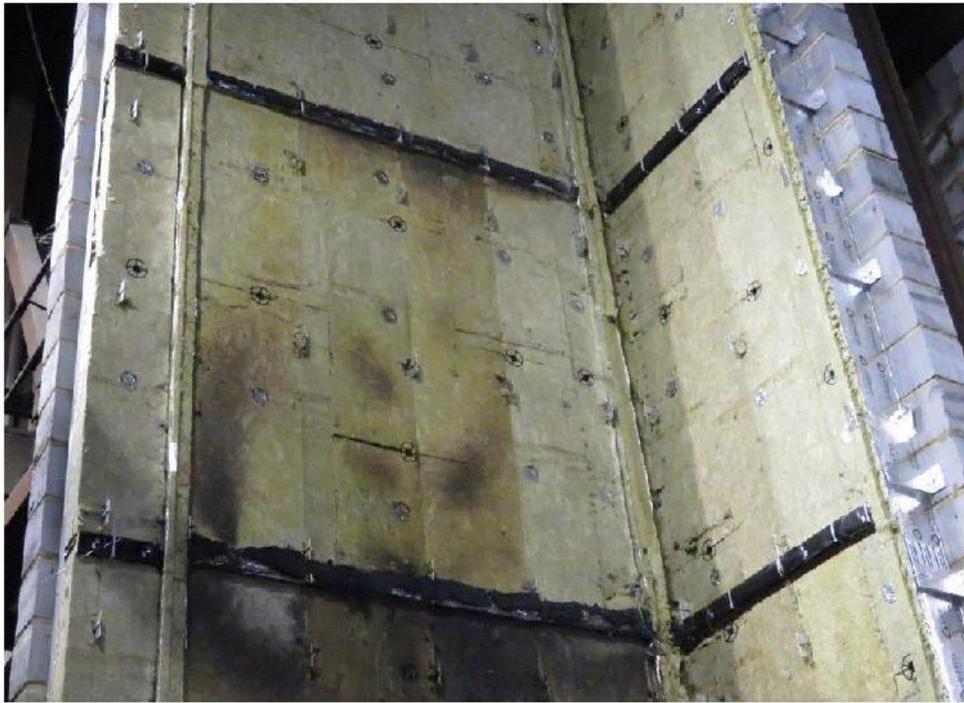
Discolouration of the stone wool insulation affected approximately 40% of the area contained between the second and third row horizontal cavity barriers and the vertical cavity barriers - see *Figure 30*. The areas of damage were concentrated:

- Bottom left corner directly above second row cavity barrier (200mm-wide×1000mm-high)
- Central 1000mm-width extending approximately 100mm below the third cavity barrier
- Central 1000mm-width extending 1000mm above the second cavity barrier

Figure 30. Cladding system beneath ACM panels between the second and third horizontal cavity barrier (approximately 2400-4700mm above combustion chamber).
