RECORD OF SIGNIFICANT FINDINGS and ACTION PLAN.

PREMISES OCCUPIER: The Tenants Management Organisation (TMO) of the Royal Borough of Kensington and Chelsea

ADDRESS: Grenfell Tower, Grenfell Road London W11 1TQ

DATED: 17th October 2014

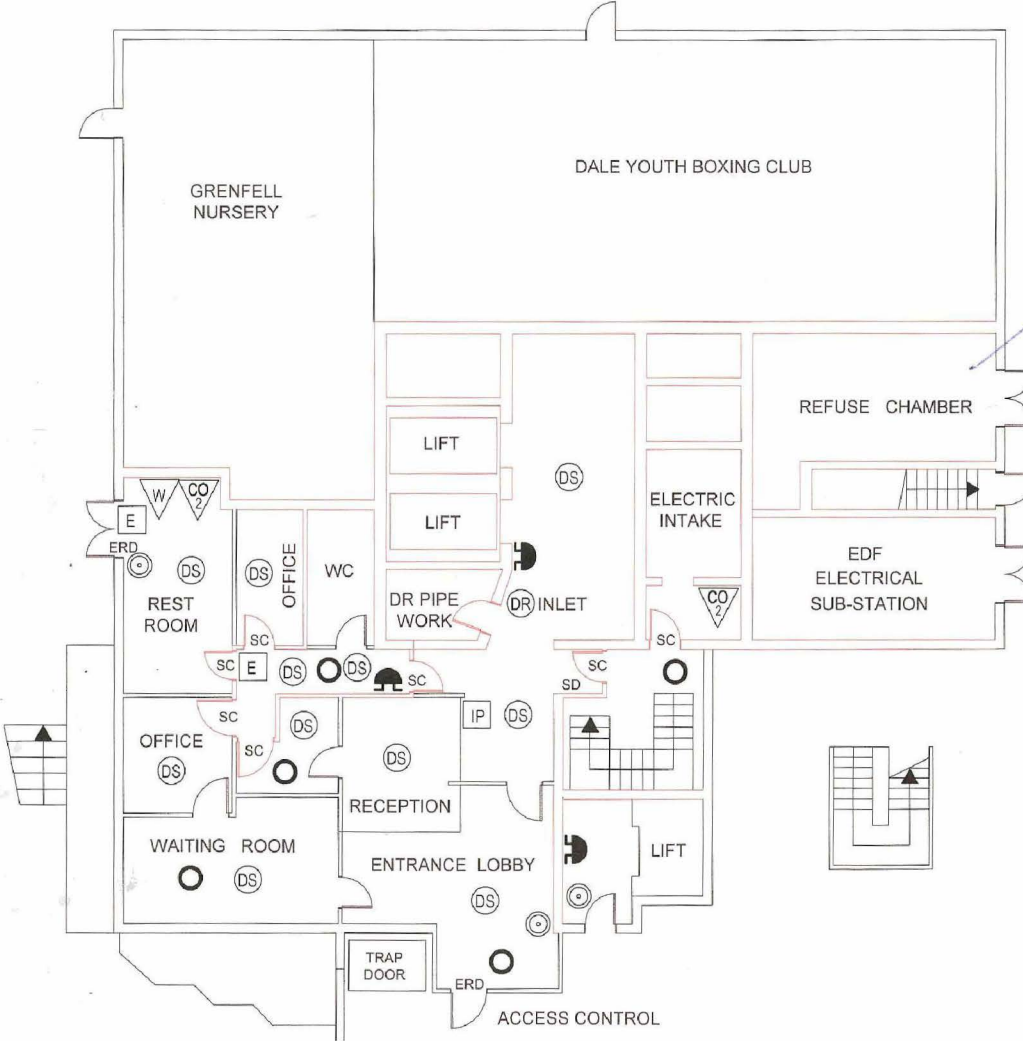
4th FLOOR

*Show as ~~not~~ see the Card
Down not shut see the Card*

*Repair work between 3 & 4
New beam of duct
P D*

*New entrance Hall
Down challenges
Fire Access*

*Walking cabinet
fall to use
cable
signifying
walking
Exit sign ↑
should be
diminished.*

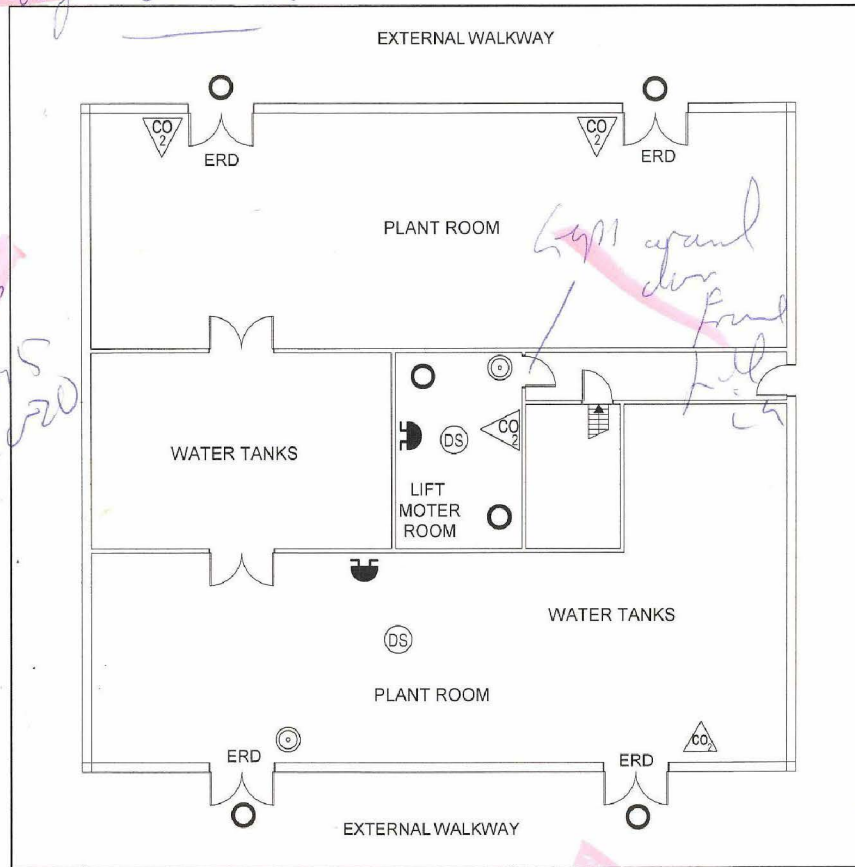
Roof Level

*16-3-16
Lifts
out the lift
CITRSD*

*Water
control
relief tanks
at this level*

*ADD BT
Turf storage*
