RECORD OF SIGNIFICANT FINDINGS and ACTION PLAN.

ADDRESS: Grenfell Tower, Grenfell Road, London W11 1TQ TMO Property reference number UPRN S217012770009

COMPLETED BY: Mr C Stokes

DATED: 26th April 2016

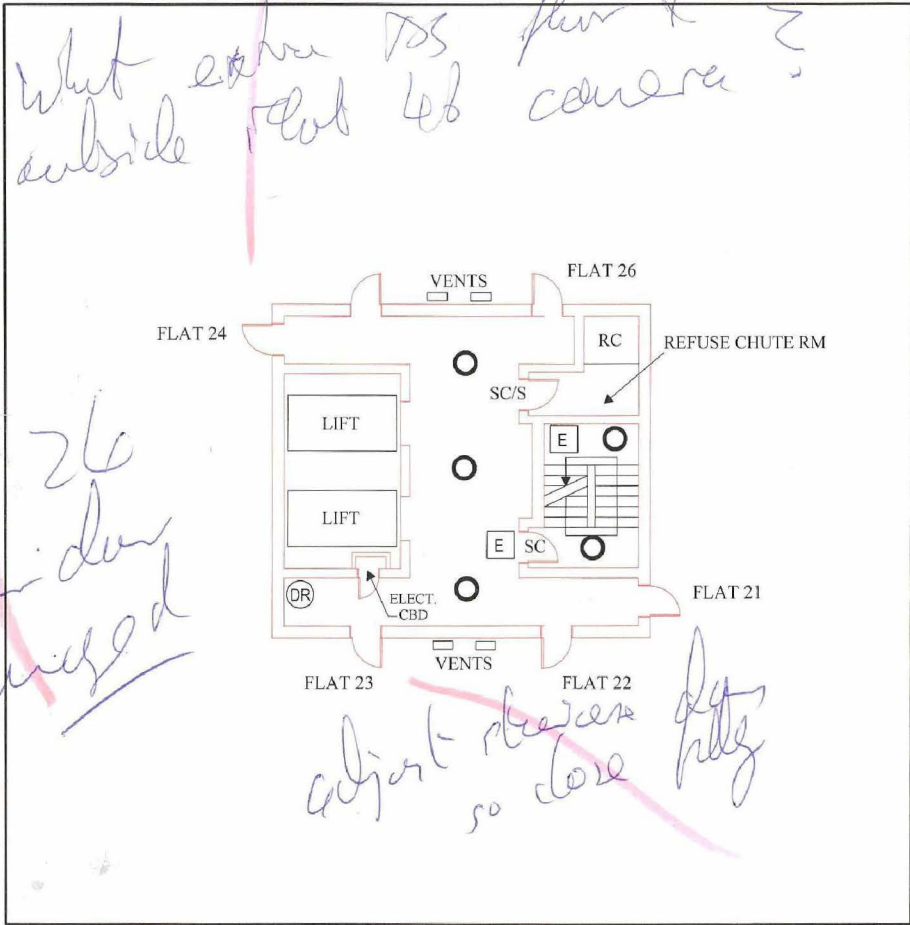
2nd Floor

~~staircase door
10 = fire rated
damaged~~

~~New door 112
pose
not shield
A730~~

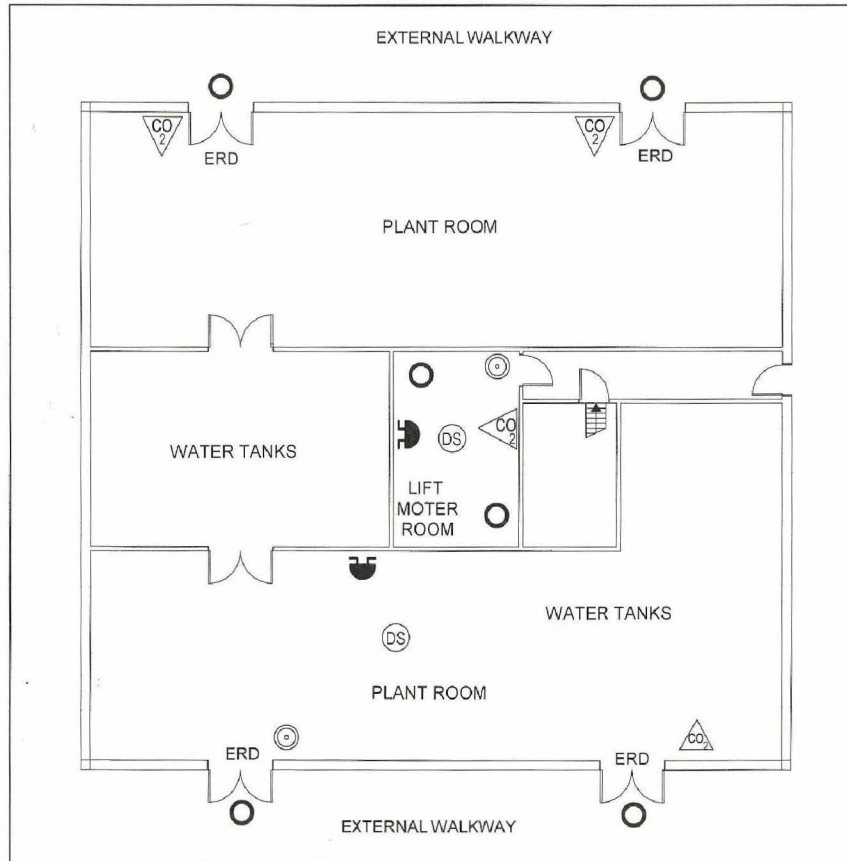
Roof Level

*Keep the
lighting
Electrical*
