C S Stokes and Associates Limited

19th October 2016

Subject: Grenfell Tower, Grenfell Road, London W11 1TQ

Thank you for asking me to inspect this building before an audit of the premises is undertaken by the London Fire Brigade under The Regulatory Reform (Fire Safety) Order 2005 (FSO) next week. I visited the building yesterday and as a result of my visit I would recommend that the following items are addressed or information obtained to assist the London Fire Brigade Inspecting Officer.

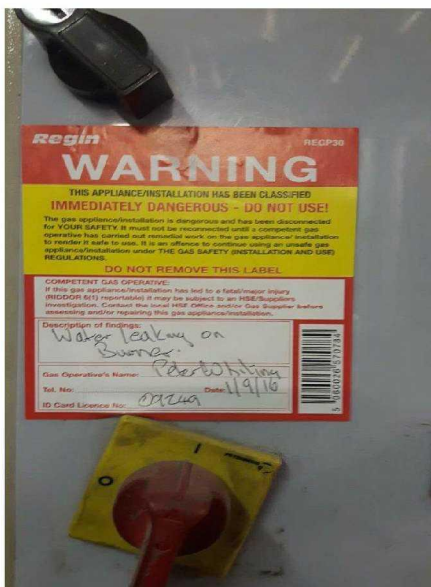
Item 4. High

The contractor's are presently working on the boilers in the basement area, there are no flue gas print outs should be attached to the gas boilers.
Gas safety certificates have been forwarded to the TMO for the installation work undertaken.

Warning label on 1 of the boilers yesterday

I would recommend that once all work connected with the gas boilers is completed that a final full gas safety check is undertaken and any defects found are rectified.
Flue gas print outs should be attached to each gas boiler.

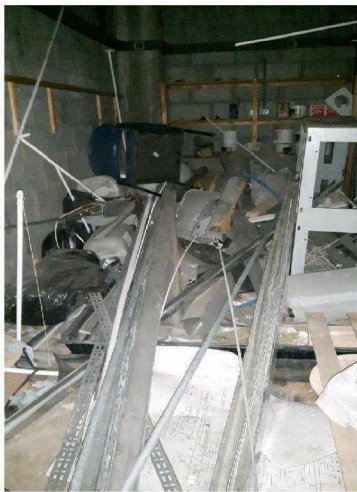
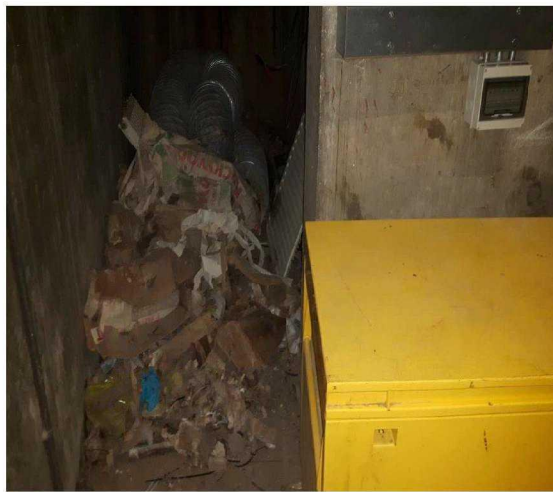
Item 9b, High

There is a lot of contractors waste in the basement boiler room.

There is still a lot of contractors waste in the basement, photos taken yesterday.

All contractors waste and rubbish in the basement boiler room and rooms off of it should be removed before this area is handed back to the TMO.

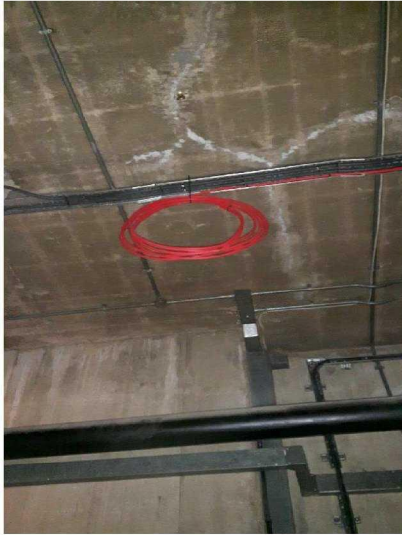
Item 17f, High

At the roof level there is a coil of fire alarm cable not connected at one end to anything.

No answers provided still outstanding, cable still in place.

What is this coil of fire alarm cable for?

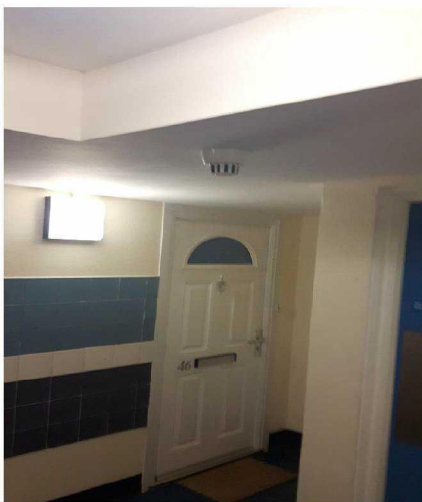
Item 17h, High

There are 2 smoke detectors fitted on the 7th floor level ceiling, the 2nd detector is a different style of smoke detector to the newly installed one. This device is on the ceiling near to the flat entrance door of flat 46. The contractor does not know anything about this 2nd device.

No answers provided still outstanding, 2nd detector still in place.

What is the reason for the 2nd smoke detector fitted on the 7th floor level ceiling near to flat 46's entrance door?

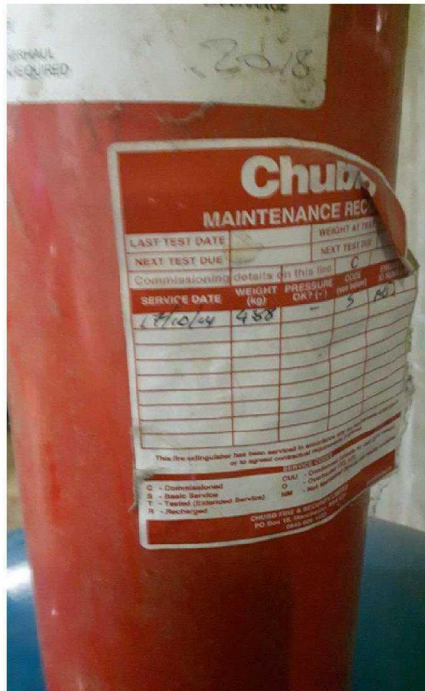
Item 23f, High

According to the contractors labels on the fire extinguishers in this building they are all out of test date. The last date on the contractors test/servicing labels is October 2014.

Extinguishers still all out of service/test date.

All of the fire extinguishers in this building should be tested/serviced immediately and any defective ones replaced.

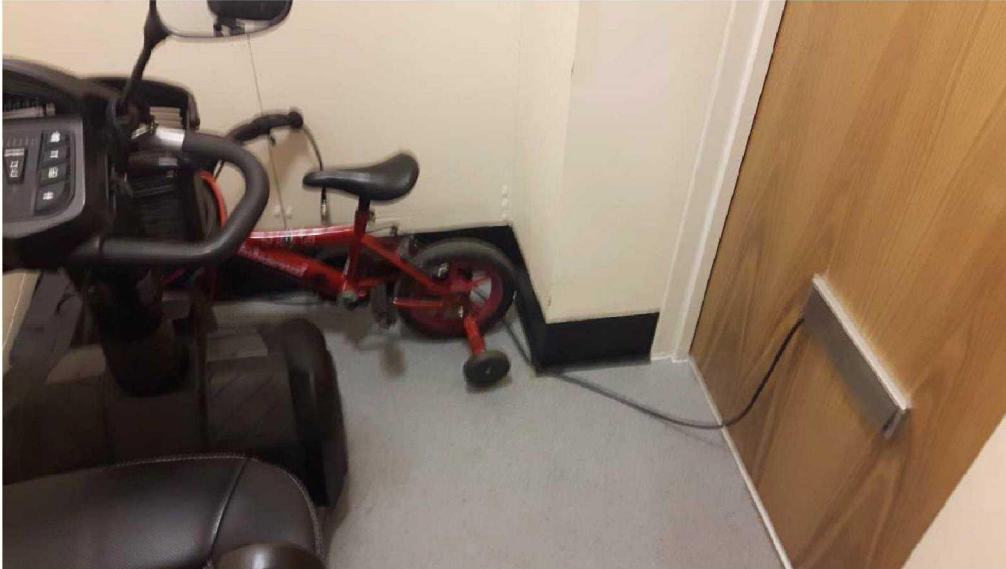
1. There is a mobility scooter being parked and charged on the landing area outside flat 9.

The charging of mobility scooters must not be undertaken in the common parts of building, this practice must stop immediately.

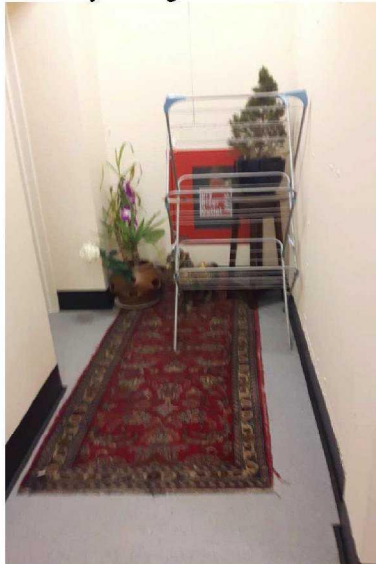
2. The dry rising main outlet outside flat 8 is being obstructed.

These items should be removed from the common parts of the building.

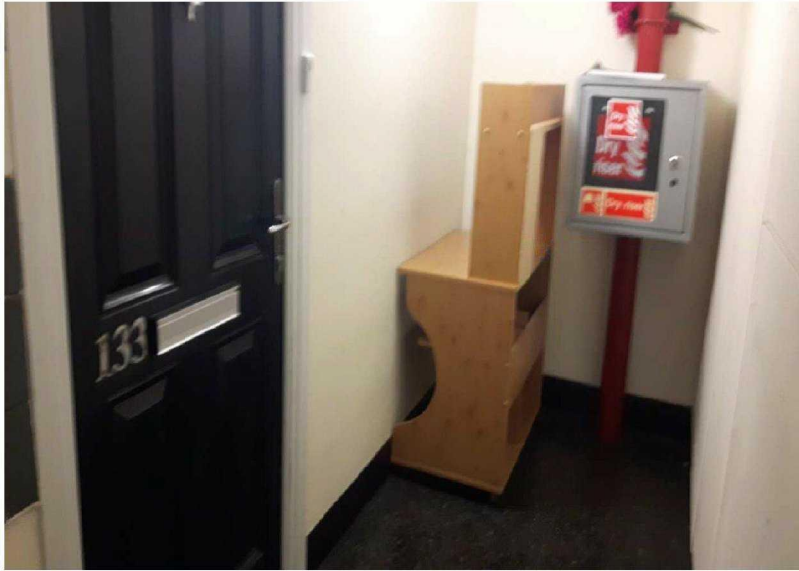
3. There is an item of furniture outside flat 133 on the flat/lift lobby area.

This item should be removed from the common parts of the building.
