C S Stokes and Associates Limited

18th March 2014

Premises: Grenfell Tower, Testerton, Barandon and Hurstway Walks on the Lancaster West Estate

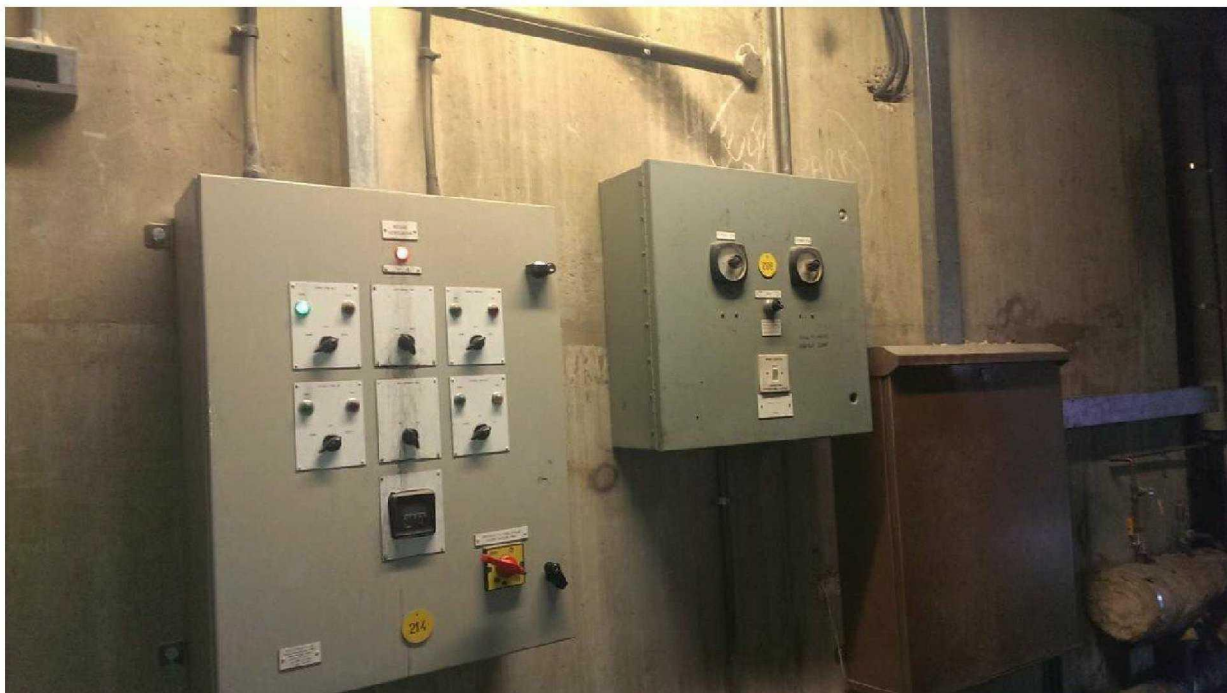
Refuse chute room extraction control panel on the left with the flat/lift lobby areas control panel on the right hand side.

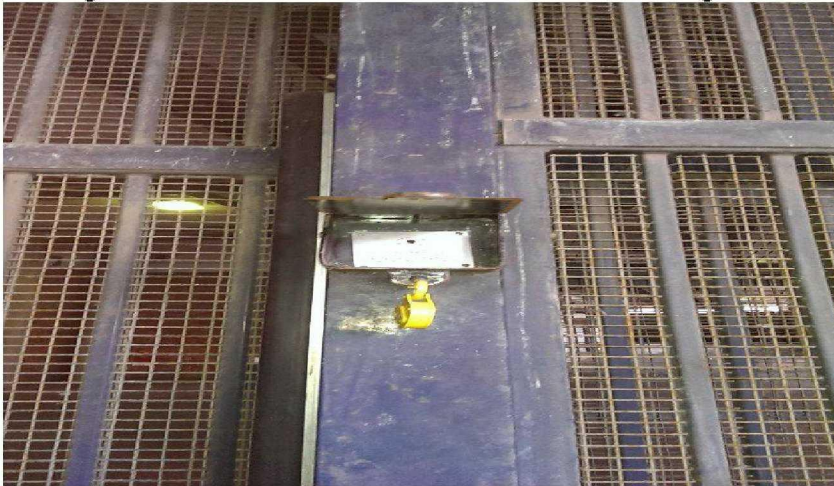
Fire fighter over ride switch in box fitted to vehicle gate

11. The fire fighter over ride switch in box fitted to vehicle gate which gives access to the lower ground floor level roads is damaged and does not open the gate, this over ride switch should be repaired or replaced so that it opens the vehicle gate when used.

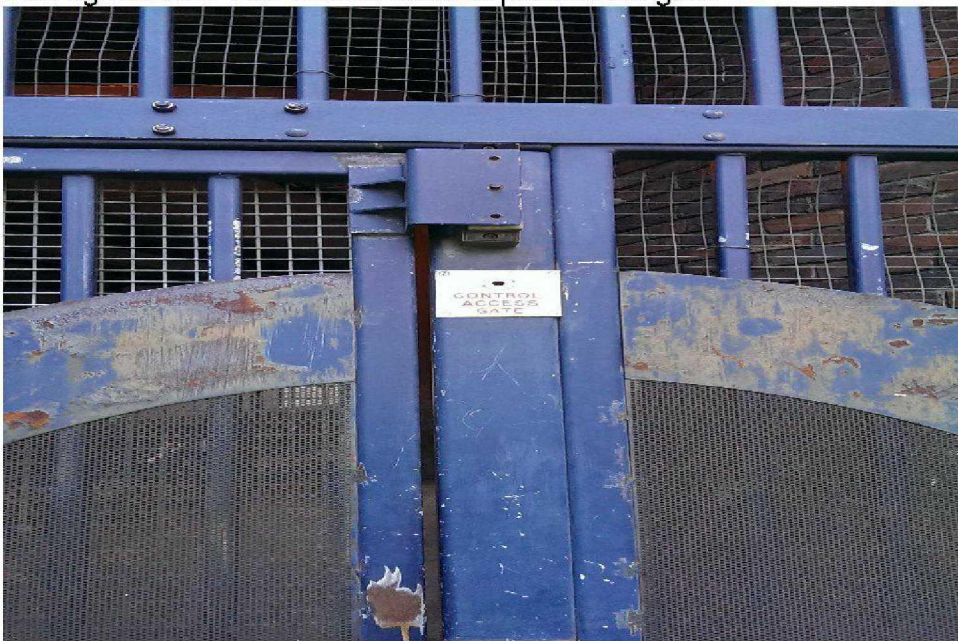
Fire fighter over ride switch fitted to pedestrian gate

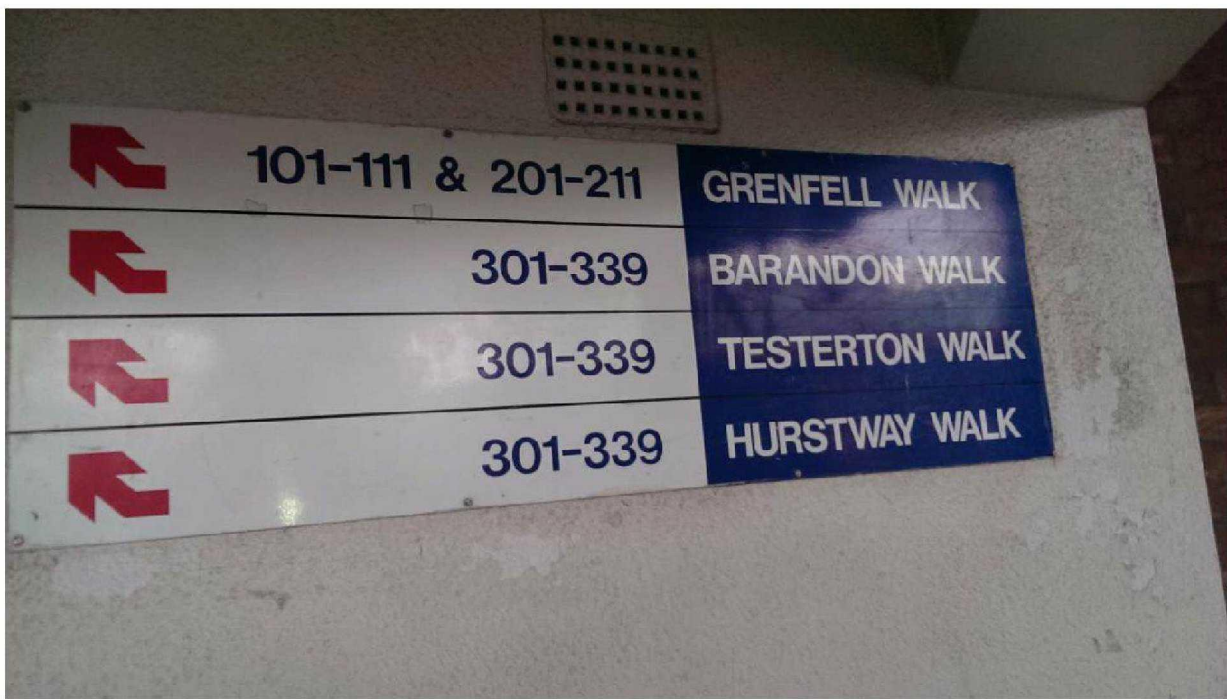
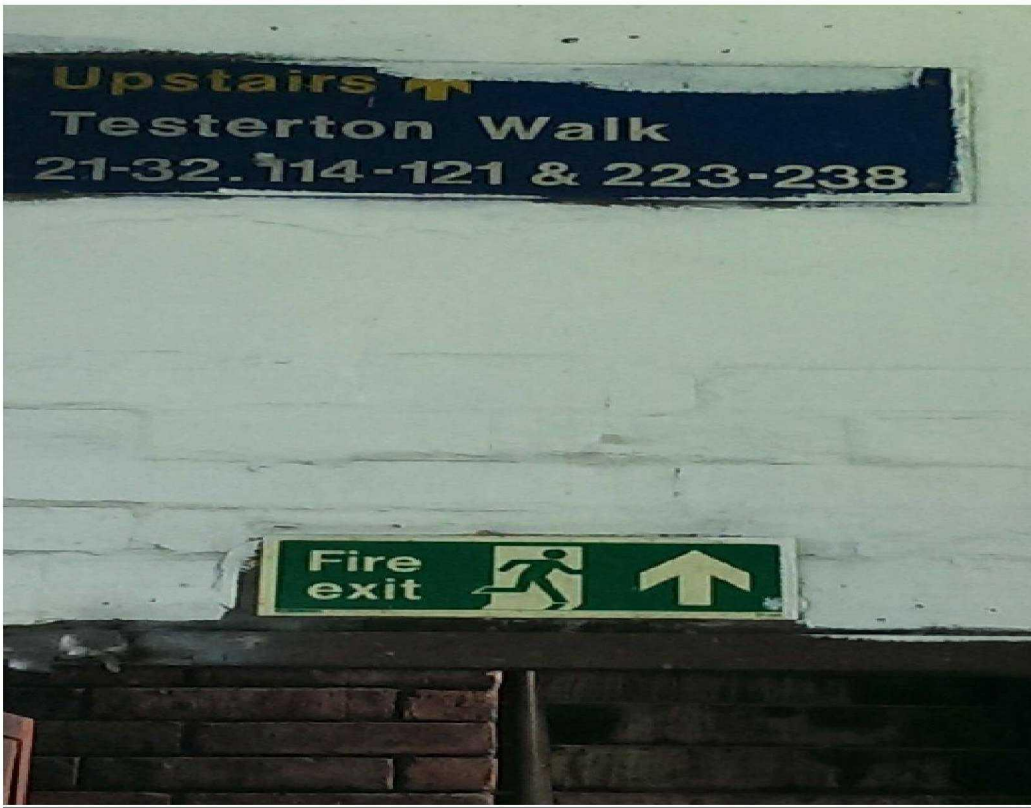
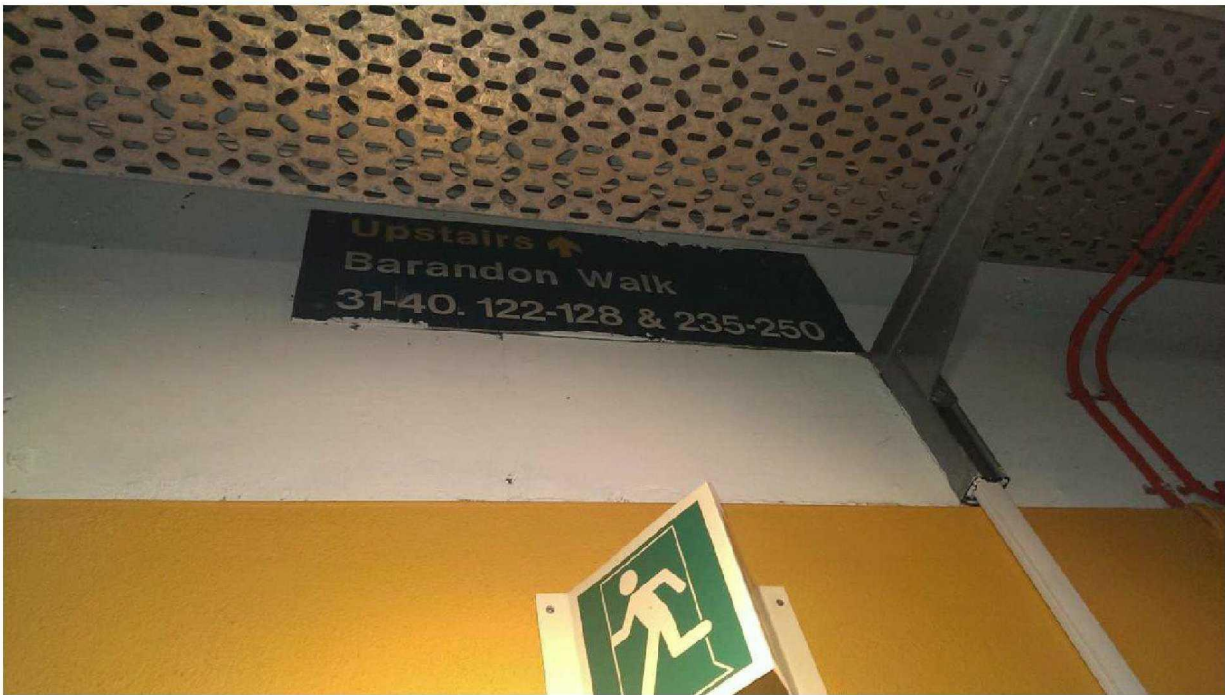
Fire officer Dan Hussey commented about the signage from the lower ground floor levels indicating the flats located above and accessed from particular staircases, please see the photographs below. I believe that the current signage is sufficient from Testerton and Hurstway roads, there is some paint on the signs but this paint does not obscure the information. There is also emergency escape exit signage displayed, some exit signs are flat to the wall others stick out, the signage which sticks out is more prominent. But only authorised persons have access to these lower ground floor areas, no members of the public so where flat signage is displayed I believe that this is sufficient. There has recently been redecoration work undertaken in Barandon Walk and because of this some new signage should be provided to show flat locations above. If the LFB require additional information this can be asked for under the 7.2 D process and then they can draw up plans showing any operational information that they require.

14. Redecoration work has been undertaken in Barandon Walk and some of the original signage indicating the flats located above and accessed from particular

staircases has been obscured or removed. New signage should be provided in Barandon Walk where needed indicating the flats located above and accessed from particular staircases, this signage should not be obstructed in anyway.

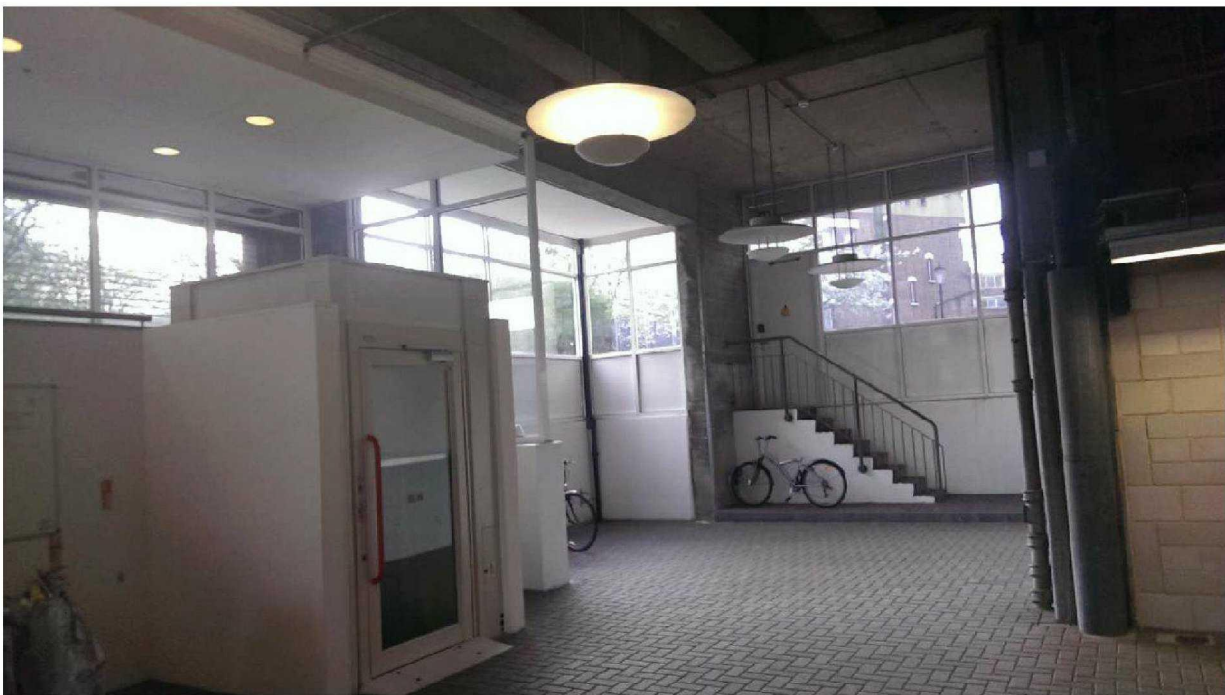
I am assuming that the fire offices did not visit Barandon Walk lower ground floor area which is totally enclosed, this area has been converted from garages to office accommodation and there is no natural ventilation in this area. If it is acceptable to have no natural ventilation in Barandon Walk then the limited natural ventilation of Testerton and Hurstway roads is an improvement. Therefore I believe that no action is needed in respect of the question of cross ventilation of the garage areas.

Barandon Walk, lower ground floor area which is fully enclosed

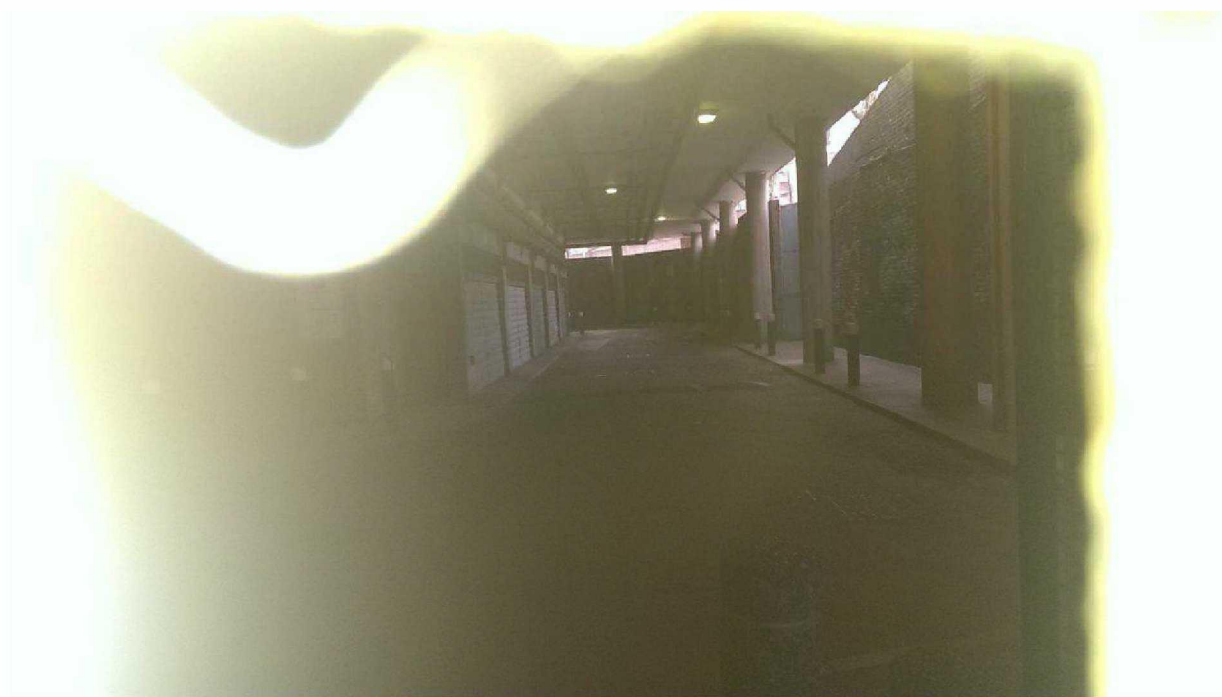
The fire officers commented on the cross ventilation of the garage areas of Testerton and Hurstway roads at the lower ground floor levels, at the ends of each of these roads there are large open areas at high level. Please see the photographs, this was how these areas were constructed. I know that some additional boarding has been fixed

above the doors of the garages for security reasons and this could reduce cross ventilation of these areas but the ends of the roads are open. There is also a 3 metre void area above the garage doors which will act as a smoke reservoir in the event of a fire in these areas. This smoke reservoir runs the whole length of these lower ground floor level areas and the fire loading of a garage would not fill this whole smoke reservoir.

The garages on the lower ground floor areas of Testerton and Hurstway walks, (sorry about the quality of this photograph)
