C S Stokes and Associates Limited

19th October 2016

Subject: Grenfell Tower, Grenfell Road, London W11 1TQ

Items from the buildings last FRA

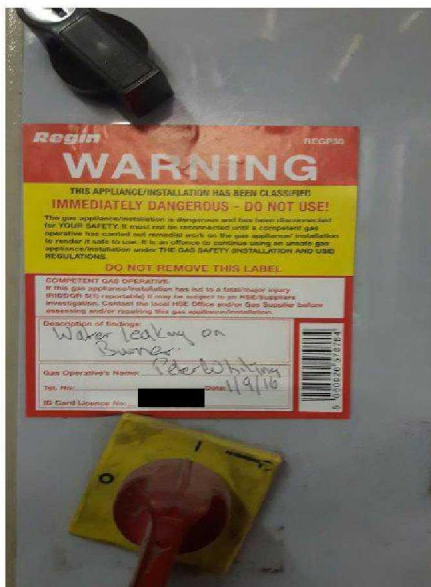
Item 4. High

The contractor's are presently working on the boilers in the basement area, there are no flue gas print outs should be attached to the gas boilers.
Gas safety certificates have been forwarded to the TMO for the installation work undertaken.

Warning label on 1 of the boilers yesterday

I would recommend that once all work connected with the gas boilers is completed that a final full gas safety check is undertaken and any defects found are rectified.
Flue gas print outs should be attached to each gas boiler.

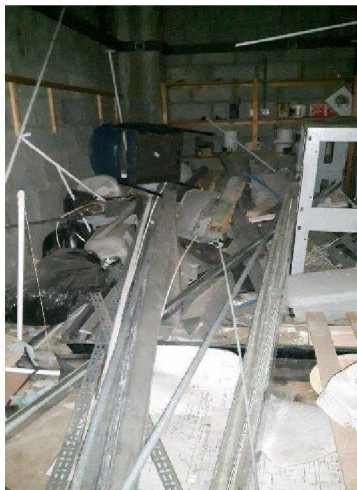
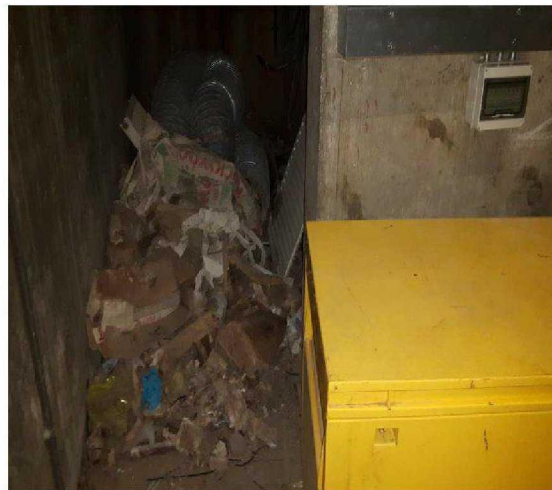
Item 9b. High

There is a lot of contractors waste in the basement boiler room.

There is still a lot of contractors waste in the basement, photos taken yesterday.

All contractors waste and rubbish in the basement boiler room and rooms off of it should be removed before this area is handed back to the TMO.

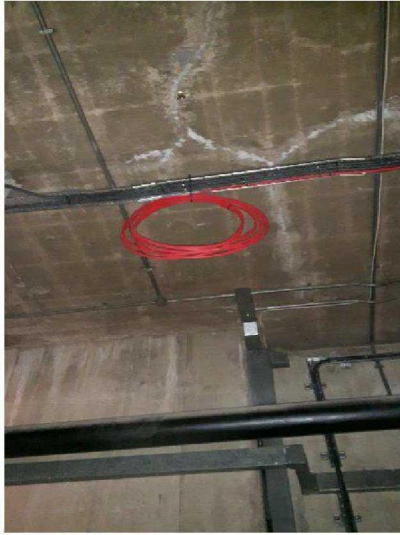
Item 17f, High

At the roof level there is a coil of fire alarm cable not connected at one end to anything.

No answers provided still outstanding, cable still in place.

What is this coil of fire alarm cable for?

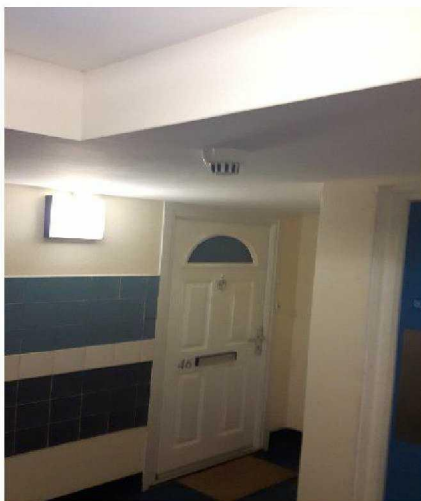
Item 17h, High

There are 2 smoke detectors fitted on the 7th floor level ceiling, the 2nd detector is a different style of smoke detector to the newly installed one. This device is on the ceiling near to the flat entrance door of flat 46. The contractor does not know anything about this 2nd device.

No answers provided still outstanding, 2nd detector still in place.

What is the reason for the 2nd smoke detector fitted on the 7th floor level ceiling near to flat 46's entrance door?

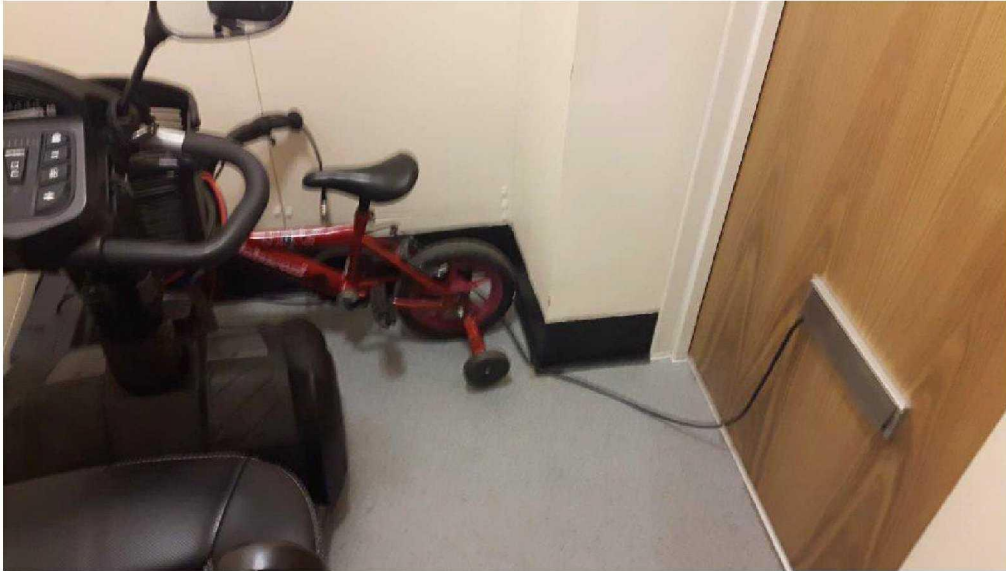
1. There is a mobility scooter being parked and charged on the landing area outside flat 9.

The charging of mobility scooters must not be undertaken in the common parts of building, this practice must stop immediately.

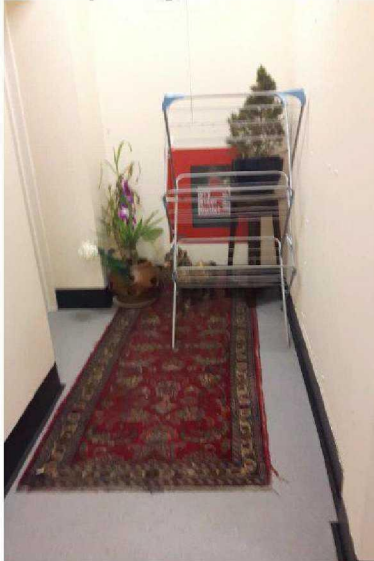
2. The dry rising main outlet outside flat 8 is being obstructed.

These items should be removed from the common parts of the building.

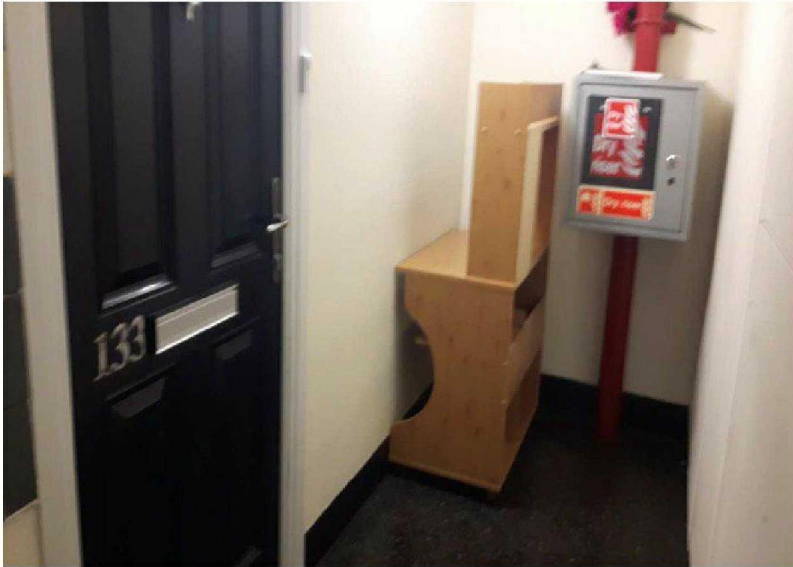
3. There is an item of furniture outside flat 133 on the flat/lift lobby area.

This item should be removed from the common parts of the building.
