C S Stokes and Associates Limited

30th January 2017

Subject: Grenfell Tower installation of new main gas pipe work.

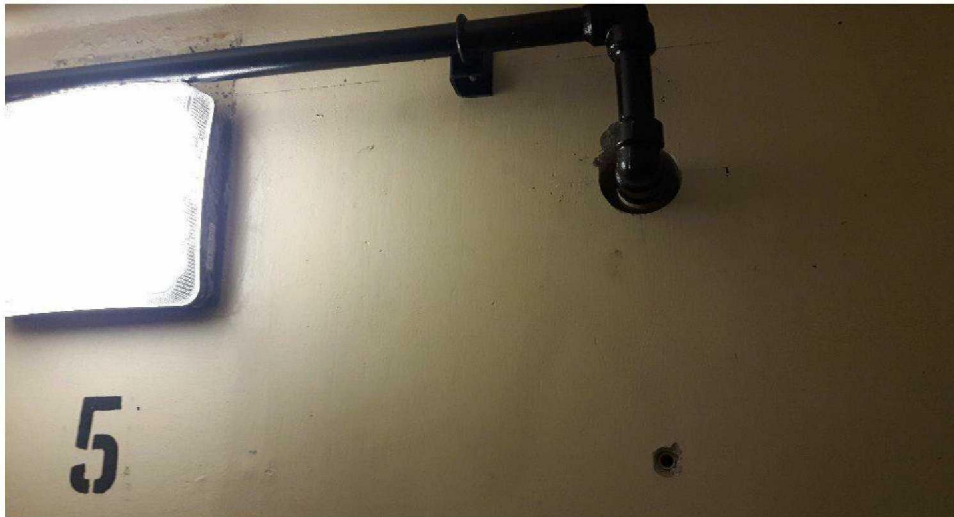
Where the gas pipe penetrates the staircase compartment wall at each floor level there are presently gaps around the pipe, the hole has not been made good. This can be seen in the next 2 photographs.

1. As structural work is being undertaken within this building as part of this project has a Building Regulations application been made for the work/project?
2. All holes in compartment wall must be suitably fire stopped using fire rated materials of a minimum of 90 minutes fire rating.
3. Documentation should be provided by the gas contractor showing the fire rated materials used for the fire stopping of the compartment walls and the fire rating of the fire collars used.

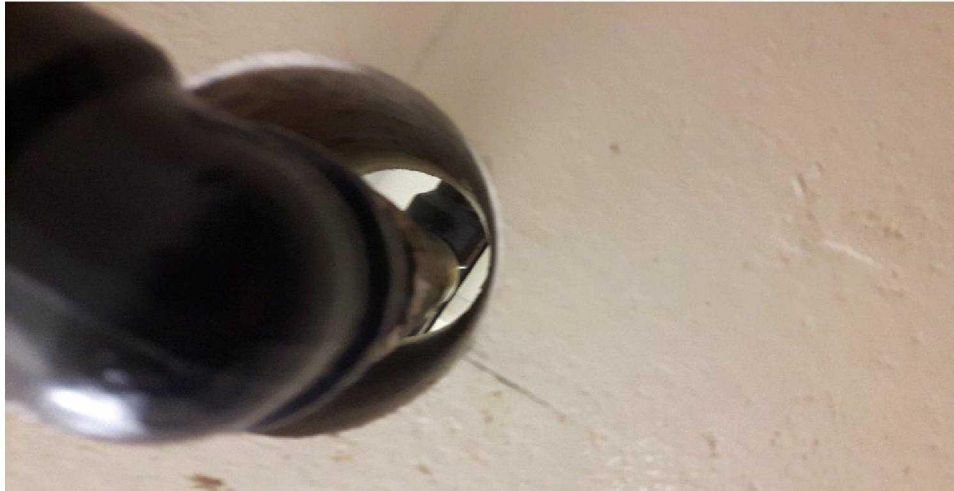
Gas pipe passing through the staircase to lift lobby area compartment wall, no fire collar has been fitted and the hole has not been made good.

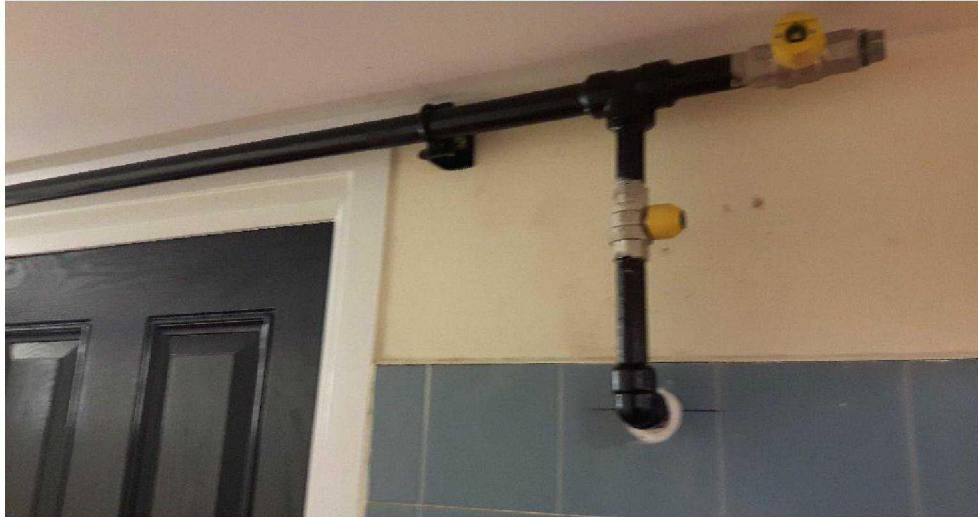
Where the gas pipe passes into the apartments the hole made has been made good, but what materials have been used to undertake this in filling?

Gas pipe passing through the flat to lift lobby area compartment wall, what fire stopping materials have been used to in fill this hole around the pipe?

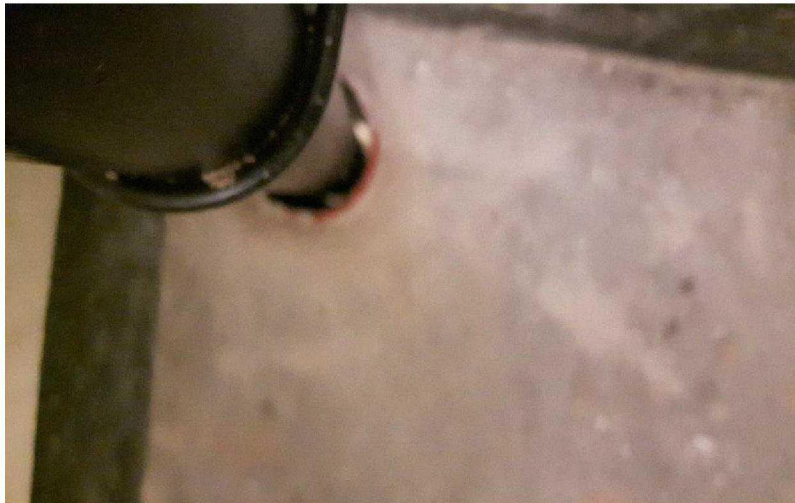
Where the gas pipe penetrates the staircase landing there is a hole through the staircase landing area which has not been made good, please see the second photograph on the next page.

Pipe penetrating the staircase landing, hole through the landing, the hole not made good.
