Subject: Grenfell Tower Grenfell Road London W11 1TQ

Background information

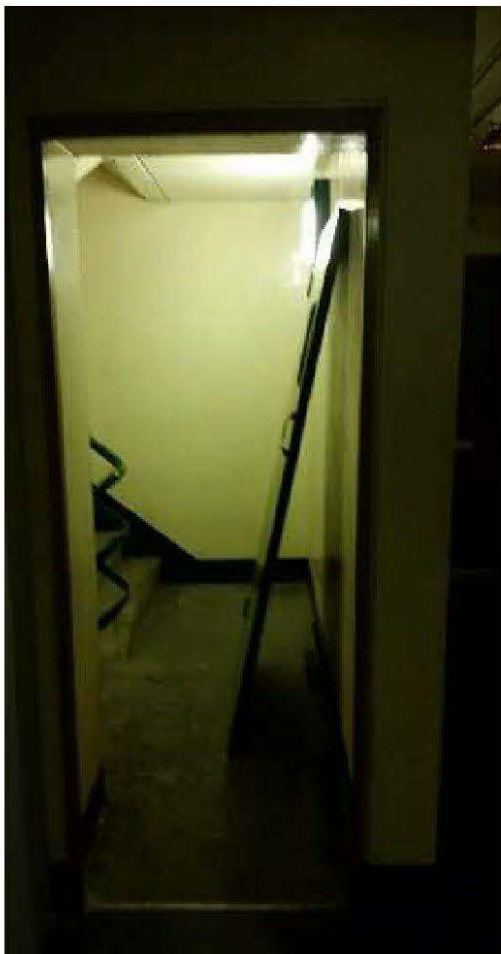
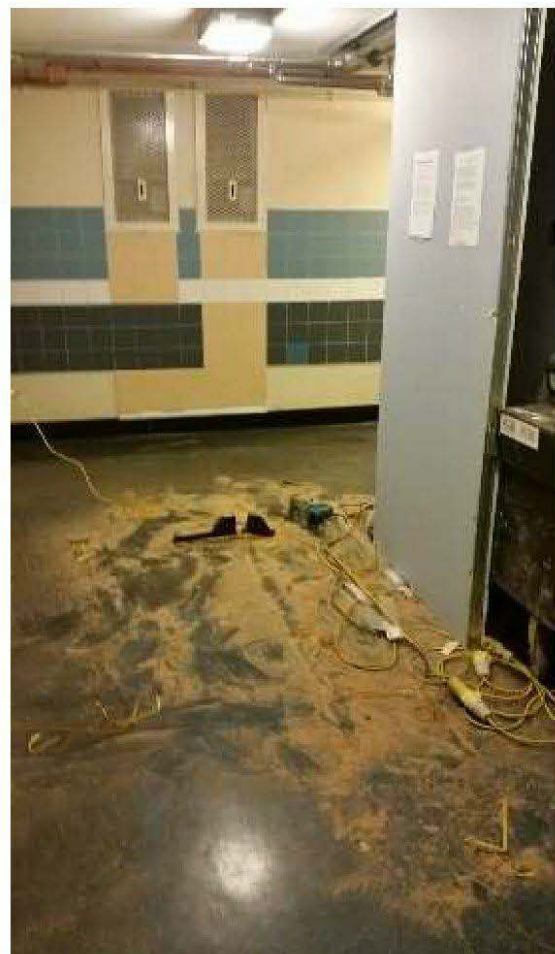
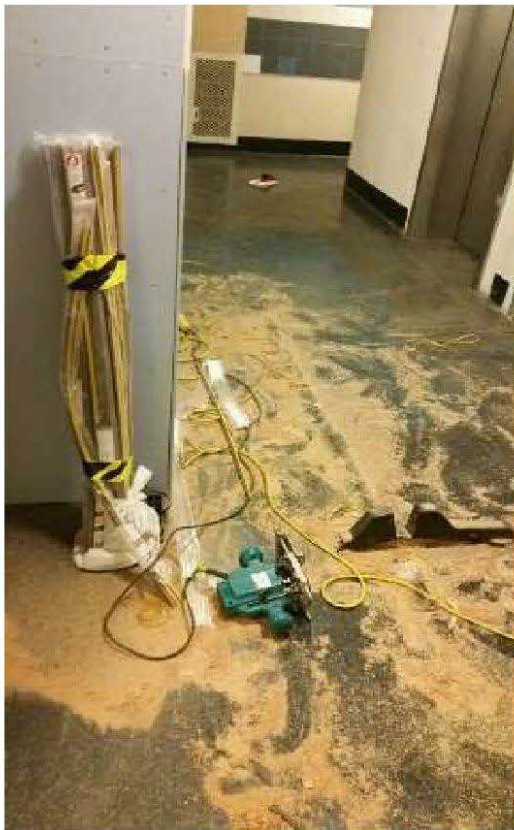
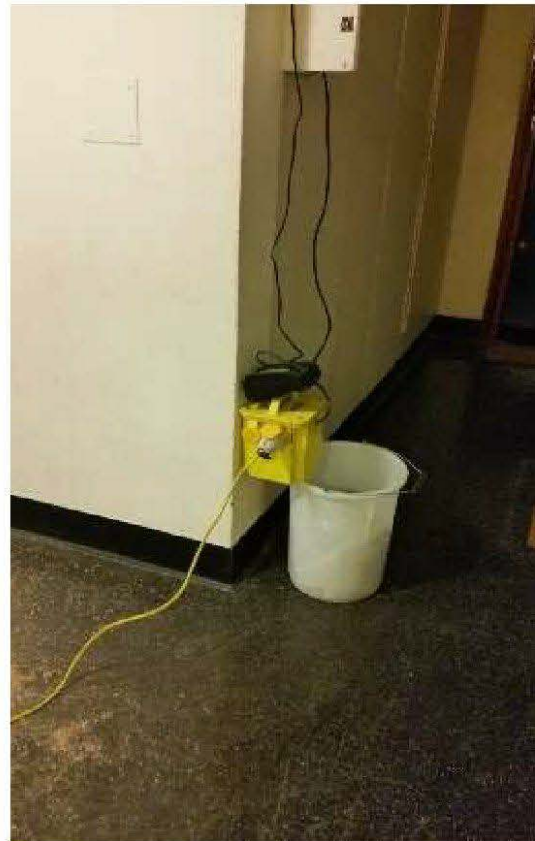
The work on the flat/lift area to staircase fire doors in this building was started on the 19th March 2015, these are photographs of the work being undertaken, as you can see the doors were removed without any attempt to maintain the fire protection of the staircase. Doors were taken to a particular floor levels where the work was undertaken, the installed smoke detectors on the flat/lift lobby areas were not covered over or isolated in any way. Also the contractor undertaking the work did not inform any TMO employee or any Rydons employees that the work was being undertaken.

1. I would recommend that the contractor responsible for undertaking the above work is asked to provide in writing that the person (s) who has undertaken the work is suitably qualified to carry out the work. This information may be required if the Fire Authority challenge the workmanship of the fitting of the cold smoke seals etc and there is any future court case.

2. I would recommend that the contractor who has undertaken the work on these flat/lift lobby area to staircase fire doors is asked to provide in writing that each of these doors, a full door schedule should be provided, is still a 30 minute fire rated door. This information may be required to be used as evidence if the Fire Authority in the future asks about the fire rating of these doors or there is a court case after an audit or fire within this building.

3. I would strongly recommend that the contractor who undertook this work is asked to provide a full list of any fire doors that they have retrospectively fitted with intumescent strips or cold smoke seals in any other TMO premises and that these doors are inspected for workmanship etc as soon as possible.

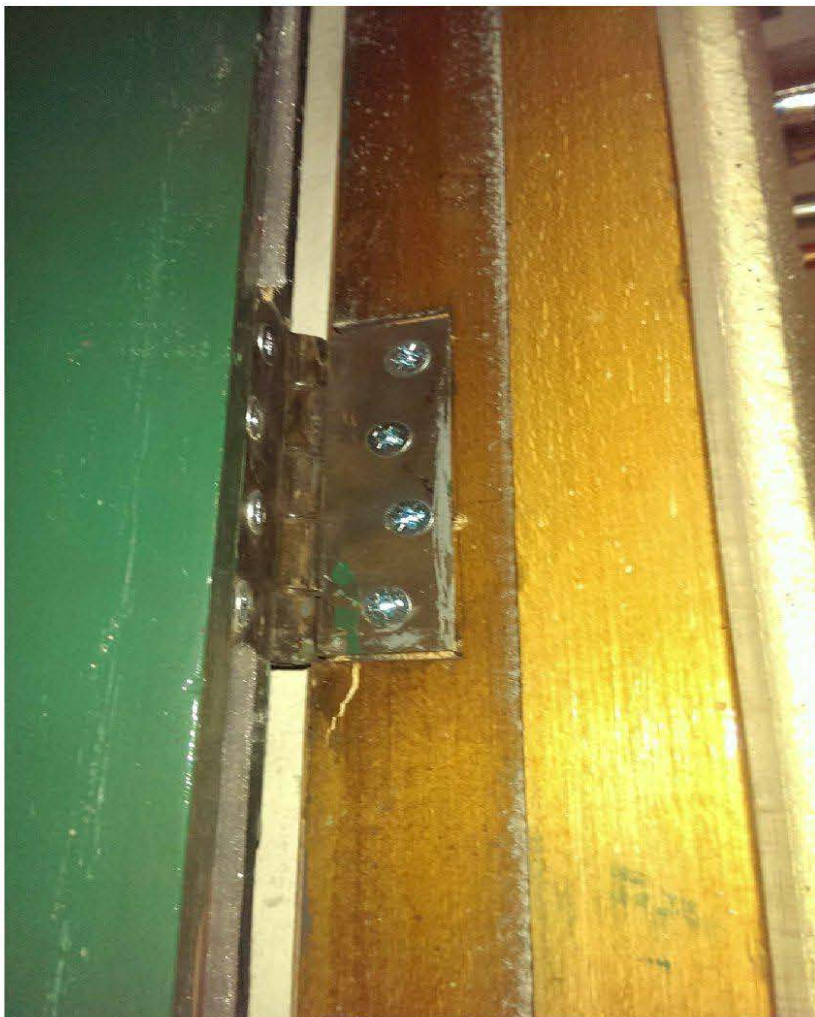
As well as fitting of the intumescent strips and cold smoke seals on the flat/lift lobby area to staircase fire doors new hinges also appear to have been fitted, as can be seen below, there is also some damage to the door frames where the new hinges have been fitted.

6. It appears that there are no intumescent strips fitted under the hinges of the doors, as required by the British Standard. I would recommend that the contractor who undertook the work on the flat/lift lobby area to staircase doors is asked to confirm that there are intumescent strips under each and every hinge on each door? This conformation should be in writing and with photograph evidence also provided.
7. I would recommend that the contractor who undertook the work on the flat/lift lobby area to staircase doors is asked to confirm in writing that the correct fire rated hinges have been used on these doors? Copies of the manufactures information sheets for the fitted hinges with the British Standard numbers shown should be forwarded and kept on file.

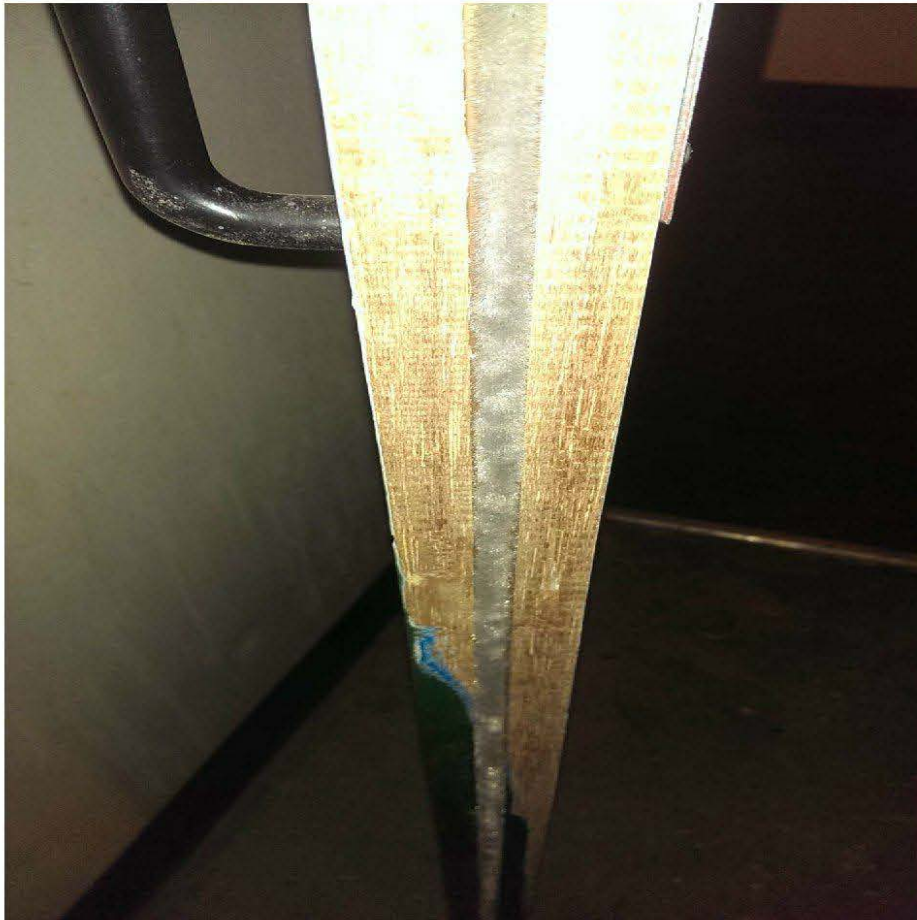
Whilst the intumescent strips and cold smoke seals on the flat/lift lobby area to staircase fire doors were being fitted it can be seen that some of the door edging was planed off, this has resulted in the door now not beings as wide as it originally was. The original painted door edge can be seen lower down the door and the exposed non painted door edge on the upper part of this photograph of the door edge.

8. Is the contractor who undertook the work on these flat/lift lobby area to staircase doors going to repaint/make good the doors where parts of the door were removed?

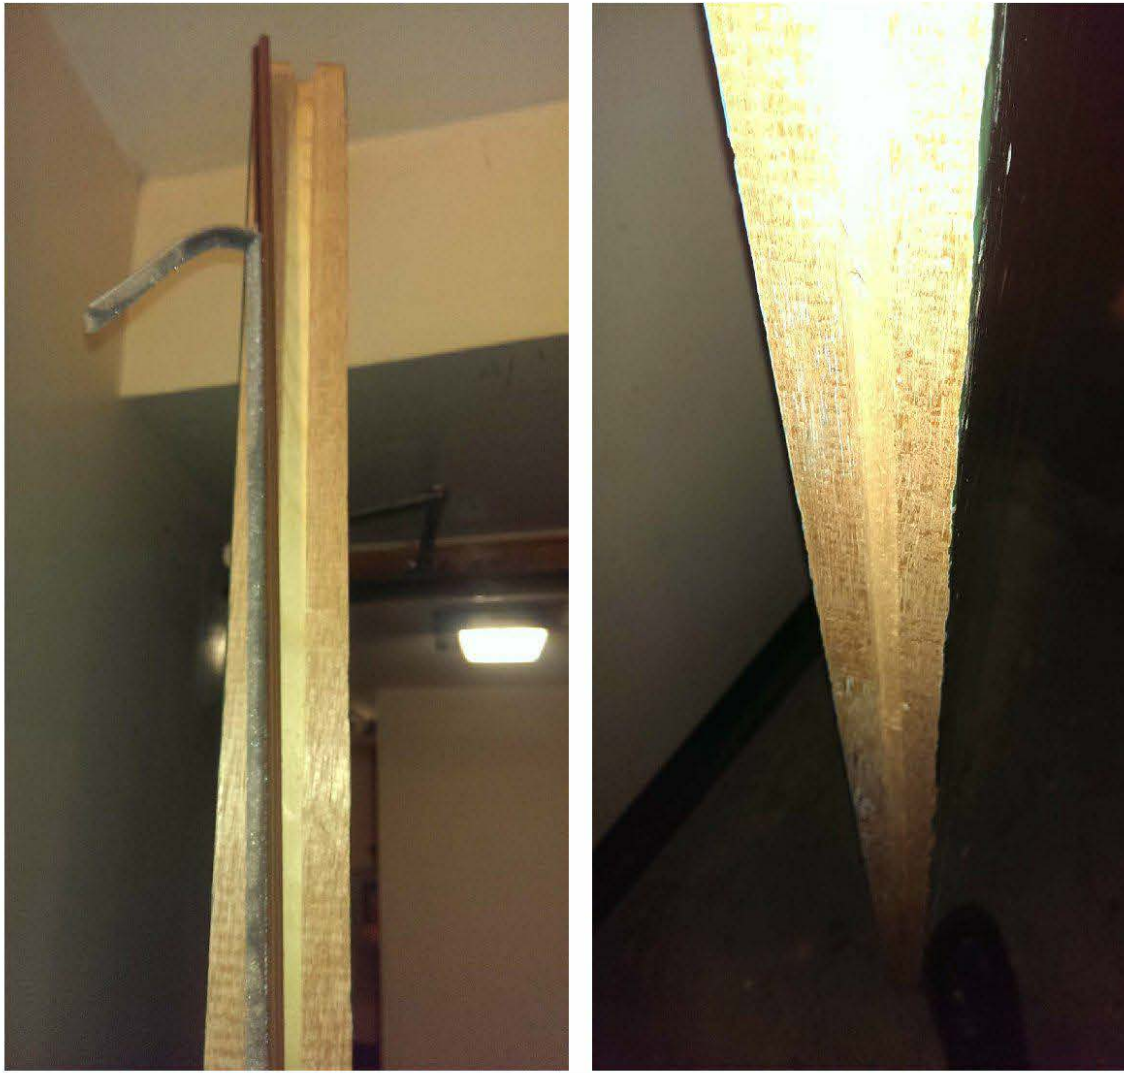
The work undertaken on these flat/lift lobby area to staircase fire doors is less than 1 month old but as can be seen from the photographs taken yesterday some strips/seals are already coming out of the grooves routed out or are missing altogether.

9. The photographs above show that the standard of workmanship in the fitting of the strips and seals appears not to be as it should be, as in less than 28 days the fitted strips and seals are not in place or are coming off. The contractor who undertook this work should be asked why the strips and seals fitted are coming out or are missing.

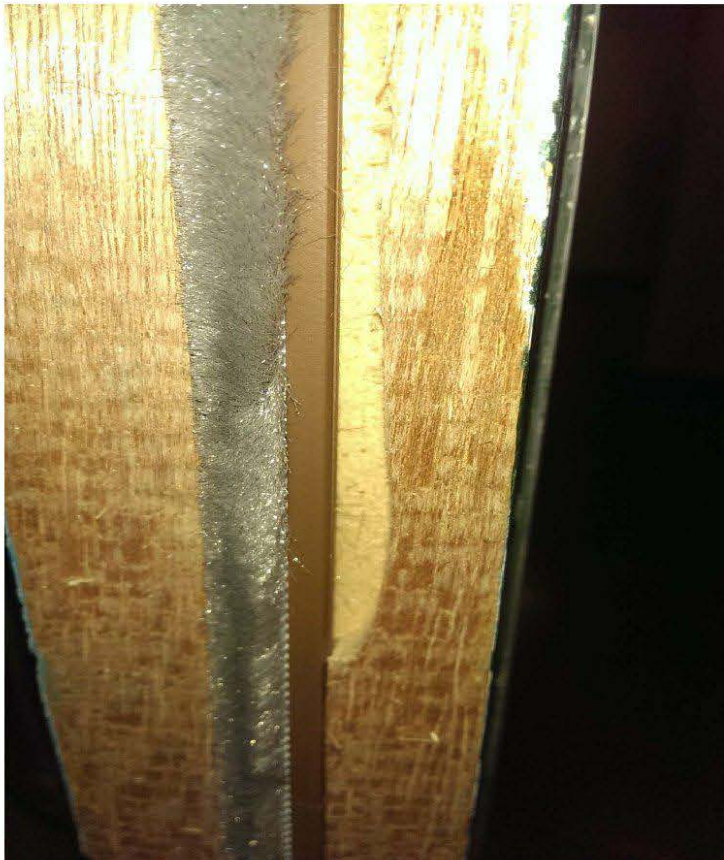
Depending on the answers received back from the ventilation consultants working for Rydens, the cold smoke seals fitted to the flat/lift lobby area to staircase fire doors may have to be removed and the fire doors made good or the contractor who undertook the work may have to provide new certified 30 minute fire rated doors in these locations. This is because were the contractor has removed/planed off the edges of the doors the gap between the door and the door frame is now wider that it originally was before the contractor undertook the work on the fire doors. Also there are damaged areas on the door edges caused when the grooves were routed out, as can be seem below in the photograph.
