C S Stokes and Associates Limited

19th October 2016

Subject: Grenfell Tower, Grenfell Road, London W11 1TQ

Thank you for asking me to inspect this building before an audit of the premises is undertaken by the London Fire Brigade under The Regulatory Reform (Fire Safety) Order 2005 (FSO) next week. I visited the building yesterday and as a result of my visit I would recommend that the following items are addressed or information obtained to assist the London Fire Brigade Inspecting Officer.

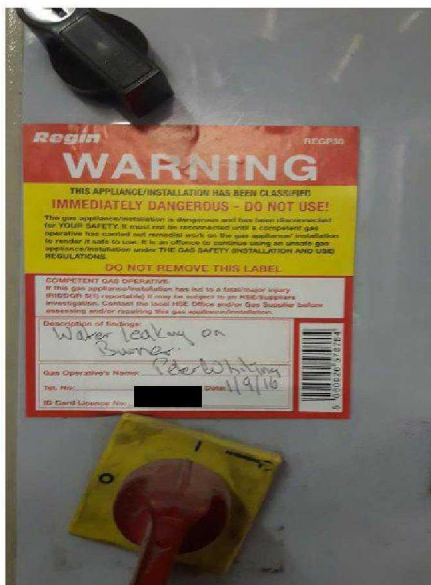
Item 4, High

The contractor's are presently working on the boilers in the basement area, there are no flue gas print outs should be attached to the gas boilers.
Gas safety certificates have been forwarded to the TMO for the installation work undertaken.

Warning label on 1 of the boilers yesterday

I would recommend that once all work connected with the gas boilers is completed that a final full gas safety check is undertaken and any defects found are rectified.
Flue gas print outs should be attached to each gas boiler.

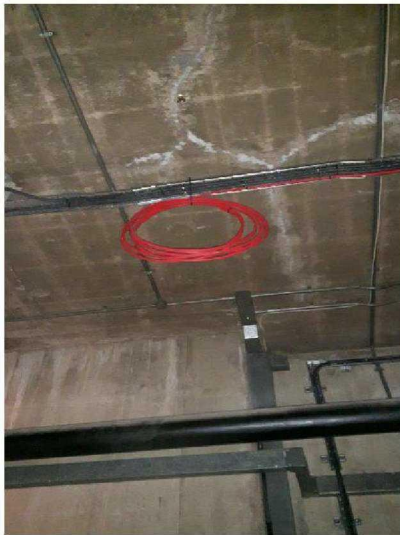
Item 17f, High

At the roof level there is a coil of fire alarm cable not connected at one end to anything.

No answers provided still outstanding, cable still in place.

What is this coil of fire alarm cable for?

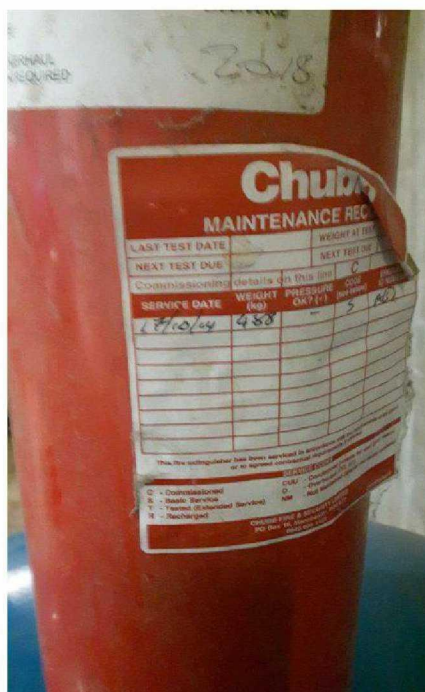
Item 23f, High

According to the contractors labels on the fire extinguishers in this building they are all out of test date. The last date on the contractors test/servicing labels is October 2014.

Extinguishers still all out of service/test date.

All of the fire extinguishers in this building should be tested/serviced immediately and any defective ones replaced.

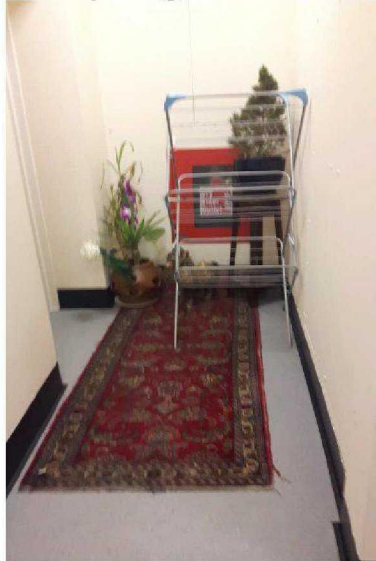
2. The dry rising main outlet outside flat 8 is being obstructed.

These items should be removed from the common parts of the building.

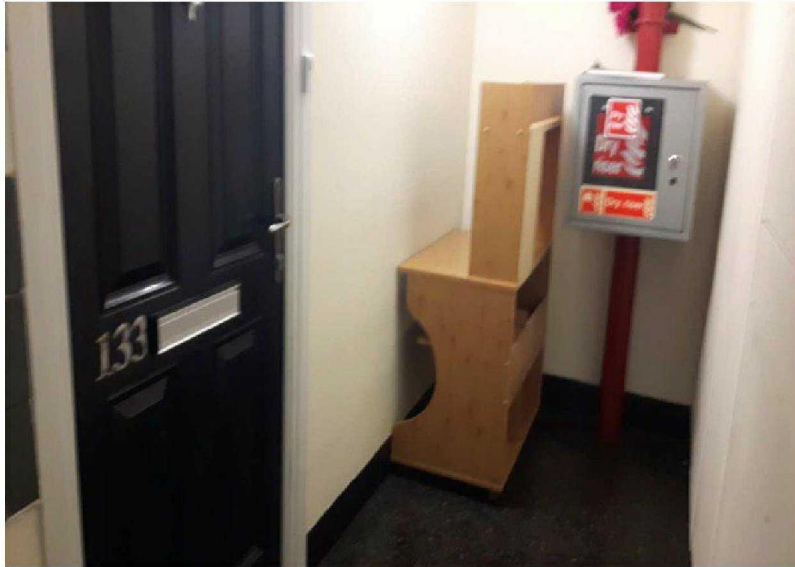
3. There is an item of furniture outside flat 133 on the flat/lift lobby area.

This item should be removed from the common parts of the building.
