C S Stokes and Associates Limited

19th October 2016

Subject: Grenfell Tower, Grenfell Road, London W11 1TQ

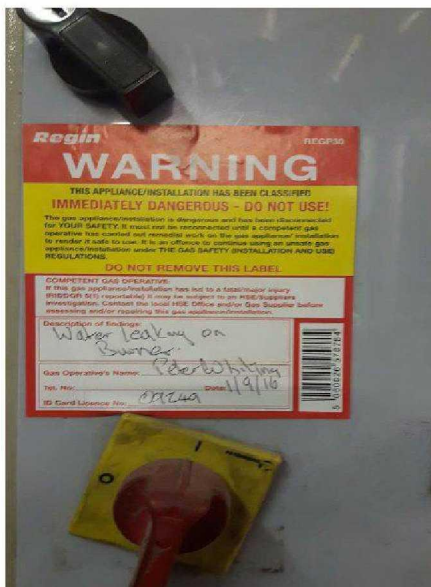
Item 4. High

The contractor's are presently working on the boilers in the basement area, there are no flue gas print outs should be attached to the gas boilers. Gas safety certificates have been forwarded to the TMO for the installation work undertaken.

Warning label on 1 of the boilers yesterday

I would recommend that once all work connected with the gas boilers is completed that a final full gas safety check is undertaken and any defects found are rectified. Flue gas print outs should be attached to each gas boiler.

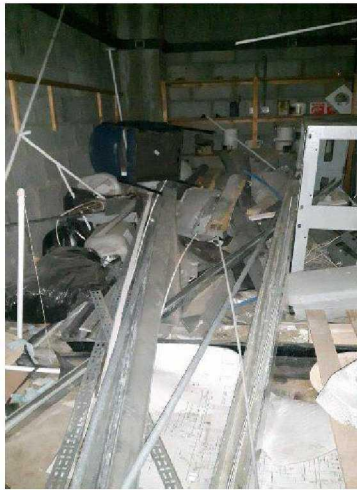
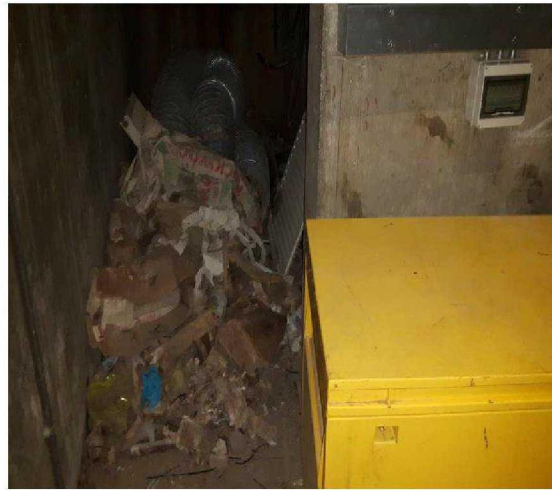
Item 9b. High

There is a lot of contractors waste in the basement boiler room.

There is still a lot of contractors waste in the basement, photos taken yesterday.

All contractors waste and rubbish in the basement boiler room and rooms off of it should be removed before this area is handed back to the TMO.
