C S Stokes and Associates Limited

Subject: Grenfell Tower Grenfell Road London W11 1TQ

Thank you for asking me to visit the above premises yesterday, Thursday the 9th April 2015, to look at the flat/lift area to staircase fire doors which a contractor has recently routed out along the door edges and fitted cold smoke seals into and also fitted new hinges on these doors. The doors on all floor levels have been worked on.

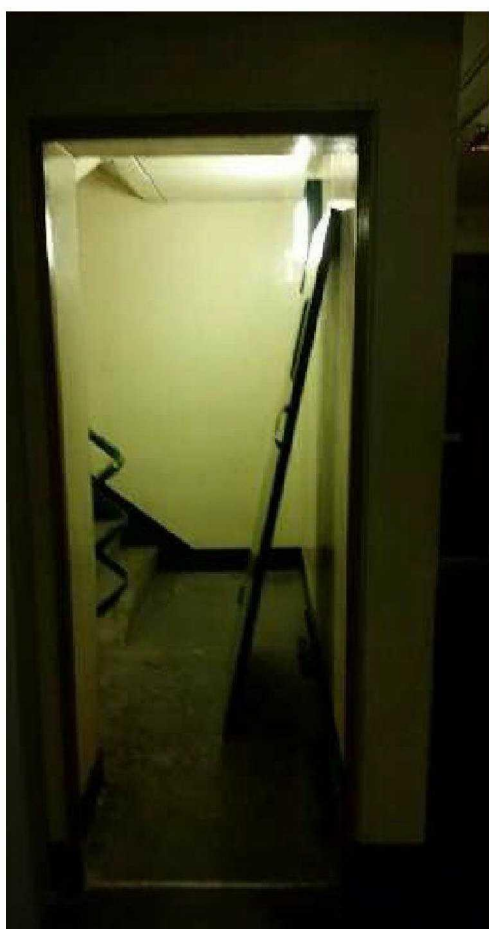
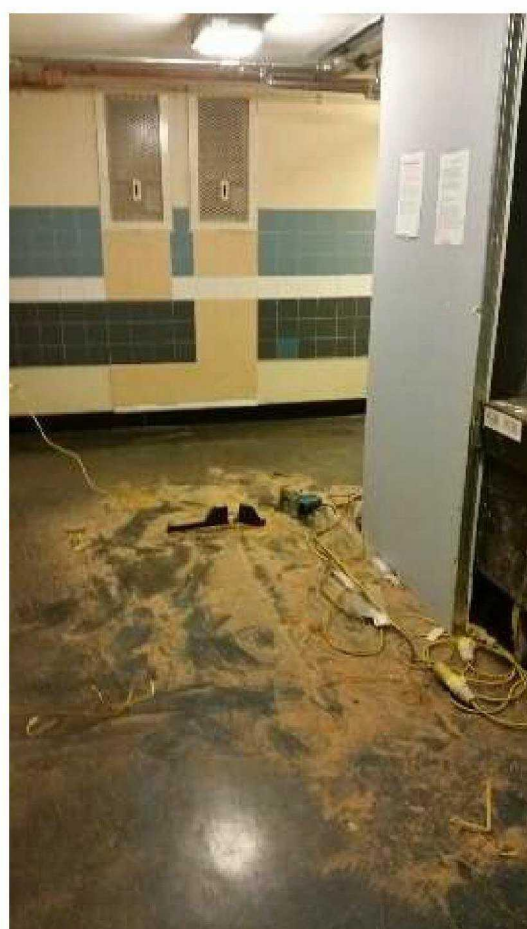
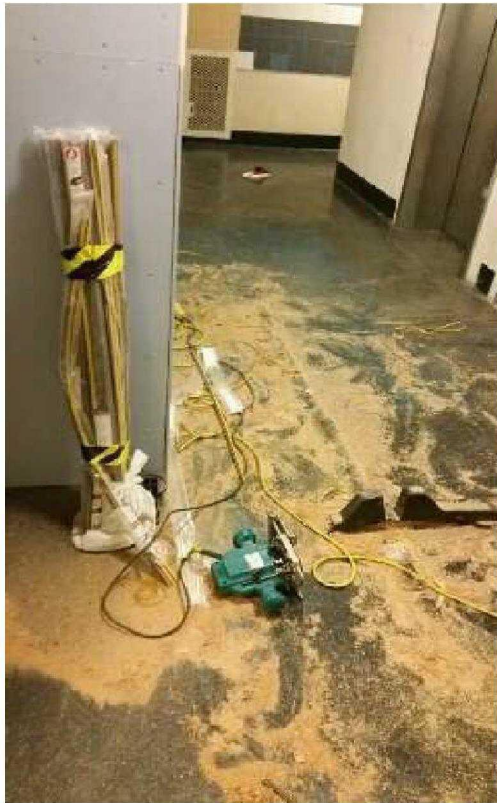
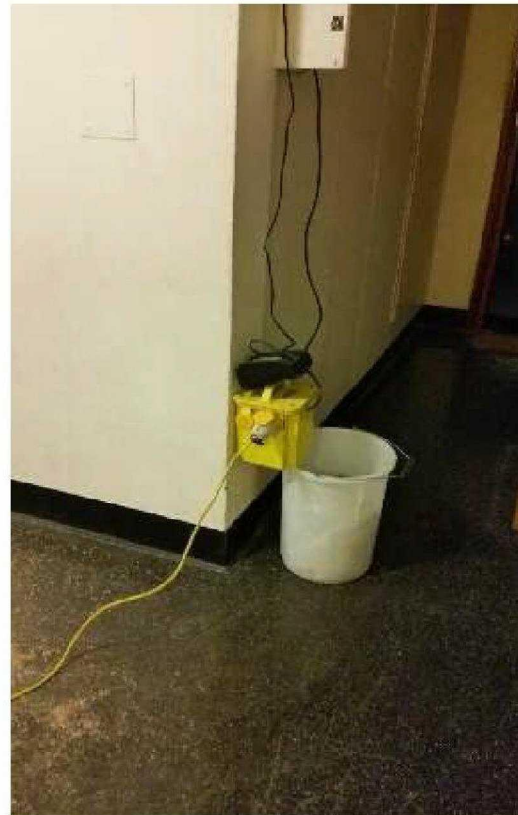
The work on the flat/lift area to staircase fire doors in this building was started on the 19th March 2015, these are photographs of the work being undertaken, as you can see the doors were removed without any attempt to maintain the fire protection of the staircase. Doors were taken to a particular floor levels where the work was undertaken, the installed smoke detectors on the flat/lift lobby areas were not covered over or isolated in any way. Also the contractor undertaking the work did not inform any TMO employee or any Rydons employees that the work was being undertaken.

1. I would recommend that the contractor responsible for undertaking the above work is asked to provide in writing that the person (s) who has undertaken the work is suitably qualified to carry out the work. This information may be required if the Fire Authority challenge the workmanship of the fitting of the cold smoke seals etc and there is any future court case.

2. I would recommend that the contractor who has undertaken the work on these flat/lift lobby area to staircase fire doors is asked to provide in writing that each of these doors, a full door schedule should be provided, is still a 30 minute fire rated door. This information may be required to be used as evidence if the Fire Authority in the future asks about the fire rating of these doors or there is a court case after an audit or fire within this building.

3. I would strongly recommend that the contractor who undertook this work is asked to provide a full list of any fire doors that they have retrospectively fitted with intumescent strips or cold smoke seals in any other TMO premises and that these doors are inspected for workmanship etc as soon as possible.

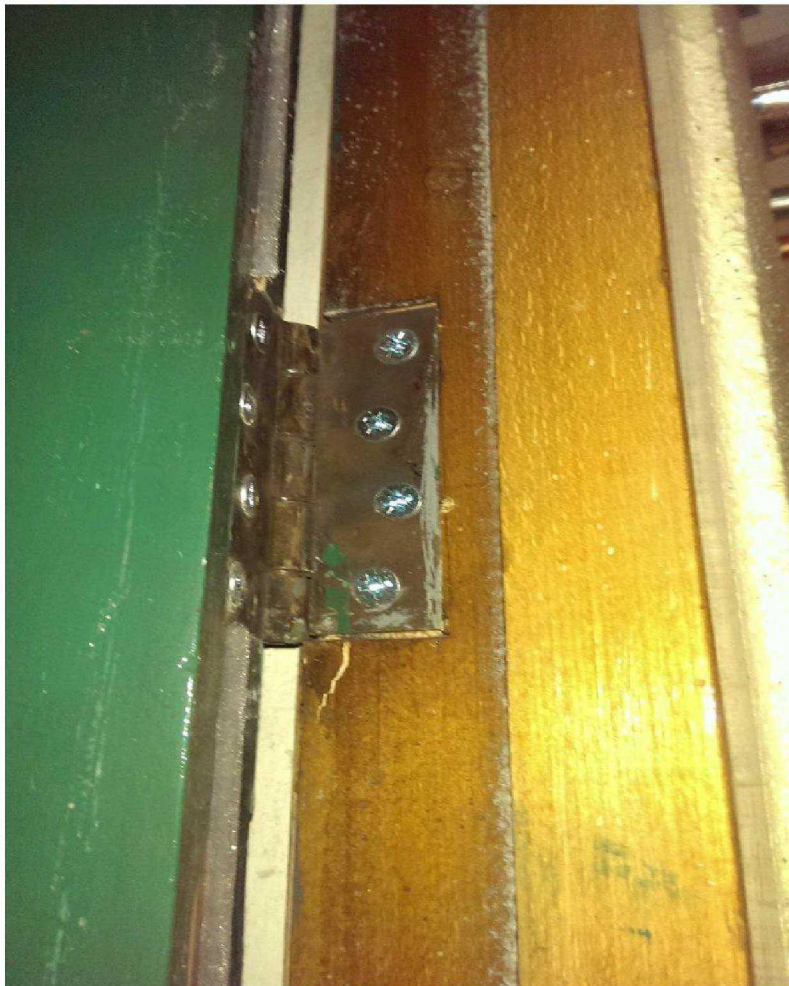
As well as fitting of the intumescent strips and cold smoke seals on the flat/lift lobby area to staircase fire doors new hinges also appear to have been fitted, as can be seen below, there is also some damage to the door frames where the new hinges have been fitted.

6. It appears that there are no intumescent strips fitted under the hinges of the doors, as required by the British Standard. I would recommend that the contractor who undertook the work on the flat/lift lobby area to staircase doors is asked to confirm that there are intumescent strips under each and every hinge on each door? This conformation should be in writing and with photograph evidence also provided.
7. I would recommend that the contractor who undertook the work on the flat/lift lobby area to staircase doors is asked to confirm in writing that the correct fire rated hinges have been used on these doors? Copies of the manufactures information sheets for the fitted hinges with the British Standard numbers shown should be forwarded and kept on file.

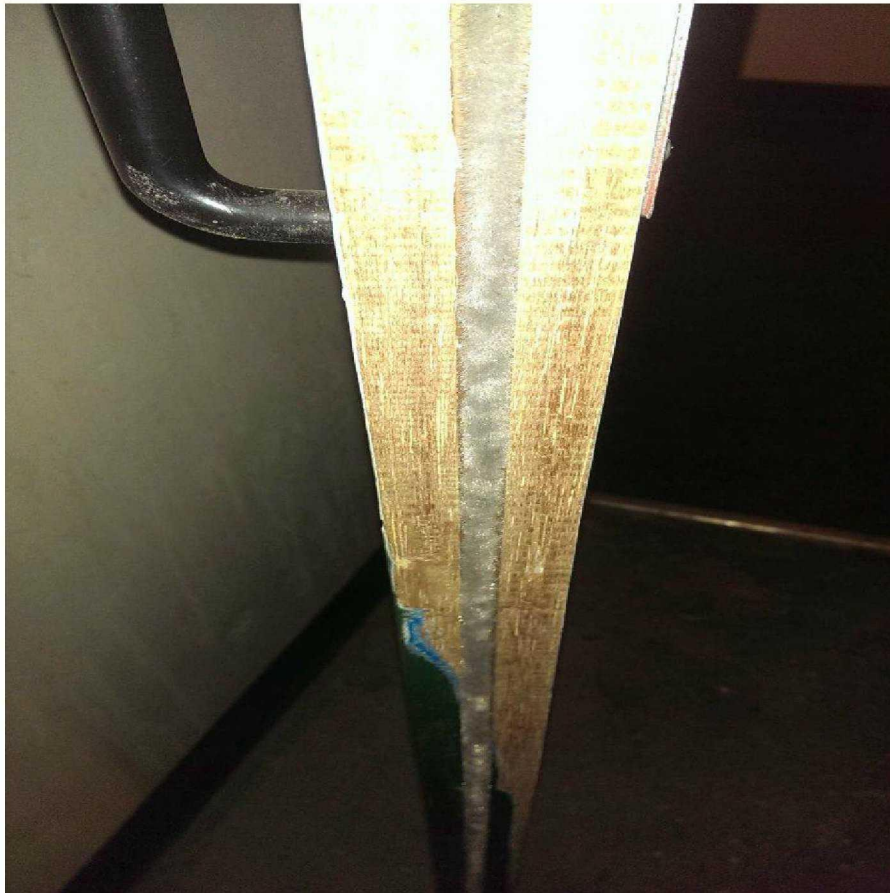
Whilst the intumescent strips and cold smoke seals on the flat/lift lobby area to staircase fire doors were being fitted it can be seen that some of the door edging was planed off, this has resulted in the door now not beings as wide as it originally was. The original painted door edge can be seen lower down the door and the exposed non painted door edge on the upper part of this photograph of the door edge.

8. Is the contractor who undertook the work on these flat/lift lobby area to staircase doors going to repaint/make good the doors where parts of the door were removed?

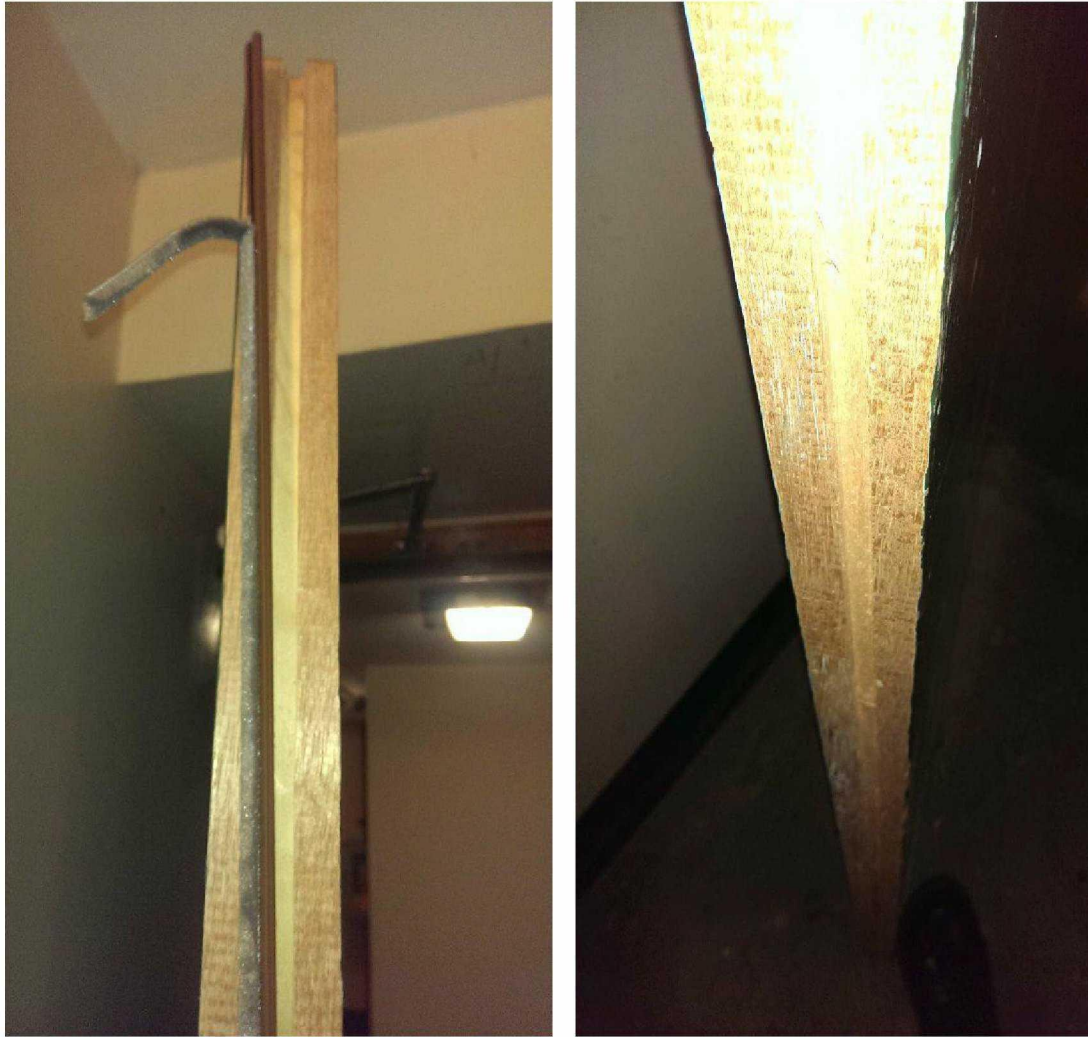
The work undertaken on these flat/lift lobby area to staircase fire doors is less than 1 month old but as can be seen from the photographs taken yesterday some strips/seals are already coming out of the grooves routed out or are missing altogether.

9. The photographs above show that the standard of workmanship in the fitting of the strips and seals appears not to be as it should be, as in less than 28 days the fitted strips and seals are not in place or are coming off. The contractor who undertook this work should be asked why the strips and seals fitted are coming out or are missing.

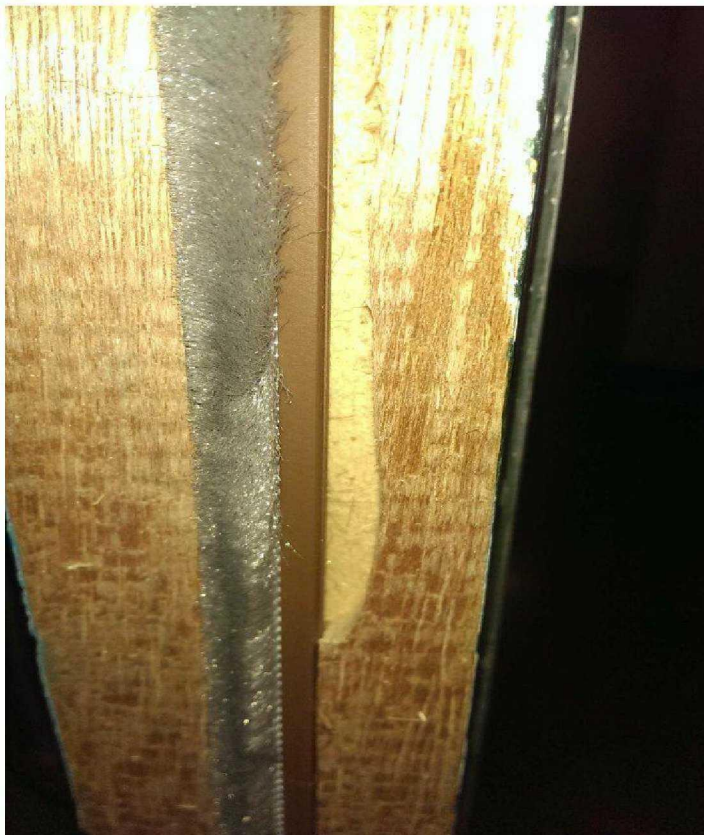
Depending on the answers received back from the ventilation consultants working for Rydons, the cold smoke seals fitted to the flat/lift lobby area to staircase fire doors may have to be removed and the fire doors made good or the contractor who undertook the work may have to provide new certified 30 minute fire rated doors in these locations. This is because were the contractor has removed/planed off the edges of the doors the gap between the door and the door frame is now wider that it originally was before the contractor undertook the work on the fire doors. Also there are damaged areas on the door edges caused when the grooves were routed out, as can be seem below in the photograph.
