C S Stokes and Associates Limited

18th March 2014

Premises: Grenfell Tower, Testerton, Barandon and Hurstway Walks on the Lancaster West Estate

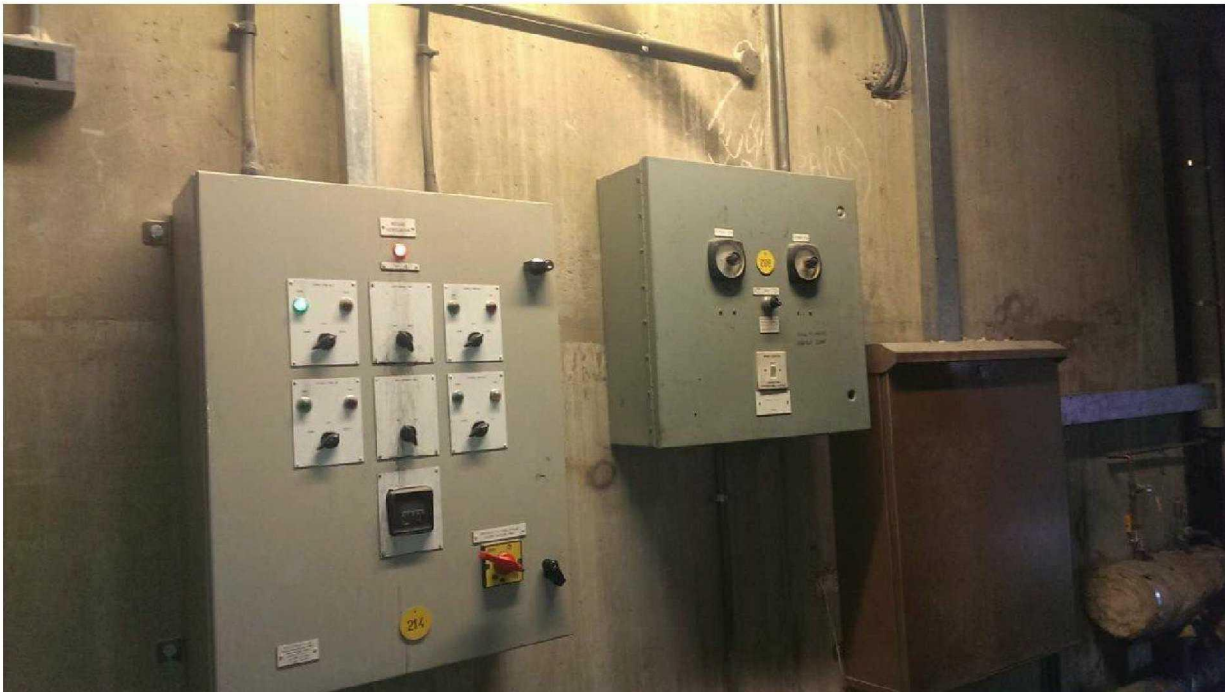
Refuse chute room extraction control panel on the left with the flat/lift lobby areas control panel on the right hand side.

As the next quarterly service is imminently due on this smoke extraction system I would recommend the contractor is asked to service the system and any findings etc made are actioned.

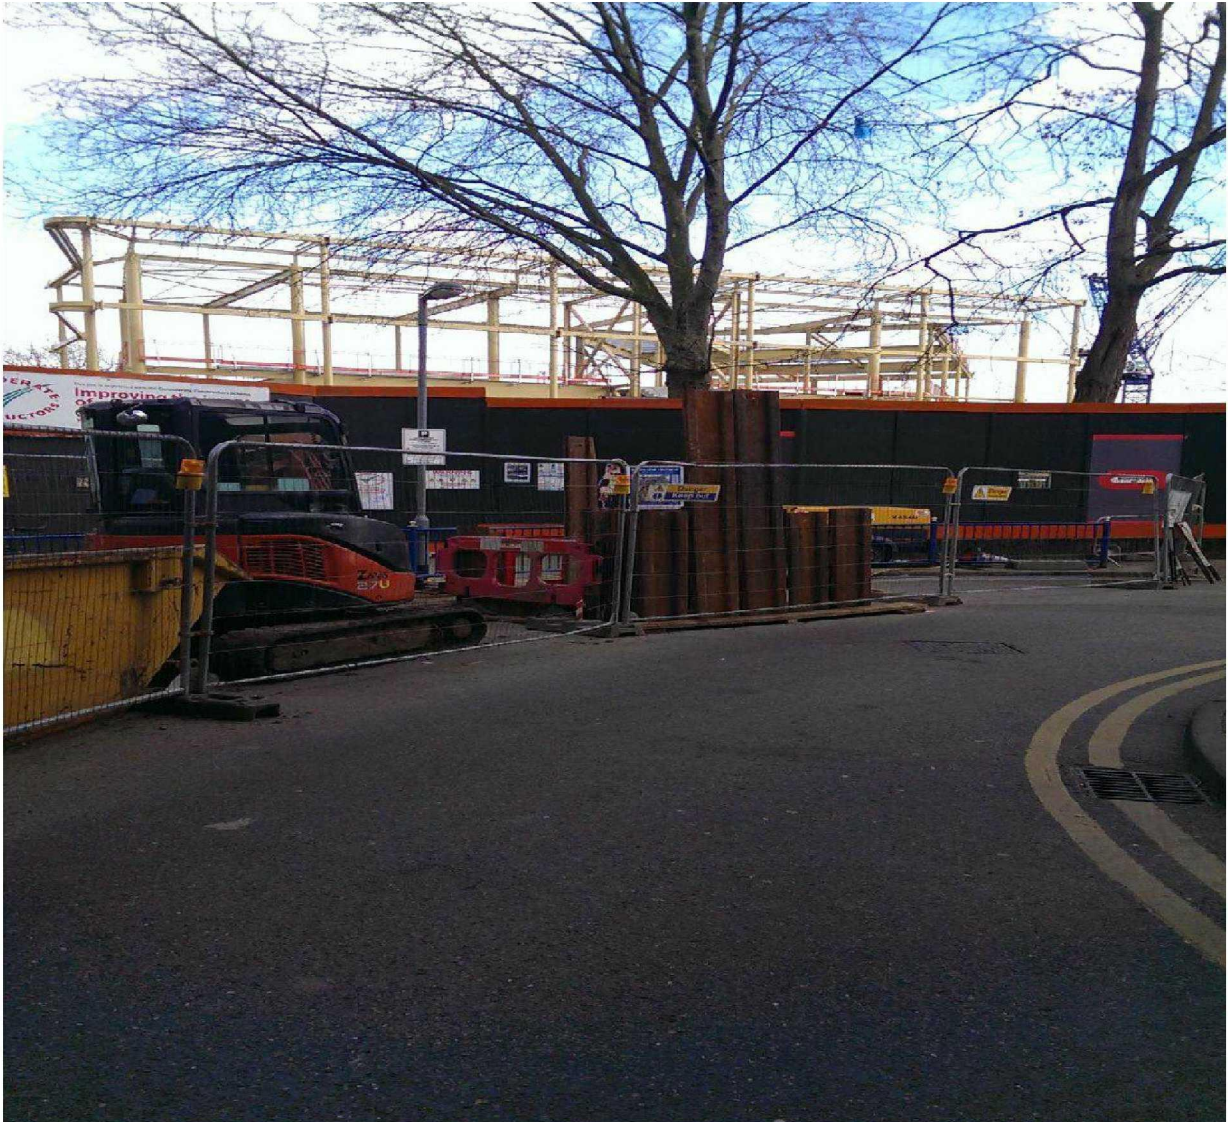
and the TMO have not control of the public highway. Presently there is working being undertaken in this public road, please see the photograph.

The contractors undertaking this work are responsible for any obstruction and congestion, if the LFB are highlighting problems the this issue should be raised with the contractors involved and the LFB should be asked to contact the contractors directly.

5. The side gated area along the side of Grenfell Tower should be maintain clear at all times with the gate being locked shut to stop illegal parking in this area.

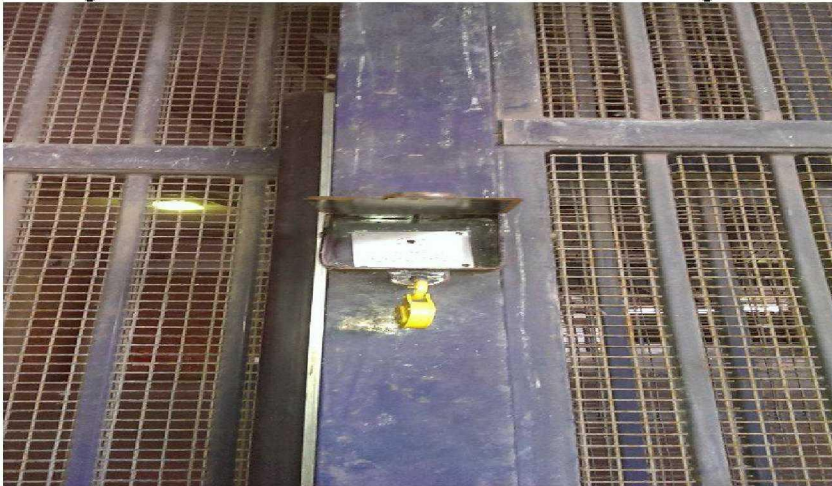
Fire fighter over ride switch in box fitted to vehicle gate

11. The fire fighter over ride switch in box fitted to vehicle gate which gives access to the lower ground floor level roads is damaged and does not open the gate, this over ride switch should be repaired or replaced so that it opens the vehicle gate when used.

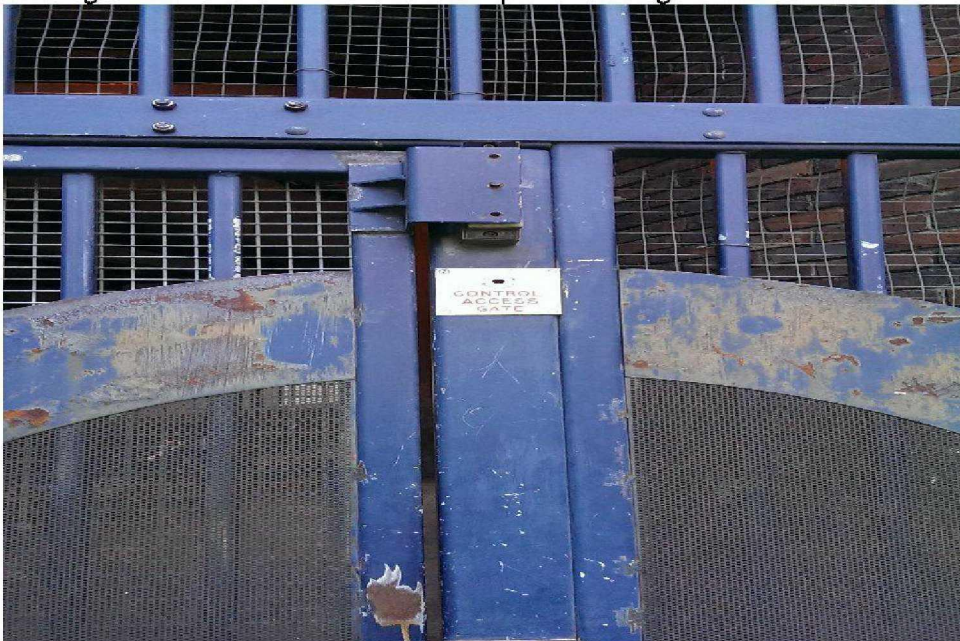
Fire fighter over ride switch fitted to pedestrian gate

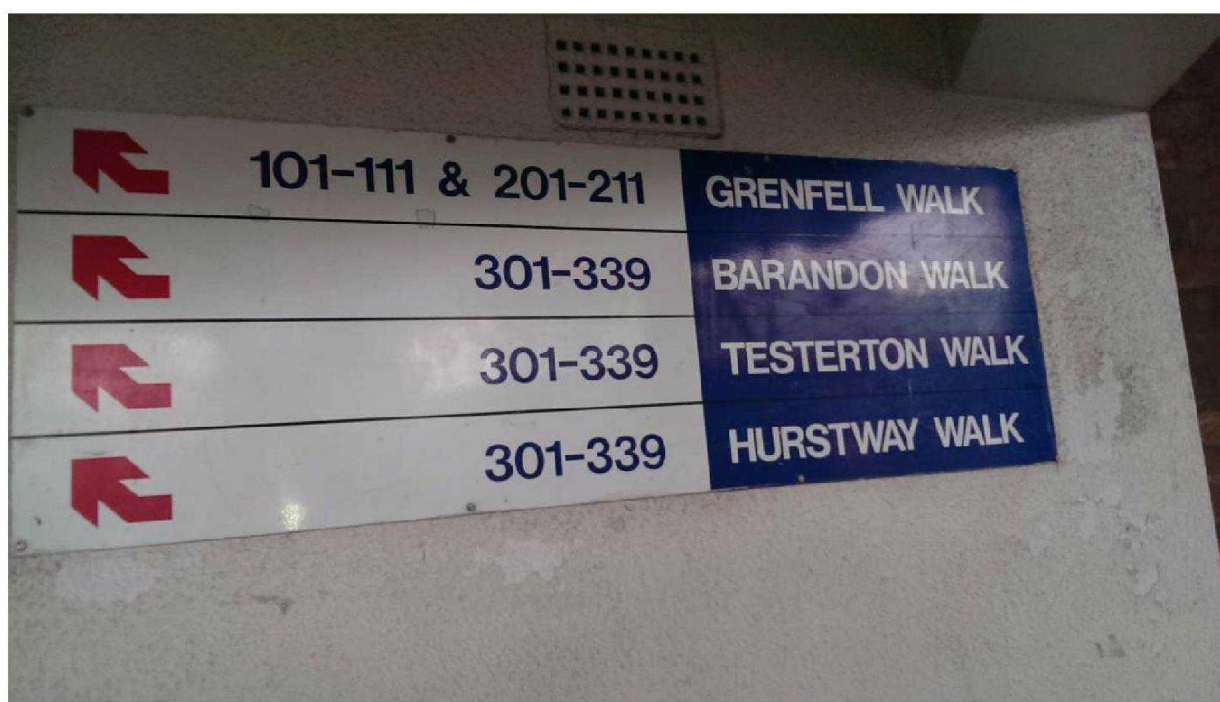
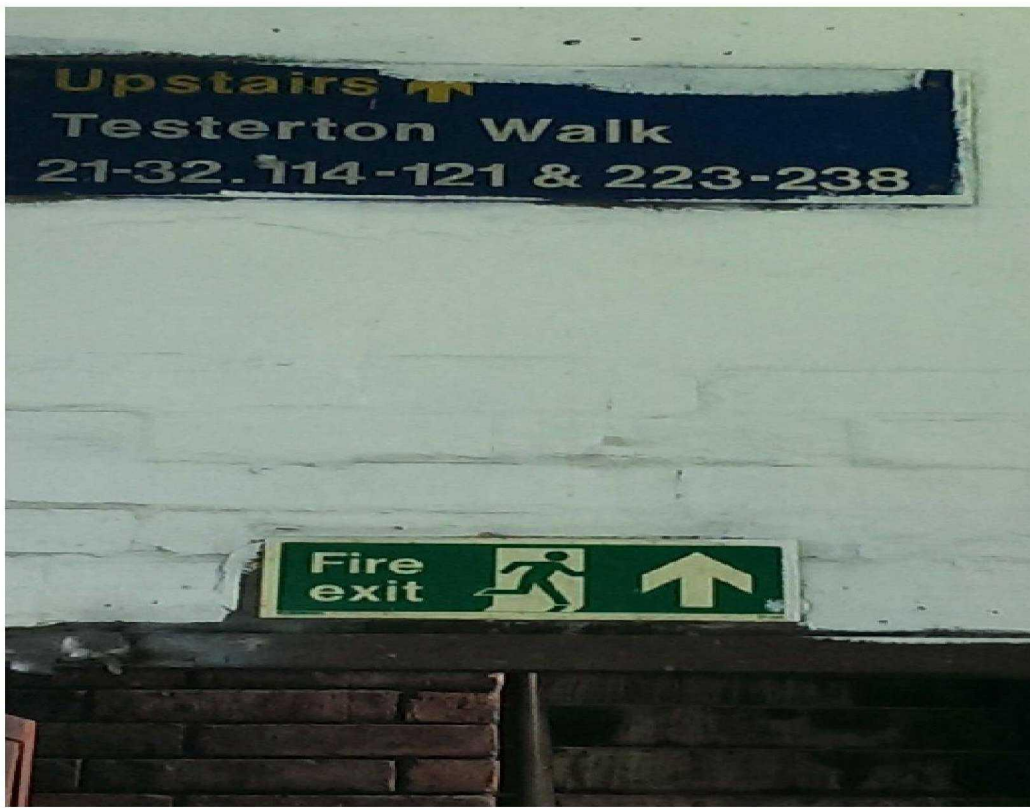
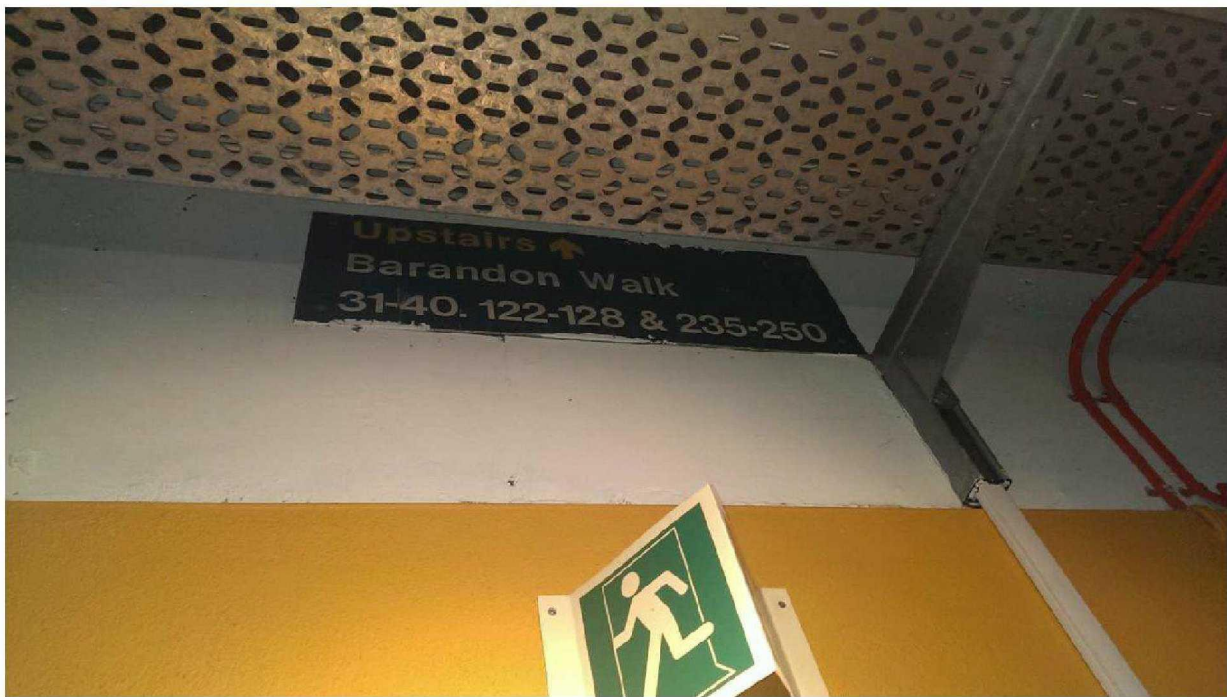
Fire officer Dan Hussey commented about the signage from the lower ground floor levels indicating the flats located above and accessed from particular staircases, please see the photographs below. I believe that the current signage is sufficient from Testerton and Hurstway roads, there is some paint on the signs but this paint does not obscure the information. There is also emergency escape exit signage displayed, some exit signs are flat to the wall others stick out, the signage which sticks out is more prominent. But only authorised persons have access to these lower ground floor areas, no members of the public so where flat signage is displayed I believe that this is sufficient. There has recently been redecoration work undertaken in Barandon Walk and because of this some new signage should be provided to show flat locations above. If the LFB require additional information this can be asked for under the 7.2 D process and then they can draw up plans showing any operational information that they require.

staircases has been obscured or removed. New signage should be provided in Barandon Walk where needed indicating the flats located above and accessed from particular staircases, this signage should not be obstructed in anyway.

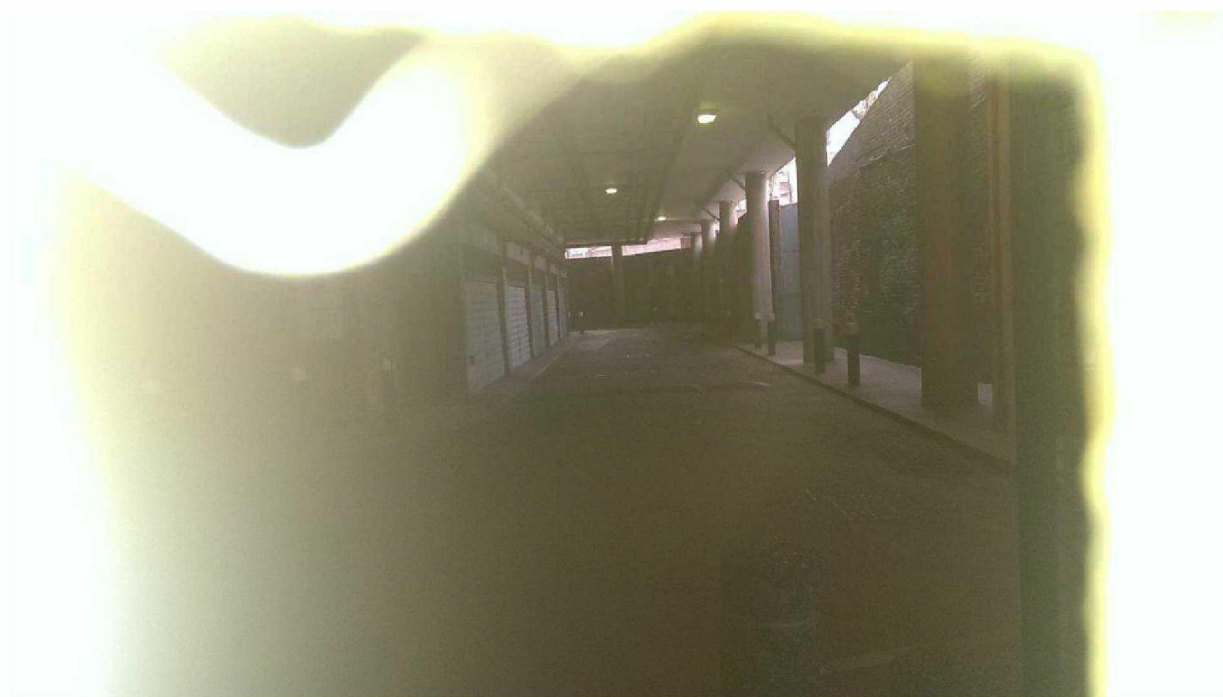
The fire officers commented on the cross ventilation of the garage areas of Testerton and Hurstway roads at the lower ground floor levels, at the ends of each of these roads there are large open areas at high level. Please see the photographs, this was how these areas were constructed. I know that some additional boarding has been fixed

The garages on the lower ground floor areas of Testerton and Hurstway walks, (sorry about the quality of this photograph)
