C S Stokes and Associates Limited

19th October 2016

Subject: Grenfell Tower, Grenfell Road, London W11 1TQ

Thank you for asking me to inspect this building before an audit of the premises is undertaken by the London Fire Brigade under The Regulatory Reform (Fire Safety) Order 2005 (FSO) next week. I visited the building yesterday and as a result of my visit I would recommend that the following items are addressed or information obtained to assist the London Fire Brigade Inspecting Officer.

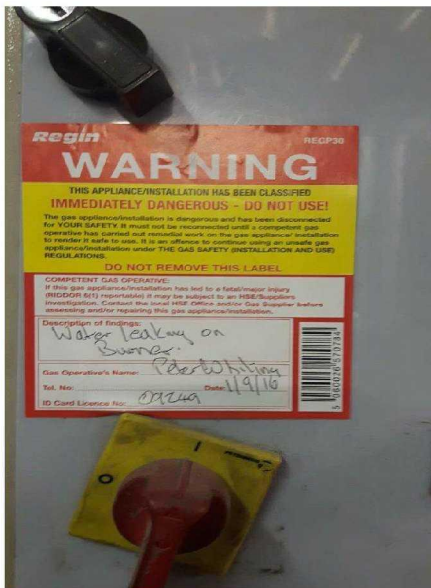
Item 4. High

The contractor's are presently working on the boilers in the basement area, there are no flue gas print outs should be attached to the gas boilers.
Gas safety certificates have been forwarded to the TMO for the installation work undertaken.

Warning label on 1 of the boilers yesterday

I would recommend that once all work connected with the gas boilers is completed that a final full gas safety check is undertaken and any defects found are rectified.
Flue gas print outs should be attached to each gas boiler.

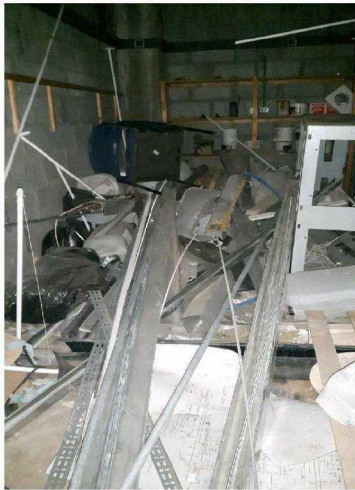
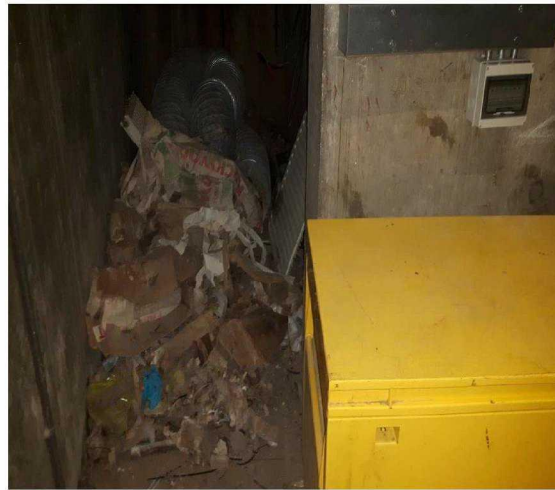
Item 9b, High

There is a lot of contractors waste in the basement boiler room.

There is still a lot of contractors waste in the basement, photos taken yesterday.

All contractors waste and rubbish in the basement boiler room and rooms off of it should be removed before this area is handed back to the TMO.

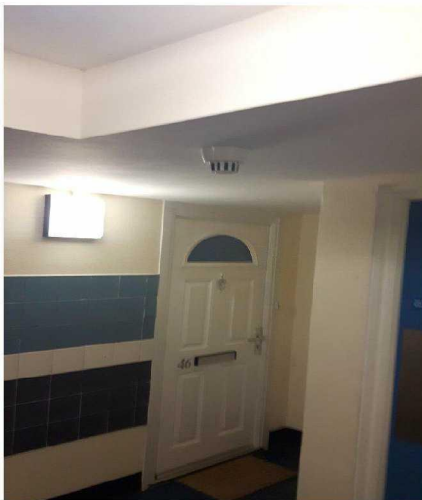
Item 17h, High

There are 2 smoke detectors fitted on the 7th floor level ceiling, the 2nd detector is a different style of smoke detector to the newly installed one. This device is on the ceiling near to the flat entrance door of flat 46. The contractor does not know anything about this 2nd device.

No answers provided still outstanding, 2nd detector still in place.

What is the reason for the 2nd smoke detector fitted on the 7th floor level ceiling near to flat 46's entrance door?

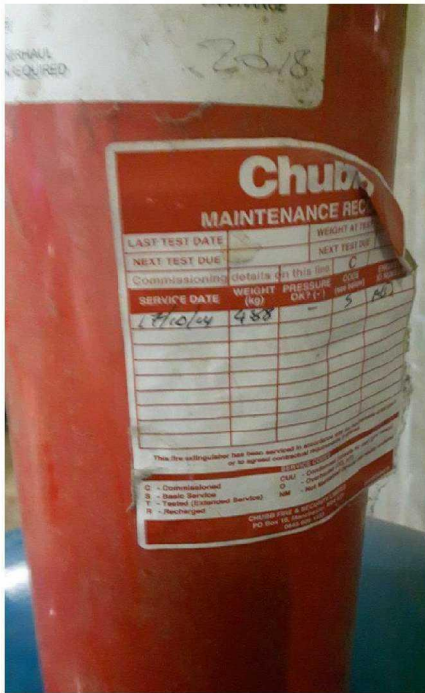
Item 23f, High

According to the contractors labels on the fire extinguishers in this building they are all out of test date. The last date on the contractors test/servicing labels is October 2014.

Extinguishers still all out of service/test date.

All of the fire extinguishers in this building should be tested/serviced immediately and any defective ones replaced.
