**RECORD OF SIGNIFICANT FINDINGS and ACTION PLAN.**

**ADDRESS:** Grenfell Tower, Grenfell Road London W11 1TQ

**COMPLETED BY:** Mr C Stokes

**DATED:** 17<sup>th</sup> October 2014

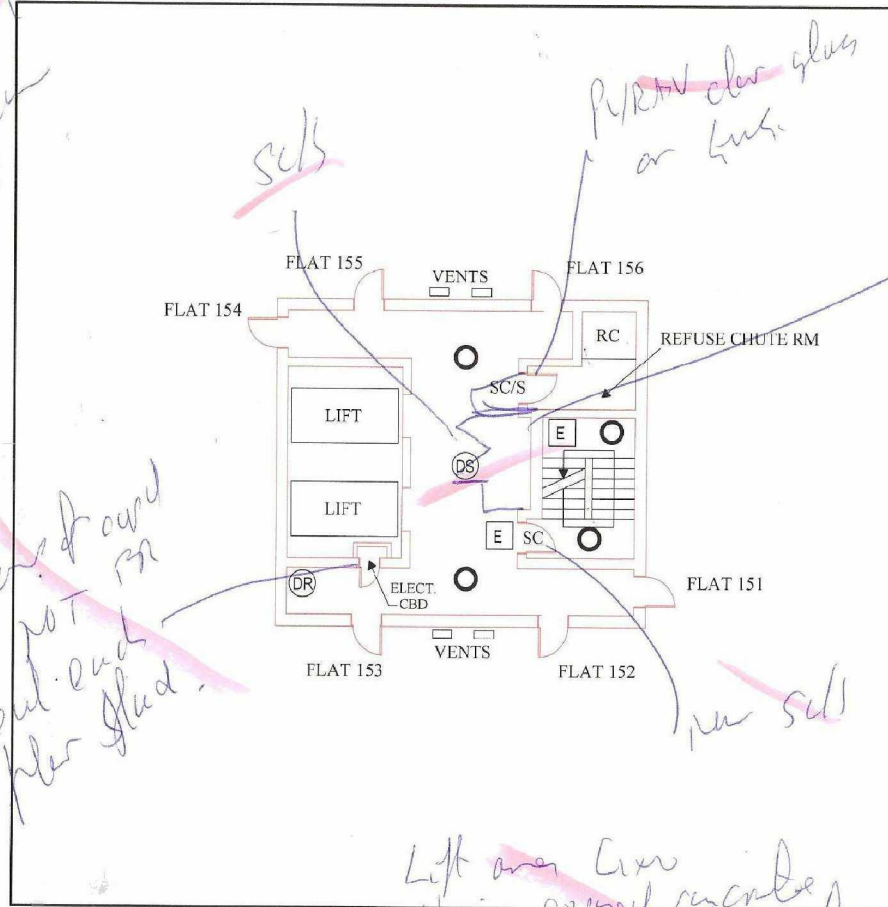
# 15th Floor

~~Part of wall  
 not  
 seal each  
 floor slab.~~

~~see fire spread flow  
 wall  
 5.1.1.1.1  
 floor no wall  
 need to check with  
 new floor  
 provide lift floor no +  
 flat no~~

~~Lift over fire  
 stair open  
 wall not sealed  
 New fire ceiling install  
 pipe work~~

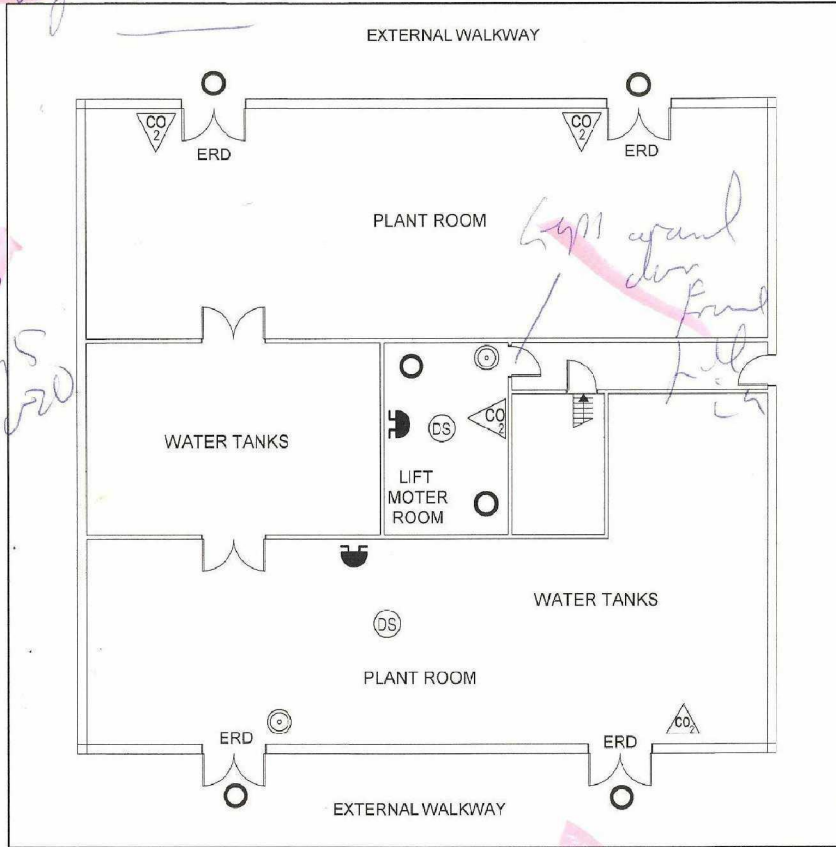
### Roof Level

Water tanks  
relief tanks  
at this level

Hold  
meat  
fill in
