C S Stokes and Associates Limited

10th April 2015

Subject: Grenfell Tower Grenfell Road London W11 1TQ

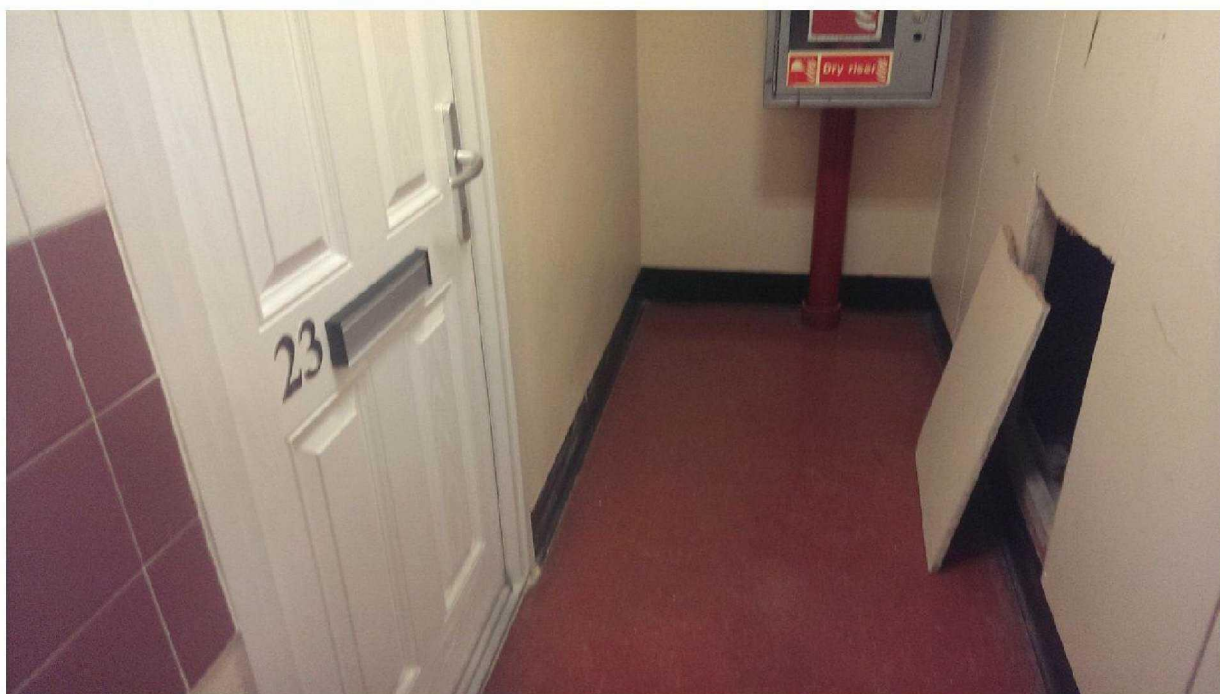
Thank you for asking me to visit the above premises yesterday, Thursday the 9th April 2015, to look at the **damaged boarding which covers in the electrical riser on each lift/flat lobby area, this damaged boarding is on the 2nd floor level opposite flat 23.** Any comments I may have, are numbered after each paragraph.

There are 4 panels of boarding on each side of the 2 lifts on each floor level of this building a total of 8 panels per floor level, these are chipboard with 1 panel on each side fixed by screws and not nailed as an access panel. As explained above these panels are not required by the Building Regulations to be fire rated as each riser is sealed/fire stopped at the floor level. This boarding is to stop unauthorised persons interfering with any cables and/or pipes contained within the risers, these cables could be on show if necessary.

The Building Regulations only requires that risers/shafts that penetrate floors etc with holes and gaps in the floors, ie no fire stopping have 30 minute fire rated covers, boarding etc separating the riser/shaft to the protected area, in this case the lift/flat lobby area. So the presently installed panels are suitable and fulfill the requirements of the Building Regulations and therefore the Fire Safety Order

1. I would recommend that this damaged boarding is replaced as soon as possible with a similar piece of boarding. This boarding does not require to be fire rated as the floor slabs are fire stopped/sealed at each floor level.
2. I would also recommend that the electrical wiring within this riser is checked to make certain that no unauthorised electrical work has been undertaken, otherwise why would this cover have been removed. If it is found that unauthorised electrical work has been undertaken then this work should be disconnected and made good.

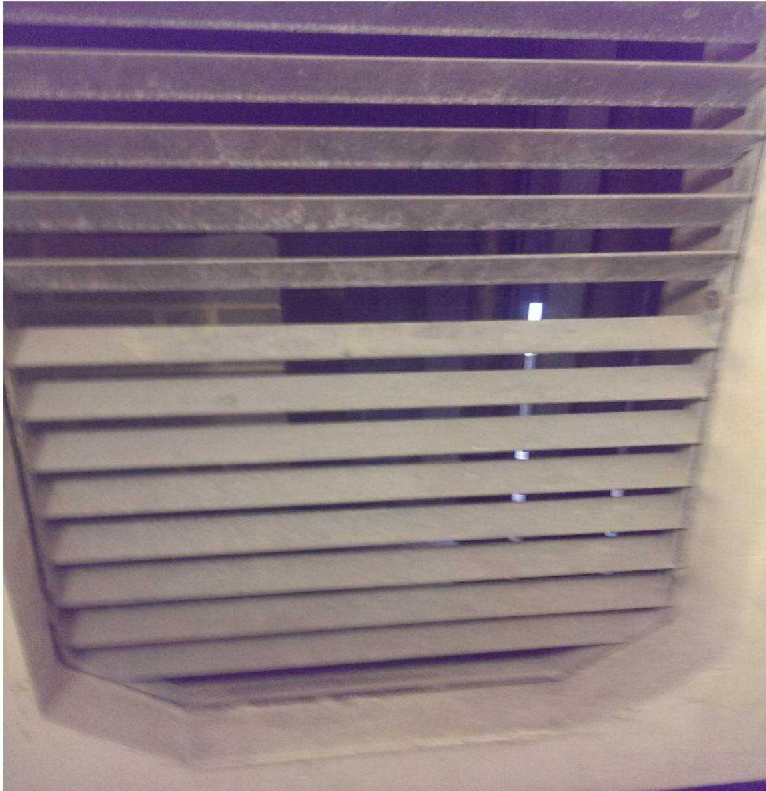
The presently installed in flow air vent at the base of the tower's staircase, which was to open air but is now an internal feature will not be needed for this new ventilation system, the consultant advises that this hole in the staircase wall could be bricked up.

Louvered vent at the base of the staircase

3. I would recommend that the contractors are asked to confirm in writing what the ventilation consultant stated on site, that the in flow louvered air vent at the base of the tower's staircase ca be bricked up. The fire rating of the brick work where

the hole is in filled should be to the same fire resistance as the remainder of the staircase wall.

4. Can Rydon's please confirm the fire rating of the wall area where the in flow louvered air vent is located and that the in filled brick work will be to this standard?

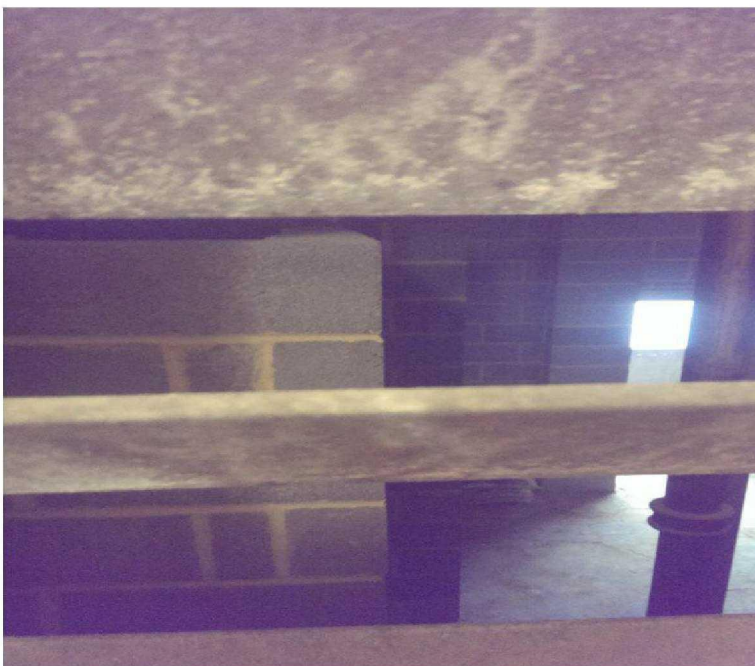
New internal construction seen on the other side of the louvered staircase vent

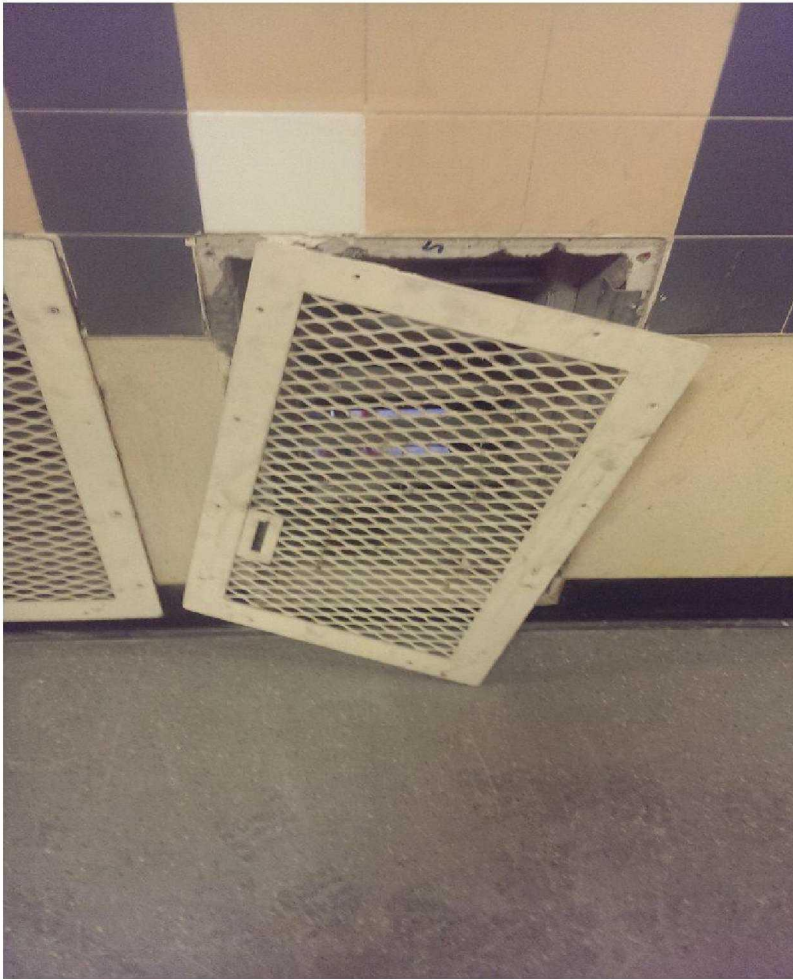
On the 1st floor level flat/lift lobby area the vents now opens out onto the construction area.

The construction site can be seen through this ventilation grille

5. These grilles/vents should be sealed off with 1 hour fire rated boarding on the construction site side of the wall. This is to stop smoke, fire etc in the event of a fire on the construction site entering the building at this floor level and the upper floor levels by way of the ventilation shaft. I would recommend that Rydons confirm to the TMO when this fire stopping has been undertaken.

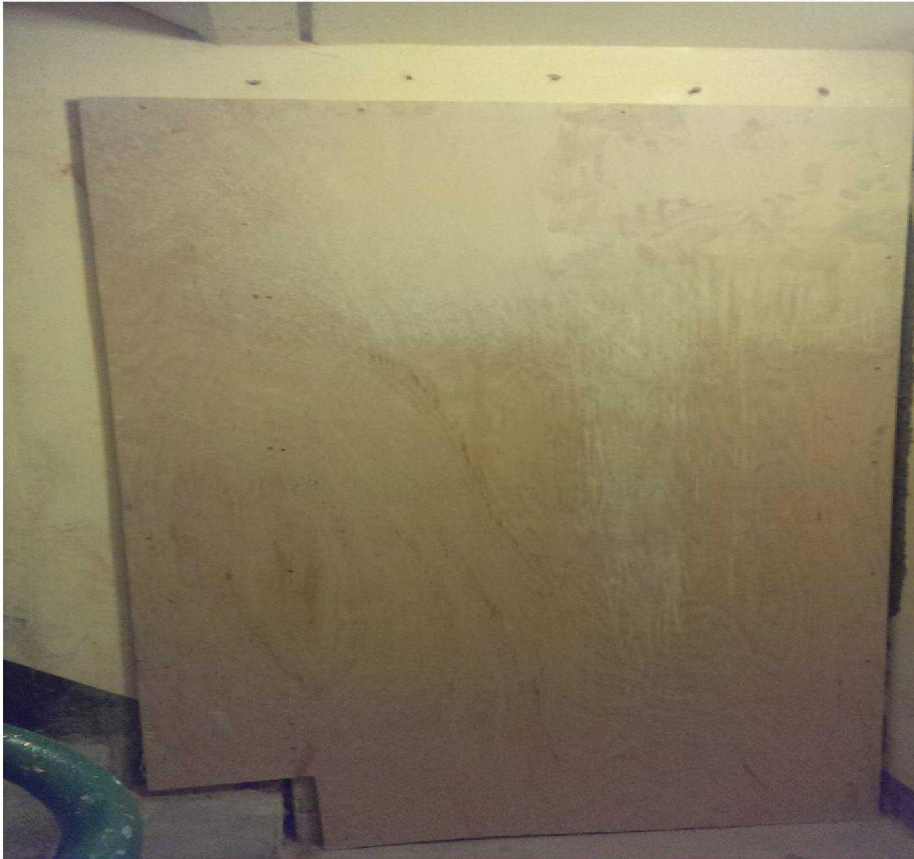
A new door opening has been created into the staircase and there are 2 holes in the staircase wall, these are just above the walkway level. It is irrelevant that there is a “stay put” policy for the residents of this building if there is a fire in the building, the staircase must be maintained fully functional and a means of escape route at all times. The residents must have the ability to leave the building at any time if there is a fire situation by a safe exit route.

Non fire rated hoarding and a gap on the right hand side

6. The door opening and the two holes in the wall of the staircase should be boarded over completely on the construction site side of the openings with 1 hour fire rated boarding. This is to stop smoke, fire etc in the event of a fire on the

construction site entering the staircase of the building which is the buildings means of escape route. I would recommend that Rydon's confirm to the TMO when this fire stopping has been undertaken.

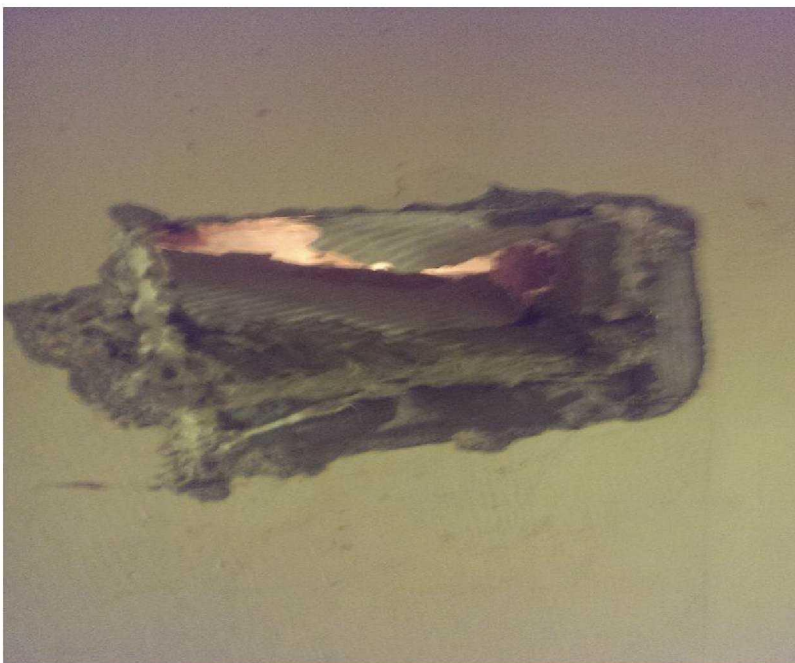
Hole in the staircase wall

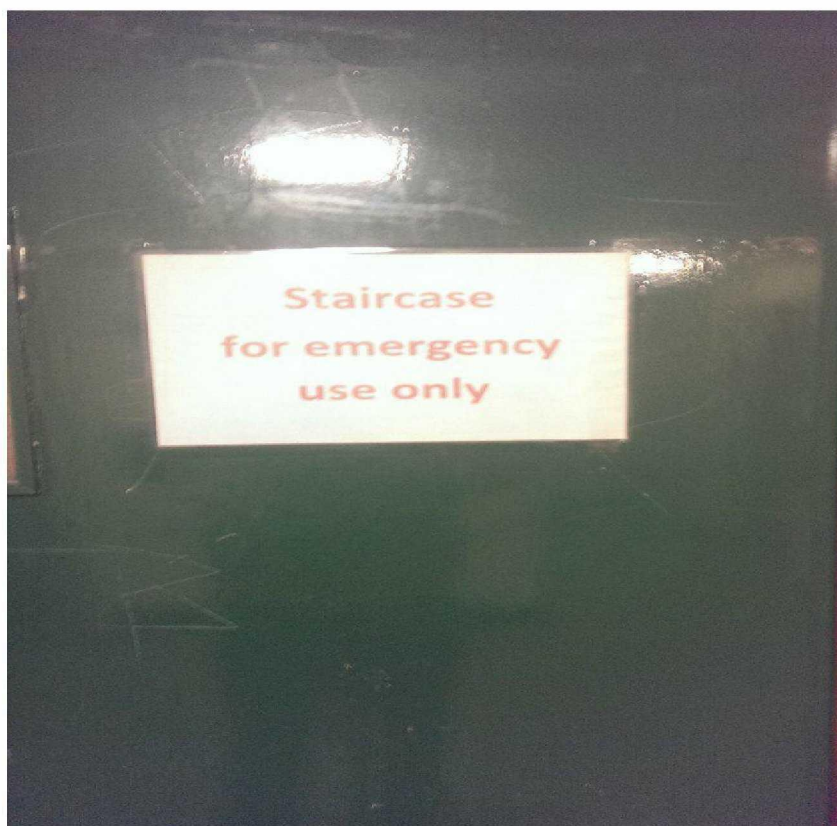
Signs have been placed on the staircase doors, stating that the "Staircase is for emergency use only". The staircase in this building is the normal route for the residents of this building as well as the means of escape route for the building's residents in an emergency situation. The staircase must be available to be used at all times and the residents must have the ability to leave the building at any time if there is a fire situation by a safe exit route. It is irrelevant that there is a "stay put" policy for the residents of this building if there is a fire in the building.

Sign on the staircase doors

10. I would recommend that the signs should be removed from the staircase doors immediately, this is the buildings staircase and is not just an emergency route.

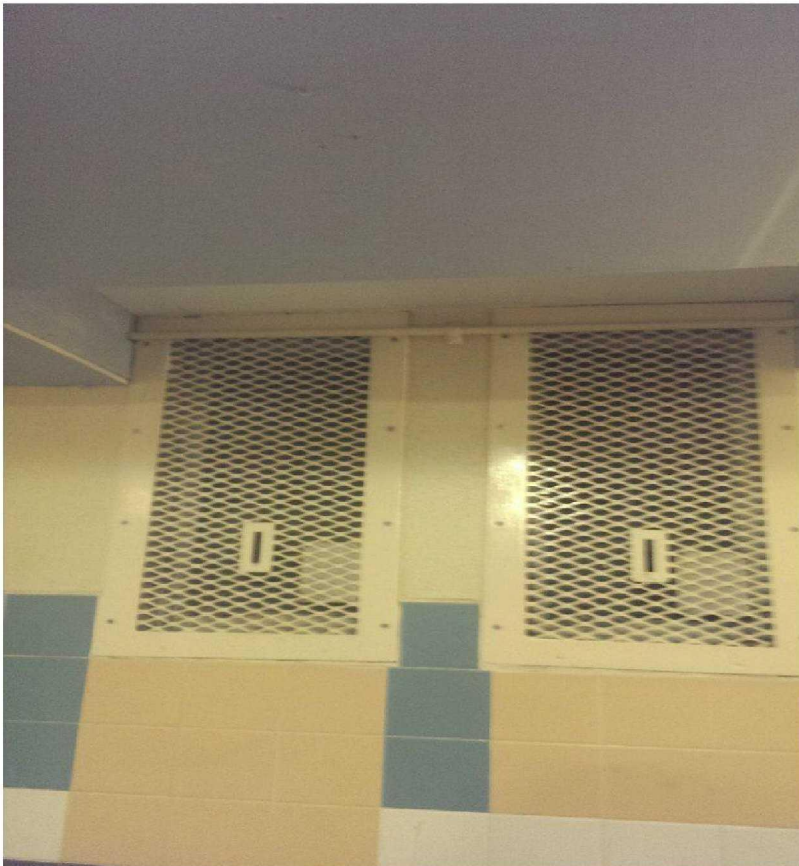
The construction of the ceilings and the cupboards is of plasterboard on a timber frame with the doors of the cupboards being 30 minute fire rated doors fitted with cold smoke seals and intumescent strips. The doors will have locks on them.

New ceiling around vents

11. Can I ask what was in the TMOs specification about the fire rating of the ceilings and how they would abut the riser panels, as the contractor says that he is constructing the ceilings to the agreed specification.
12. The riser panels are not being replaced but there are being removed to be altered where the new ceiling joins up to them. I would commend that the contractor is asked just to check the fire stopping of each riser at the floor level when the panels are removed. If any fire stopping work is needed to the floors then I would recommend that this is undertaken at this time. This fire stopping should be of 1 hour fire rating.

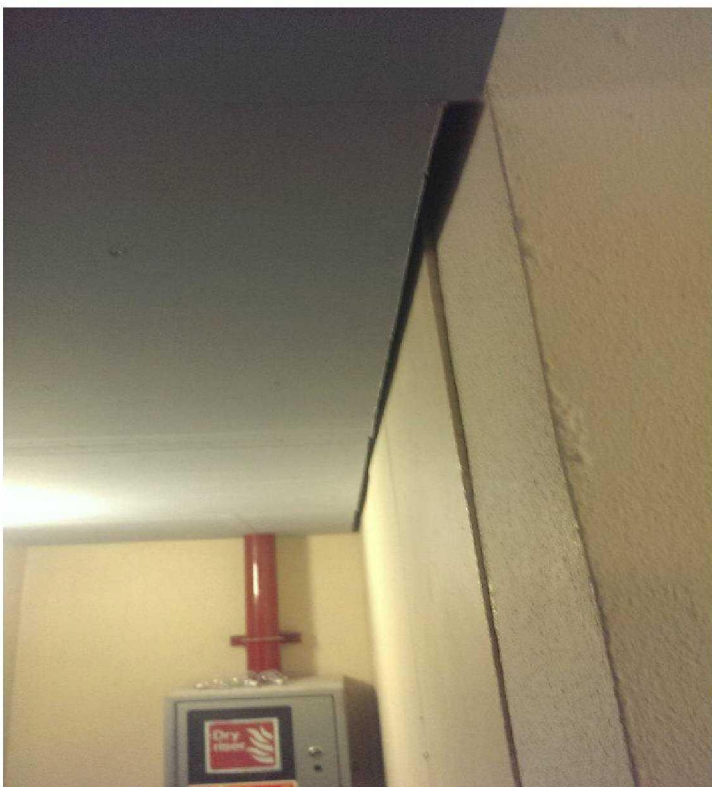
I was told that where the ceiling abut up to the walls the access panels of the risers are being cut at the new ceiling height so access to the electrical cable risers is maintained.

Wall access panels to be cut at the new ceiling height so access to the electrical cable risers can be maintained

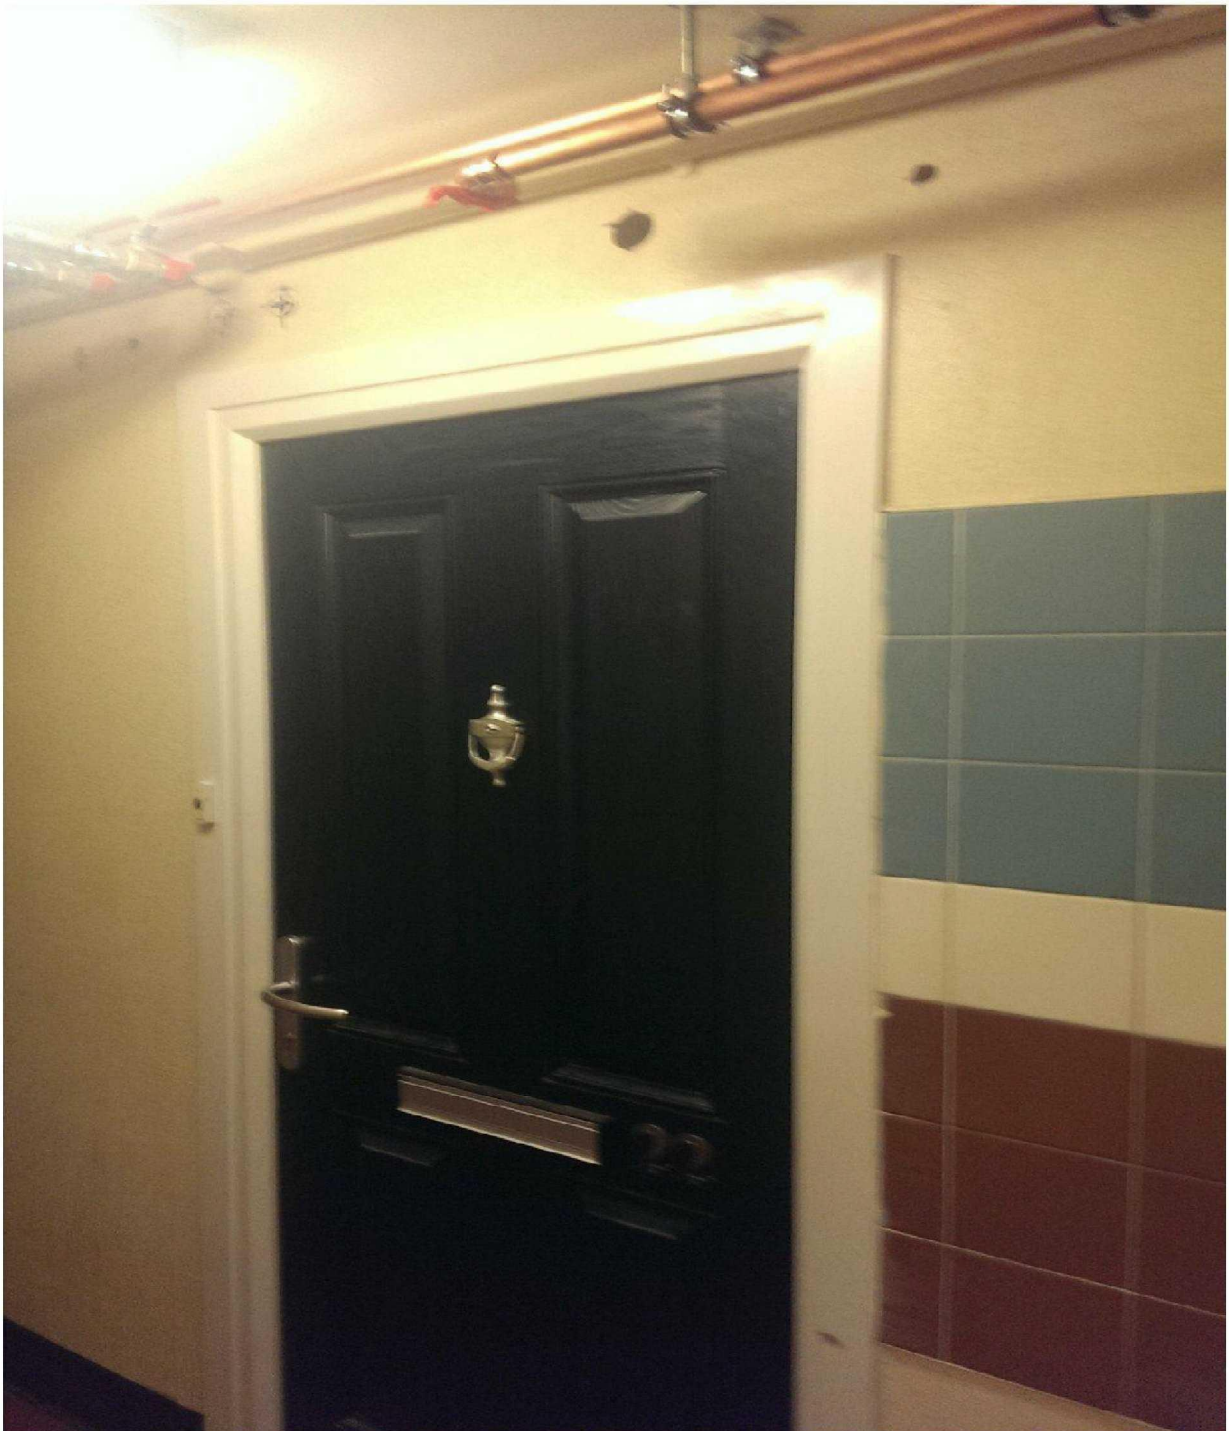
On this floor level the new pipe work can be seen, there is fire stopping into the flats where the pipe holes have been drilled through the flat/lift lobby to dwelling walls.

14th Floor level showing pipe work and holes

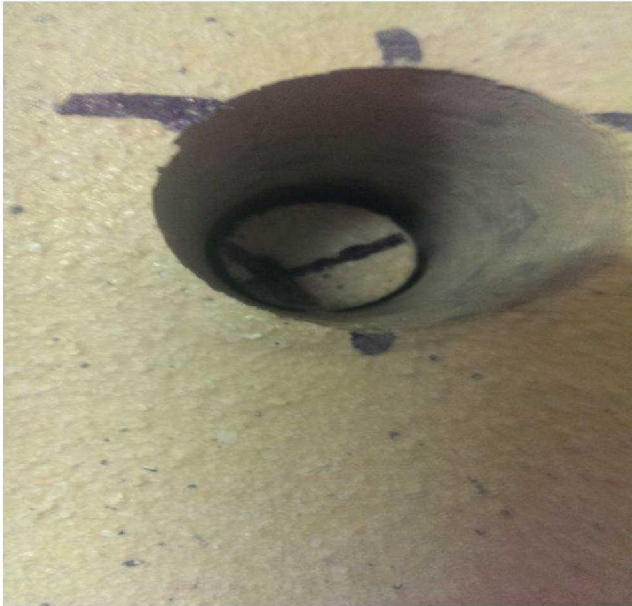
Pipe holes sealed into the flats
