## C S Stokes and Associates Limited

17<sup>th</sup> September 2014

**Subject: Grenfell Tower Grenfell Road London W11 1TQ**

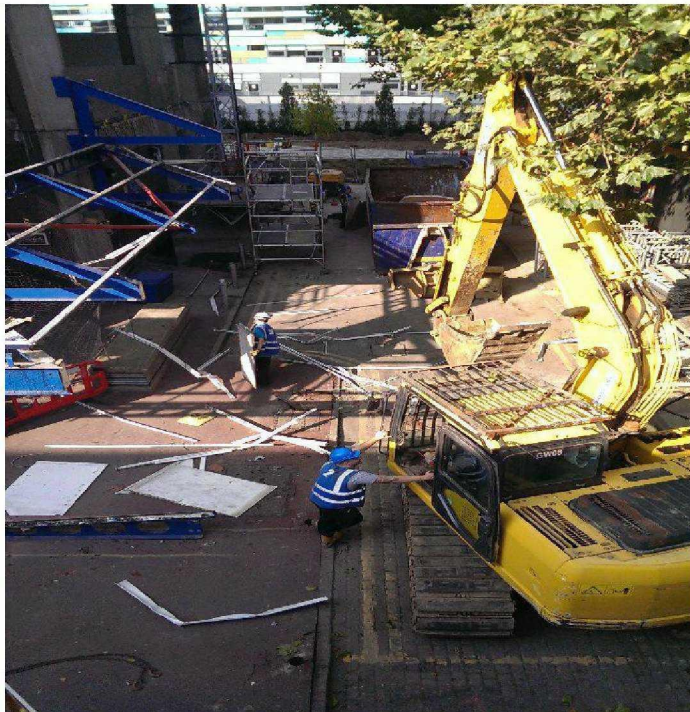
The area directly outside the building and to the left hand side of it is being used by the contractor as part of the building site and these areas are now not available to be used by other persons as they are within the fenced off site area. The left hand side area of this building has always been an area designated for "emergency use only" and a barrier was erected to restrict access to this area. While the Academy was being constructed the local Fire Safety Officers of the LFB were insistent on this area being maintained completely clear. The Rydon's project manager told me yesterday that the TMO surveyor Mrs Claire Williams said that they can use this area as part of their site and that the operational LFB crews have not commented that the area should remain clear during their site visits. To comply with the requirements of the Building Regulations, Approved Document B Part 5 there should be a clear area for fire service use directly outside of this building so that there is parking for the fire appliances and a working area to comply with the requirements to use the dry rising main installed within the building.

Emergency parking area to the left of the building, as seen yesterday.

4. Can it please be confirmed by the LFB fire safety team that the present parking and access arrangements are suitable to them and that they were consulted before the arrangements were put in place? I would recommend that this conformation is in writing and by a suitable qualified person within the LFB. If there has not been any agreement or the LFB are not happy with the present arrangements then the emergency parking area must be reinstated immediately along with the access barrier to control parking in this area.

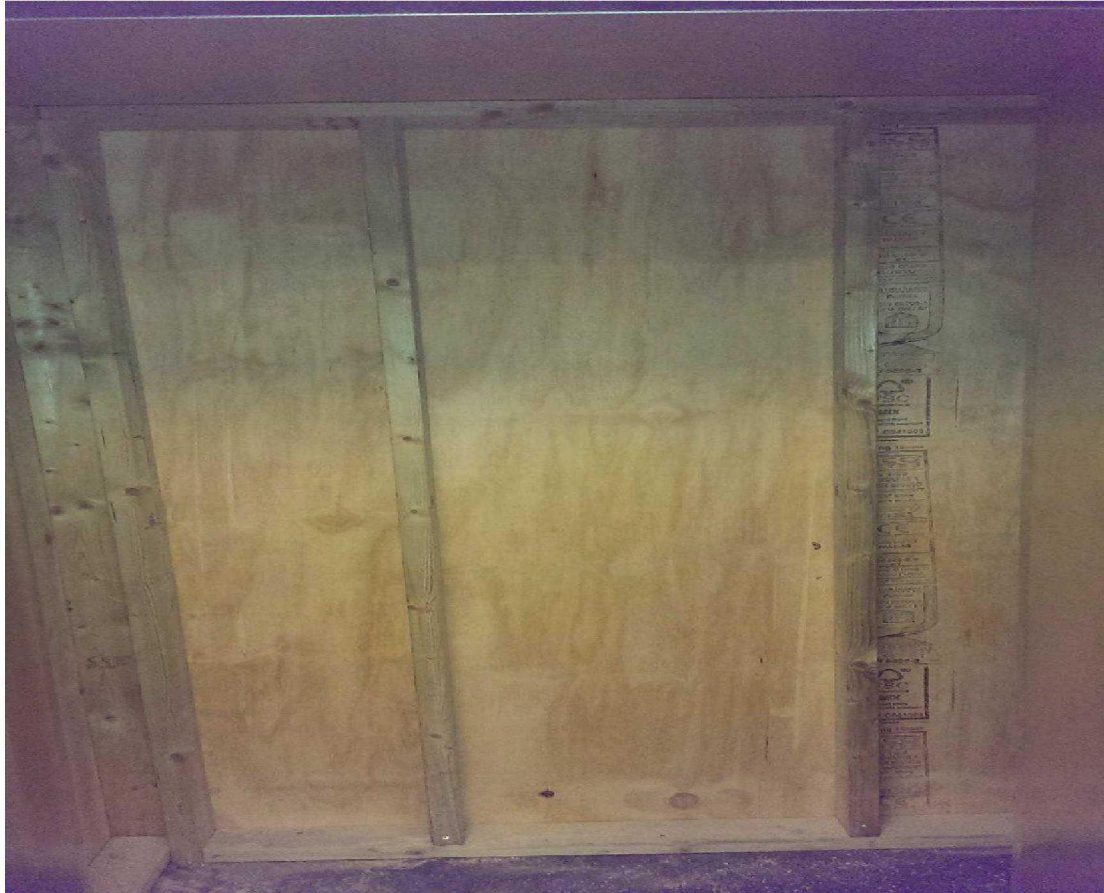
Hoarding at the road level.

Hoarding has been erected in front of the lift doors so a person is trapped in this small gap if they exit the lift, this has been like this since the start of this month, I was told that the hoarding is to be removed this week. When it is removed there will be a scaffold staircase up to the site office, this is the only way out of this area and the only way out of the site office while the demolition of the upper part of the external staircase is undertaken. This part of the old lift lobby area will then be partition off from the remainder of the ground floor area.

5. Can it please be confirmed that the TMO are happy with this access and egress arrangement for residents of this building? , there will only be single travel at certain times and the Building Regulations only allows 18 metres for a single

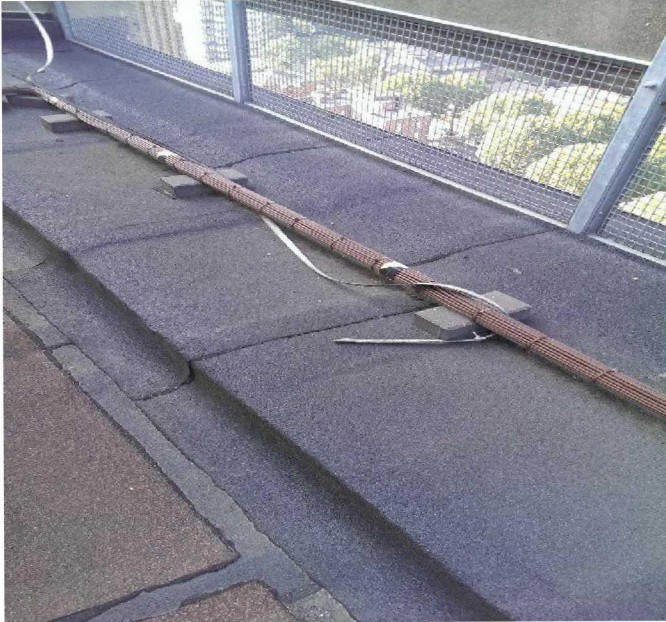
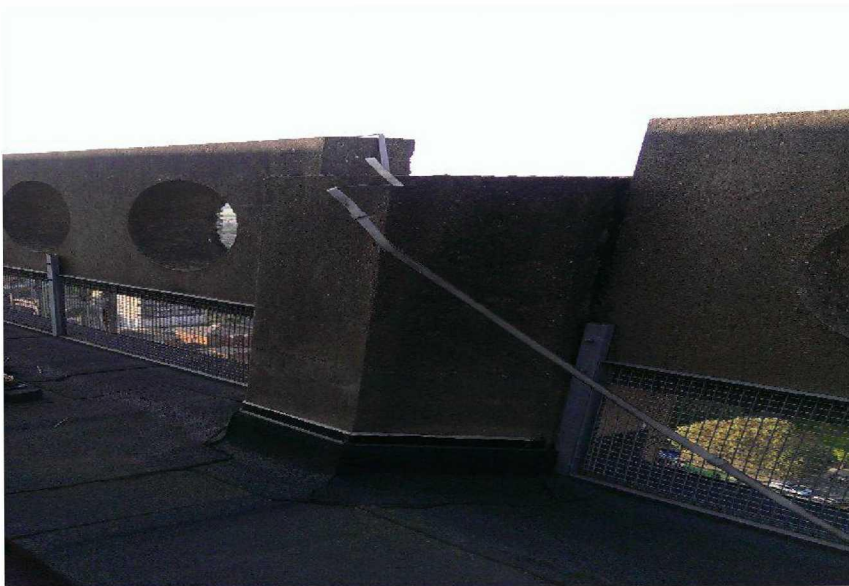
#### Damaged lightning protection system

Work has been undertaken by "SCCI Alphatrack" to relocate satellite disks positioned on the face of the building to the roof level, the lightning protection system on this building has been wilfully damaged and this company have left cardboard boxes at the roof level obstructing the means of escape. The door to the external roof is damaged and does not close, there is waste and rubbish blocking the drains at the roof level and the cables are obstruction the doors to the plant areas and laid on the floor causing a

trip hazard. Under the FSO it is an offence to wilfully damage fire safety equipment in or on the building whether these are fixed systems or portable ones, a person who commits an offence, this is criminal law, can be imprisoned for up to two years or an unlimited fine.

17. The installed lightning protection system on this building should be repaired immediately and a completion and or a commissioning certificated issued by the contractor to state that the system is in full working order.
18. All the rubbish should be removed from the roof level and the drains unblocked etc.
19. The door to the external roof area should be repaired or replaced and locks etc fitted so that it can be secured shut.

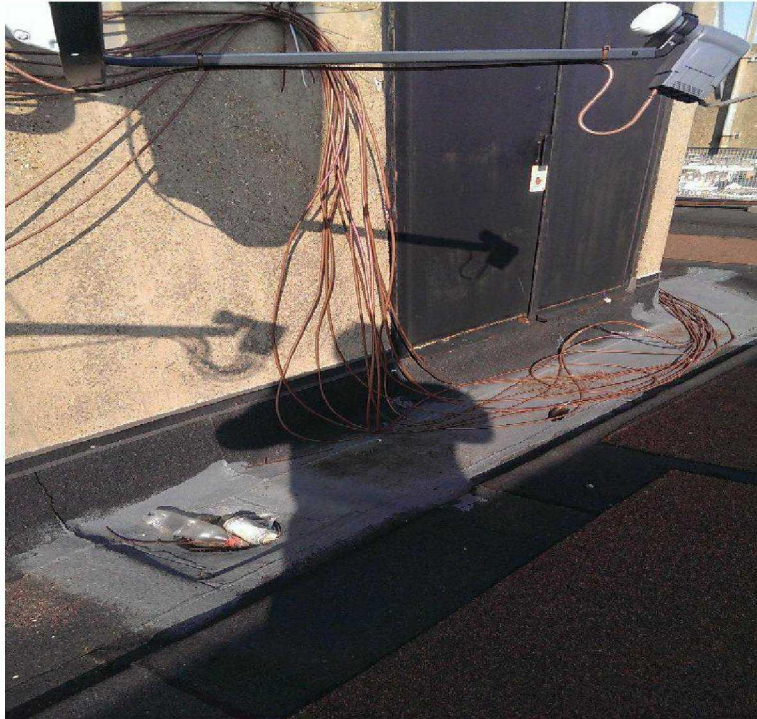
Cables on the floor and drains blocked

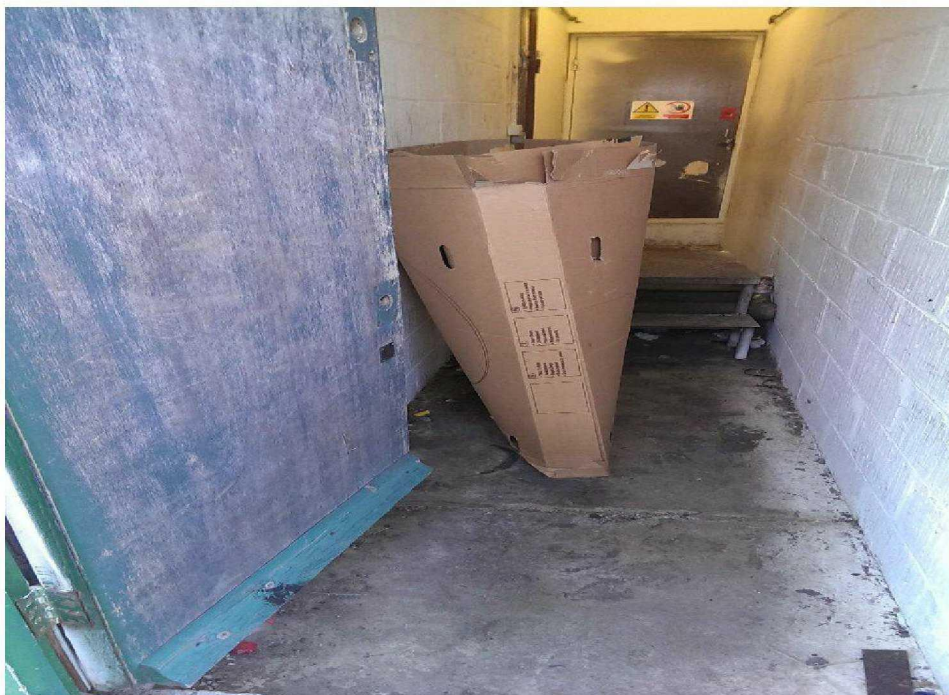
Old satellite cardboard boxes

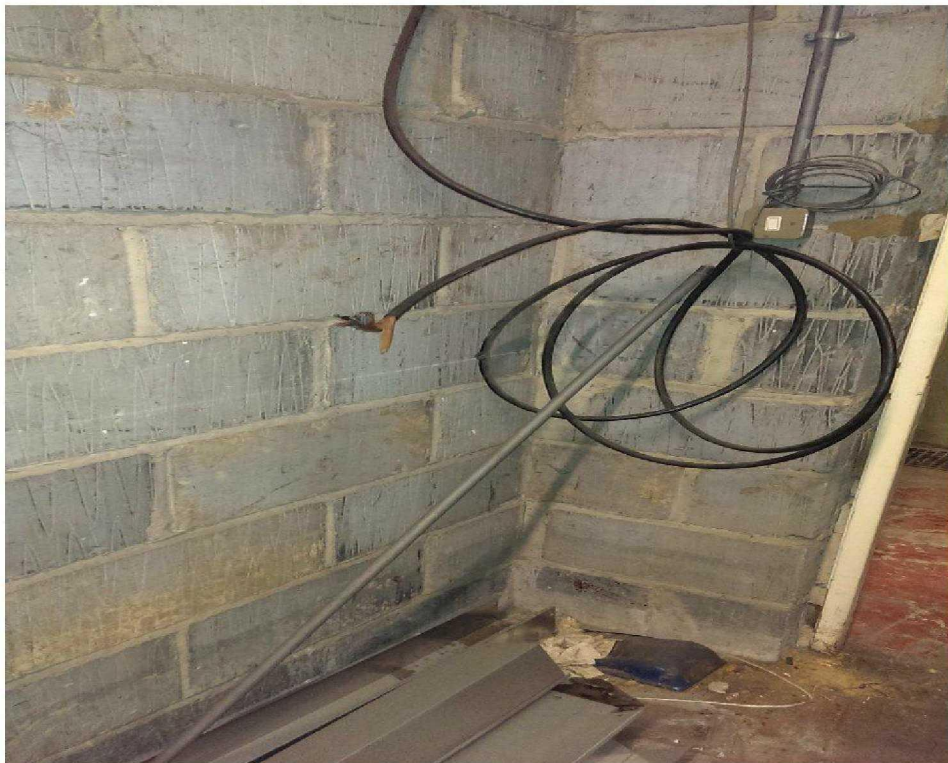
Cables

Work is being undertaken in the basement area of this building, new boilers will be installed etc, the door at the base of the staircase is damaged and there are electrical cables hanging down from the ceiling etc.

22. Can it please be confirmed by the contractor that all cut and hanging electrical cables in the basement area are not live?

23. The damaged door and door frame at the base of the staircase down to the basement should be repaired or a new door set installed.
24. The amount of combustible waste in the basement area should be kept as low as possible, with rubbish and waste removed at regular intervals, I would recommend that the contractor is asked to tidy up and remove combustible waste from this basement area.

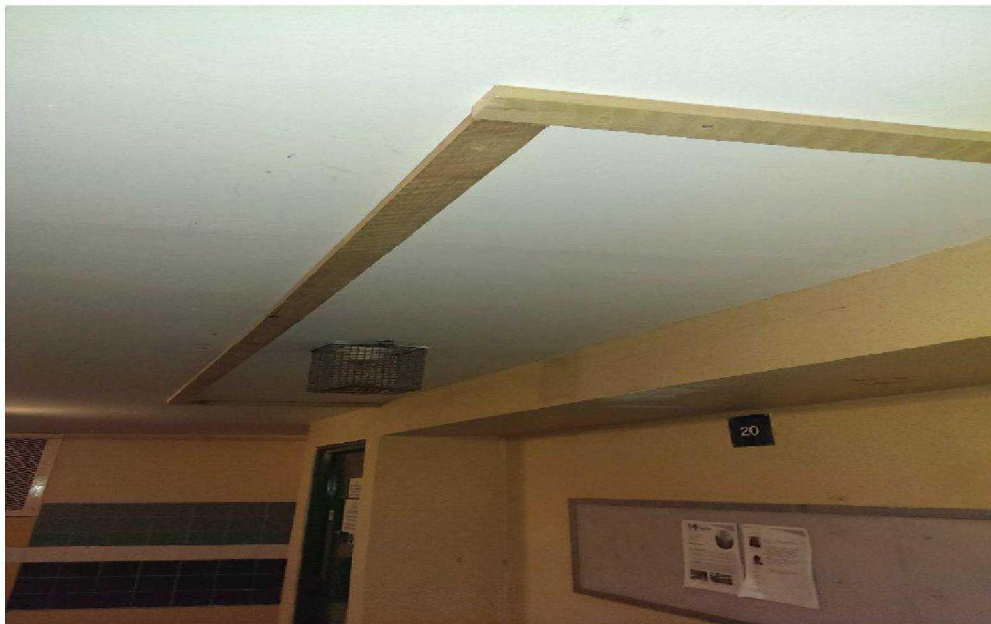
On each of the residential floor lift lobby areas a cupboard will be constructed with the heating pipes etc within them.

Cupboard to be constructed, area marked out with the battens on the ceiling.

25. As can be seen above the smoke detectors on the lift lobby area landings will be inside the new cupboards, in some cases, can the contractor please provide the scope of works for the new fire alarm detection installation?
26. Can the contractor please provide information of the materials to be used to construct the new cupboards?
27. Can the contractor please provide information on how fire stopping will be achieved between each floor level for the pipe work?
