C S Stokes and Associates Limited

17th September 2014

Subject: Grenfell Tower Grenfell Road London W11 1TQ

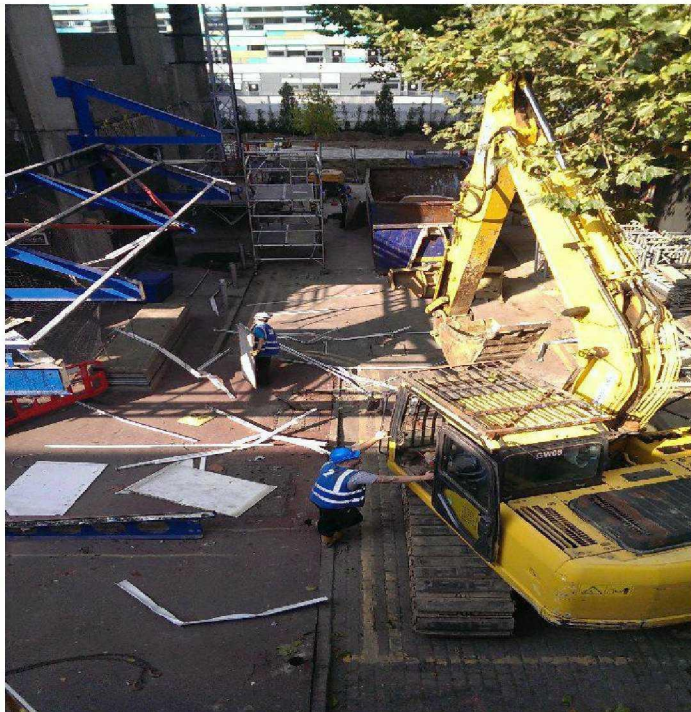
The area directly outside the building and to the left hand side of it is being used by the contractor as part of the building site and these areas are now not available to be used by other persons as they are within the fenced off site area. The left hand side area of this building has always been an area designated for "emergency use only" and a barrier was erected to restrict access to this area. While the Academy was being constructed the local Fire Safety Officers of the LFB were insistent on this area being maintained completely clear. The Rydon's project manager told me yesterday that the TMO surveyor Mrs Claire Williams said that they can use this area as part of their site and that the operational LFB crews have not commented that the area should remain clear during their site visits. To comply with the requirements of the Building Regulations, Approved Document B Part 5 there should be a clear area for fire service use directly outside of this building so that there is parking for the fire appliances and a working area to comply with the requirements to use the dry rising main installed within the building.

Emergency parking area to the left of the building, as seen yesterday.

4. Can it please be confirmed by the LFB fire safety team that the present parking and access arrangements are suitable to them and that they were consulted before the arrangements were put in place? I would recommend that this conformation is in writing and by a suitable qualified person within the LFB. If there has not been any agreement or the LFB are not happy with the present arrangements then the emergency parking area must be reinstated immediately along with the access barrier to control parking in this area.

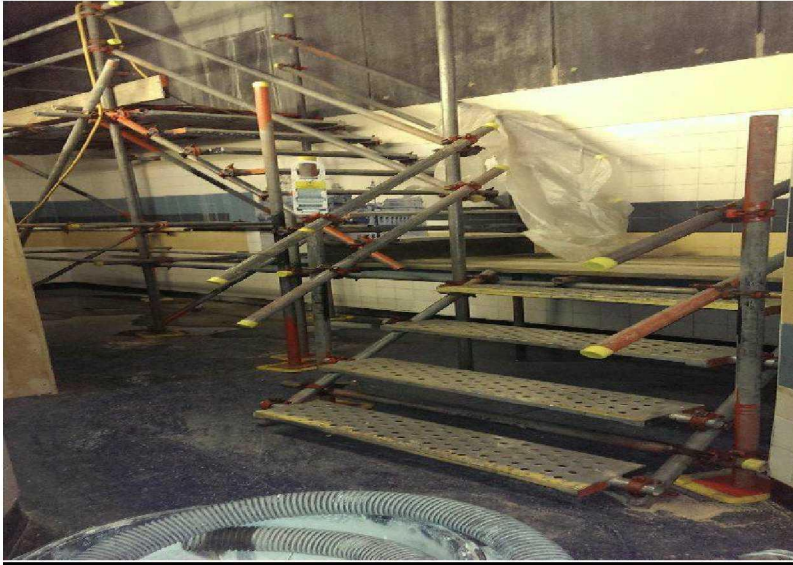
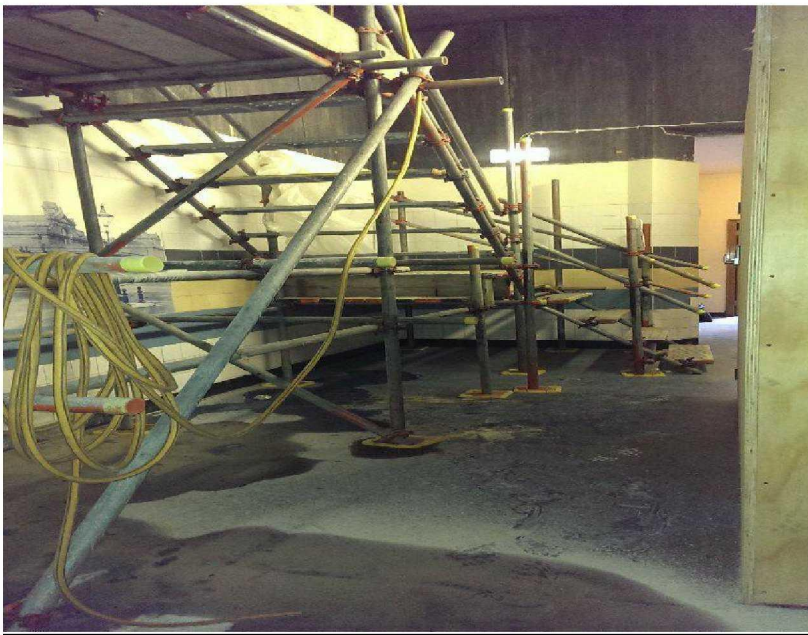
Scaffold staircase

6. Has this access arrangement been considered under the Equality Act and for disable persons to use, including the staircase?

7. Can the contractor please provide information on what ventilation, emergency lighting and automatic fire detection will be installed within this area, as this is in effect a basement additional standards apply?

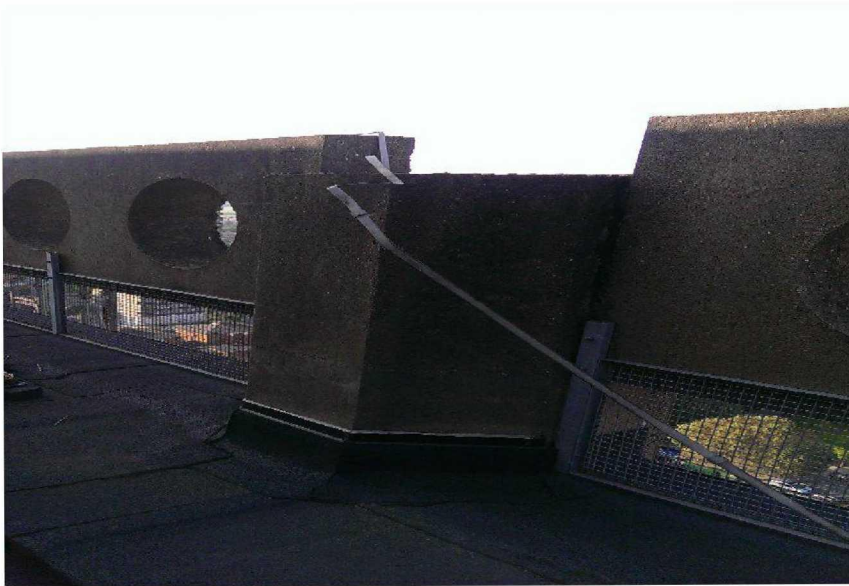
Work has been undertaken by "SCCI Alphatrack" to relocate satellite disks positioned on the face of the building to the roof level, the lightning protection system on this building has been wilfully damaged and this company have left cardboard boxes at the roof level obstructing the means of escape. The door to the external roof is damaged and does not close, there is waste and rubbish blocking the drains at the roof level and the cables are obstruction the doors to the plant areas and laid on the floor causing a

trip hazard. Under the FSO it is an offence to wilfully damage fire safety equipment in or on the building whether these are fixed systems or portable ones, a person who commits an offence, this is criminal law, can be imprisoned for up to two years or an unlimited fine.

Damaged lightning protection system

17. The installed lightning protection system on this building should be repaired immediately and a completion and or a commissioning certificated issued by the contractor to state that the system is in full working order.
18. All the rubbish should be removed from the roof level and the drains unblocked etc.
19. The door to the external roof area should be repaired or replaced and locks etc fitted so that it can be secured shut.

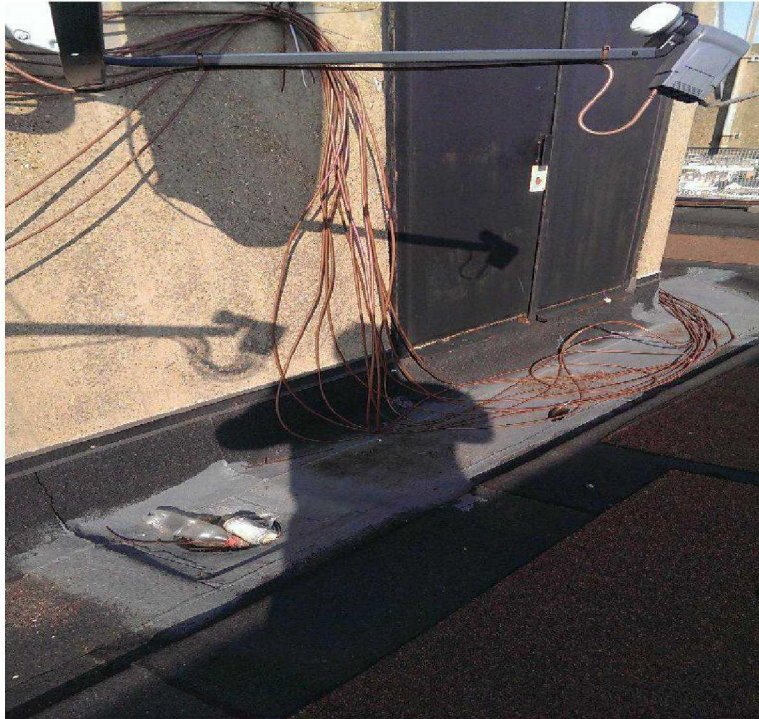
Cables on the floor and drains blocked

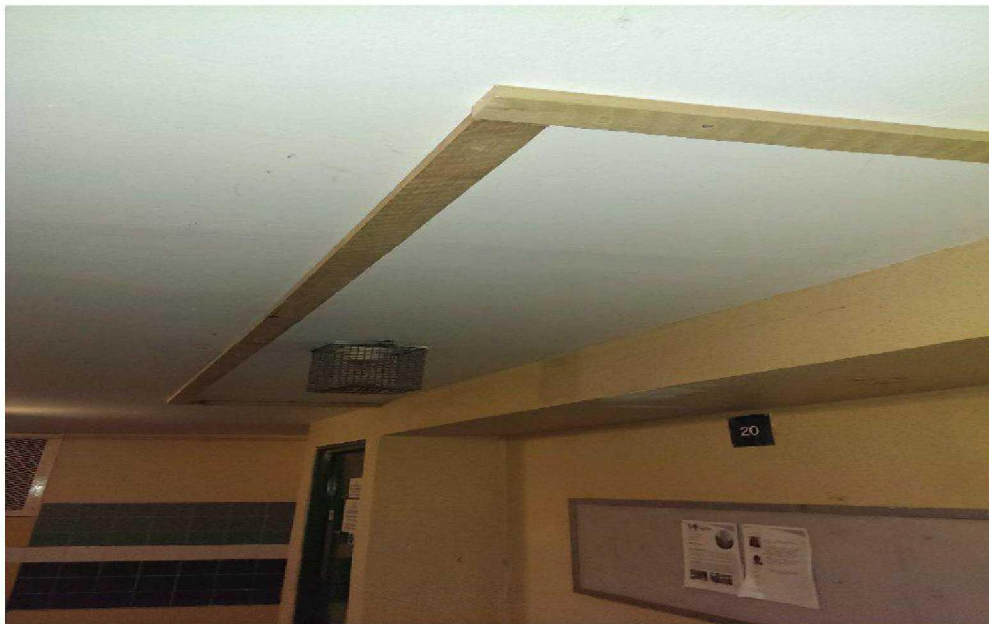
On each of the residential floor lift lobby areas a cupboard will be constructed with the heating pipes etc within them.

Cupboard to be constructed, area marked out with the battens on the ceiling.

25. As can be seen above the smoke detectors on the lift lobby area landings will be inside the new cupboards, in some cases, can the contractor please provide the scope of works for the new fire alarm detection installation?
26. Can the contractor please provide information of the materials to be used to construct the new cupboards?
27. Can the contractor please provide information on how fire stopping will be achieved between each floor level for the pipe work?
