C S Stokes and Associates Limited

17th September 2014

Subject: Grenfell Tower Grenfell Road London W11 1TQ

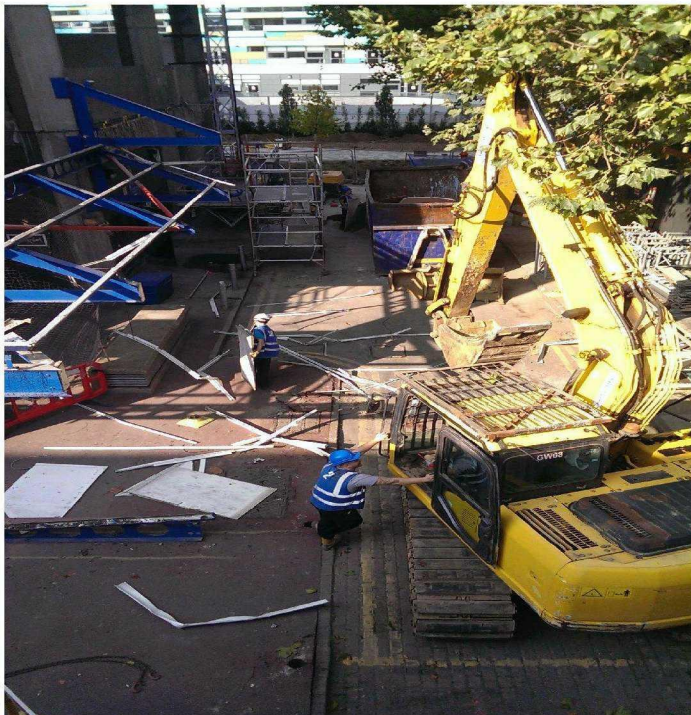
The area directly outside the building and to the left hand side of it is being used by the contractor as part of the building site and these areas are now not available to be used by other persons as they are within the fenced off site area. The left hand side area of this building has always been an area designated for “emergency use only” and a barrier was erected to restrict access to this area. While the Academy was being constructed the local Fire Safety Officers of the LFB were insistent on this area being maintained completely clear. The Rydon’s project manager told me yesterday that the TMO surveyor Mrs Claire Williams said that they can use this area as part of their site and that the operational LFB crews have not commented that the area should remain clear during their site visits. To comply with the requirements of the Building Regulations, Approved Document B Part 5 there should be a clear area for fire service use directly outside of this building so that there is parking for the fire appliances and a working area to comply with the requirements to use the dry rising main installed within the building.

Emergency parking area to the left of the building, as seen yesterday.

4. Can it please be confirmed by the LFB fire safety team that the present parking and access arrangements are suitable to them and that they were consulted before the arrangements were put in place? I would recommend that this conformation is in writing and by a suitable qualified person within the LFB. If there has not been any agreement or the LFB are not happy with the present arrangements then the emergency parking area must be reinstated immediately along with the access barrier to control parking in this area.

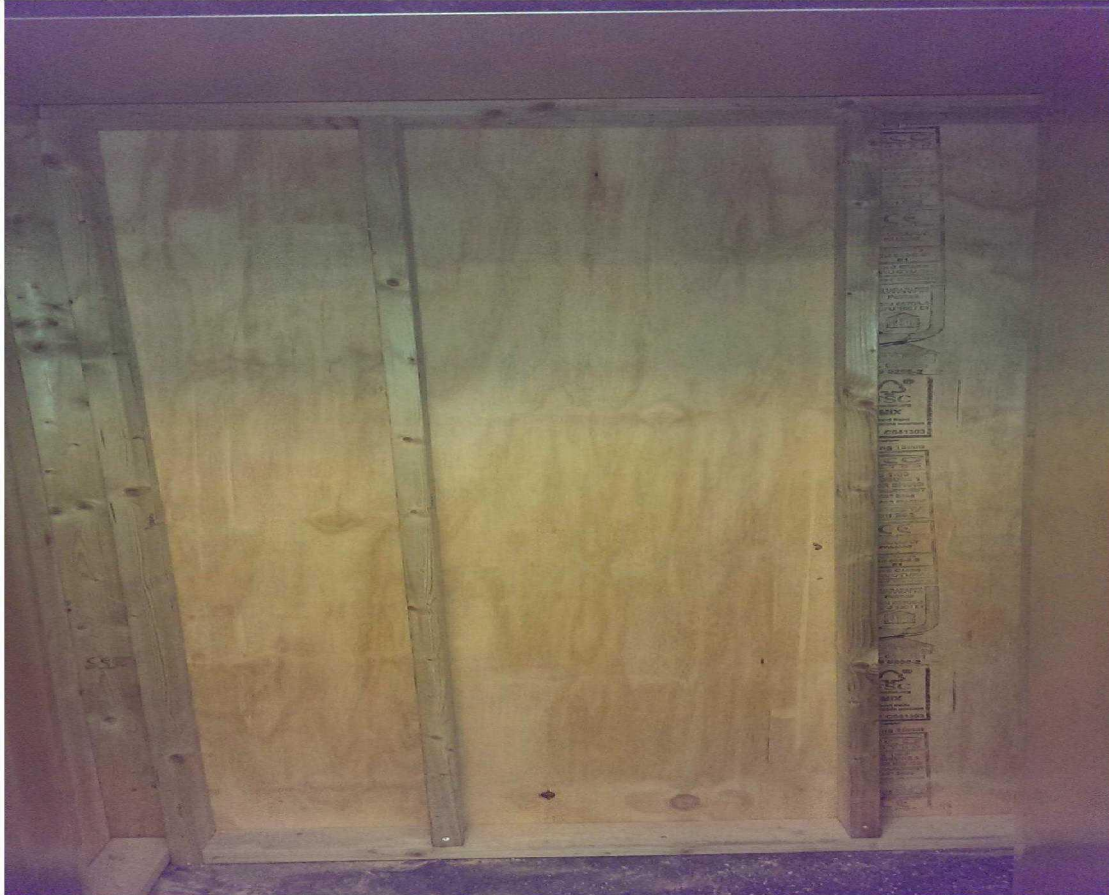
Hoarding at the road level.

Hoarding has been erected in front of the lift doors so a person is trapped in this small gap if they exit the lift, this has been like this since the start of this month, I was told that the hoarding is to be removed this week. When it is removed there will be a scaffold staircase up to the site office, this is the only way out of this area and the only way out of the site office while the demolition of the upper part of the external staircase is undertaken. This part of the old lift lobby area will then be partition off from the remainder of the ground floor area.

5. Can it please be confirmed that the TMO are happy with this access and egress arrangement for residents of this building? , there will only be single travel at certain times and the Building Regulations only allows 18 metres for a single

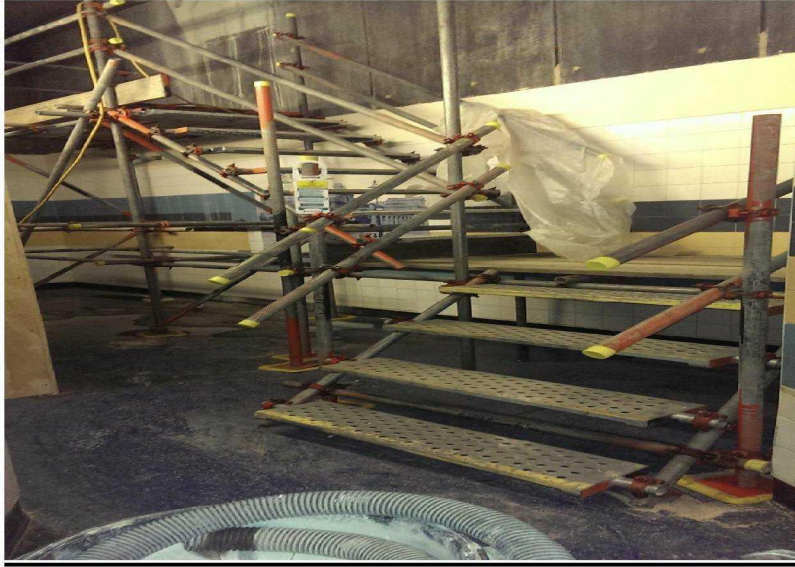
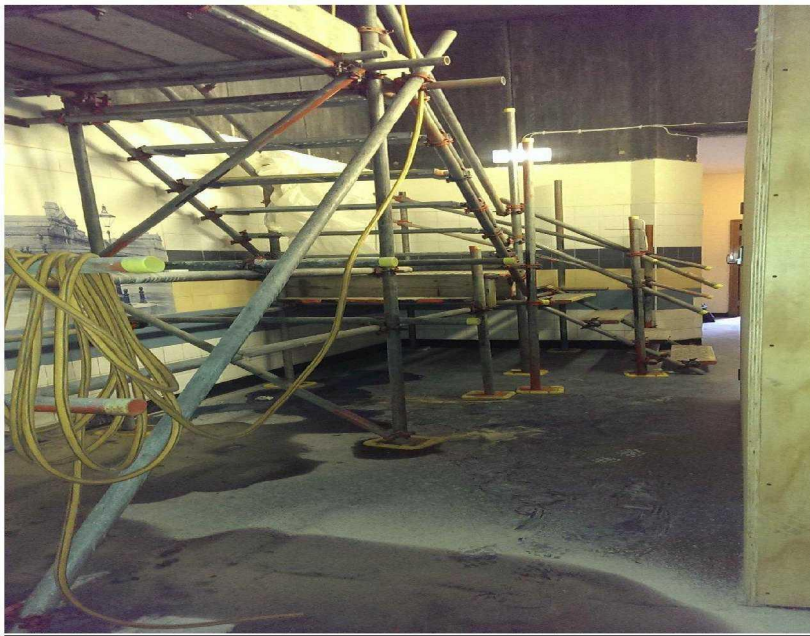
Scaffold staircase

6. Has this access arrangement been considered under the Equality Act and for disable persons to use, including the staircase?

7. Can the contractor please provide information on what ventilation, emergency lighting and automatic fire detection will be installed within this area, as this is in effect a basement additional standards apply?

8. To what standard will the partitioning be, ie 30 fire rated etc which will separate the ground floor lift lobby area from the remainder of the ground floor building site area, has this partitioning been approved by the Building Control Officer and can his comment please be forwarded.
9. I would recommend that the "S" button on the lifts is covered over so that the residents cannot access the street level as a matter of course.
10. The lifts in this building are fire fighter/evacuation lifts, have they been reprogrammed so that the fire service can control them from the walkway level? If so can the service documents and certificates from the lift contractors please be forwarded so that there is evidence if required that the lifts are in full working order as fire fighter/evacuation lifts.

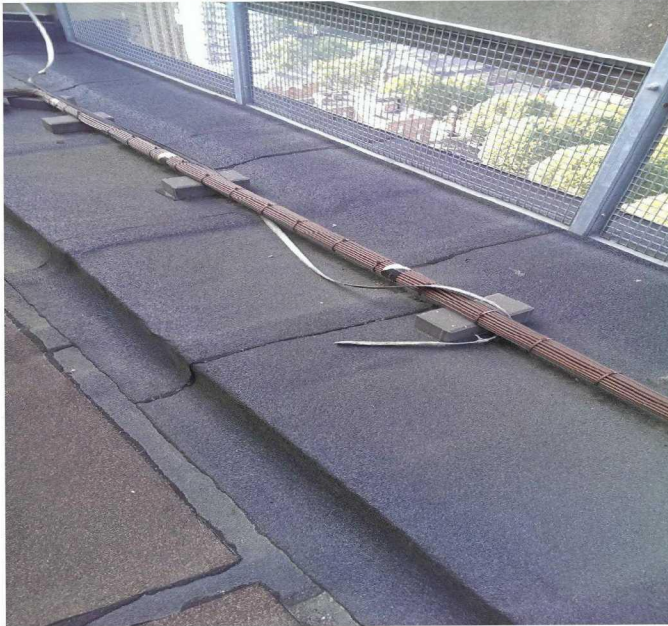
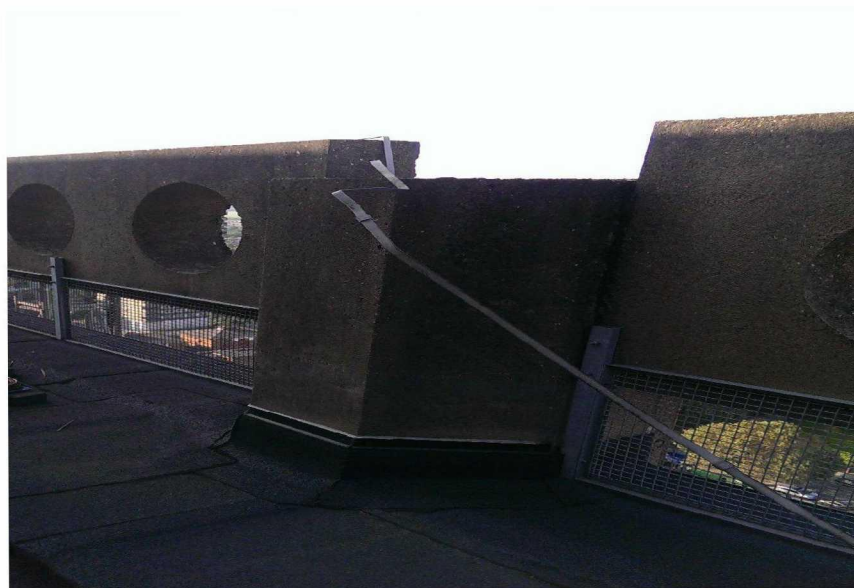
Work has been undertaken by "SCCI Alphatrack" to relocate satellite disks positioned on the face of the building to the roof level, the lightning protection system on this building has been wilfully damaged and this company have left cardboard boxes at the roof level obstructing the means of escape. The door to the external roof is damaged and does not close, there is waste and rubbish blocking the drains at the roof level and the cables are obstruction the doors to the plant areas and laid on the floor causing a

trip hazard. Under the FSO it is an offence to wilfully damage fire safety equipment in or on the building whether these are fixed systems or portable ones, a person who commits an offence, this is criminal law, can be imprisoned for up to two years or an unlimited fine.

Damaged lightning protection system

17. The installed lightning protection system on this building should be repaired immediately and a completion and or a commissioning certificate issued by the contractor to state that the system is in full working order.
18. All the rubbish should be removed from the roof level and the drains unblocked etc.
19. The door to the external roof area should be repaired or replaced and locks etc fitted so that it can be secured shut.

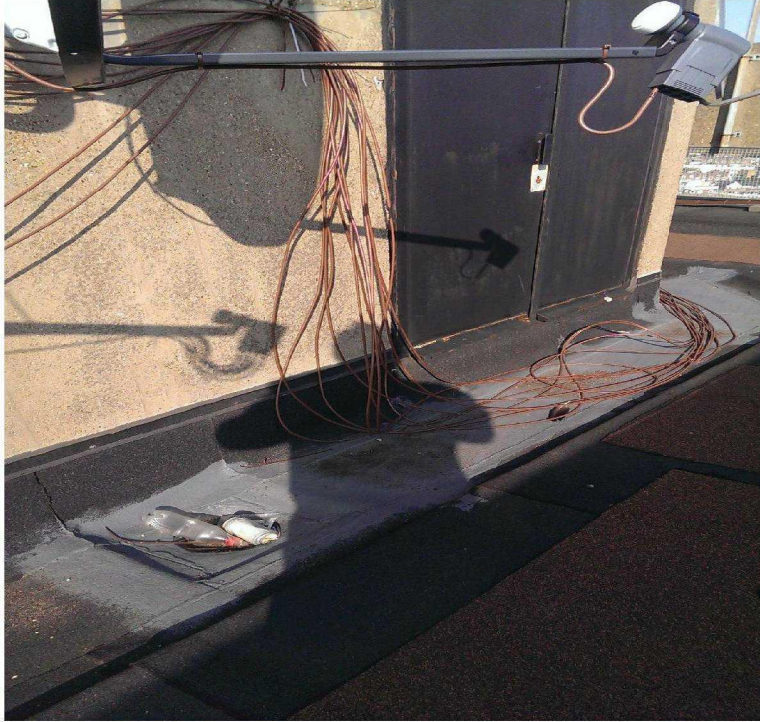
Cables on the floor and drains blocked

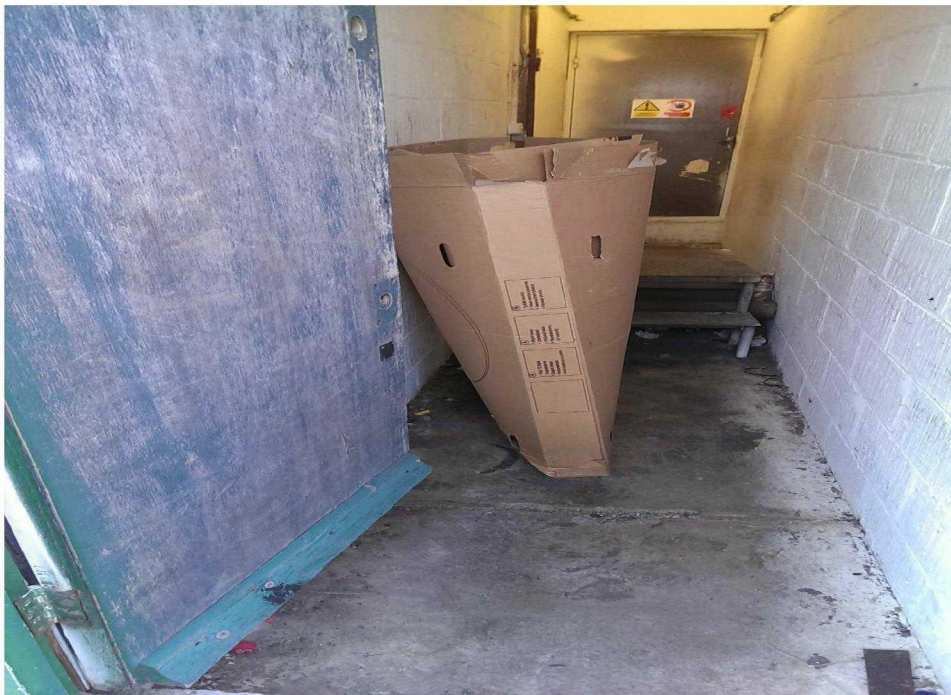
Old satellite cardboard boxes

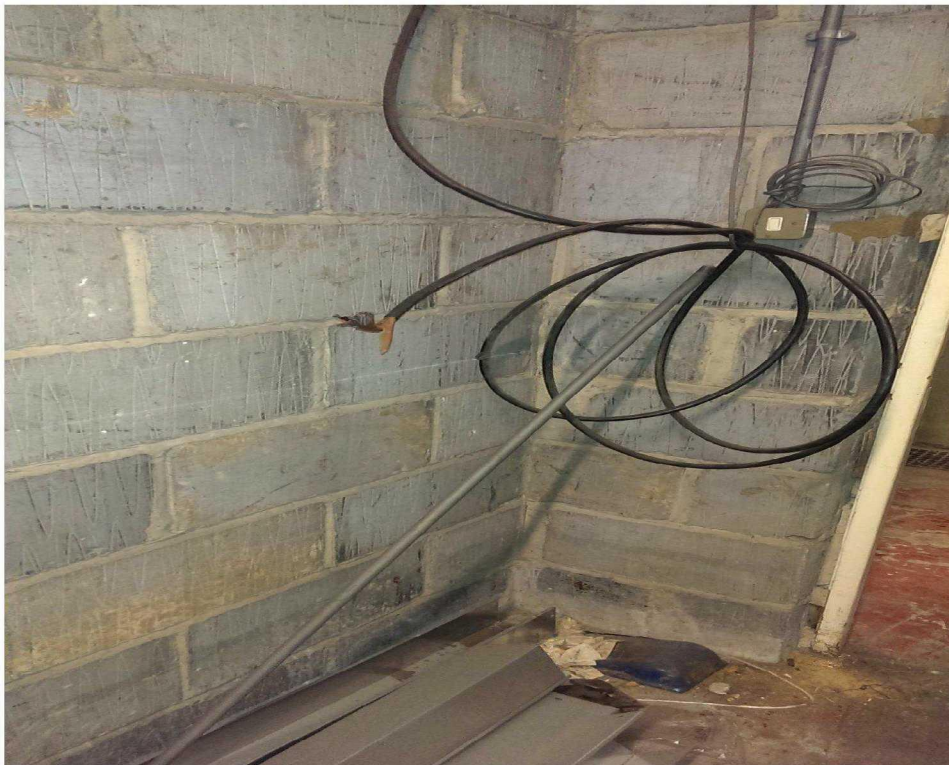
Work is being undertaken in the basement area of this building, new boilers will be installed etc, the door at the base of the staircase is damaged and there are electrical cables hanging down from the ceiling etc.

Cables

22. Can it please be confirmed by the contractor that all cut and hanging electrical cables in the basement area are not live?

23. The damaged door and door frame at the base of the staircase down to the basement should be repaired or a new door set installed.
24. The amount of combustible waste in the basement area should be kept as low as possible, with rubbish and waste removed at regular intervals, I would recommend that the contractor is asked to tidy up and remove combustible waste from this basement area.

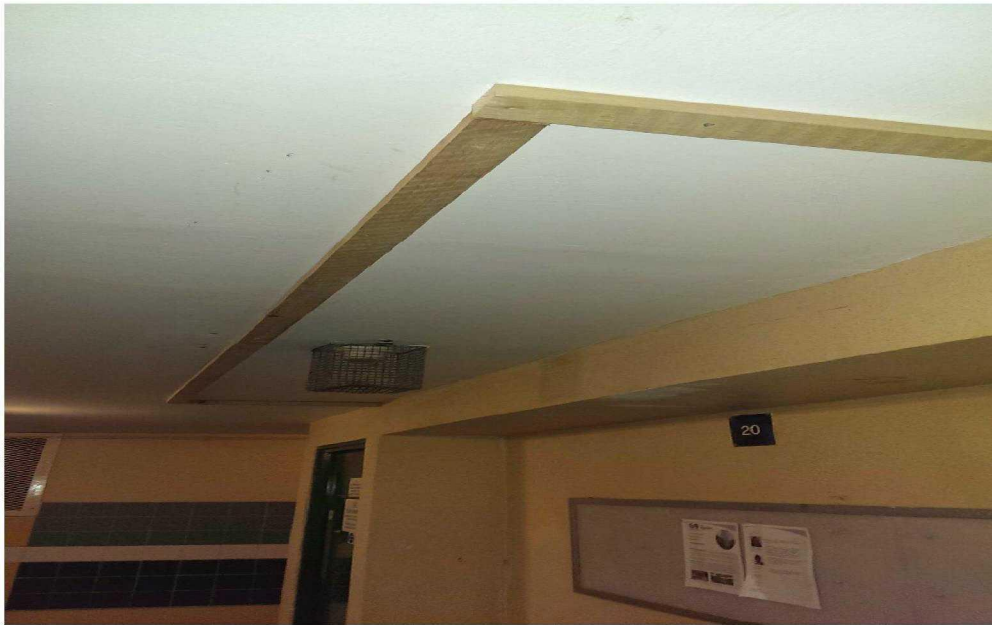
On each of the residential floor lift lobby areas a cupboard will be constructed with the heating pipes etc within them.

Cupboard to be constructed, area marked out with the battens on the ceiling.

25. As can be seen above the smoke detectors on the lift lobby area landings will be inside the new cupboards, in some cases, can the contractor please provide the scope of works for the new fire alarm detection installation?
26. Can the contractor please provide information of the materials to be used to construct the new cupboards?
27. Can the contractor please provide information on how fire stopping will be achieved between each for level for the pipe work?
