*REPORT OF  
THE SUMMERLAND  
FIRE COMMISSION*

GOVERNMENT OFFICE,  
ISLE OF MAN.

## REPORT OF THE SUMMERLAND FIRE COMMISSION

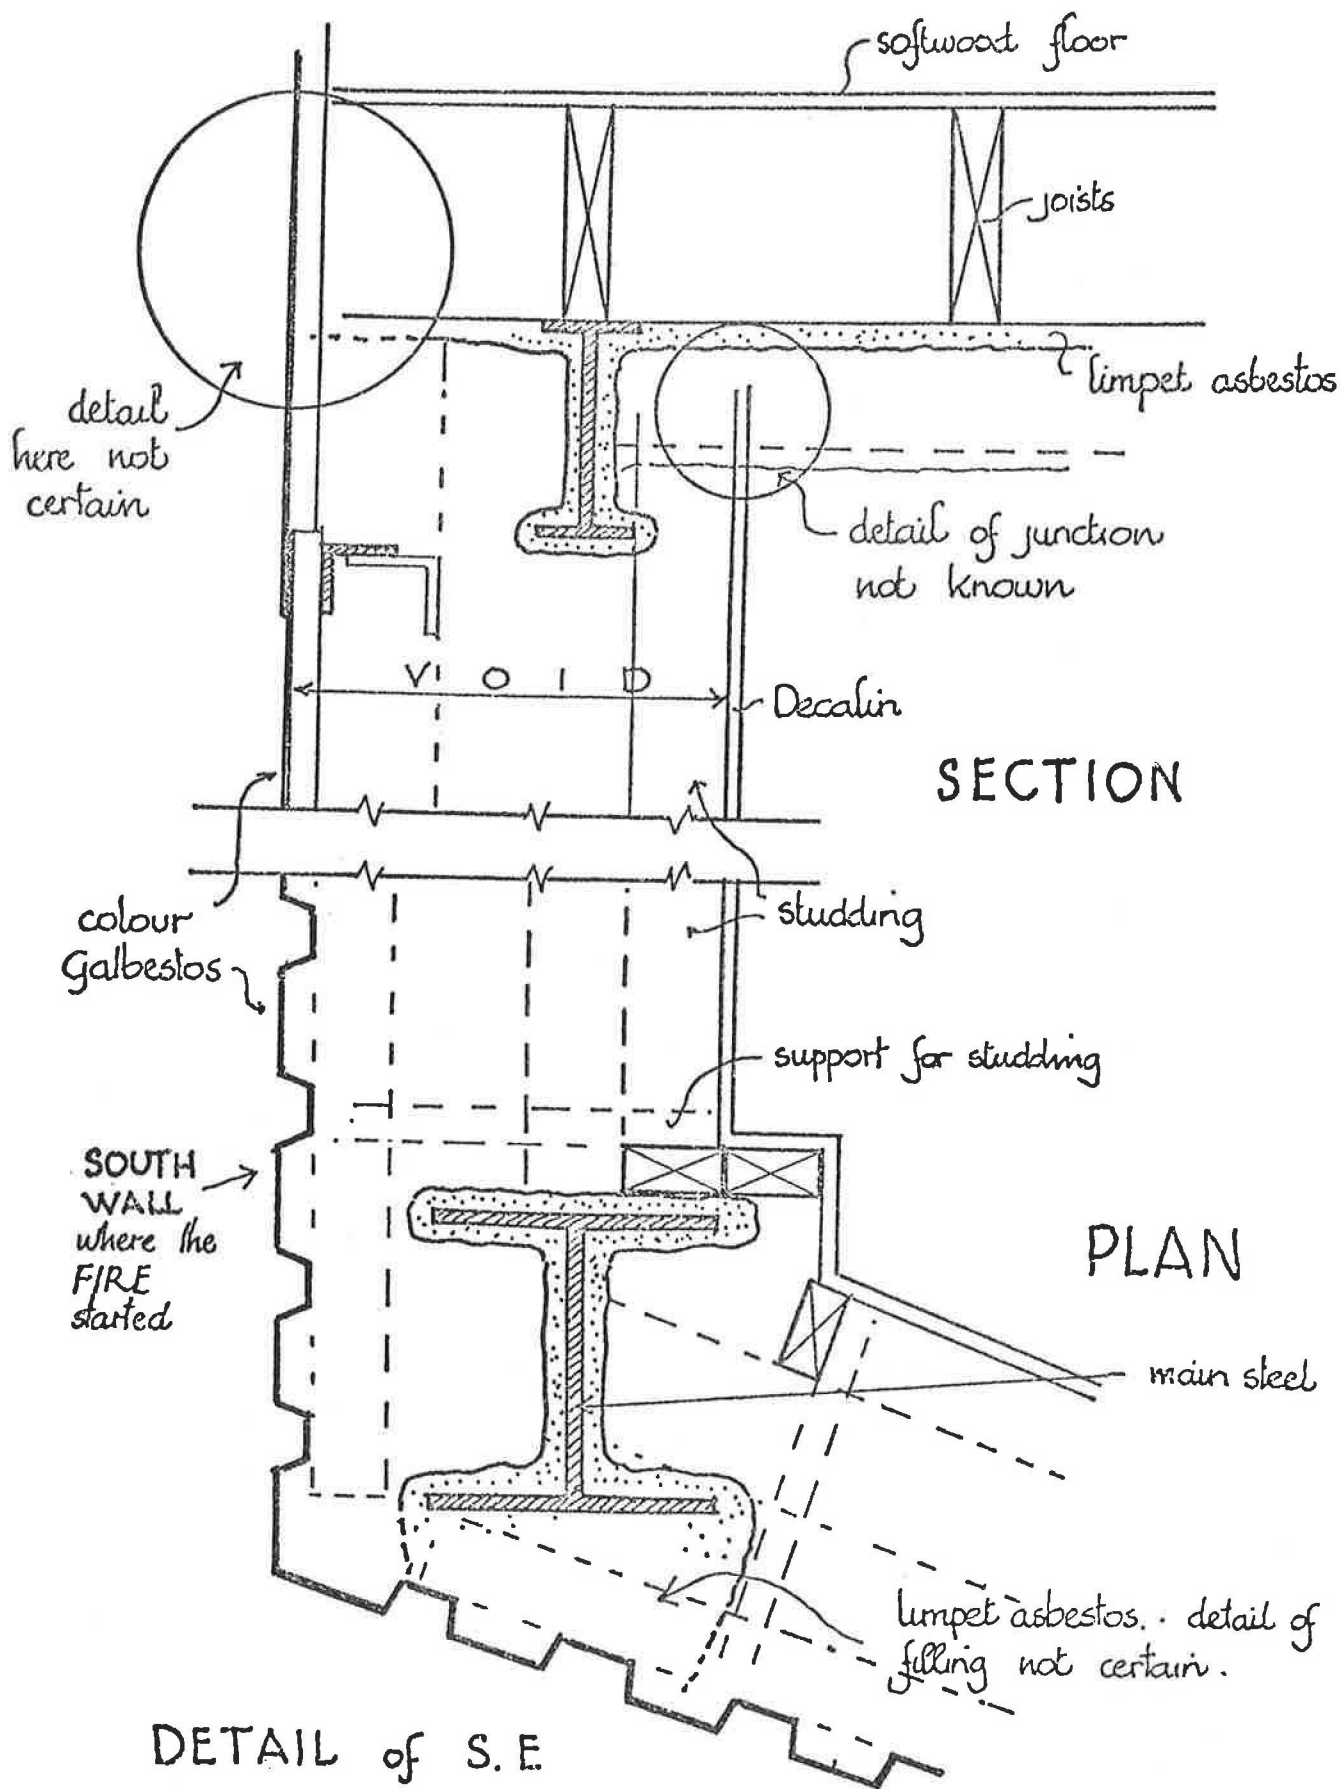
DETAIL of S.E.

108. The stage at which Oroglas became involved in the fire deserved and received special attention, particularly as there was at one time a widespread public impression that Oroglas played the primary role in the development and spread of fire within the building. This is contrary to the evidence. We are satisfied by clear and positive evidence of eye-witnesses that the Oroglas was ignited from fire within the building and was not ignited until there was a very substantial fire in the Amusement Arcade. We also accept Professor Rasbash's deduction from photographs which were taken at an early stage of the fire and from other evidence that the Oroglas on the south wall was almost certainly ignited from flames spilled over the ceiling of the Amusement Arcade into "the chimney" already referred to.

109. Within a matter of a few minutes the Oroglas was burning both in the south wall and in the roof at the east end. It is Professor Rasbash's opinion that the roof caught fire from flames which first travelled vertically up the Oroglas wall and we think this is likely. It is necessarily a matter of deduction or conjecture, because eye-witnesses involved at that time in a very alarming drama cannot reasonably be expected to record reliable impressions of the precise sequence of events which crowded upon one another. What is clear is that a very considerable conflagration rapidly developed on the whole height of the building at the east end and within a few minutes of the flames sweeping up the front of the terraces the roof burned open or blew open at the east end. The fire moved much more rapidly westwards along the roof than it did along the south wall. This progress of the fire is recorded vividly in photographs and cine films taken at the time.
