GRENFELL TOWER INQUIRY: PHASE 1 REPORT OVERVIEW

REPORT of the PUBLIC INQUIRY into the
FIRE at GRENFELL TOWER
on 14 JUNE 2017

Chairman: The Rt Hon Sir Martin Moore-Bick
October 2019

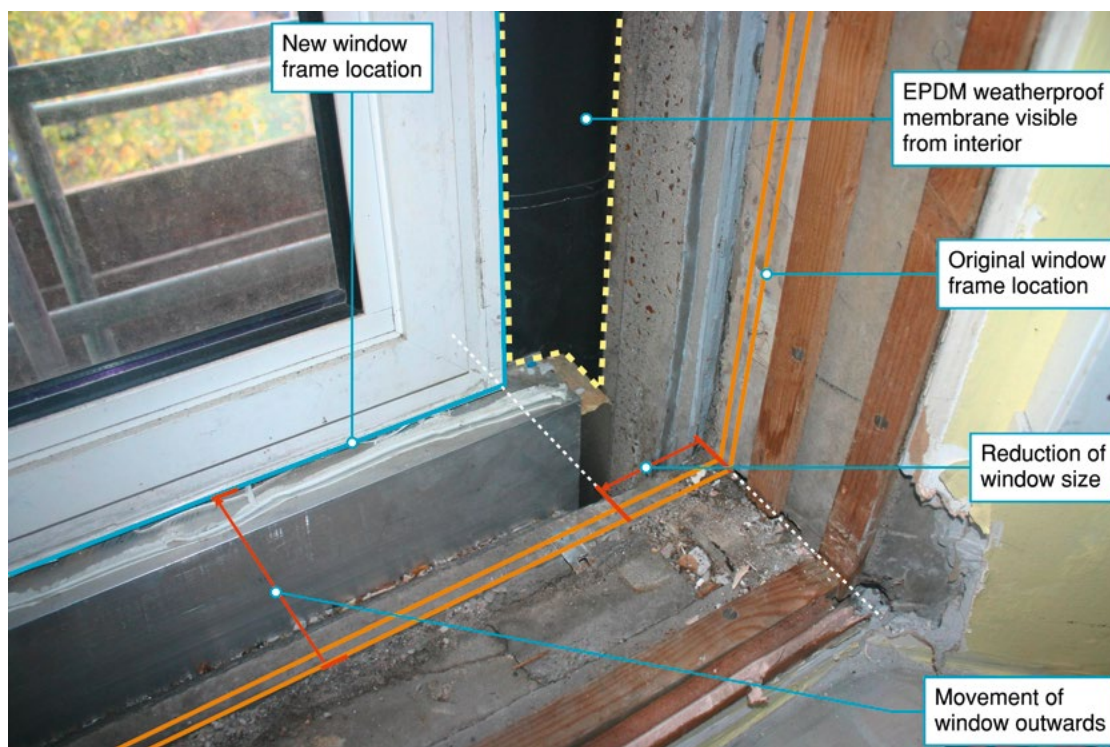
Figure 6.10

6.33 The following figures show the position of the original window frames together with other features of the new window arrangement, including the windows themselves, the EPDM membrane and the gaps created by the reconfiguration of the windows:⁷³

6.34 No cavity barriers were installed around the windows.⁷⁴

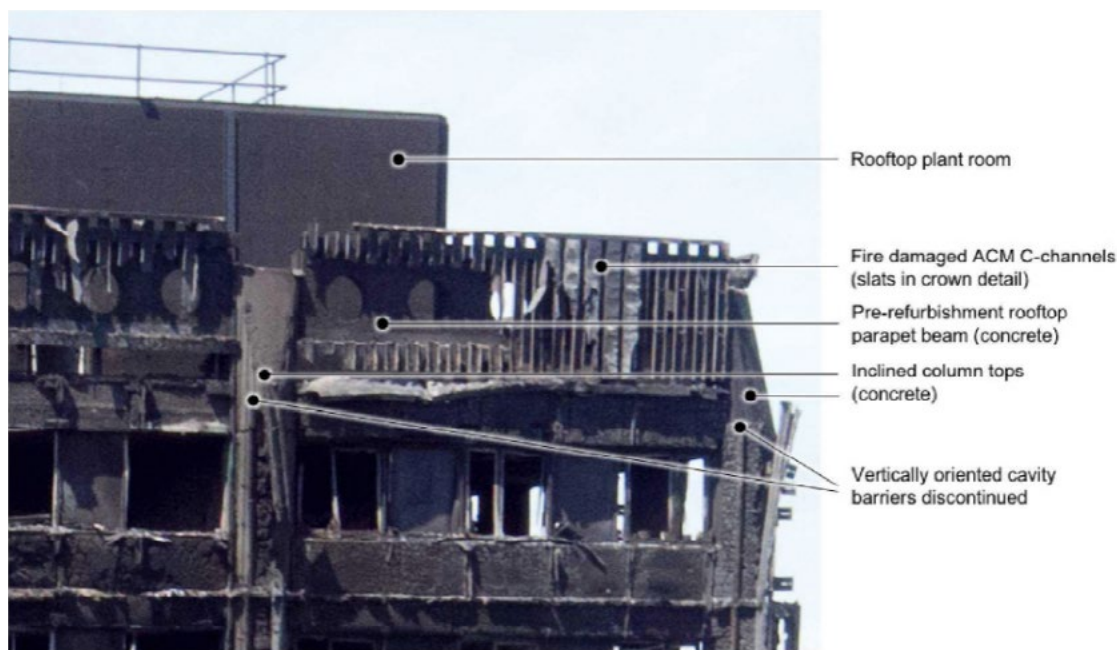
Figure 6.12

- 6.37 In the following picture of the crown taken after the fire it is possible to see the remains of the ACM fins and aluminium rails, together with the original concrete behind.⁷⁷
