HARLEY CURTAIN WALL

INCIDENT REPORT FORM 1

CONTRACT NO: C1031 Chalcots Estate
LOCATION: TAPLOW HOUSE
RE: INITIAL REPORT FROM FIRE DAMAGED
DATE OF INCIDENT: SUNDAY 16TH / MONDAY 17TH January, 2012
DATE OF REPORT: 17th January 2012

To Record Initial Findings of Damage To The External Façade.

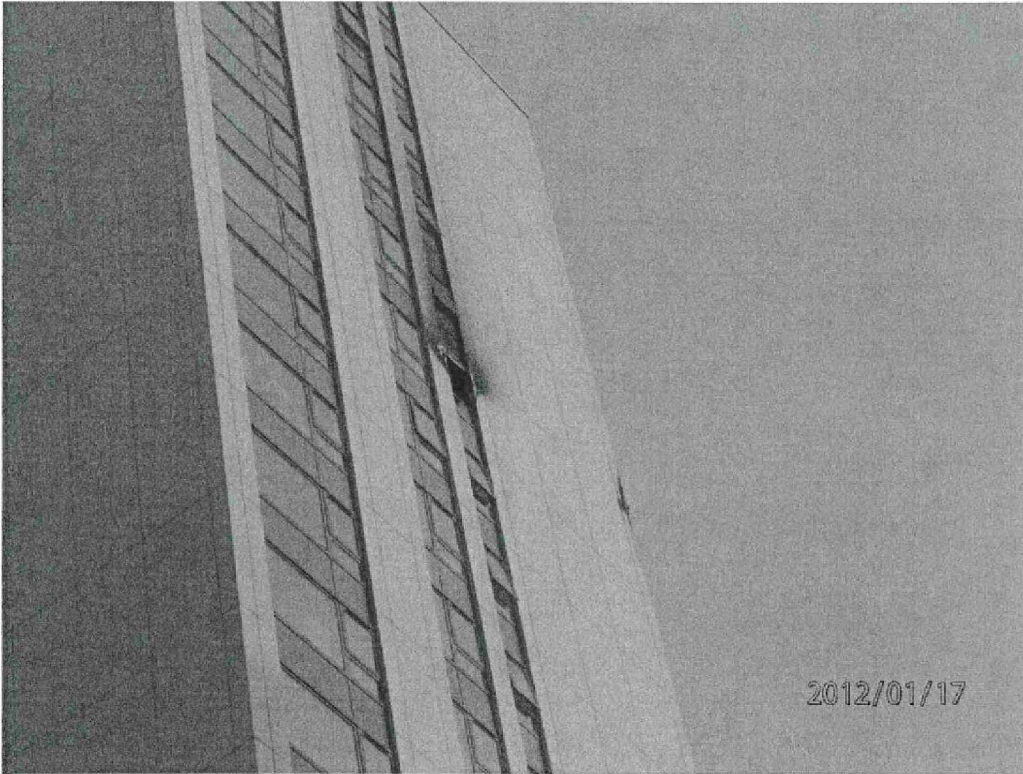
From the outside it was clear the windows had melted and smoke damaged had occurred to junction of Adelaide road.

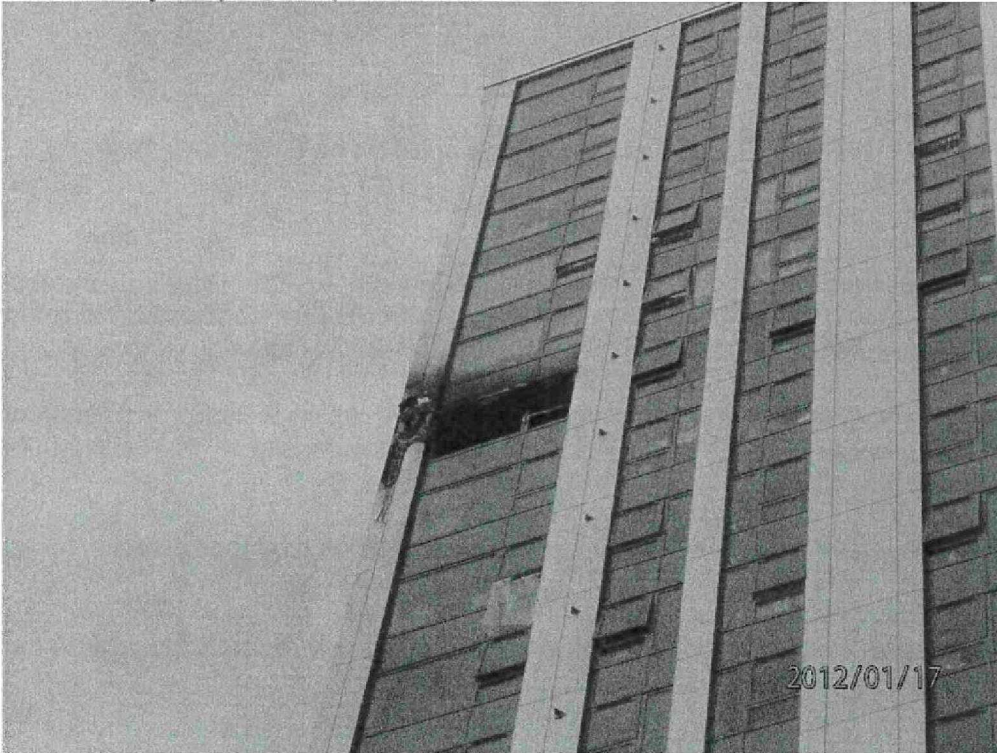
The fire damage was also evident on elevation facing Adelaide Road where the corner of the cladding was also affected. It appears that as the fire had melted the windows the cladding had been damaged by flame spread and smoke.

Although the fire breaks prevent the spread of fire from flat to flat, a further survey is required to fully ascertain the external extent of the damage to the cladding. It has therefore been agreed and arranged that Harley will instruct Southern Access Solutions to Abseil the external façade and take sufficient photographs.

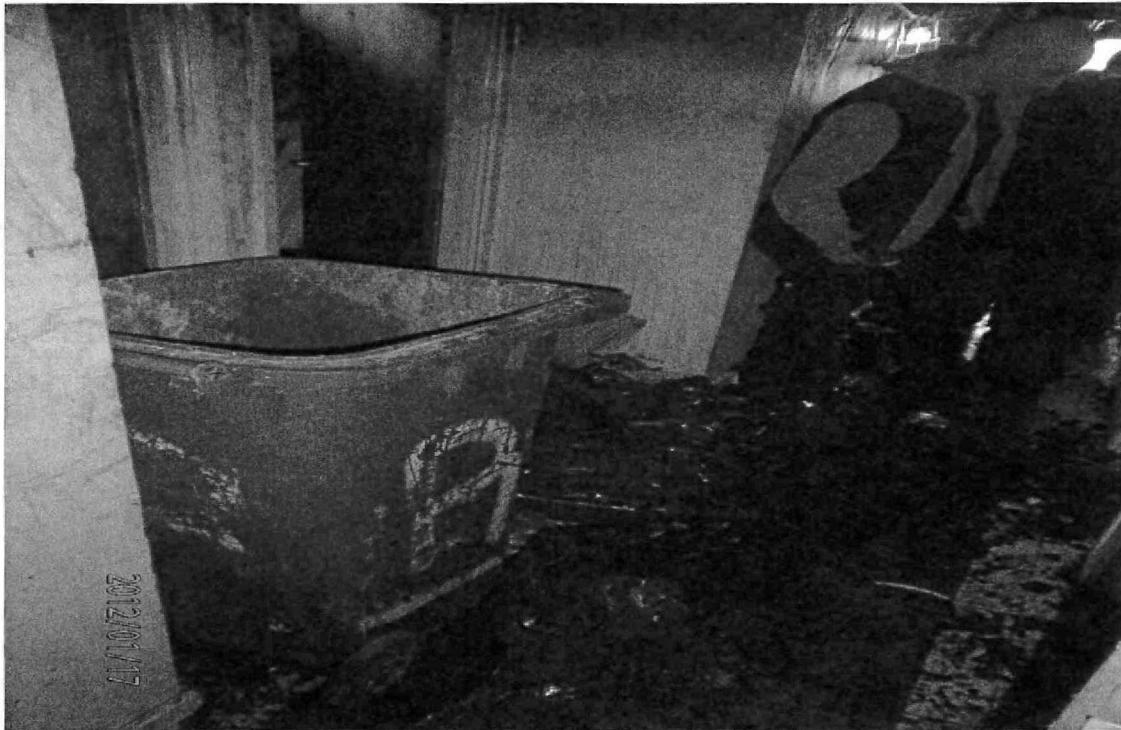
From the inside of the Tenanted Flat it was clear that the fire was aggressive and caused considerable damage to the fabric of the building.

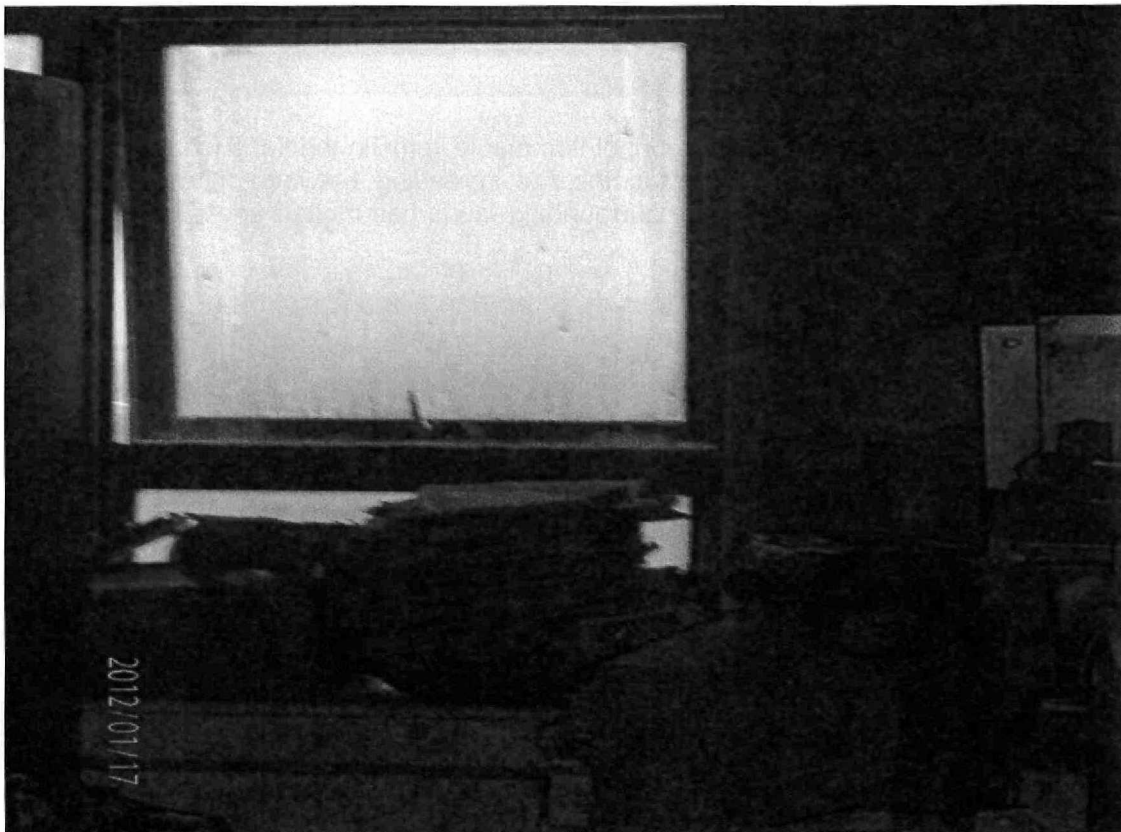
The fire also caused visible smoke damage to the Kitchen area.

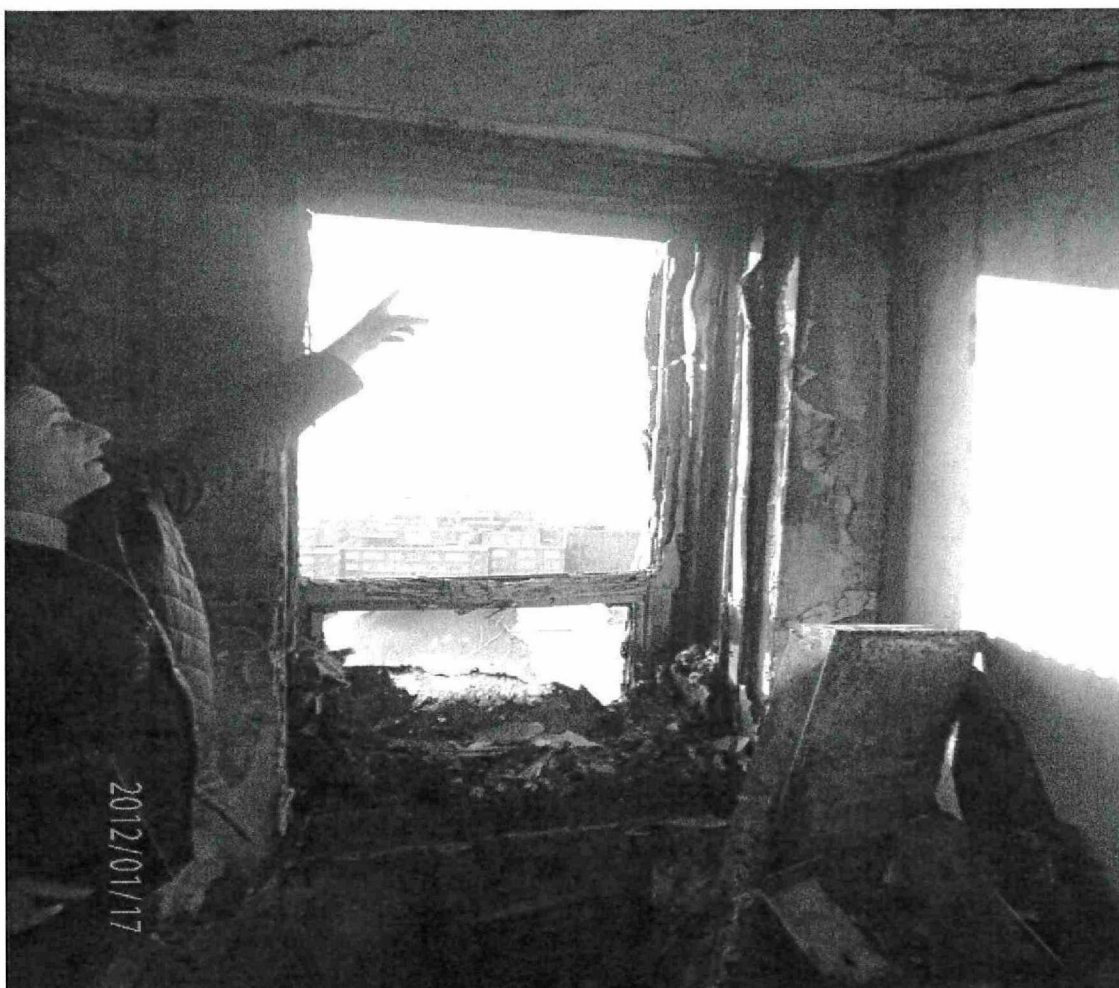
The fire had caused extensive damaged to the living room, the windows and building structure as all had been subject to extensively high temperatures.

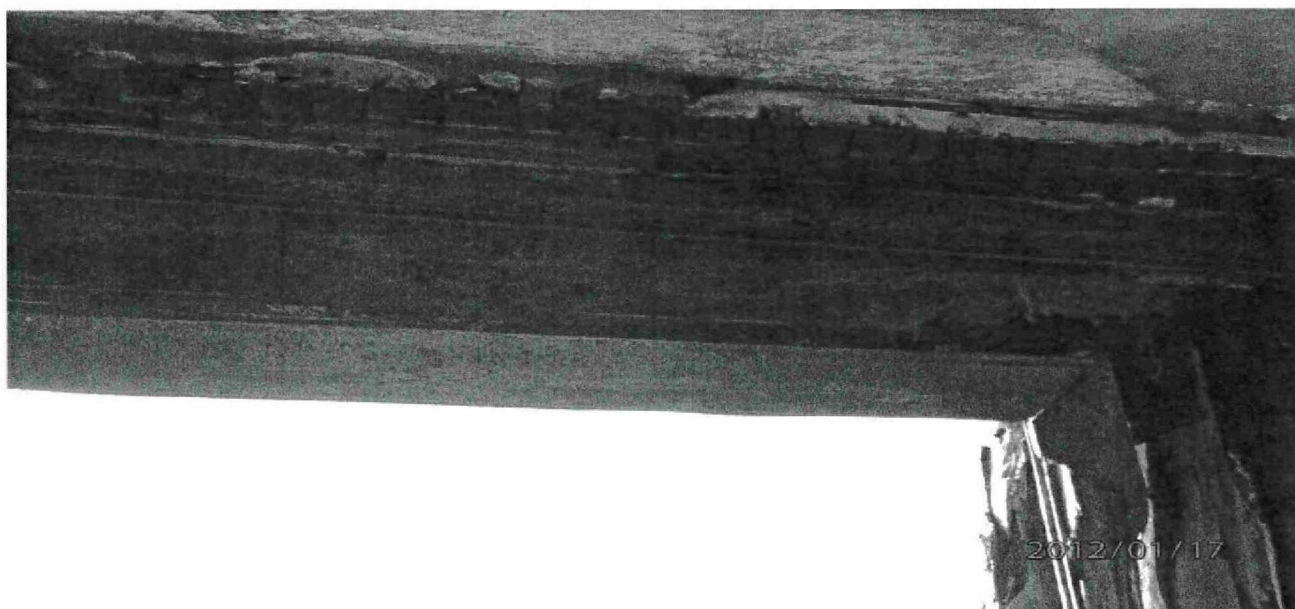
It was evident that despite the fire and the amount of flammable items in the flat such as paper etc. The fire breaks were still intact and prevented the fire spreading between flats. The Harley designed fire break system is visible, now the surrounding fabric has melted under the extensive heat.

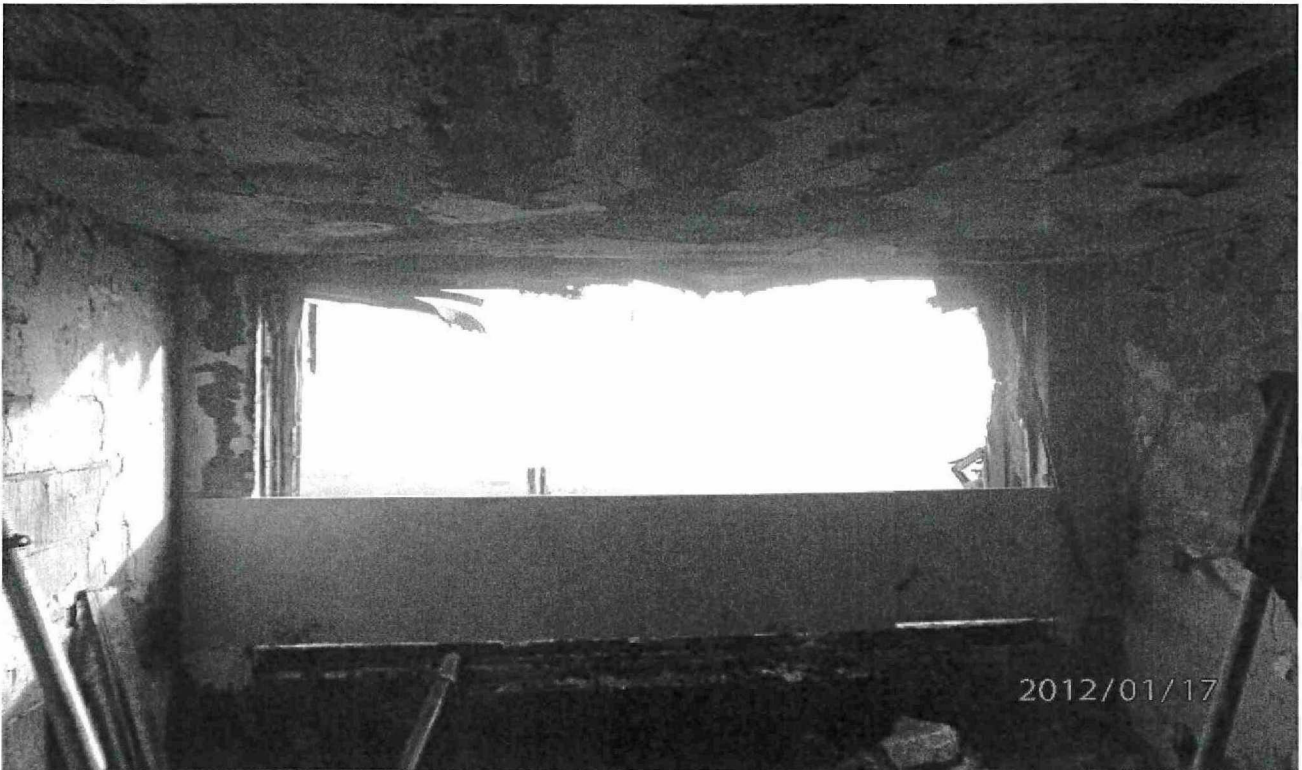
The damage mainly occurred within the living room with the main window and ceiling being severely damaged.

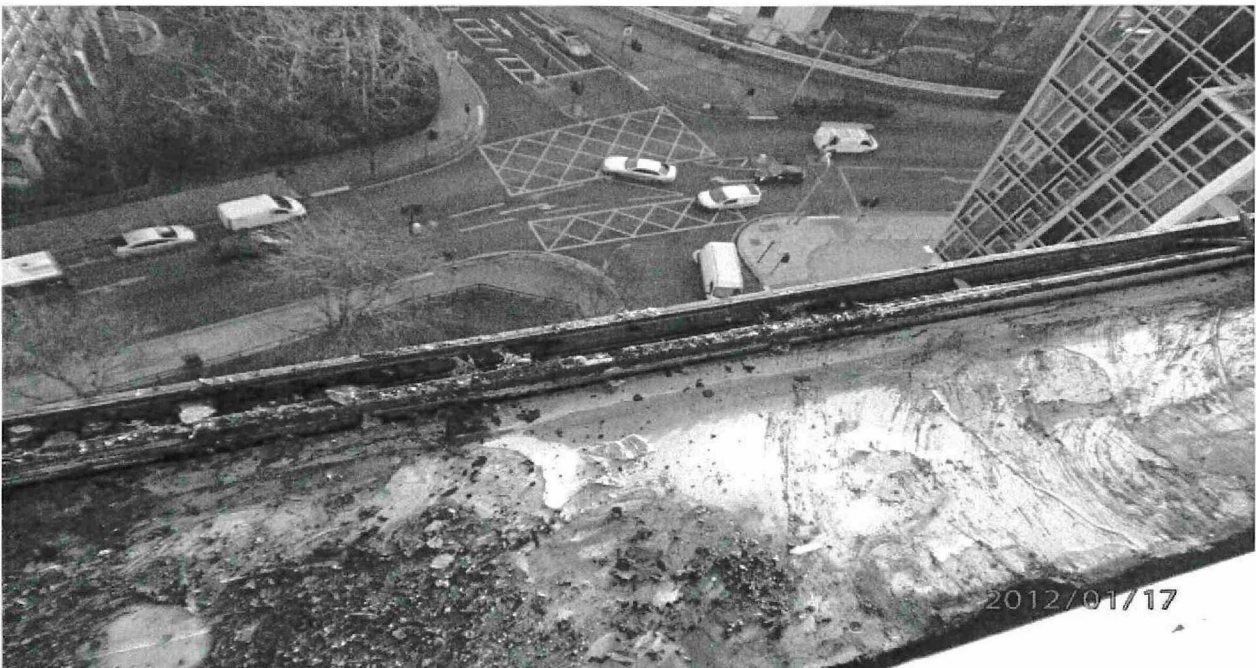
Sill Level

Upon close inspection it was also evident that despite the excessive damage to the whole fabric, which left steel rebar exposed, as the plaster and concrete had melted away. The fire breaks were still intact as shown the photos below.
