THE GRENFELL TOWER INQUIRY

EXHIBIT TNG/11

This is the Exhibit marked “TNG/11”
referred to in the witness statement
of Tobias Neville Guise

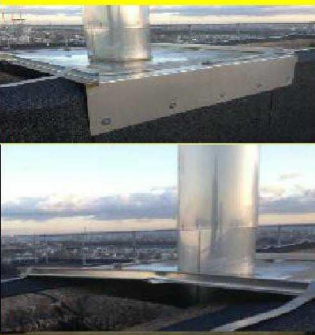
12	24	03/01/2016	Roof	Roof	The flue termination has been poorly installed, the weather cowl is firstly holding a lot of water, the support holding the plate in place is only with steel screws and washers which will rust in 12 months. picture 2 shows the wind has already picked up the one side of the plate lifting it up.

Item 24 Please ensure this is passed onto Midtherm to be rectified, I have more pictures if required
