BRE Global Test Report

BS 8414-1:2015 + A1:2017 test on a ventilated façade system with Kingspan Kooltherm K15 insulation and Alpolic/fr panels.

Prepared for: Kingspan Insulation Limited

Report Number: P107017-1000 **Issue:** 1

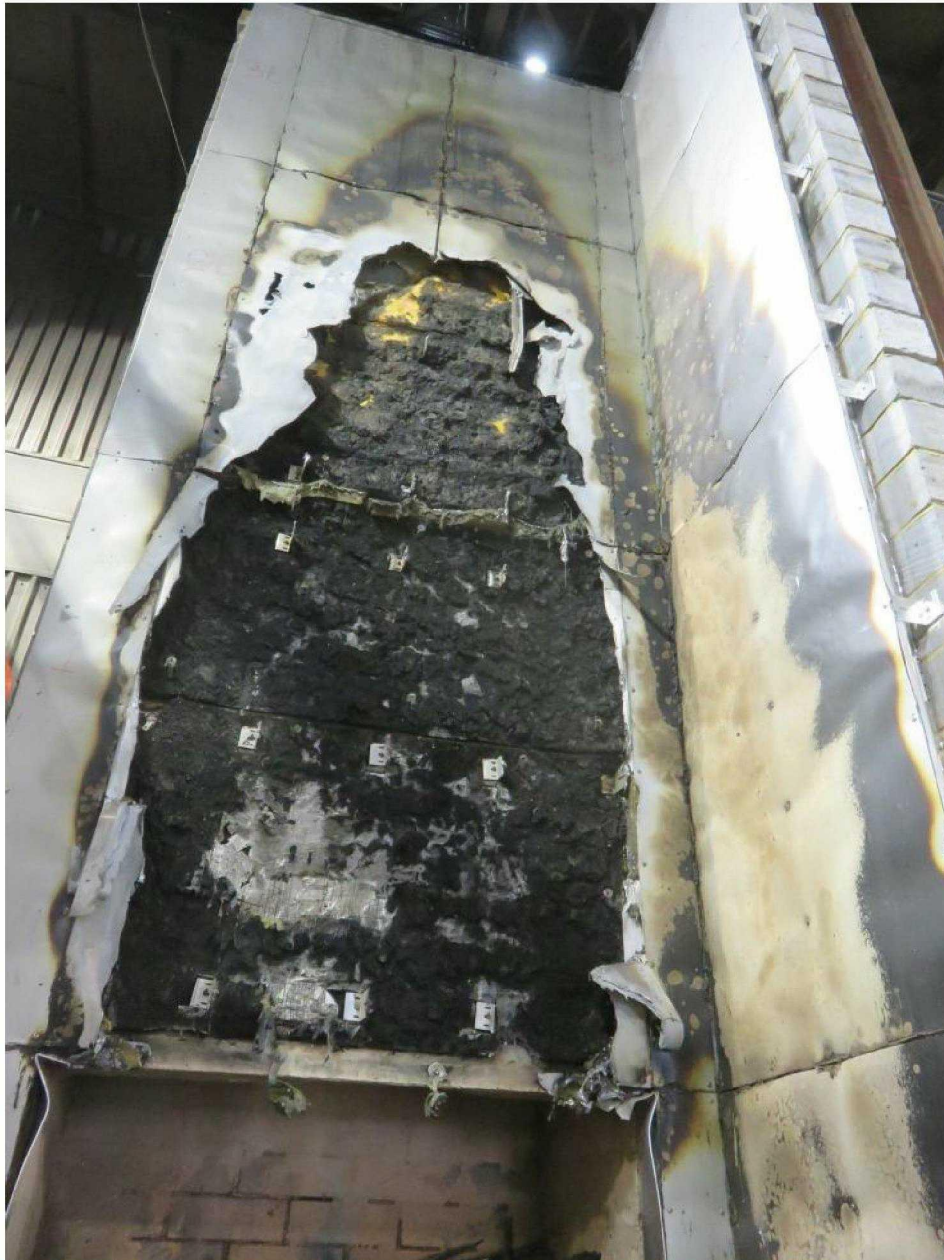
Row 0 – Panel 0A was significantly distorted and discoloured (approximately 70% panel coating removed, 25% dark discolouration). On panel 0B there was a small area (approximately 300mmx150mm) of dark discolouration in the top left hand corner of the panel (adjacent to the combustion chamber). Panel 0E was not visibly damaged.

Row 1 – Panel 1A was significantly distorted and discoloured (approximately 50% panel coating removed, 25% dark discolouration). Panel 1B was significantly distorted and discoloured (approximately 50% panel coating removed, 50% dark discolouration). Panels 1C and 1D were both almost fully consumed. Panel 1E was distorted and darkly discoloured in a 50mm-wide full-height vertical strip in line with the combustion chamber opening.

Row 2 – Panel 2A was distorted and discoloured (<10% panel coating removed, 50% dark discolouration). Panel 2B was distorted and discoloured at the base of the panel (small areas of panel coating removed, 40% dark discolouration). Panels 2C and 2D were damaged across the full panel surface: panel consumed (55% and 40% respectively), distorted and discoloured across the remaining panel. An area approximately 1500mm x 400mm of panel 2D remained loosely attached with consumption of the panel core. Small holes approximately 50mm x 300mm and 50mm x 50mm were observed in panel 2D approximately 3750mm above combustion chamber. Panel 2E was distorted and slightly discoloured.

Row 3 – Panels 3A&3B had minor distortion. Panel 3C was distorted and discoloured (small areas of panel coating removed, approximately 30% dark discolouration). Panel 3D was distorted and discoloured (small areas of panel coating removed, approximately 25% dark discolouration). Panel 3E had minimal visible damage.

The central aluminium 'T'-shaped rail on the main wall was fully consumed up to a height of approximately 4m. Partial consumption and distortion continued to the top of 2C-2D panel junction.

The 'L'-shaped rails to the left and right of centre on the main wall were fully consumed up to a height of approximately 3.5m. Partial consumption and distortion continued for approximately 500mm.

Figure 14. Full-height photograph immediately after test.

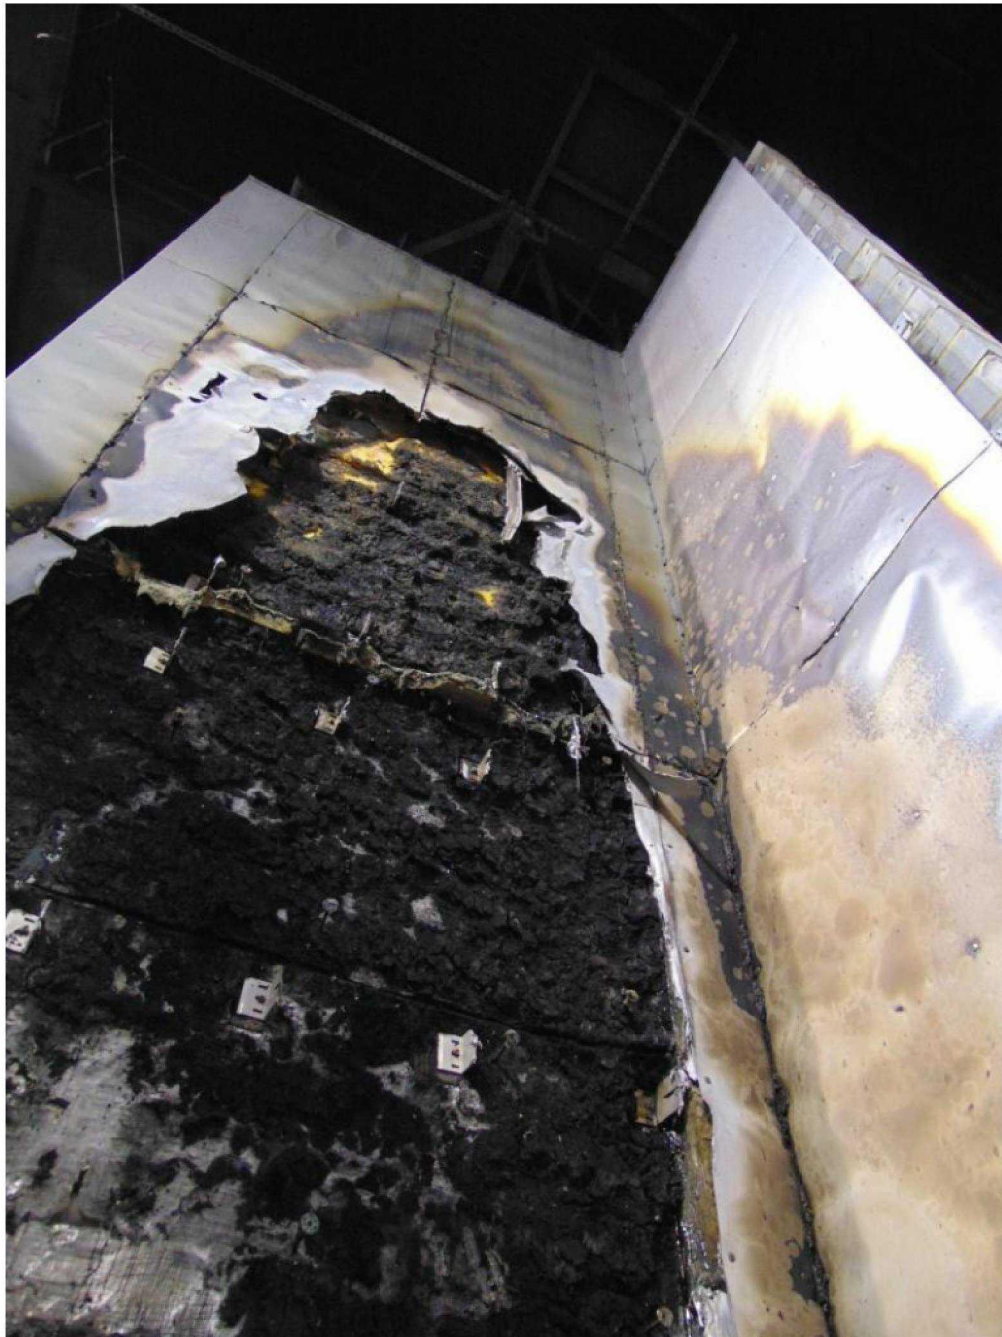
On the main wall face, at the location of panel/s (refer to *Figure 2*):

- 0E. The foil facing on the insulation remained intact
- 1B. Dark discolouration towards the second horizontal cavity barrier and small areas of detachment/consumption of foil facing.
- 1C&1D. Small amount of charred insulation remains. Rear foil facing visible across approximately 10%, mostly intact.
- 1E. Foil facing of insulation intact Slight discolouration in places.
- 2B. Minor discolouration of the foil facing.
- 2C. Charring of the insulation occurred in decreasing severity between the second and third cavity barrier. External foil facing and some uncharred insulation remained adjacent to the third horizontal cavity barrier. The internal foil facing was not visible.

- 2D. Damage to the insulation was similar to that observed beneath panel 2C, however; a band of significant insulation consumption and detachment extended from approximately mid-height to approximately 300mm below the third cavity barrier. The blockwork was exposed in an approximately 300mm-width which would have been directly below the damaged edge of the remains of panel 2D.
- 2E. Insulation appeared to be undamaged.
- 3B. Insulation appeared to be undamaged.
- 3C&3D. Discolouration of the foil facing most pronounced along centre line of combustion chamber opening.
- 3E. Insulation appeared to be undamaged.

Figure 15. Post-test photo of exposed insulation on the main wall.

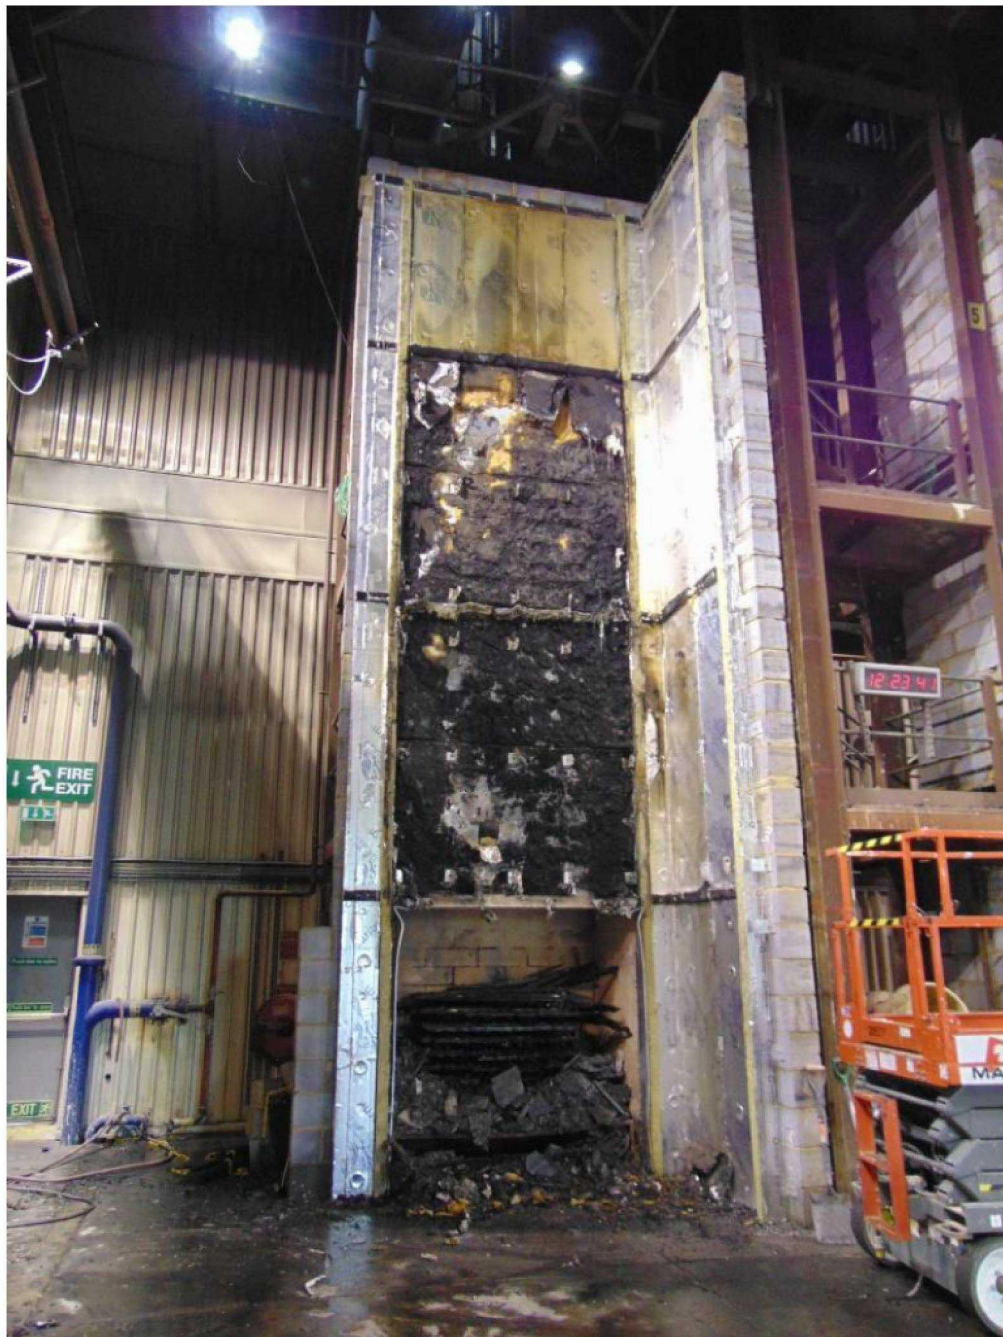
Figure 16. Full-height photograph of system following removal of ACM panels and aluminium rail substructure.

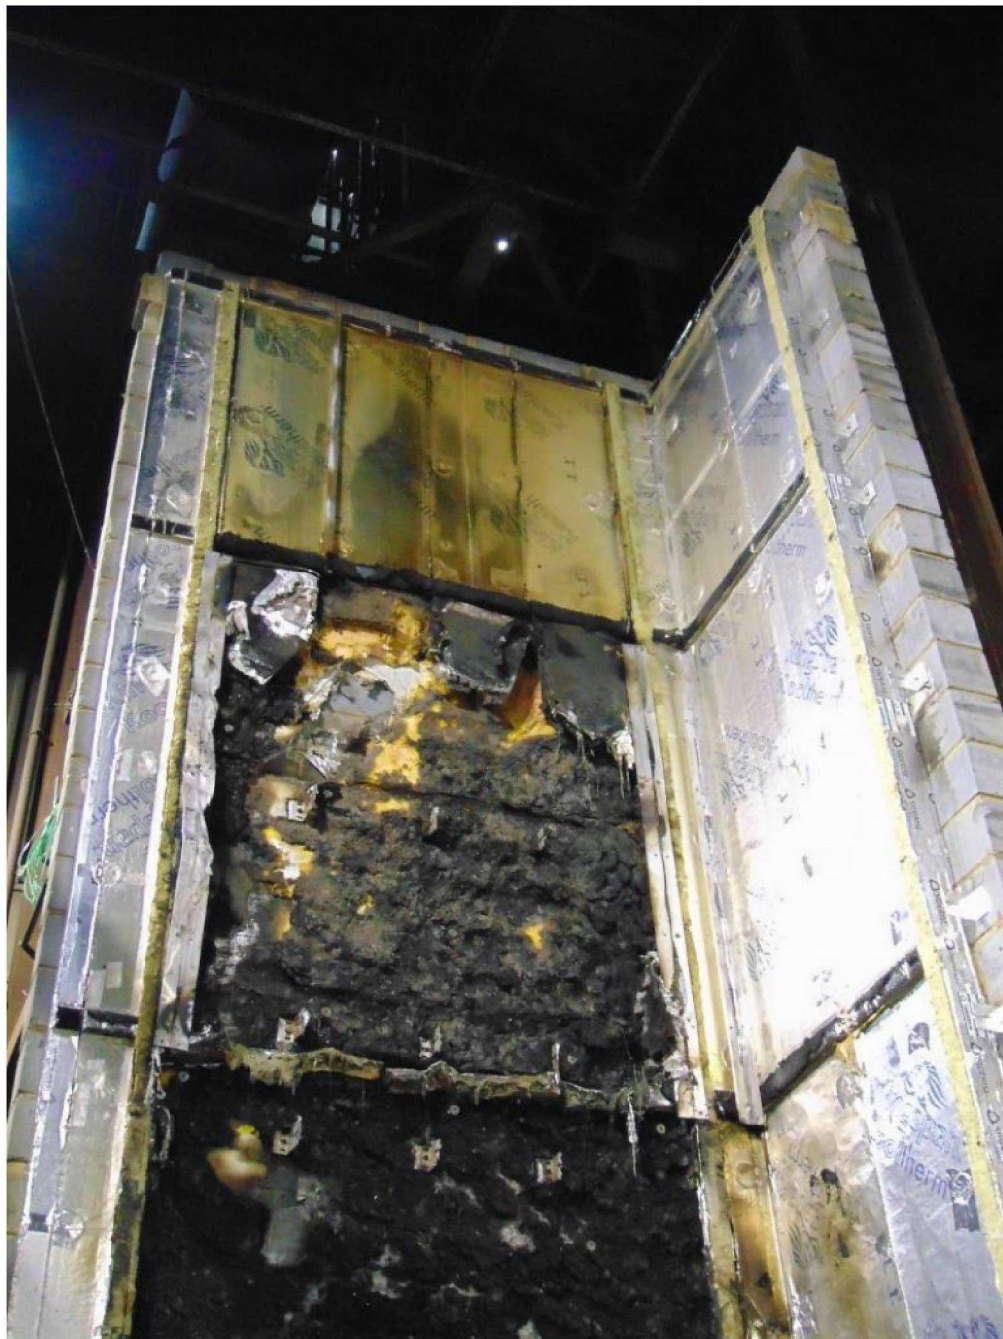
The Siderise RSV 90/30 vertical cavity barriers on the main and wing wall remained intact throughout the height of the system. On the main, there was minor surface discolouration up to the height of the third horizontal cavity barrier. The wing wall vertical cavity barrier sustained no visible damage.

Figure 17. Post-test photo of system following removal of cladding panels.

Note: majority of aluminium rail substructure has been removed.

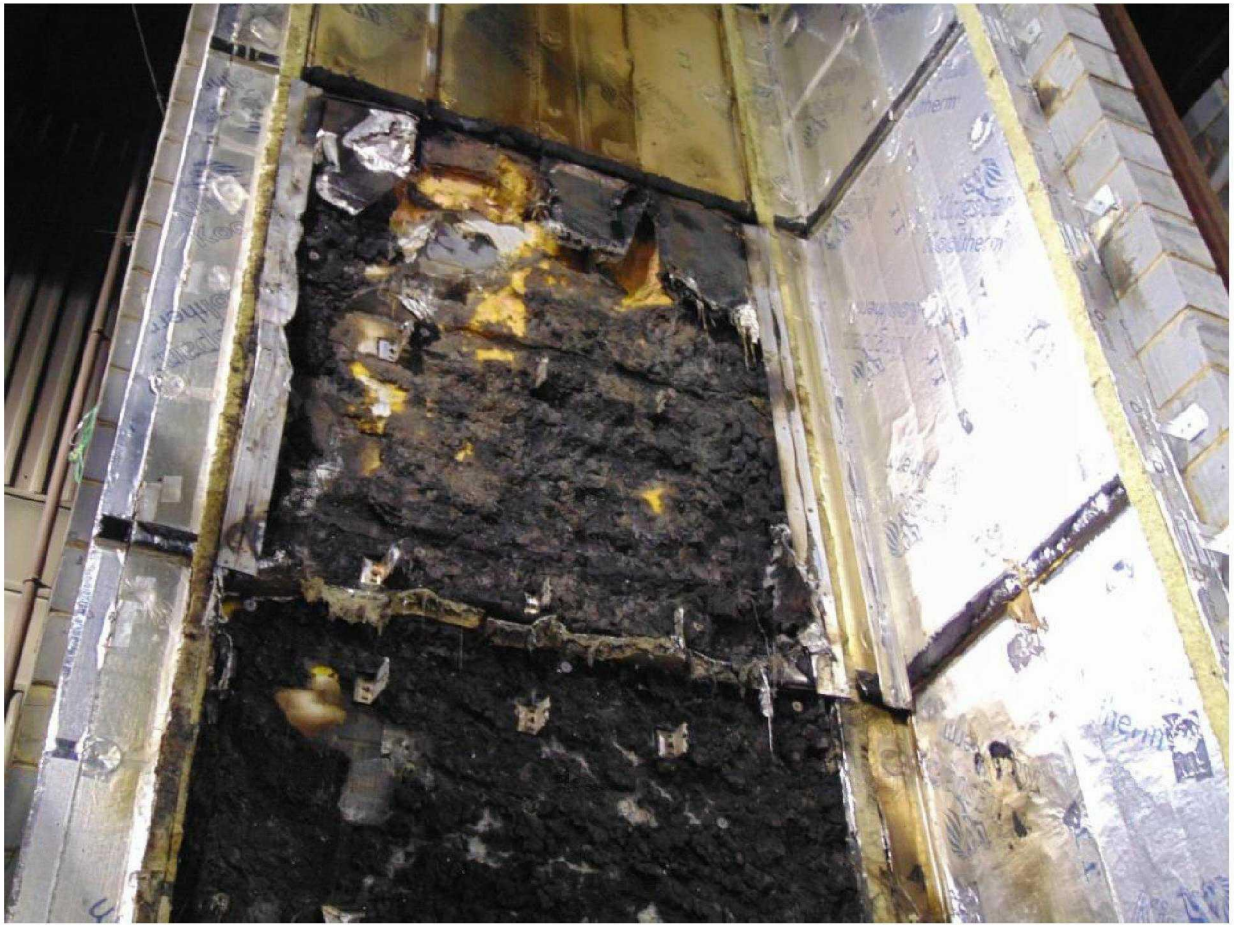
The second row horizontal cavity barrier had activated but was significantly damaged (directly in line with the combustion chamber opening) up the vertical cavity barriers, beyond these there was evidence of activation across the full width of main and wing walls.

The third row horizontal cavity barrier had fully activated across the central 2000mm-width (directly in line with the combustion chamber opening). Partial activation of the intumescent strip occurred across the wing wall. Evidence of slight heat damage was visible at the outside edge of the main wall.

Figure 18. Post-test photo between second and third row Siderise RH25G 90/30 horizontal open state cavity barriers.

Note: majority of aluminium rail substructure has been removed.

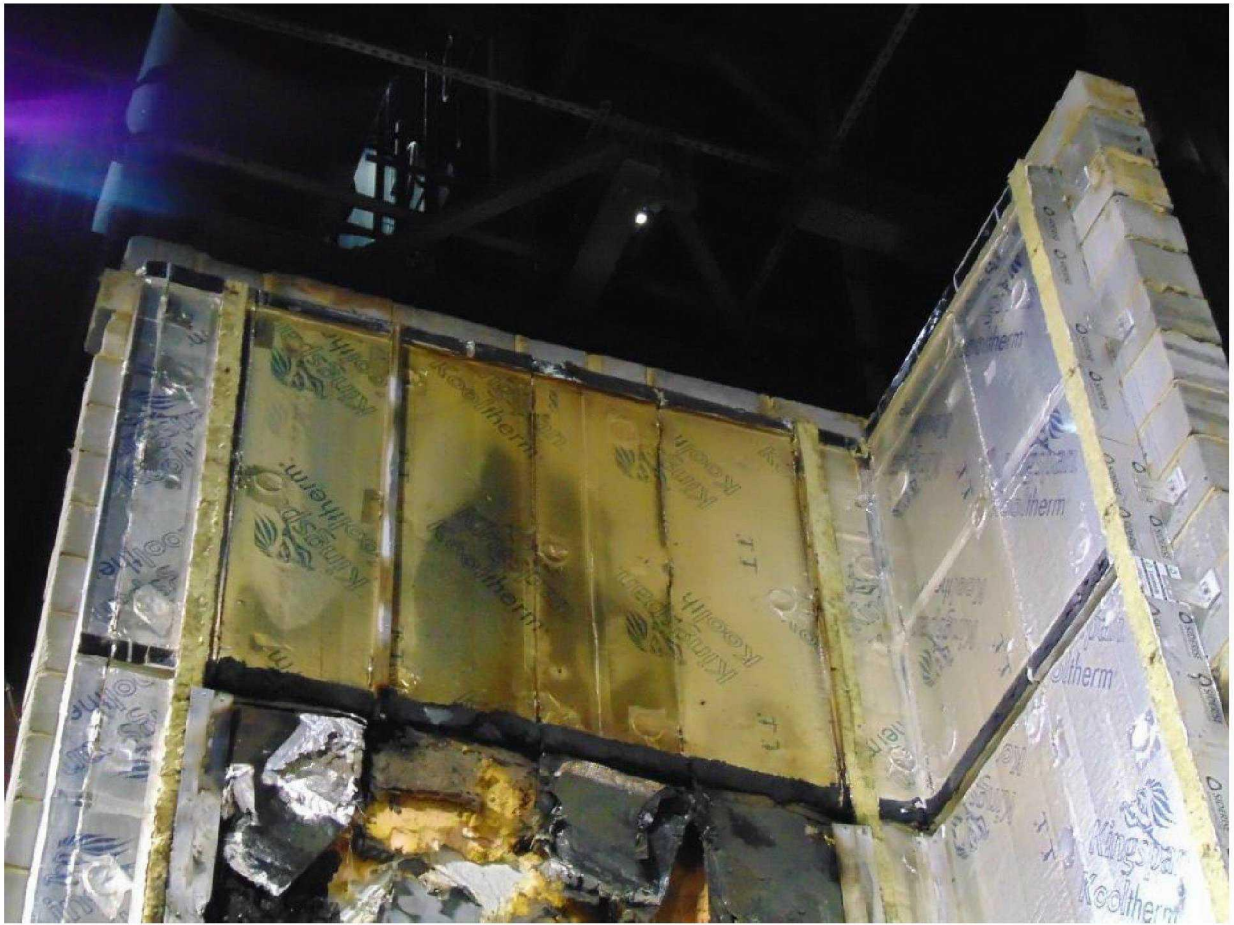
The fourth row horizontal cavity barrier had partially activated across the central 2000mm-width (directly in line with the combustion chamber opening). Partial activation of the intumescent strip occurred up to mid-width on the wing wall. At the outside edge of the main wall there was no evidence of activation.

Figure 19. Post-test photo between third and fourth row Siderise RH25G 90/30 horizontal open state cavity barriers.

Note: majority of aluminium rail substructure has been removed.
