BRE Global Test Report

BS8414-2 : 2005 Test on a Stofix insulated facade system

Prepared for: Stofix Oy
Date: 5/11/2015
Report Number: 303931 Issue 1

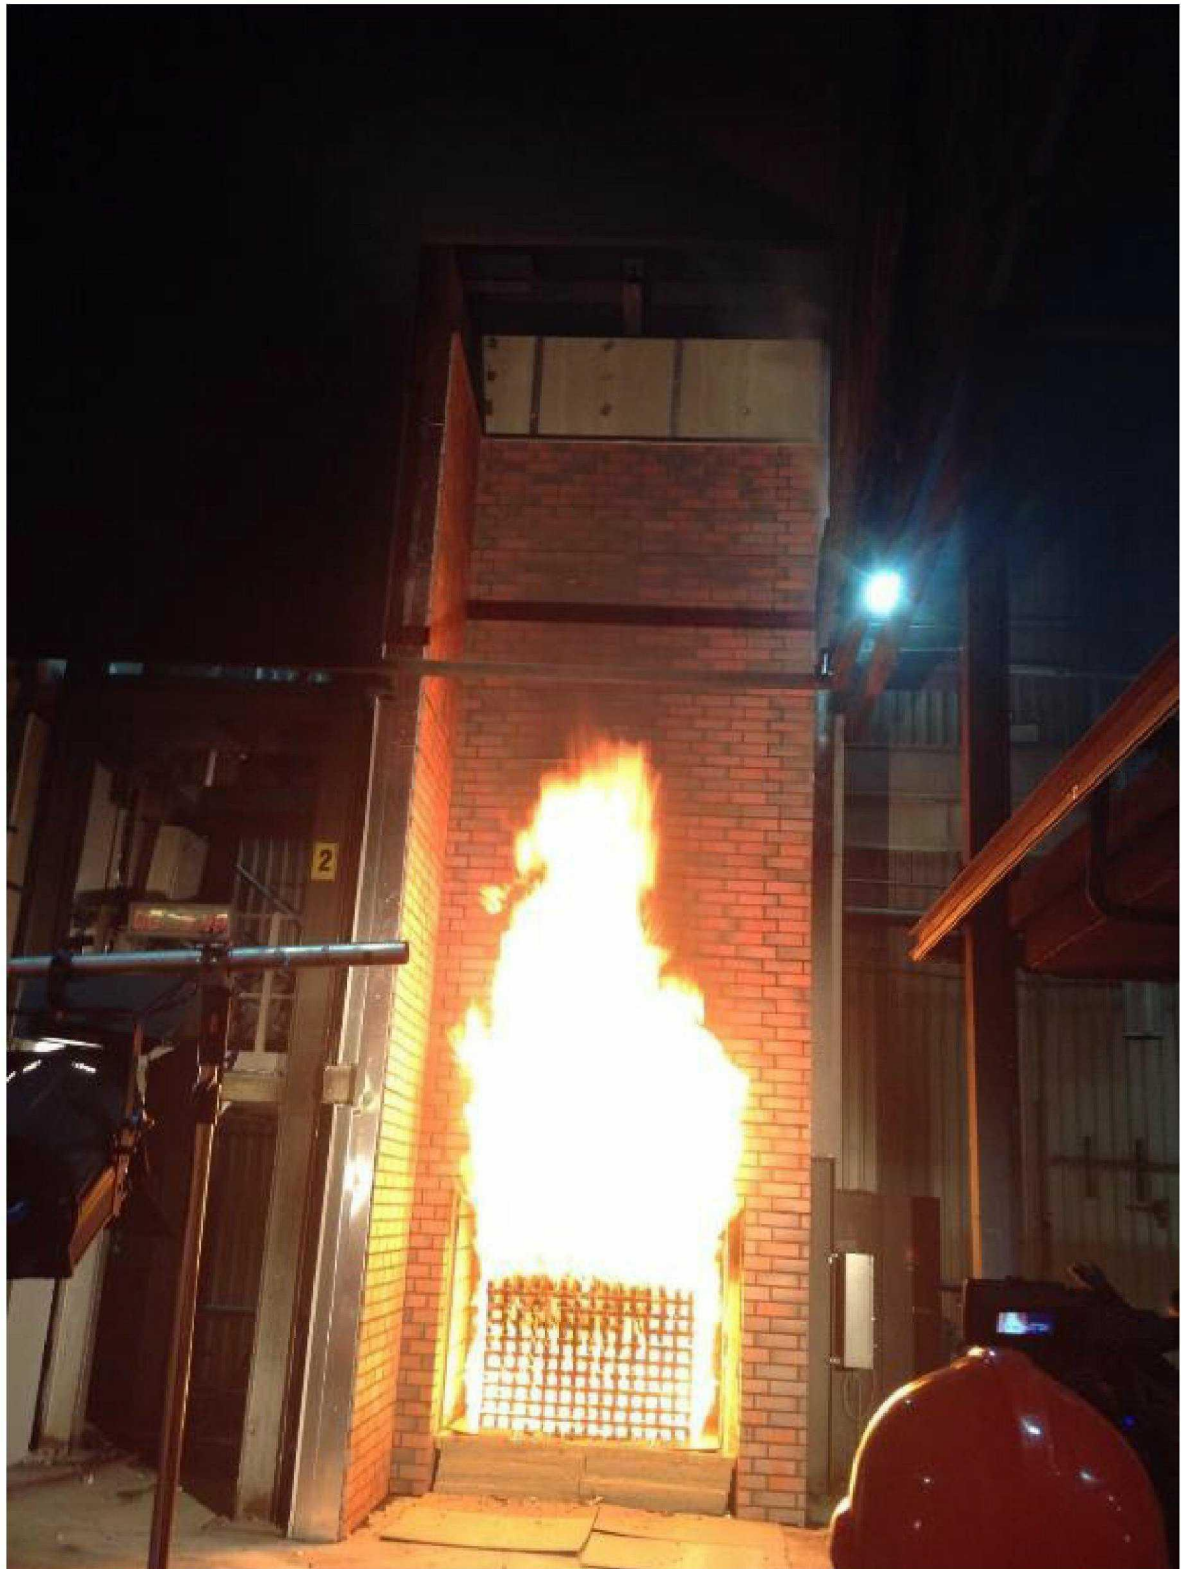
Figure 19. Cladding system during the test.

Time (mins:secs)	Description
-5:00	Logger start
0:00	Ignition of crib
2:28	Flames out of hearth
2:52	Flames to 1.5m
3:08	Smoke from right side of main face
3:35	Flames to 2m main wall centreline
5:07	Smoke clearing from right side on main face
7:45	Flames to 2.5m
8:50	Visible expansion joint
9:44	Burning above hearth main wall centreline
10:30	Discolouration to 2.5m main face wing wall
11:19	Flames from expansion joint on main face at 1m within flame plume
19:00	Burning of Mastic on wing wall
21:20	Crib starting to collapse
30:00	Crib extinguished
33:38	Flaming behind façade at 2.5m main face centreline

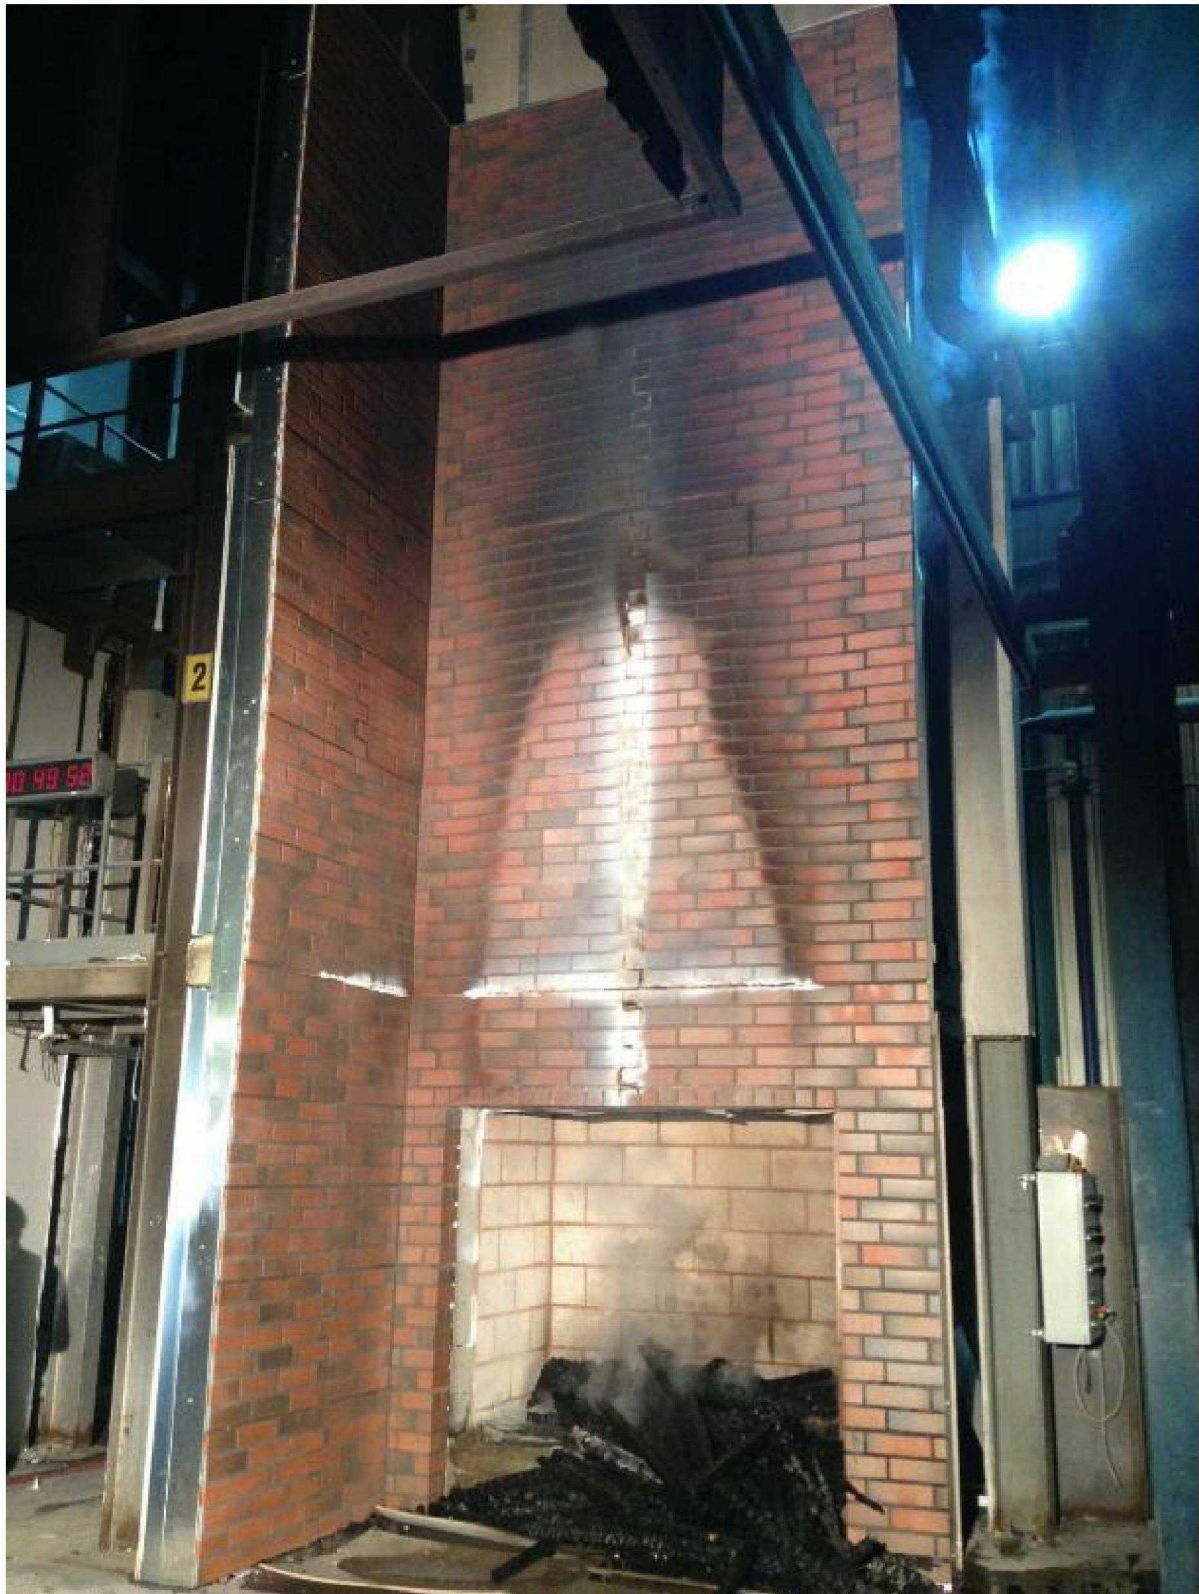
Figure 20. Tested system on completion of the test (1)

A vertical crack formed on the main face of the system, from immediately above the hearth to the second level fire break.

A second crack formed horizontally at the first level fire break level, extending from the middle of the main face to the width of the hearth on both sides of the centre.

A small horizontal crack also formed on the wing face of the wall at the same level as the main face horizontal crack, on the right hand side extending roughly 1m horizontally on the wall.

The remainder of the system above the hearth was not seen to be damaged.

No tiles or panels were observed to have detached from the system.

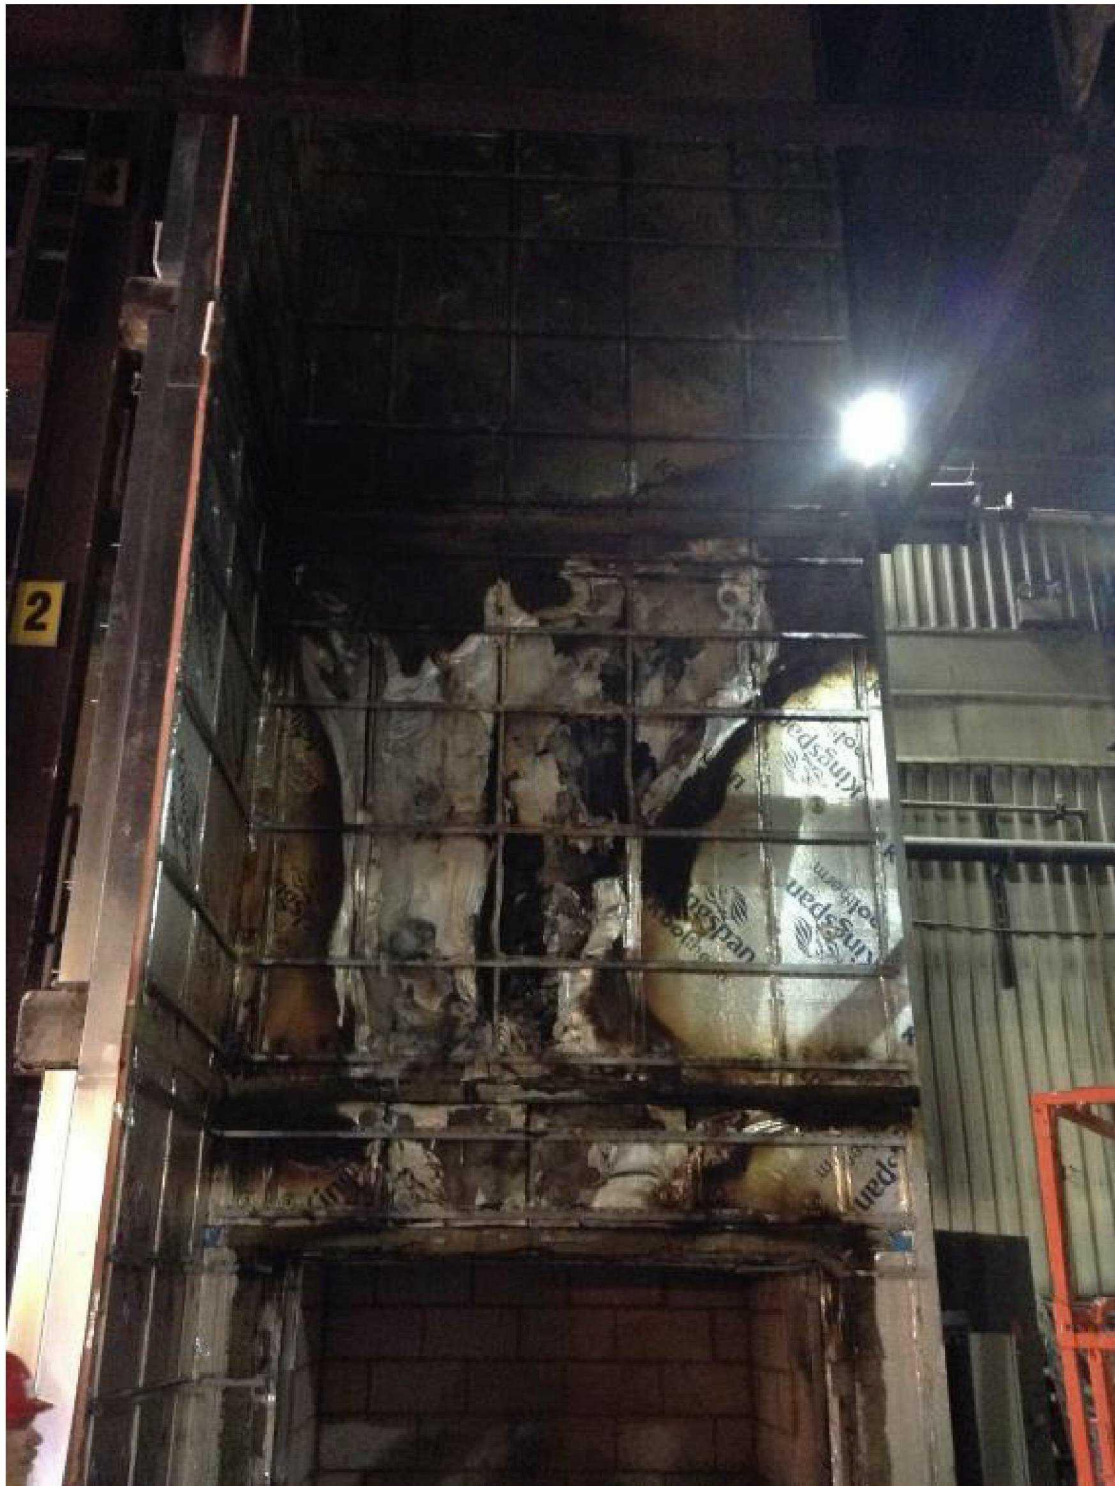
Figure 22. Photograph of insulation following removal of the brick slip panels.

After removing the brick slips, the damage assessment was as follows.

The insulation on the main face of the wall was melted and damaged up to the level 2 firebreak around the centreline of the wall (see figure 22). Insulation surrounding this area was lightly charred up to the level two fire break. The remainder of the insulation remained intact.
