Fire Performance Testing of an External Cladding System
BS 8414-1:2015 + A1:2017

Test Report

Prepared for : Kingspan Insulation Ltd.
Project : System Development
Report No. : DLR1453 Rev.0
Sample : Kooltherm K15 –Alpolic/fr - BML100

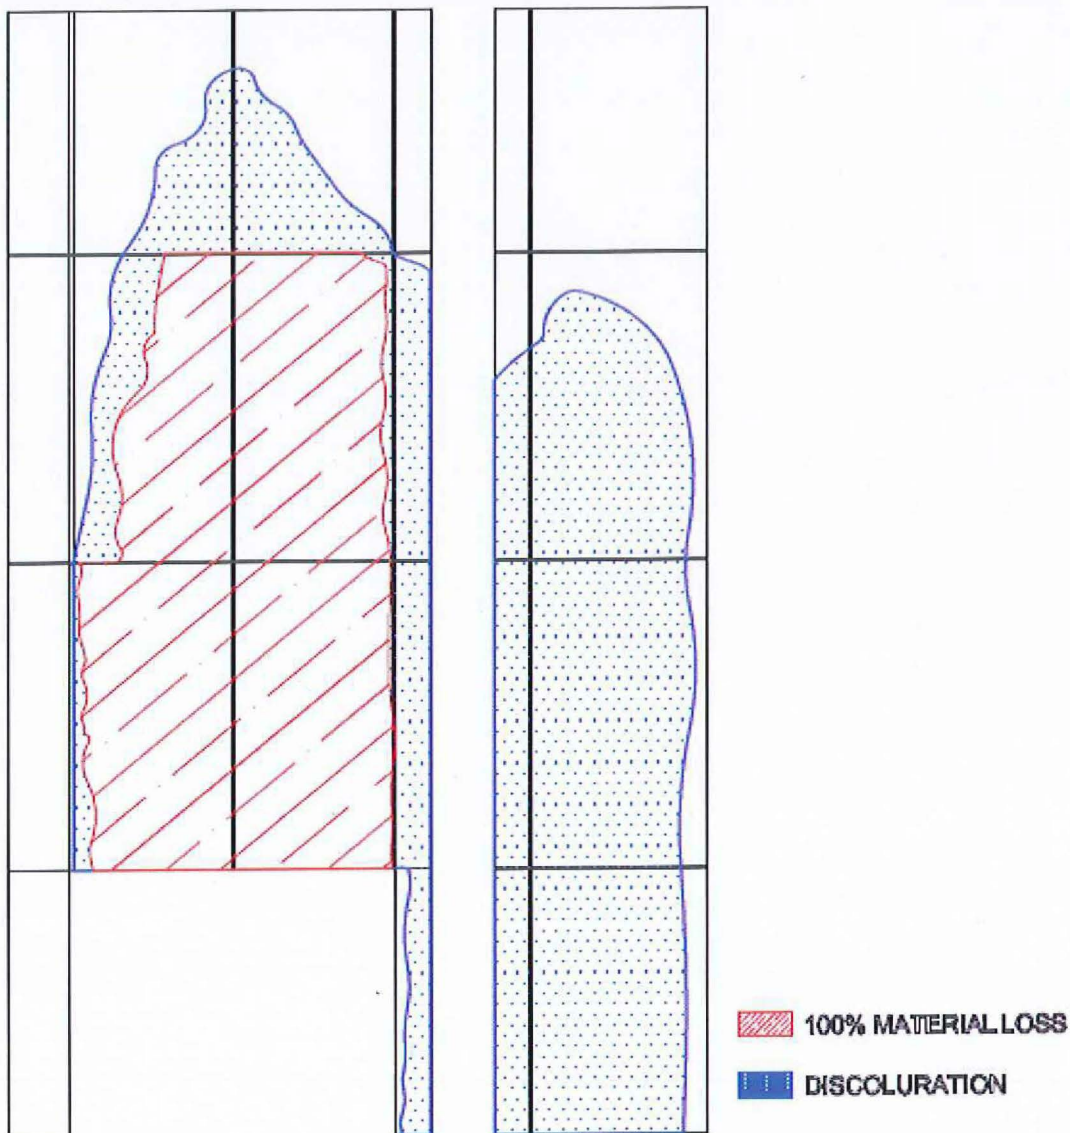
Figure 8 ACM panel damaged area

- Approximately 8m² of the total panel was completely consumed by fire.
- Approximately 10m² of the total panel was discoloured.

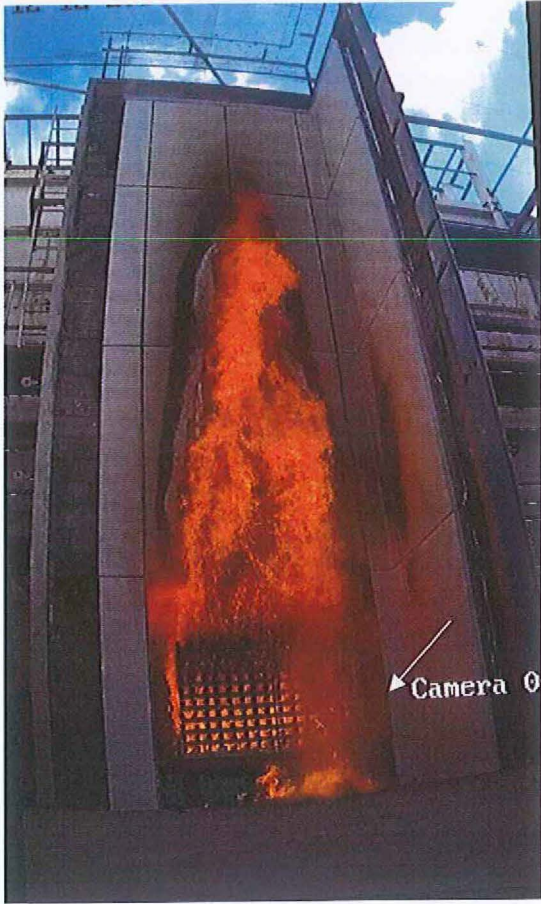
09:18:00	427	Melted aluminium dripped from main wall.	-
09:18:20	447	Flame on top of flashing above combustion chamber	-
09:18:57	484	Flaming debris fell down from main wall.	DLP C2753C/0001

DLP C2753C /0001 Flaming debris fell down from main wall.

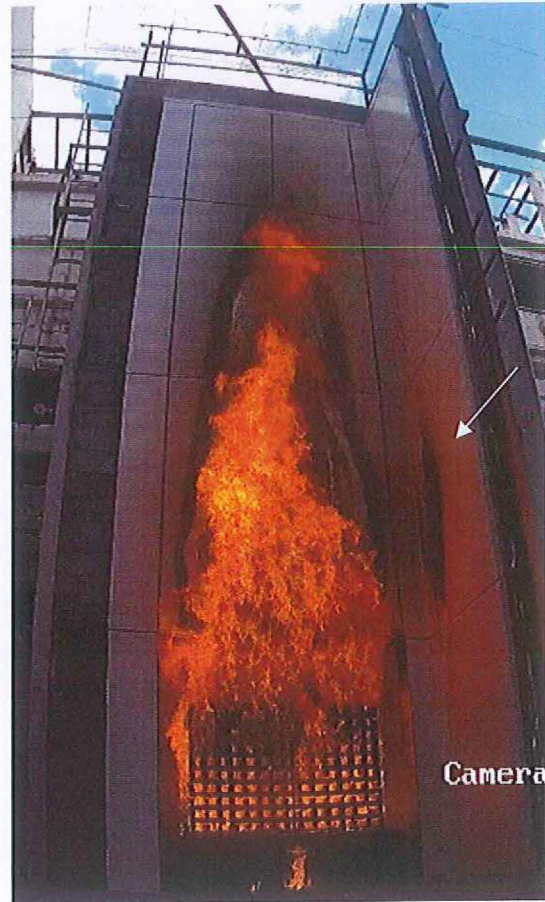
09:20:06	718	Discolouration on panel W2	DLP C2753C/0002
09:20:23	570	Discolouration on panels M12 and M13	-
09:20:30	577	Sustained flame observed on M4 & M5 vertical joint.	DLP C2753C/0003

DLP C2753C /0002 Discolouration on W2

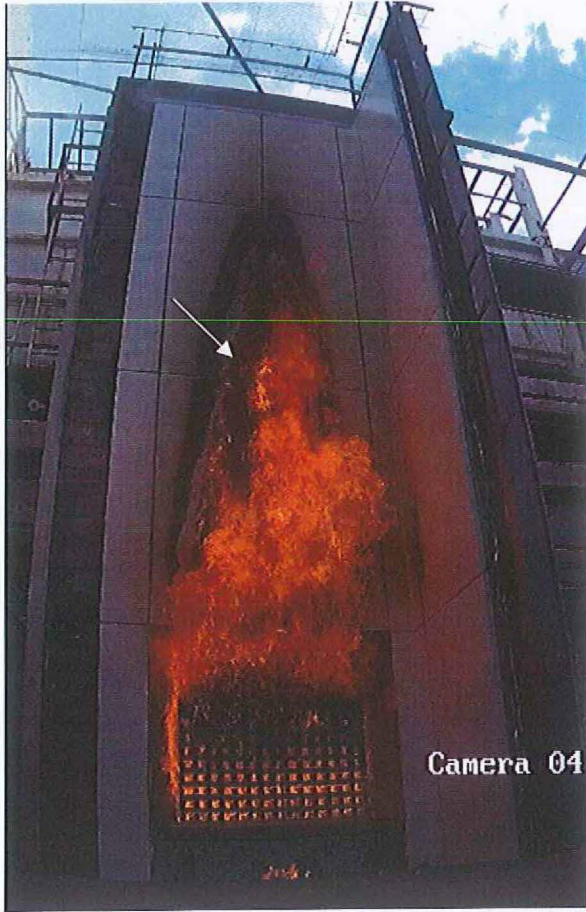
DLP C2753C/0003 Self sustained flame on M4 & M5

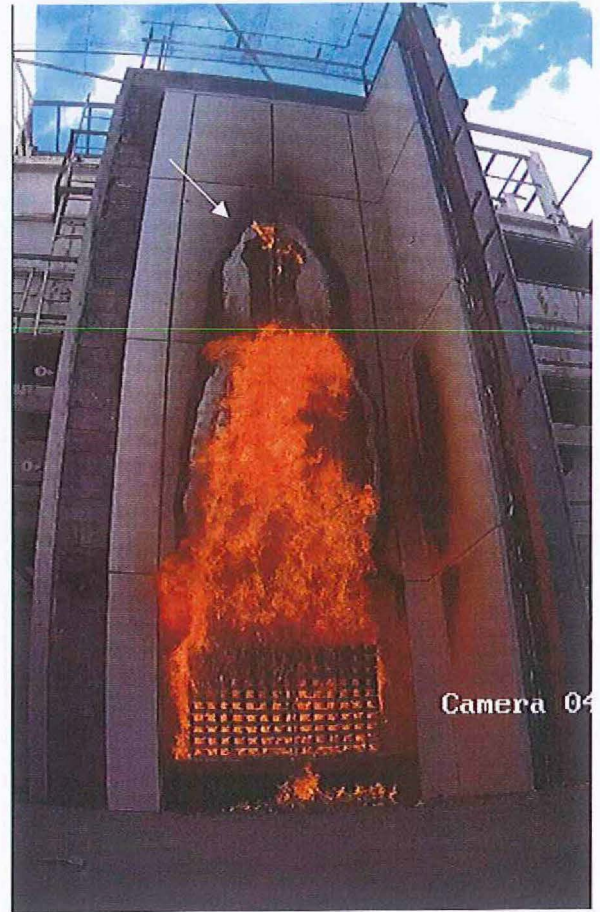
09:21:00	607	Flames observed in around burned edges of panel M4	-
09:21:28	635	Sustained flame observed on M8 & M9 vertical joint.	DLP C2753C/0004
09:22:53	720	Burning debris fell off the main wall.

DLP C2753C/0004 Self sustained flame between M8 & M9

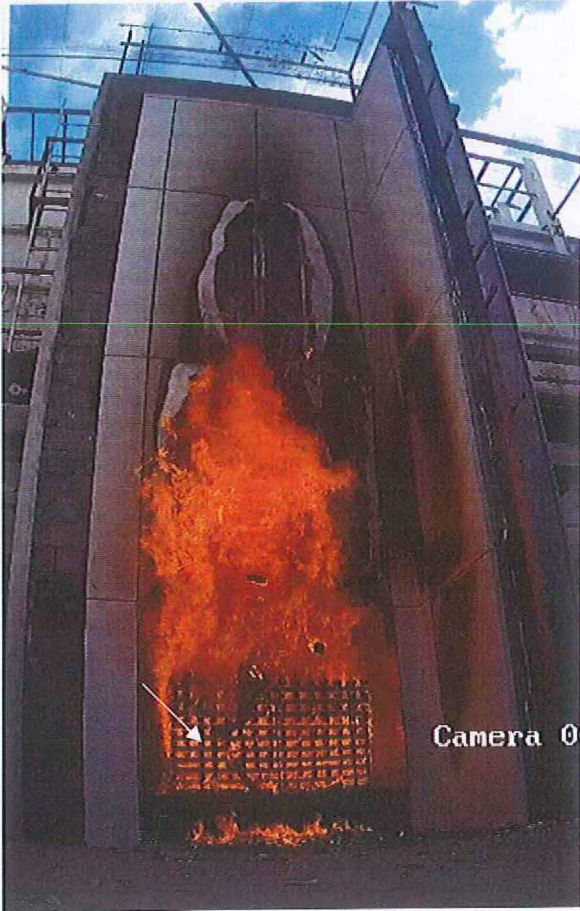
09:28:14	1041	Aluminium railings behind panel M4 and M5 melted	-
09:28:44	1071	Debris fell off the main wall.	DLP C2753C/0005
09:30:38	1185	Sustained flame at corners of panels M4 & M5.	-

DLP C2753C/0005 Debris fell off the main wall

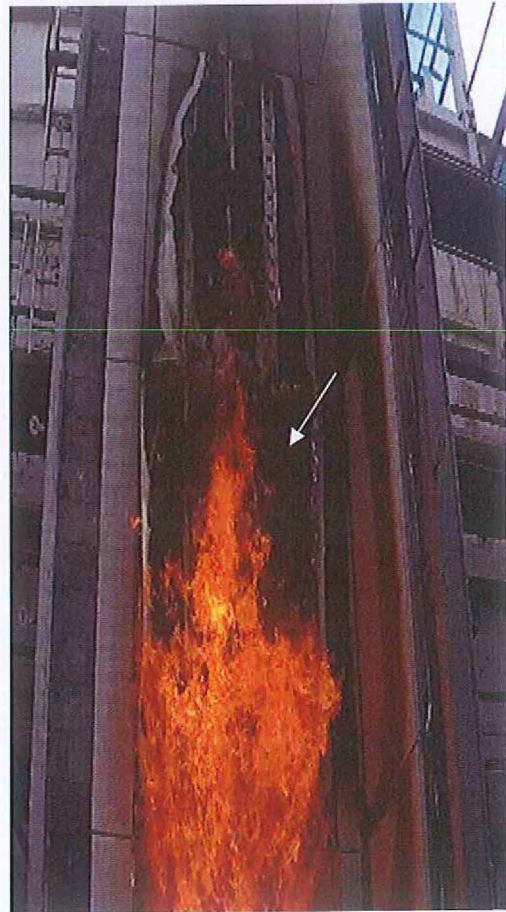
09:32:26	1293	100% of the panels M4 and M5 were consumed by fire.	DLP C2753C/0006
09:33:00	1327	Insulation behind burned panels were exposed as char.	-
09:35:39	1486	Burned insulation behind the panel M4 & M5 fell off.	-

DLP C2753C/0006 M4 & M5 panels consumed by fire

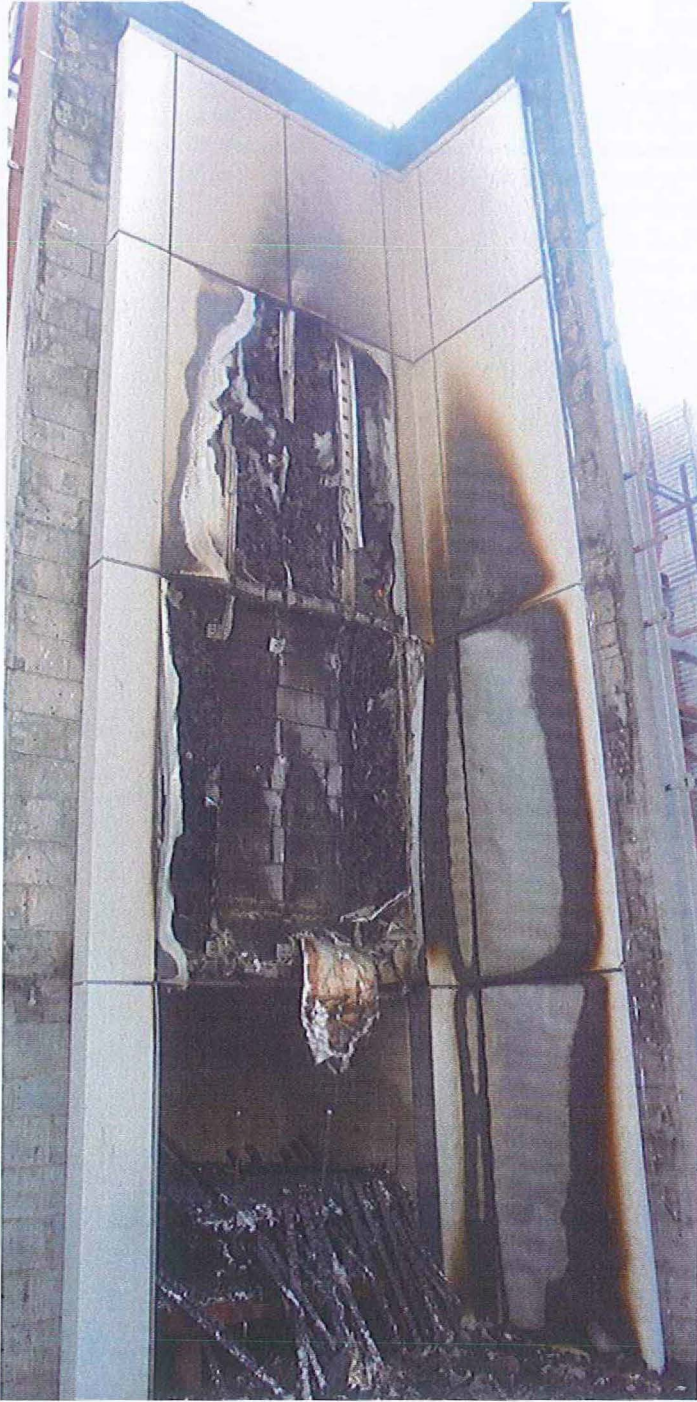
DLP C2753C/0007

Sl. No.	Components	Observation	Photo Reference
1	Aluminium composite panels	<p>Approximately 27% of material loss on the panels.</p> <p>Approximately 37% of panel was discoloured.</p> <p>Panels M1, M7, M11 and M14-W7 corner, W8 - No damage was observed.</p> <p>Panel M2-W1 corner – 100% discolouration on W1. Minor discolouration on M2.</p> <p>Panel M3 - Minor discolouration was observed at edge. No other damage was observed</p> <p>Panels M4, M5 - 100% of the panel was consumed by fire.</p> <p>Panel M6-W3 corner - 100% of the panel was discoloured and 1st layer of coating was burned from panel W3.</p> <p>Panel M8 - Approximately 60% of the panel was consumed by fire, the remaining was distorted, discoloured and buckled.</p> <p>Panel M9 - Approximately 90% of the panel was consumed by fire, the remaining was distorted, discoloured and buckled.</p> <p>Panel M10-W5 corner - Minor discolouration was observed.</p> <p>Panels M12, M13 – Top coating was burned at the vertical joint, discolouration was observed</p> <p>Panels M12, M13 – Top coating was burned at the vertical joint.</p> <p>W2- Approximately 80% top coating was burned and discoloured.</p> <p>W4- Approximately 75% top coating was burned, discoloured and buckled.</p> <p>W6- Approximately 50% discolouration was observed.</p>	<p>DLP C2753C/0007</p> <p>See Figure 8 in this section for area details.</p>

Sl. No.	Components	Observation	Photo Reference
5	Brackets	100% of brackets behind panels M4, M5, M6-W4, M8 and M9 were damaged. All other brackets were discoloured and were in place without any damage.	DLP C2753C/0007.

View of the sample after the test completion

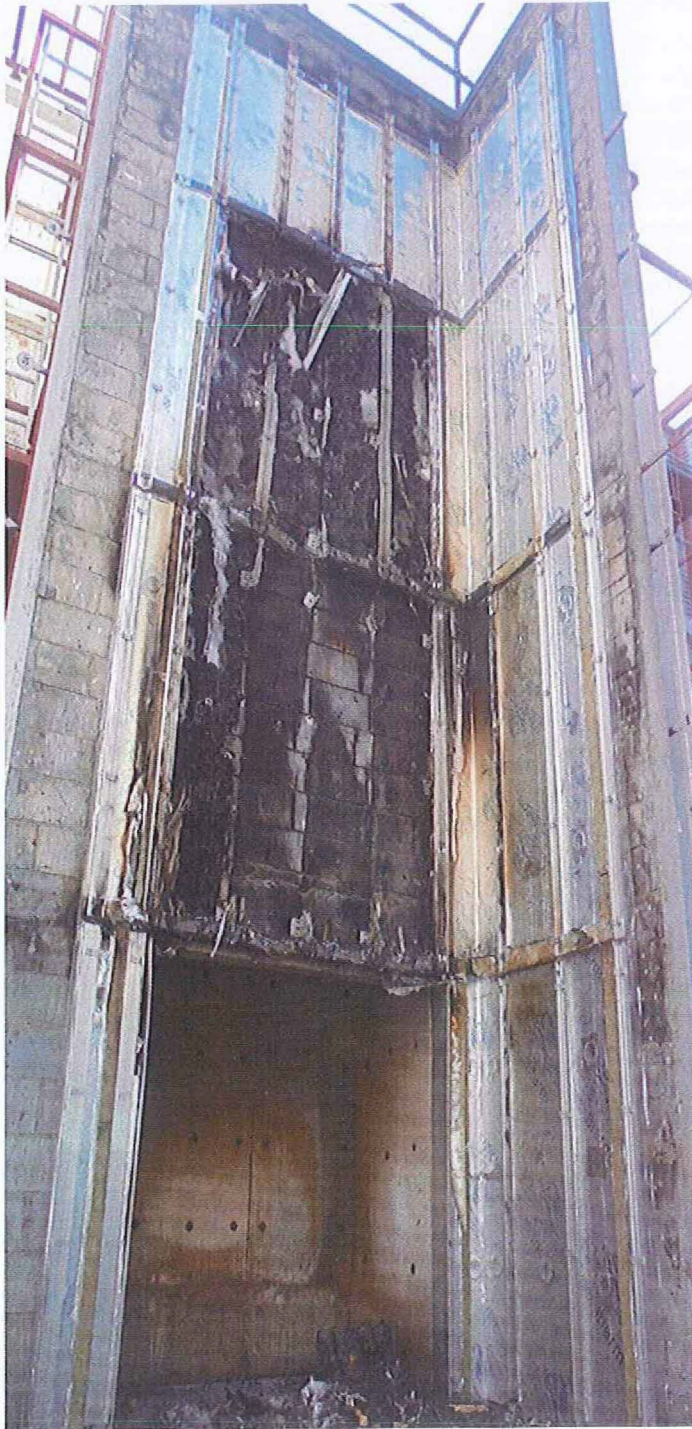
Sl. No.	Components	Observation	Photo Reference
2	Cavity barrier	<p>Horizontal intumescent cavity barrier:</p> <p>The 1st horizontal cavity barrier at 150mm above the combustion chamber was activated. Melted aluminium debris fell onto the barrier and was compressed by its weight. Material loss and damage was observed.</p> <p>The 2nd horizontal cavity barriers at 2480mm was activated. The expanded intumescent layer was not present on the main wall during dismantling.</p> <p>The 3rd horizontal cavity barriers at 4810mm on main wall was activated and on wing wall was not activated. No material loss were observed.</p> <p>The 4th horizontal cavity barriers at 6425mm on main wall and was partially activated on main wall and on wing wall was not activated. No material loss was observed.</p> <p>Vertical cavity barrier:</p> <p>Minor discolouration and buckling to the vertical cavity barriers extending between panel M1 and combustion chamber.</p> <p>Buckling and minor material loss on vertical cavity barriers extending between combustion chamber and panel M2. No damage to the vertical cavity barrier on wing wall.</p>	DLP C2753C/0008, DLP C2753C/0009 & DLP C2753C/0010.

3	Insulation	<p>100% damage on Kooltherm K15 insulations and core wall was exposed behind panels M4, M5.</p> <p>Insulation behind W3 was discoloured.</p> <p>Insulation behind M8, M9 was damaged and exposed as charcoal.</p> <p>All other insulations were in place without any damage.</p>	DLP C2753C/0008 & DLP C2753C/0009
4	Railing	<p>All railings behind panels M4 & M5 were melted off.</p> <p>Railings behind panels M3, M7, M11, M12 and M13 were discoloured.</p> <p>Railings behind M2-W1 and W2 were buckled and discoloured. All other railings were in place without any damage.</p>	DLP C2753C/0009

DLP C2753C/0008 Cavity barrier and insulation

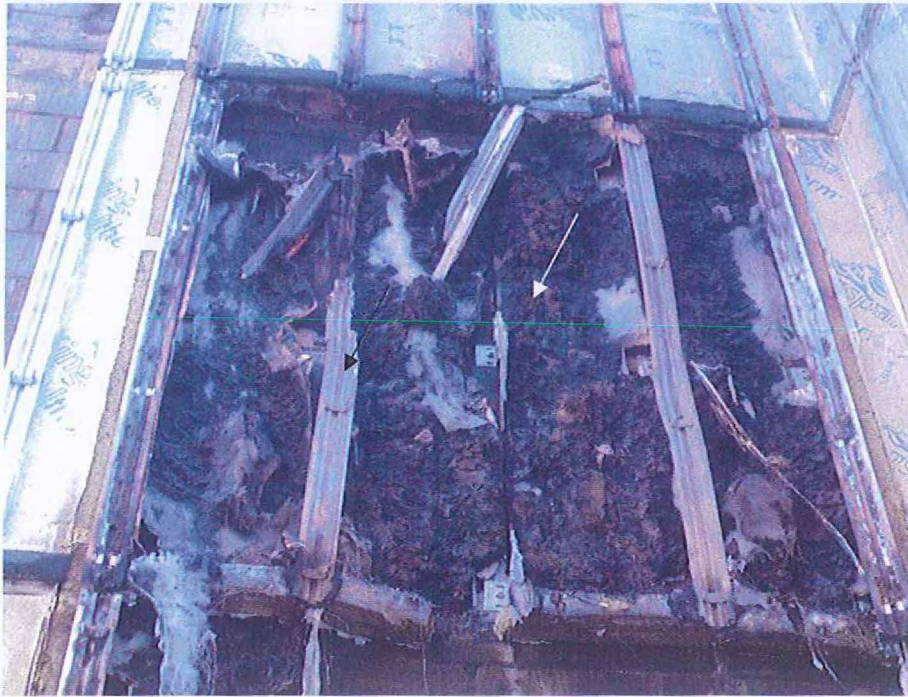
DLP C2753C/0009 Burned Kooltherm K15 insulation and railings

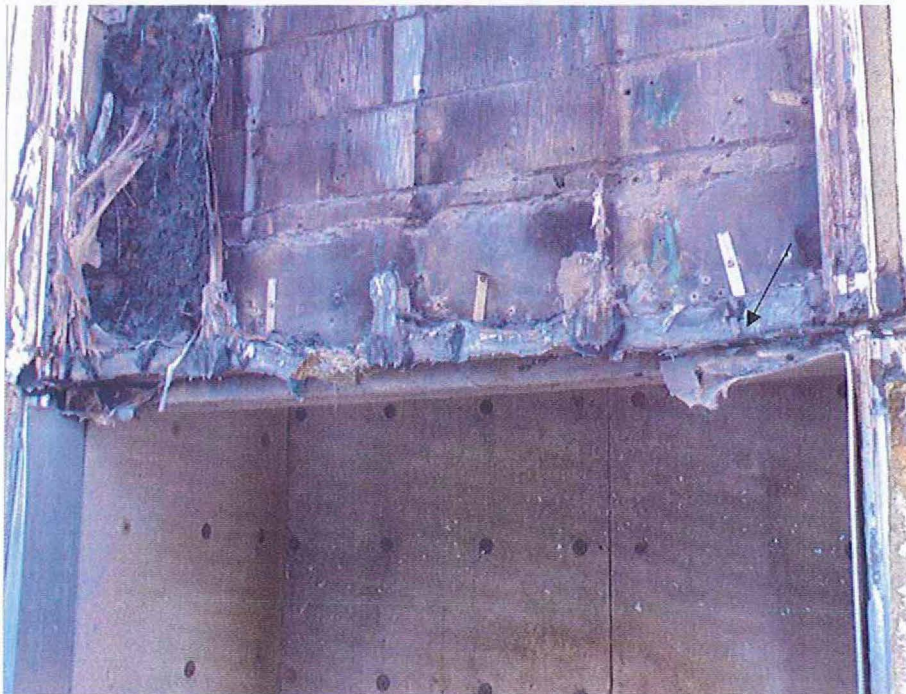
DLP C2753C/0010 Cavity barrier at the top of combustion chamber
