Fire Performance Testing of an External Cladding System
BS 8414-1:2015 + A1:2017

Test Report

Report No. : DLR1448 Rev.0

Sample : Kooltherm K15 100mm - 3mm Aluminium Cassette

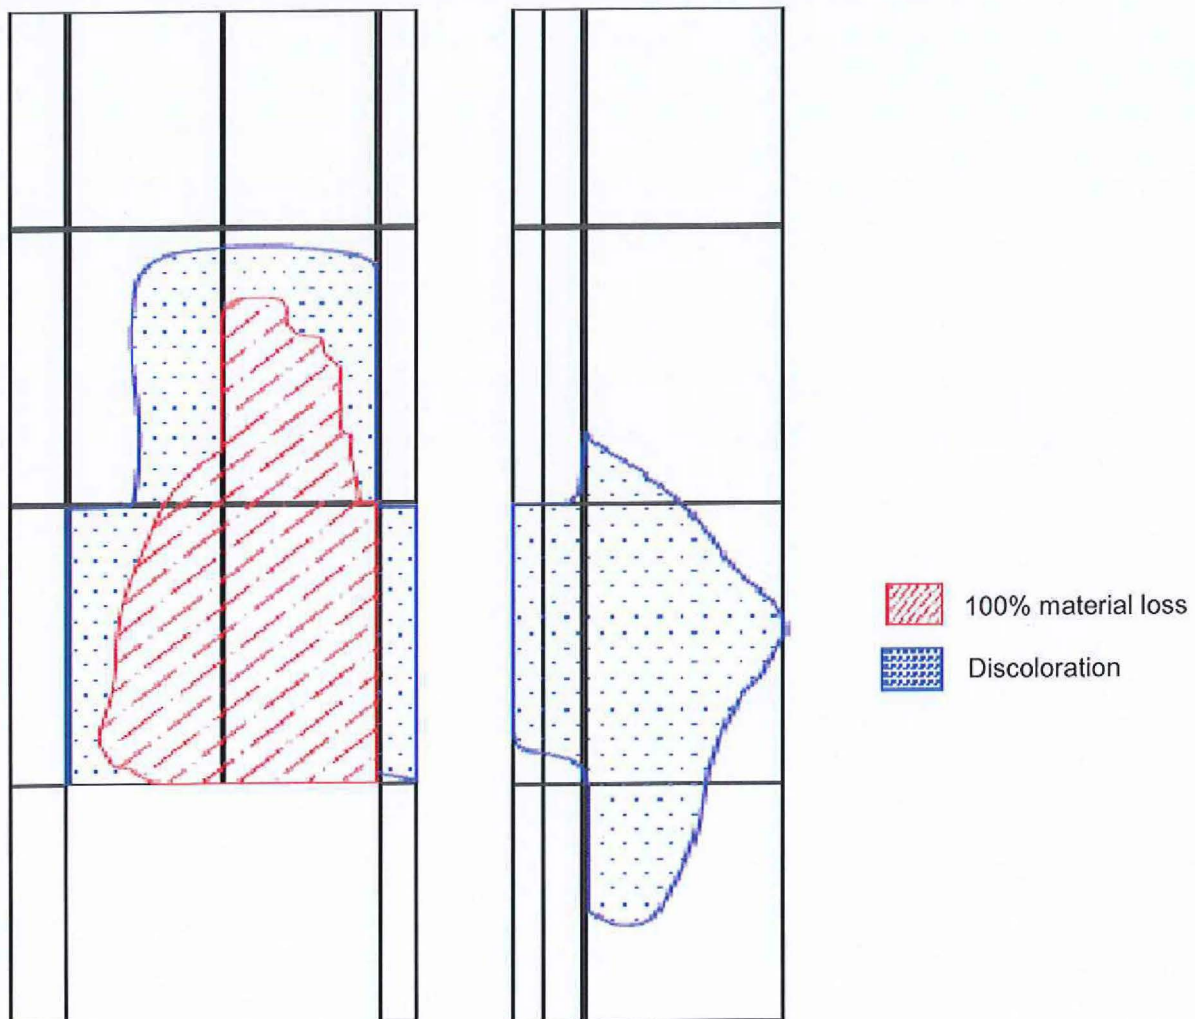
Figure 8 Area Map Showing the Condition of the aluminium panels after the Test

Sl. No.	Components	Observation	Photo Reference
1	Aluminium panels	<ul style="list-style-type: none"> Approximately 28% (5m²) of complete material loss on main wall aluminium panels. No material loss on wing wall aluminium panels. Approximately 19% (3.4m²) of discolouration on main wall aluminium panels. Approximately 28% (3.6m²) of discolouration on main wall aluminium panels. <p>Panels M1, M7, M11, M14-W7 corner & W8 - No damage was observed.</p> <p>Panel M2-W1 corner – Minor discolouration.</p> <p>Panel M3 - Minor discolouration at the corner. No other damage was observed</p> <p>Panel M4 - Approximately 50% of the panel was consumed in fire, the remaining was distorted, discoloured and buckled.</p> <p>Panel M5 - 100% of the panel was consumed in fire.</p> <p>Panel M6-W3 corner - 90% of the panel was discoloured and the 1st coating was burned.</p> <p>Panel M8 - Approximately 10% of the panel was consumed in fire, the remaining was distorted, discoloured and buckled.</p> <p>Panel M9 - Approximately 60% of the panel was consumed in fire, the remaining was distorted, discoloured and buckled.</p> <p>Panels M10-W5 corner, M12 & M13 – Minor discolouration.</p> <p>Panel W2- Approximately 25% of the top coating was burned and discoloured.</p> <p>Panel W4 - Approximately 85% top coating was burned and discoloured and buckled.</p> <p>Panel W6 - Minor discolouration.</p>	<p>DLP C2753B/0005</p> <p>See Figure 8 in this section for area details.</p>

- Approximately 5m² of the total aluminium panels was completely consumed by fire.
- Approximately 7m² of the total aluminium panels was discoloured.

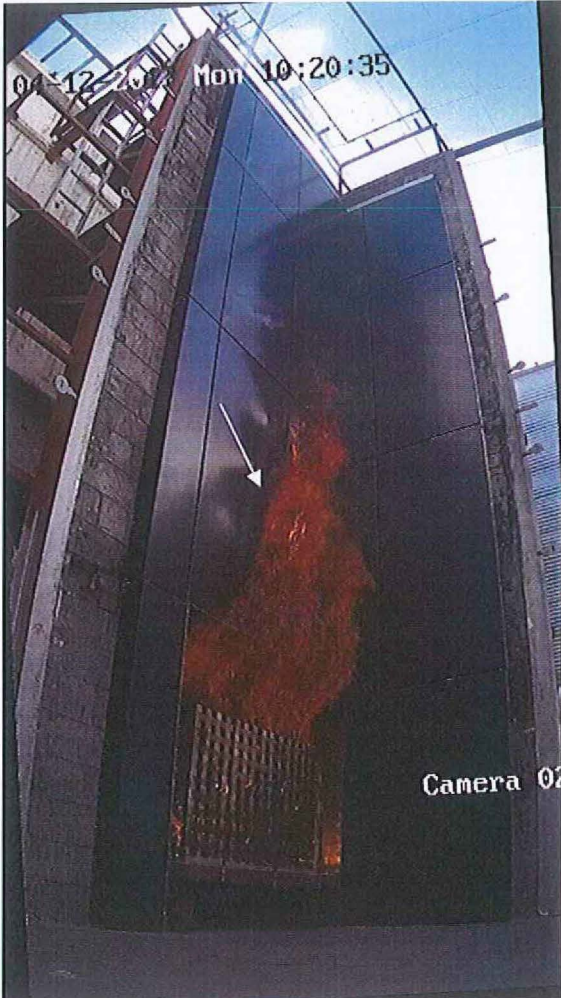
DLP C2753B/0001 1st layer of coating started to burn.

10:20:21	190	Flames reached 2000mm above the combustion chamber.	-
10:20:35	152	1 st layer of coating of panels M4 & M5 started to burn.	DLP C2753B/0001

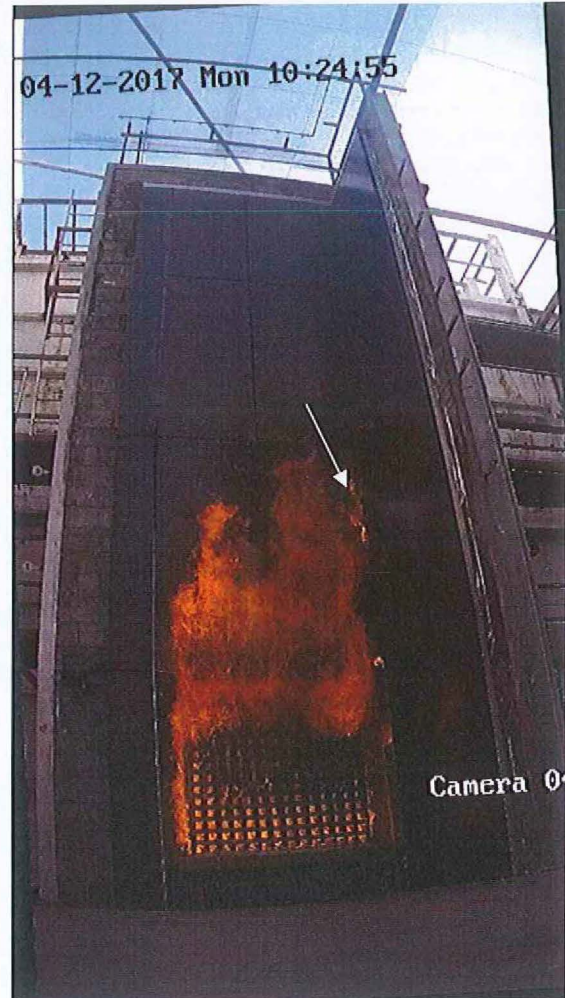
DLP C2753B/0002 Continuous flame observed on panels M5 & M6 vertical joint.

10:24:54	463	Sustained flame observed on panels M5 & M6 vertical joint.	DLP C2753B/0002
10:25:40	509	Panels M4 & M5 melted.	-
10:26:33	562	Railings behind panels M4 & M5 melted.	-

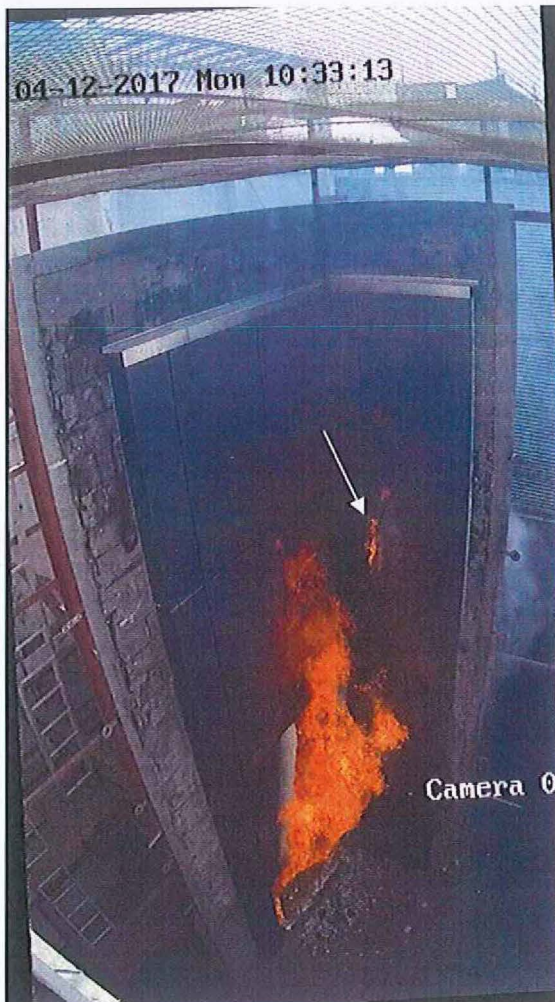
DLP C2753B/0003 Continuous flame observed on W5 & W6 vertical joint.

Time	Seconds	Observation	Photo Reference
10.31.39	868	Flames observed between panes W2 & W3 horizontal joint.	-
10.33.13	962	Sustained flame observed on panels W5 & W6 vertical joint.	DLP C2753B/0003

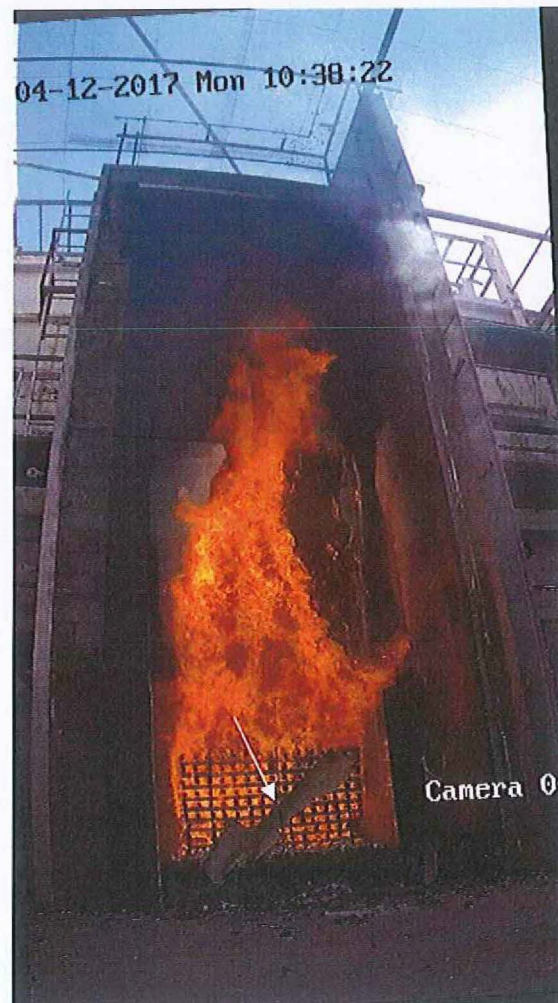
DLP C2753B/0004 Panel M5 fell from the main wall.

10.38.22	1271	Panel M5 fell from the main wall.	DLP C2753B/0004
10.39.38	1347	Kooltherm K15 insulation behind panels M4, M5, M8 & M9 was exposed as charcoal.	-

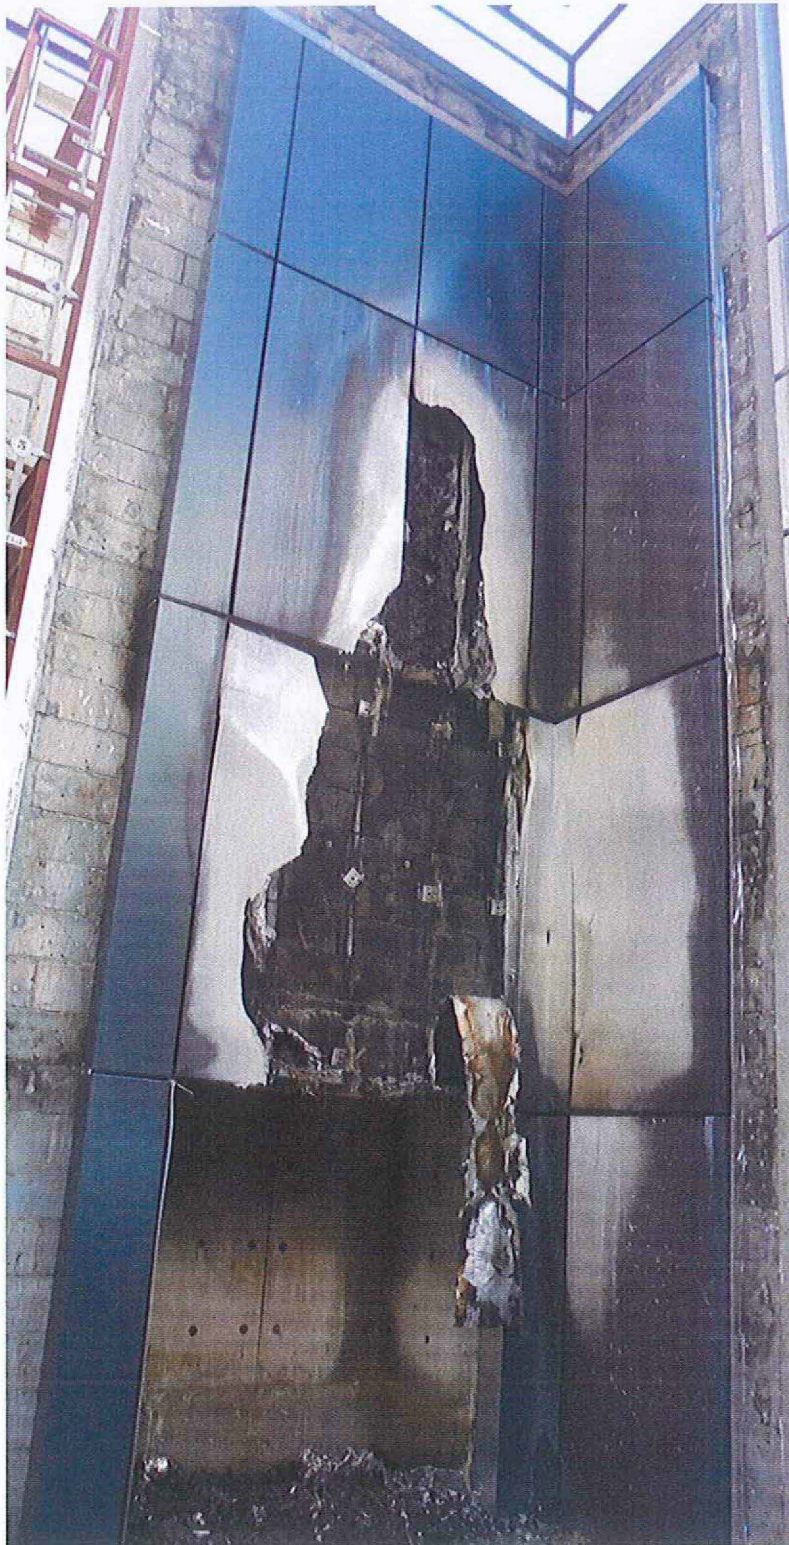
DLP C2753B/0005

View of the sample after the test completion

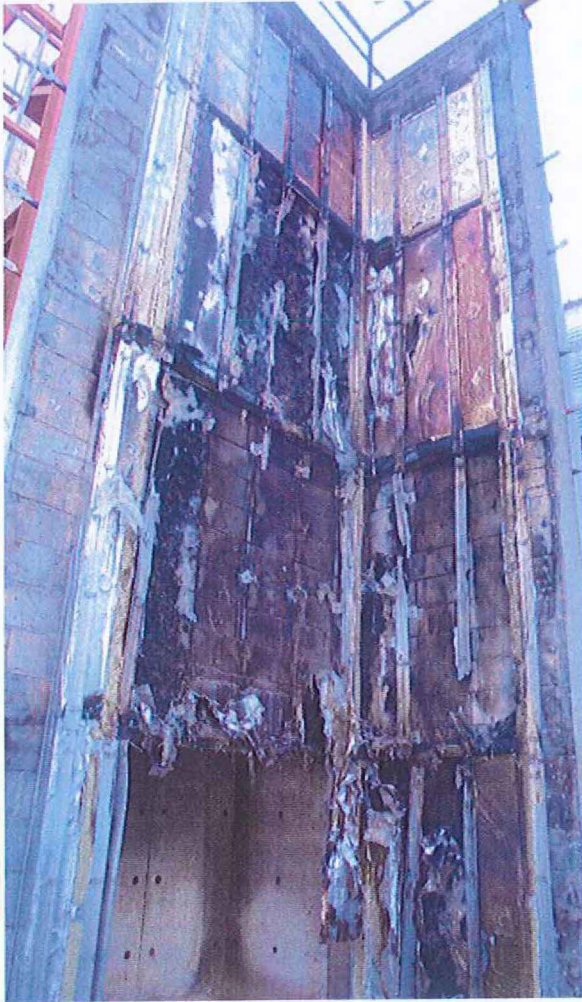
Sl. No.	Components	Observation	Photo Reference
2	Cavity barrier	<p>Horizontal intumescent cavity barrier:</p> <p>The 1st horizontal cavity barrier above the combustion chamber was activated. Melted aluminium and middle core of the panel debris fell onto the barrier and was compressed by its weight. Material loss and damage was observed.</p> <p>The 2nd horizontal cavity barrier at 2330mm above the combustion chamber was activated. The expanded intumescent layer was not present on the main wall during dismantling.</p> <p>The 3rd horizontal cavity barrier at 4660mm above the combustion chamber on main wall and wing wall was activated. No material loss was observed.</p> <p>The 4th horizontal cavity barrier at 6274mm above the combustion chamber on main wall and wing wall was activated. No material loss was observed.</p> <p>Vertical cavity barrier:</p> <p>Minor discolouration to the vertical cavity barrier extending between panel M1 and the combustion chamber.</p> <p>Buckling and minor material loss on vertical cavity barrier extending between the combustion chamber and panel M2.</p> <p>Minor discolouration to the vertical cavity barrier on wing wall.</p>	DLP C2753B/0006, DLP C2753B/0007 & DLP C2753B/0008.

3	Insulation	<p>100% damage on Kooltherm K15 insulations and core wall was exposed behind panels M4, M5, M6-W3, M9 & M10-W5.</p> <p>Insulation behind panels W2, W4 & W6 were charred and exposed as charcoal.</p> <p>Discoloration was observed to insulations behind panels M1, M3, M7, M11, M12, M14-W7 & W8.</p>	DLP C2753B/0007
4	Railing	<p>Railings behind panels M4, M5, M6-W3, W4, M8 & M9 were melted. Railings behind panels M1, M3, M7, M11, M12, M13, M14-W7 and W8 were discoloured.</p> <p>Railings behind panels M2-W1 & W2 were buckled and discoloured.</p>	DLP C2753B/0007

SI. No.	Components	Observation	Photo Reference
5	Bracket	100% of the brackets behind panels M4, M5 & M6-W4 were damaged. All other brackets were discoloured and were in place without damage.	DLP C2753B/0007.

View of the sample
without panels

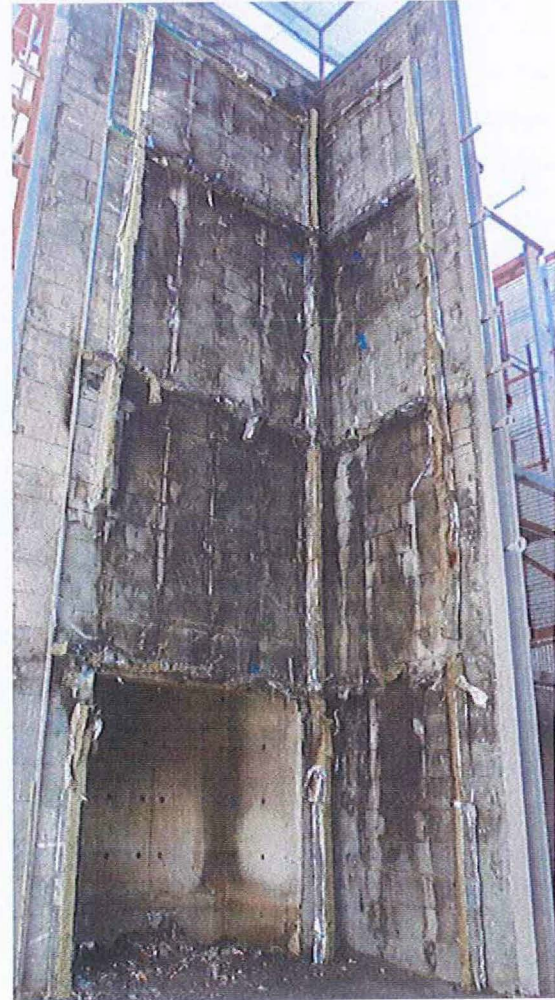
DLP C2753B/0008

View of the cavity
barriers

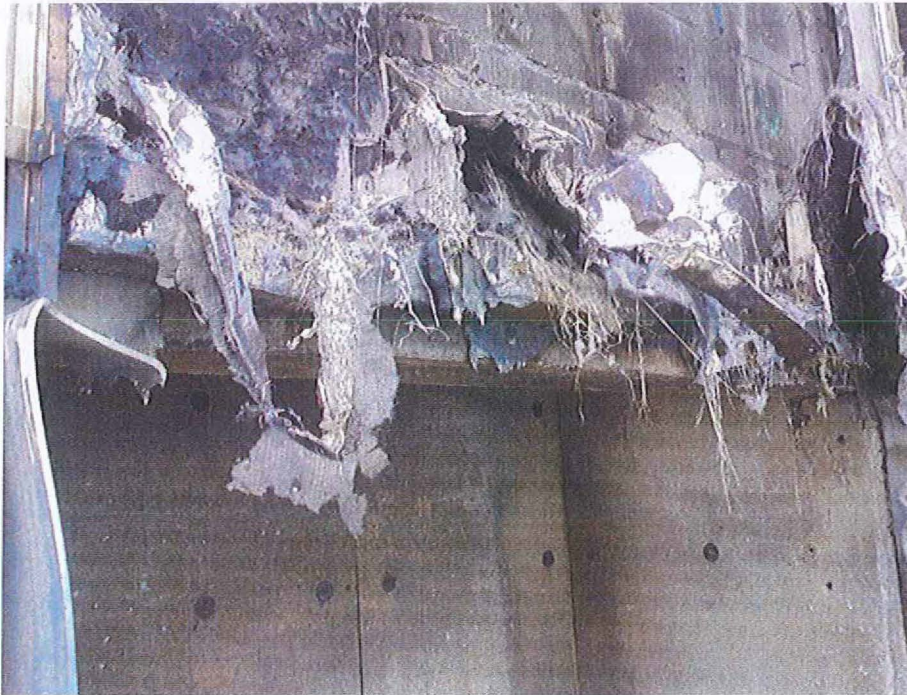
DLP C2753B/0006

Cavity barrier at the top of combustion chamber
