BRE Global Test Report

BS 8414-2:2015 + A1:2017 Test on a ventilated façade system with Kingspan Kooltherm insulation (100mm-thick) and Alpolic A2 panels (4mm-thick).

Date: 25th July 2018

Report Number: P109938-1000 **Issue:** 1

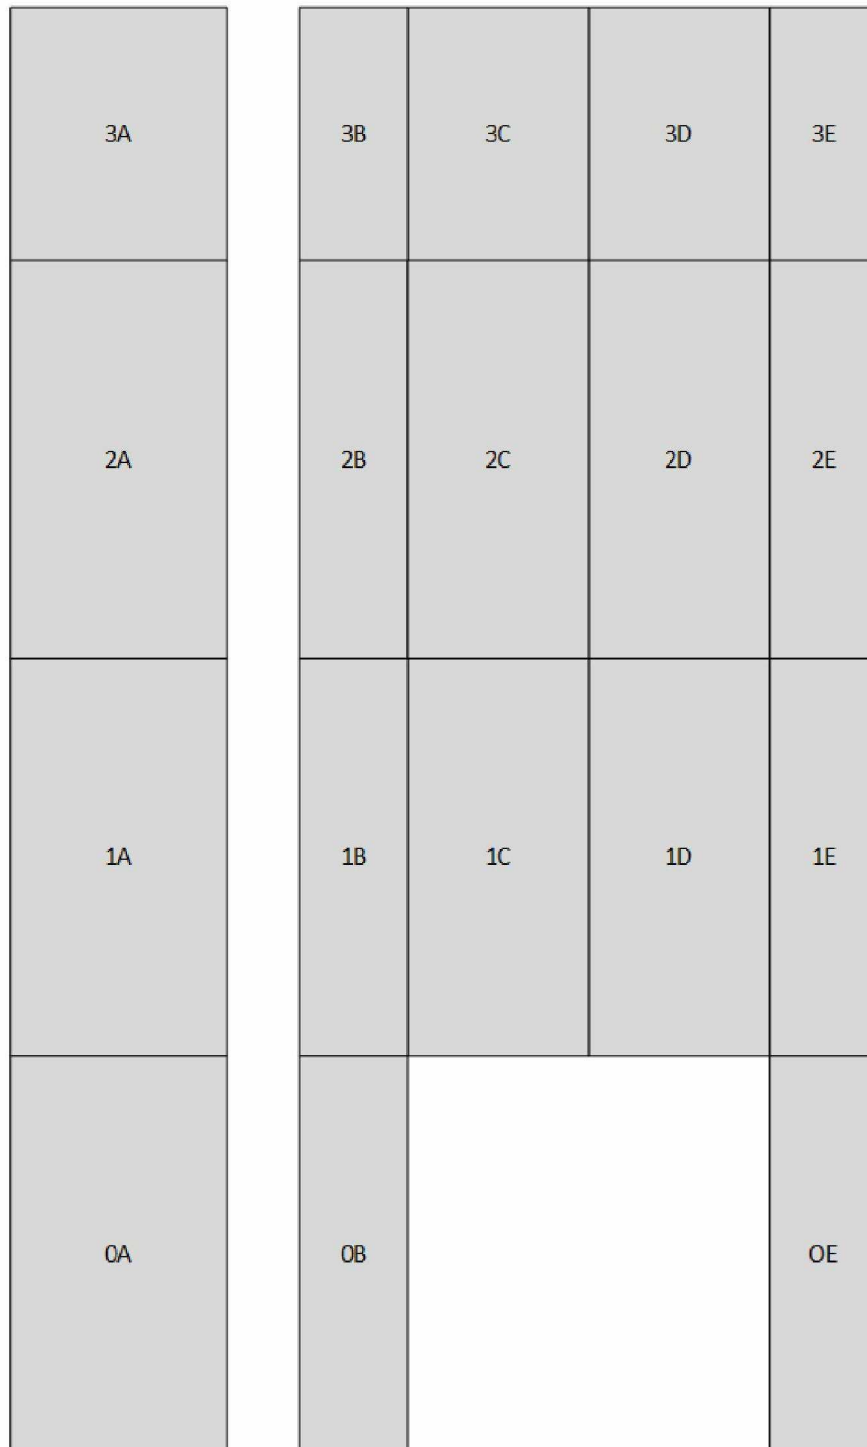
Figure 2. Layout of panels and numbering system used for reporting. Not to scale.

Panel 0A – 70% of coating removed and 20% dark discolouration and panel distorted.

Panel 0B – Intact and in place with distortion across panel.

Panel 0E – dark discoloration at top left-hand corner, no visible damage across the rest of the panel.

Panel 1A – 70% coating removed and 20% dark discolouration, panel distorted.

Panel 1B – 90% dark discolouration with distortion.

Panel 1C – 80% consumed. 80% of coating removed and 20% dark discolouration on the remainder of the panel.

Panel 1D – 80% consumed. 60% of coating removed and 30% dark discolouration on the remainder of the panel.

Panel 1E – localised areas of dark discolouration with minor distortion across the panel.

Panel 2A – 30% dark discolouration with distortion across the panel.

Panel 2B – dark discolouration at bottom left-hand corner. Distortion across panel.

Panel 2C – 40% consumed. 60% of coating removed and 20% dark discolouration on the remainder of the panel.

Panel 2D – 40% consumed. 40% coating removed and 20% dark discolouration on the remainder of the panel.

Panel 2E – dark discolouration at bottom left-hand corner. Minor distortion across panel.

Panel 3A – intact and in place. Slight distortion.

Panel 3B – intact and in place. Slight distortion.

Panel 3C – slight consumption at base of panel (<0.01m²). 30% dark discolouration and 10% of coating removed.

Panel 3D – 20% dark discolouration with 10% of coating removed. Heavy distortion at base with slight distortion throughout panel.

Panel 3E – no visible damage.

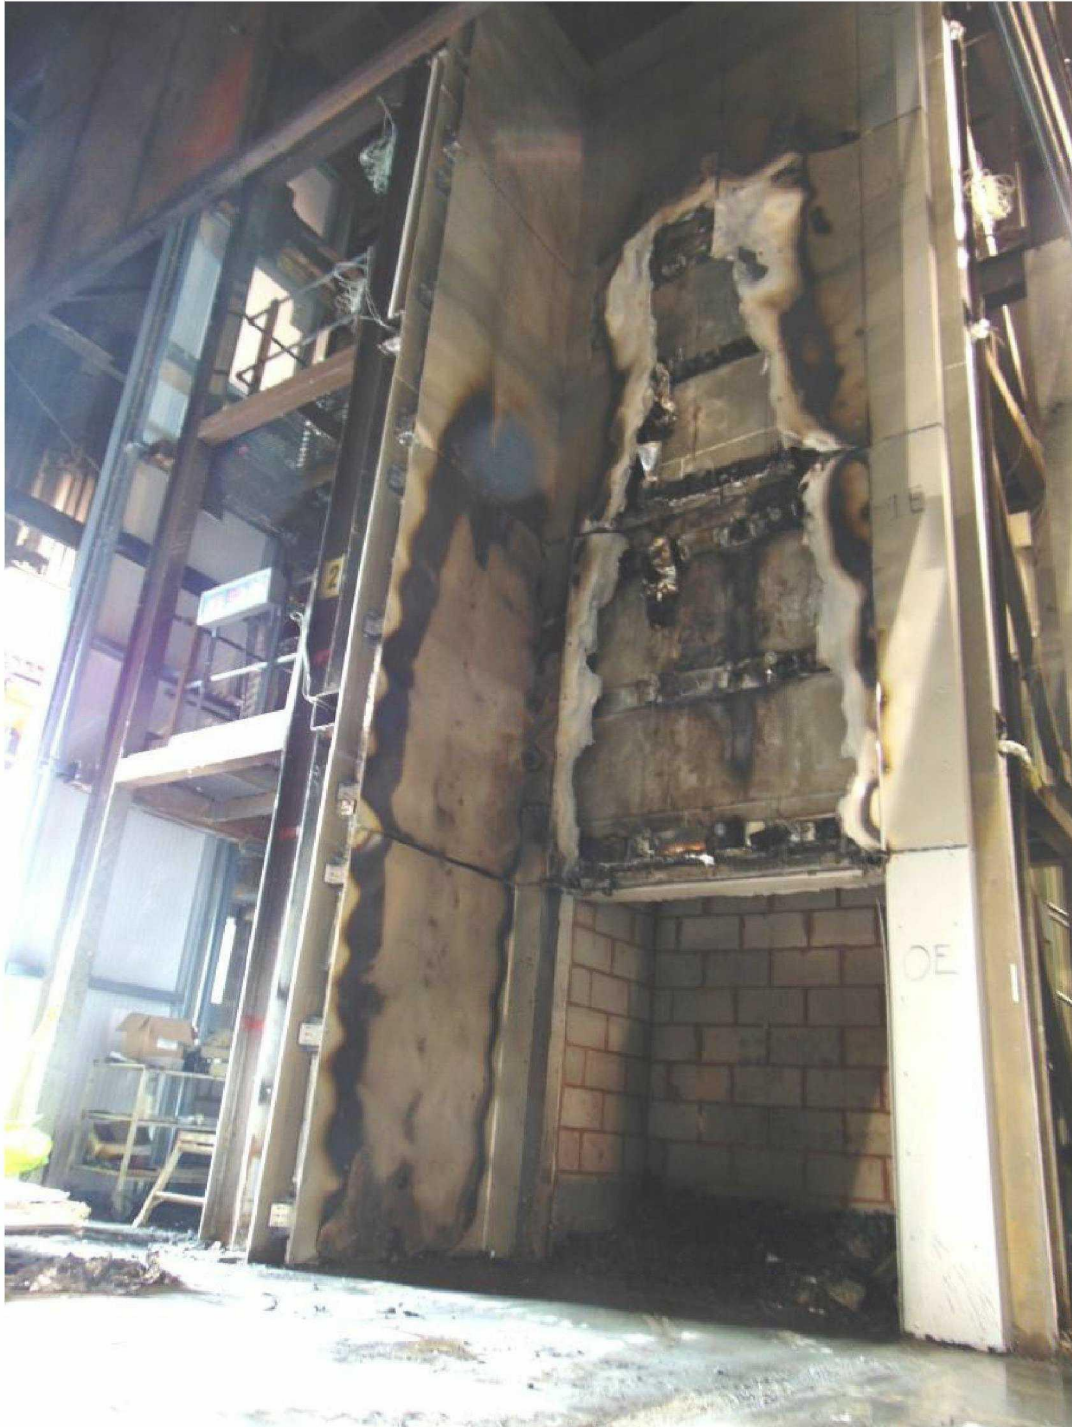
Flaming debris was observed from the cladding system from 12 minutes 5 seconds until approximately 19 minutes 25 seconds. A small fire formed at the base of the cladding system as a result. Consumption of ACM panels was observed tapering up to a height of approximately 5m above the top of the combustion chamber. Detachment of insulation and horizontal cavity barriers was also observed.

After the crib was extinguished flaming continued within the exposed insulation until approximately 35 minutes 10 seconds where the flaming was concentrated behind the remainder of panels 1C, 1D, 2C and 2D. All flaming ceased at 50 minutes 40 seconds.

Figure 20. Full-height photograph of cladding system immediately after test.

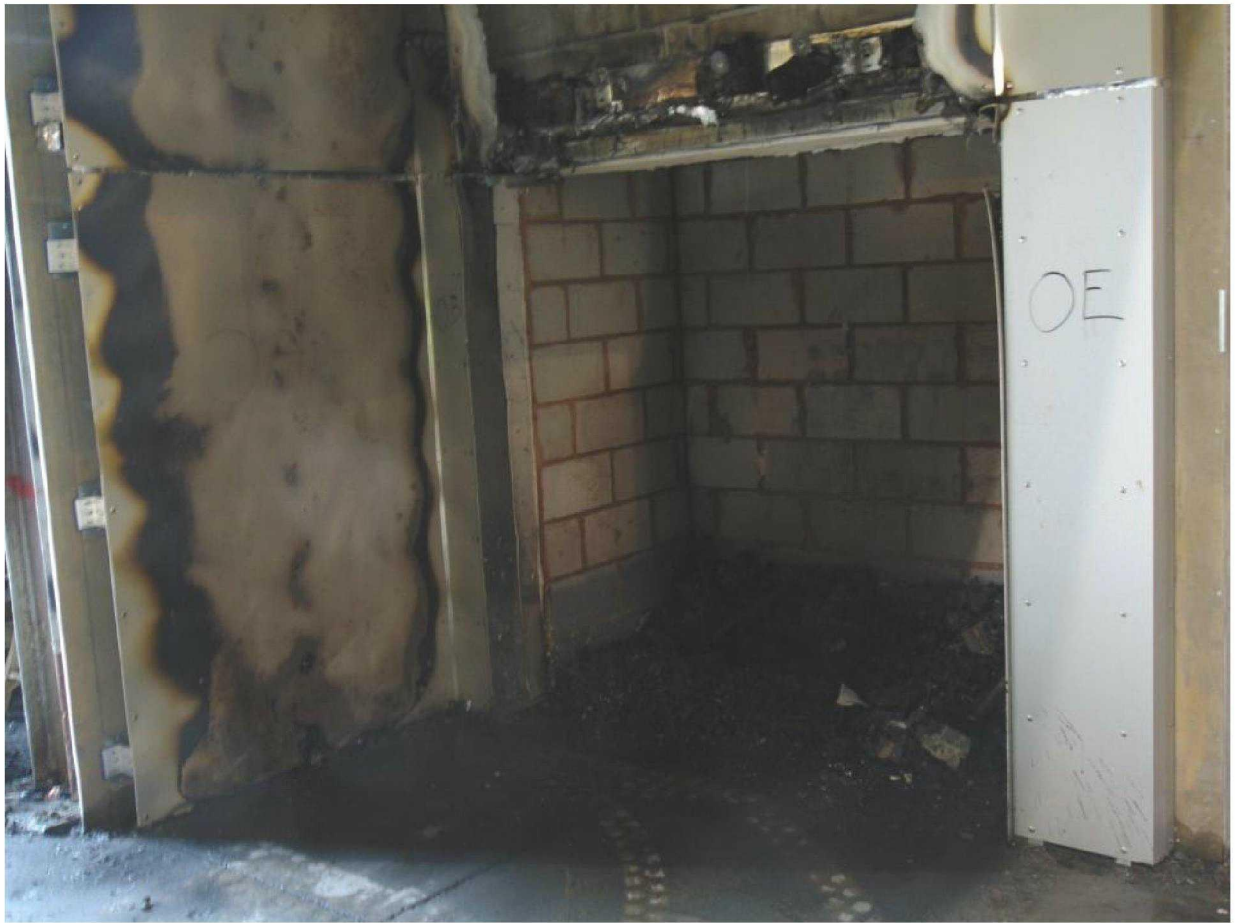
Figure 21. Damage to panels between ground and top of combustion chamber opening.

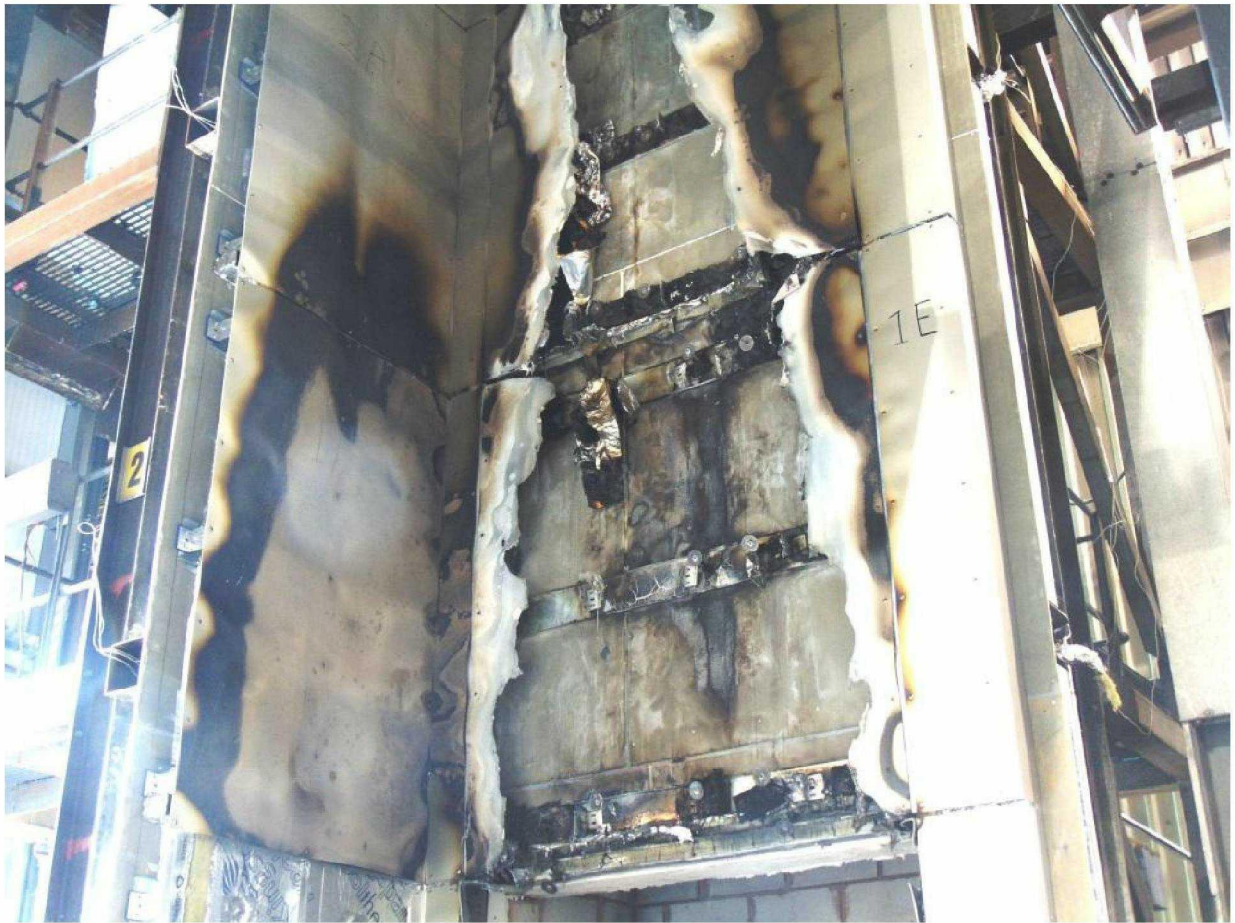
Figure 22. Damage to panels between top of combustion chamber and a height of approximately 5000mm above the top of the combustion chamber.

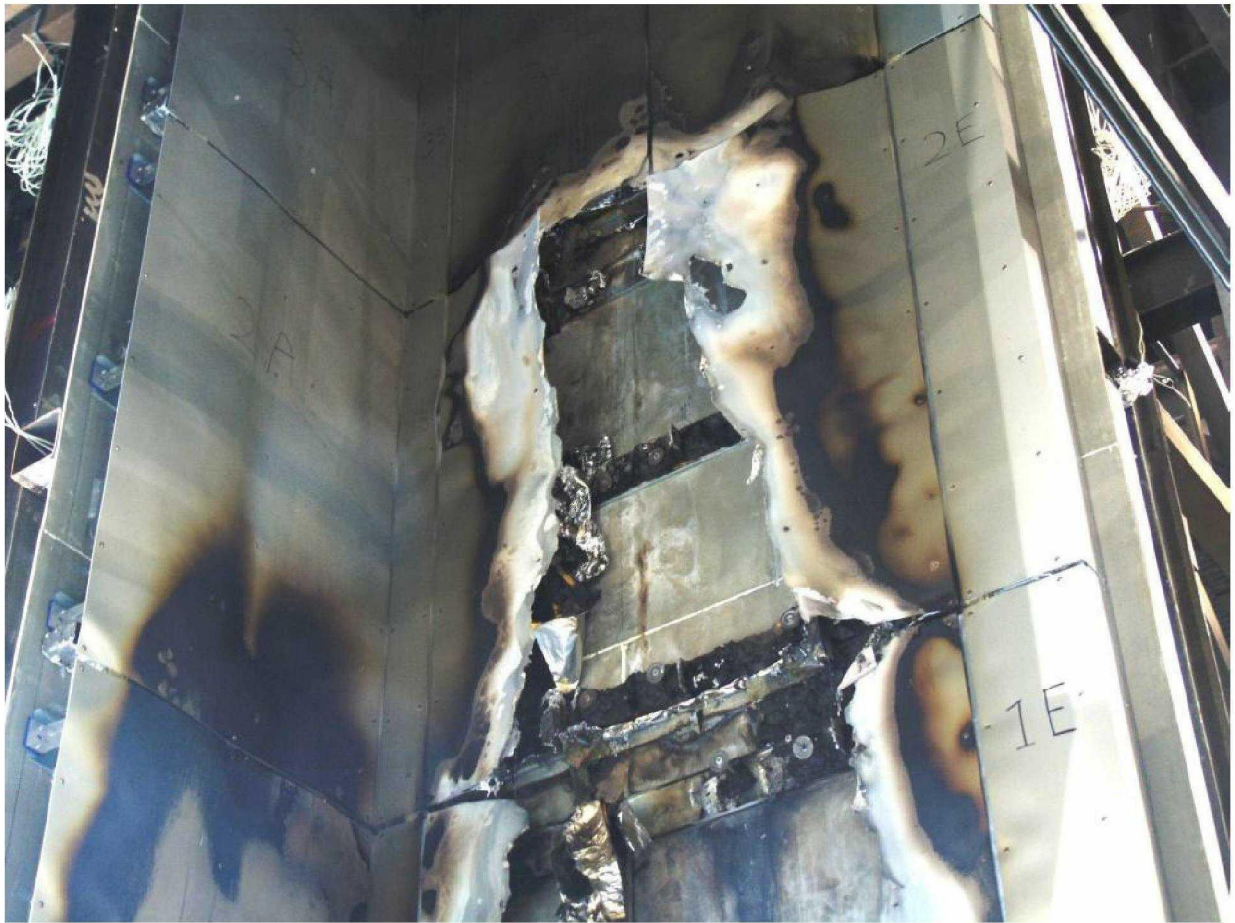
Figure 23. Damage to panels between a height of approximately 4000mm and 6000mm above the top of the combustion chamber.

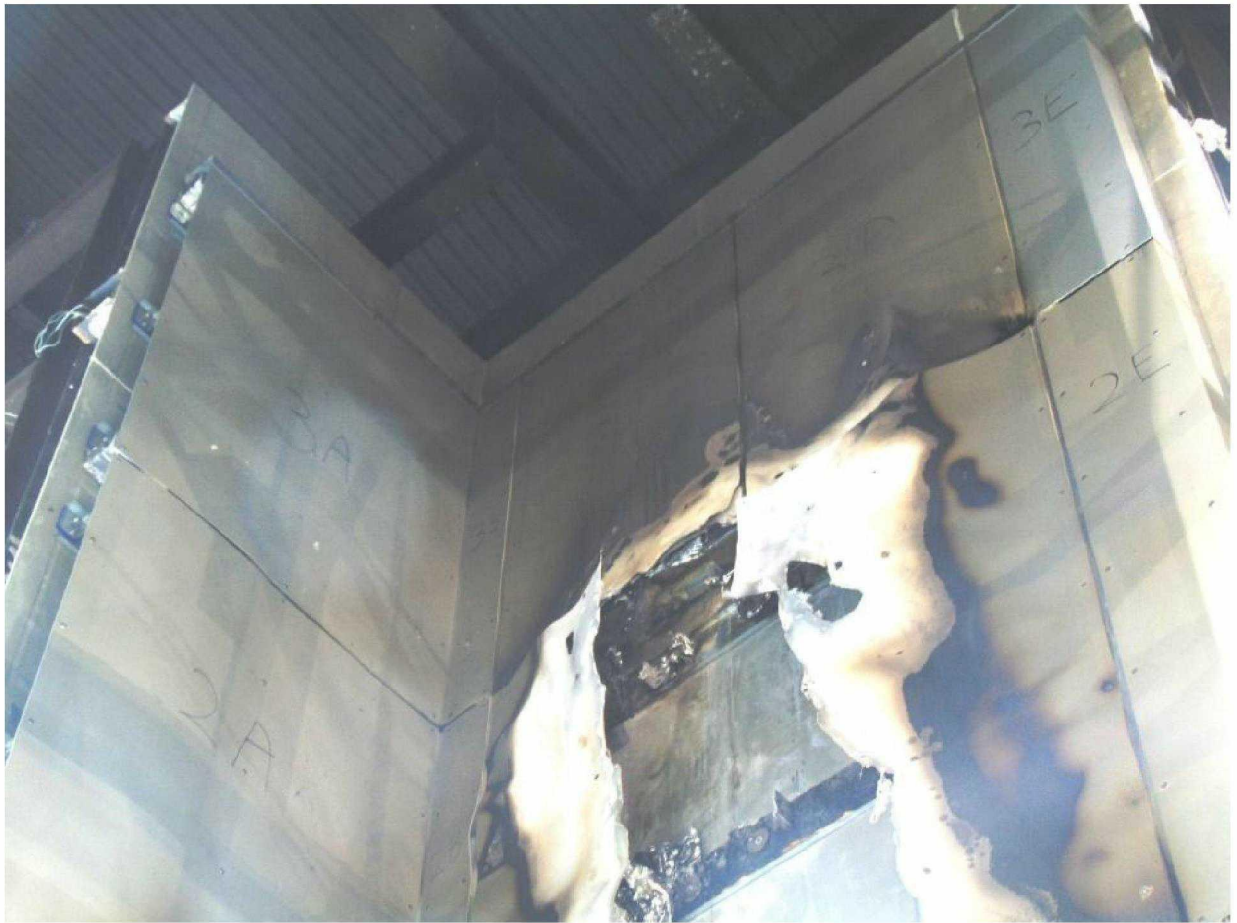
Figure 24. Damage to panels between a height of approximately 6000mm above the top of the combustion chamber and the top of the cladding system.

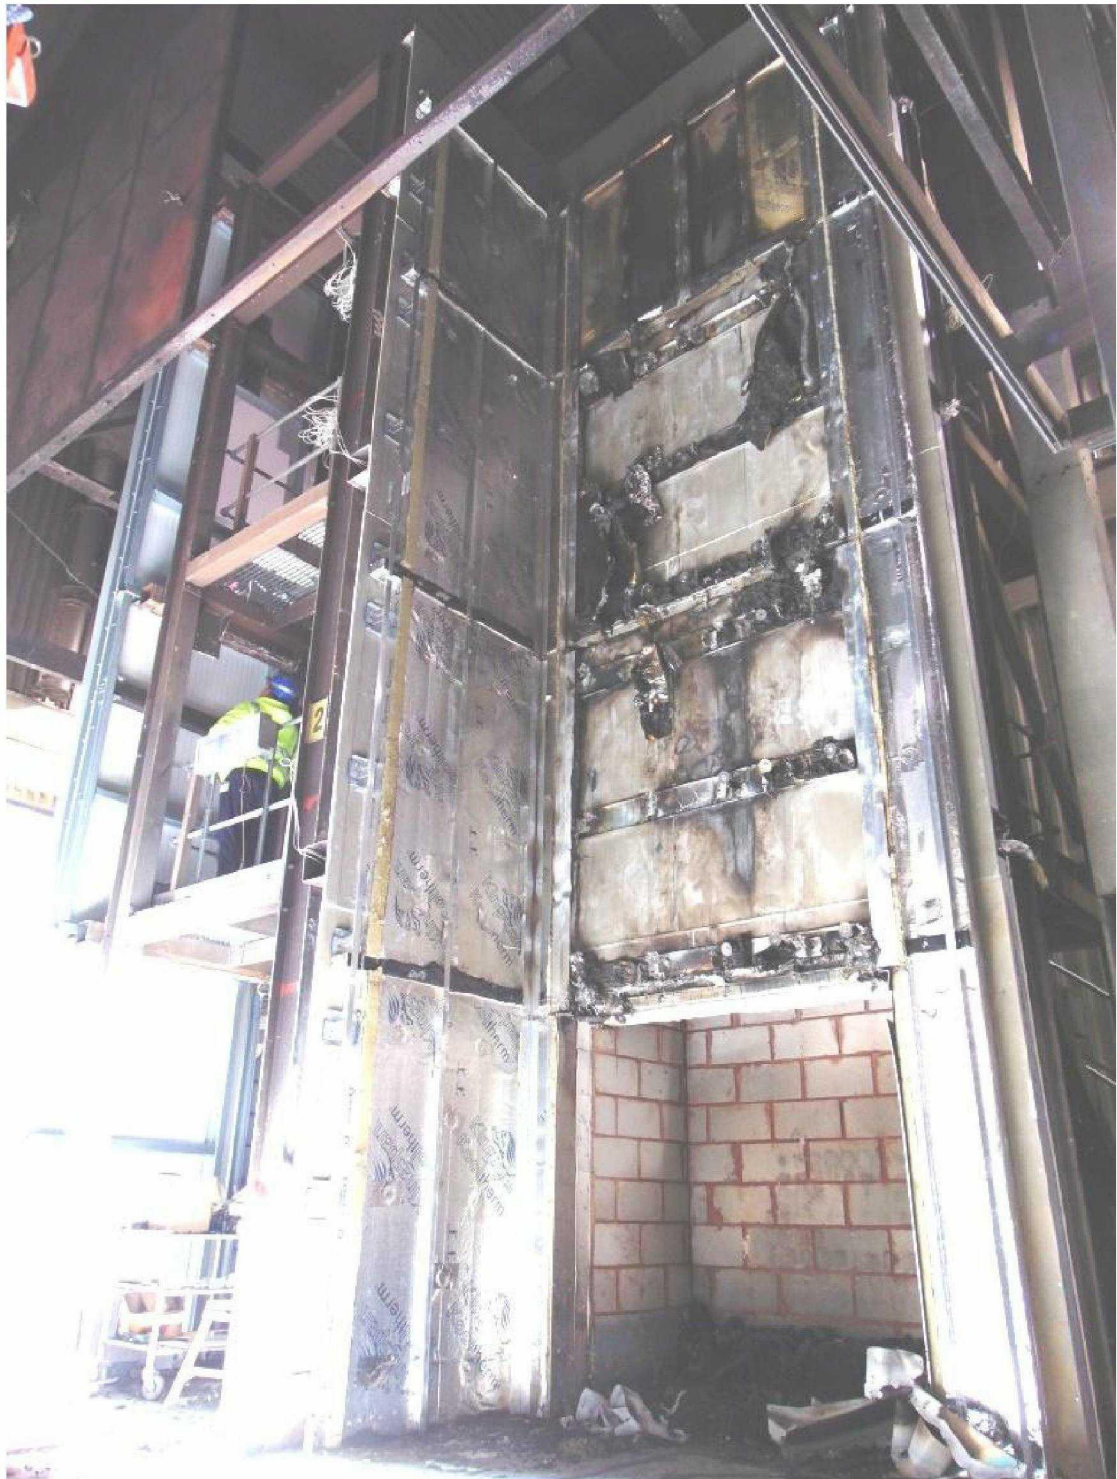
Figure 25. Full-height photograph of damage to insulation.

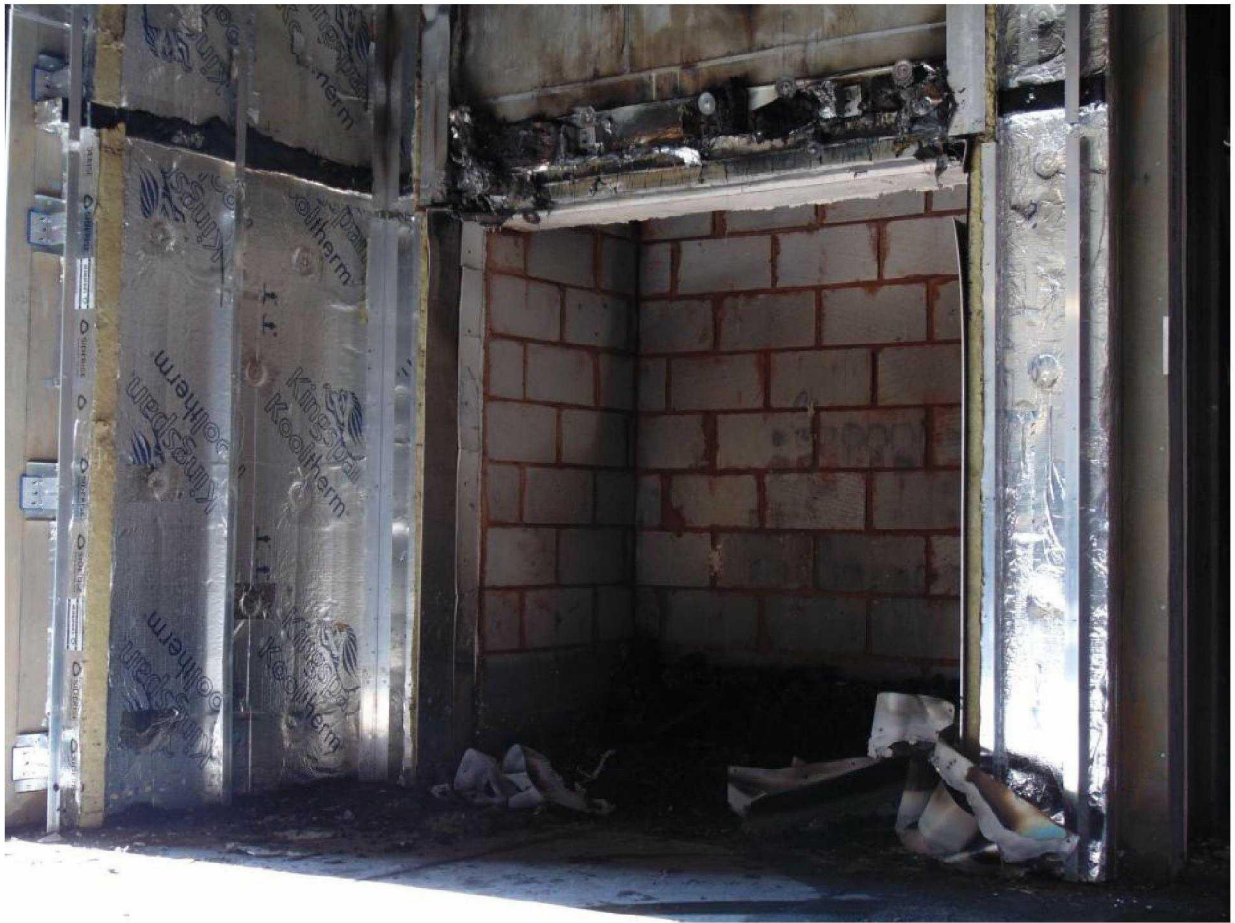
Figure 26. Damage to insulation between ground and top of combustion chamber opening.

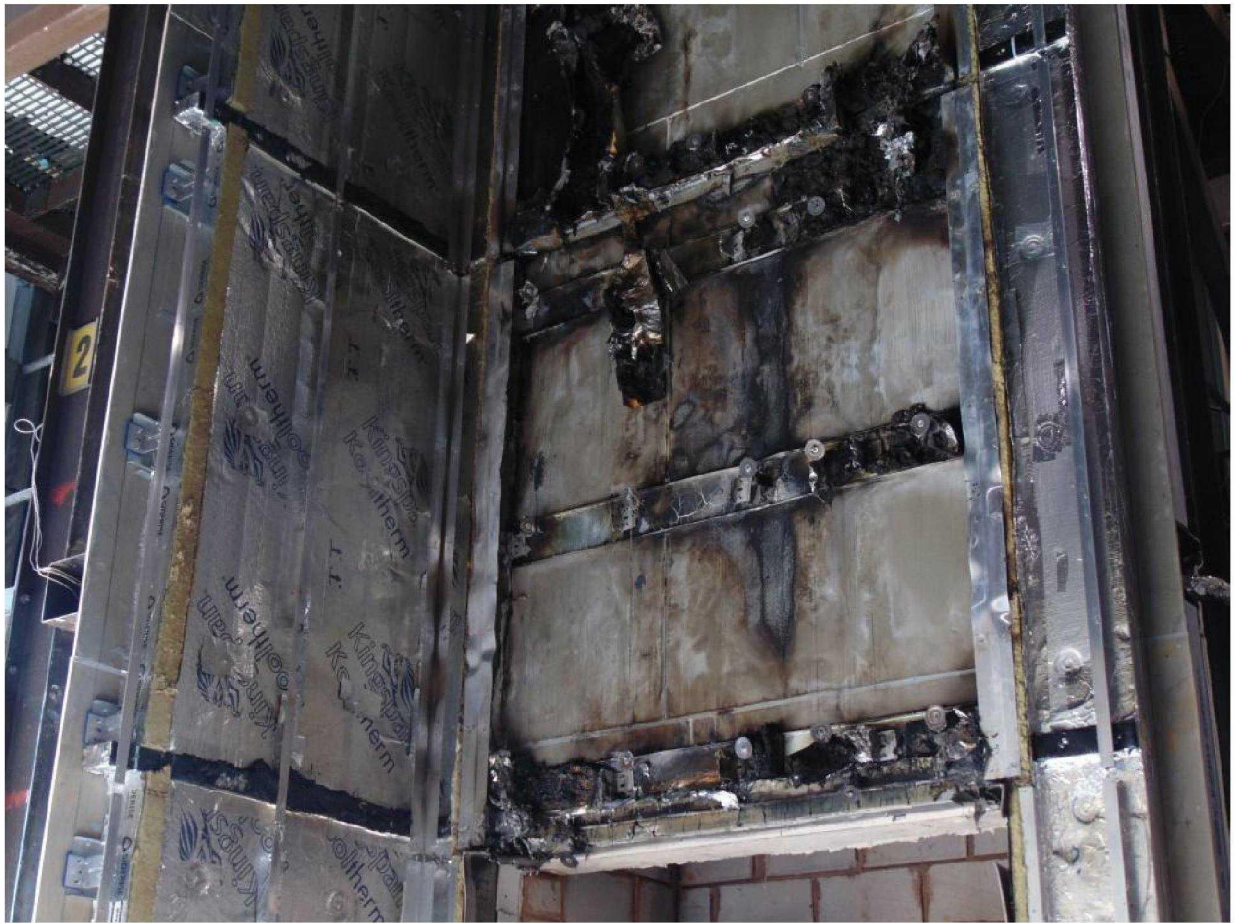
Figure 27. Damage to insulation between top of combustion chamber and a height of approximately 4500mm above the top of the combustion chamber.

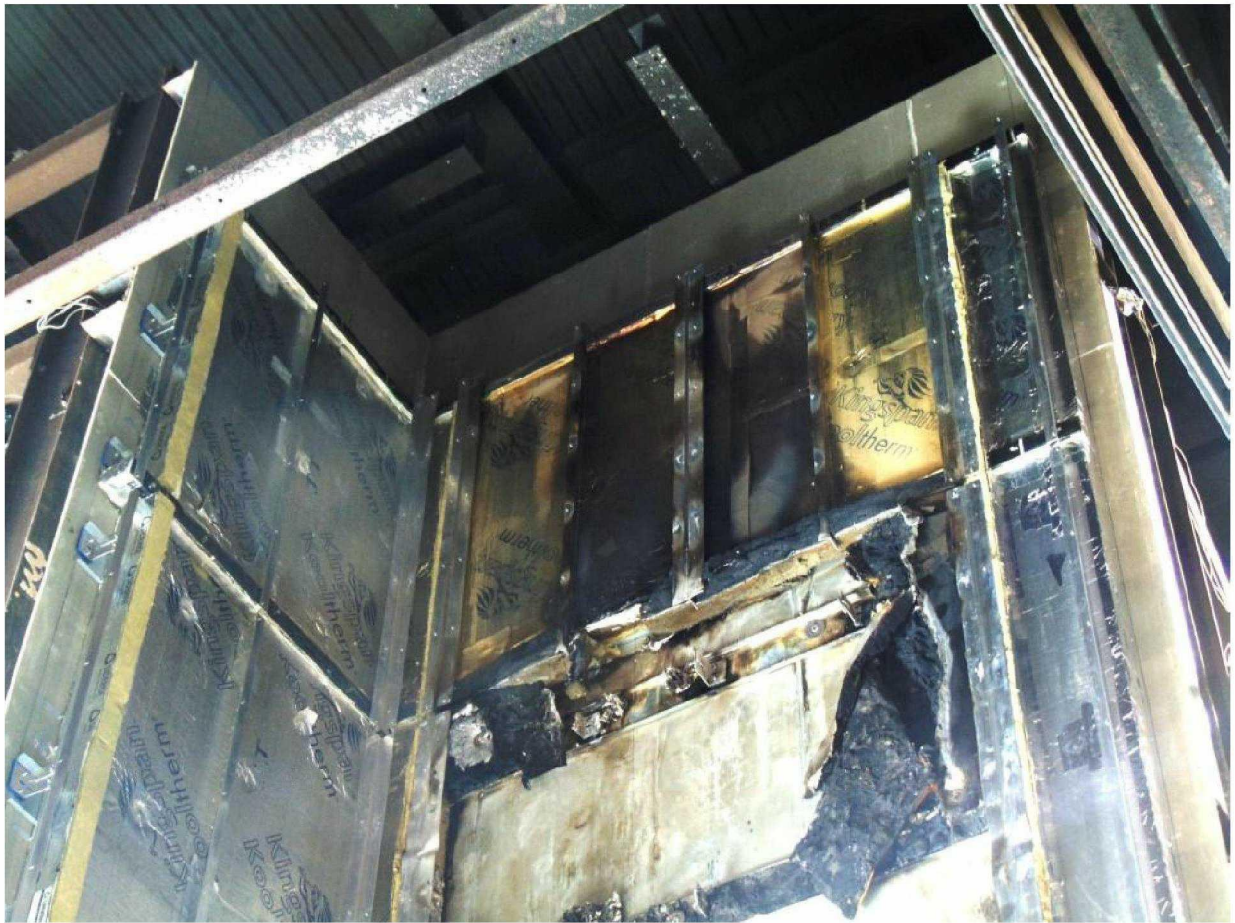
Figure 28. Damage to panels between a height of approximately 5000mm above the top of the combustion chamber and the top of the cladding system.

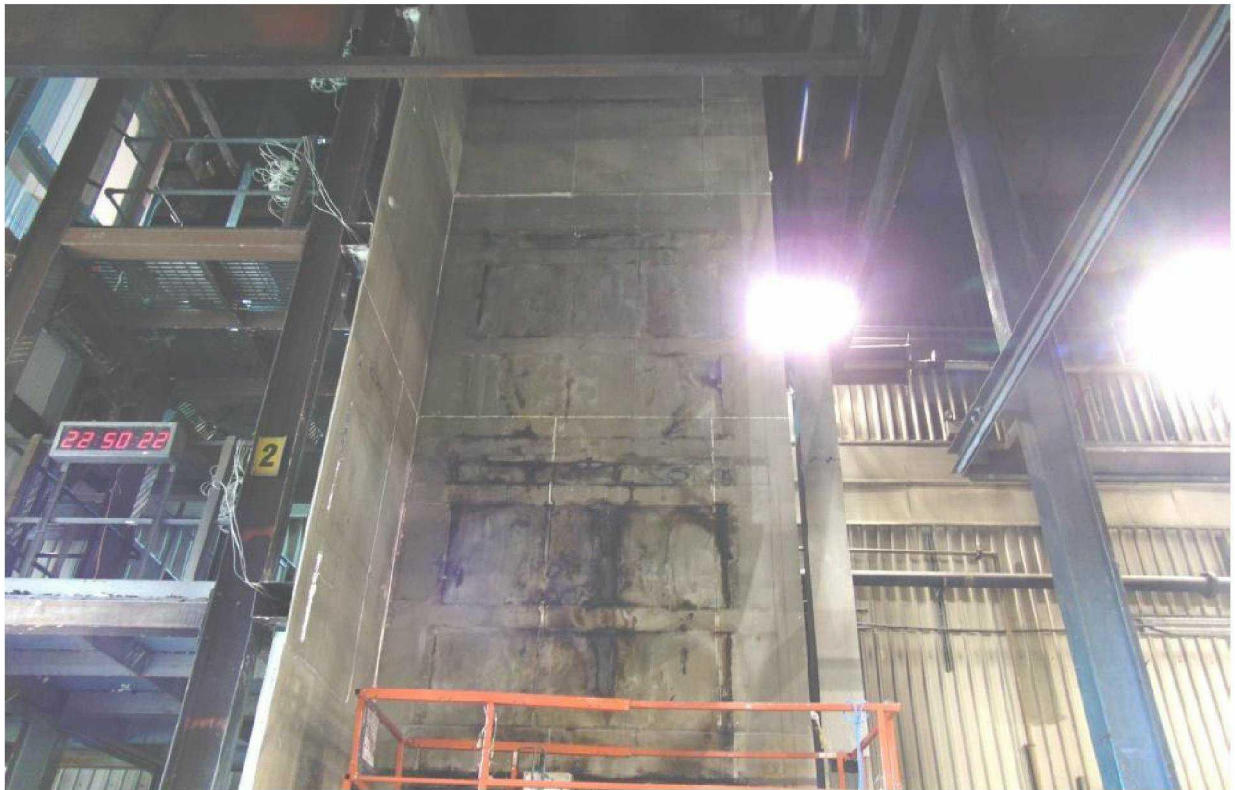
Figure 29. Damage to cement board from the top of the combustion chamber to the top of the cladding system.
