BRE Global Client Report

BS 8414-1:2015 + A1:2017 Test referred to as DCLG test 7.

Prepared for: DCLG
Date: 18th August 2017 (Issue 1.0)
12th September 2017 (Issue 2.1)
Report Number: B137611-1037 (DCLG test 7) Issue: 2.1

This report is one of a series, commissioned by the Department for Communities and Local Government (DCLG) intended to establish how different types of Aluminium Composite Material (ACM) panels in combination with different types of insulation behave in a fire.

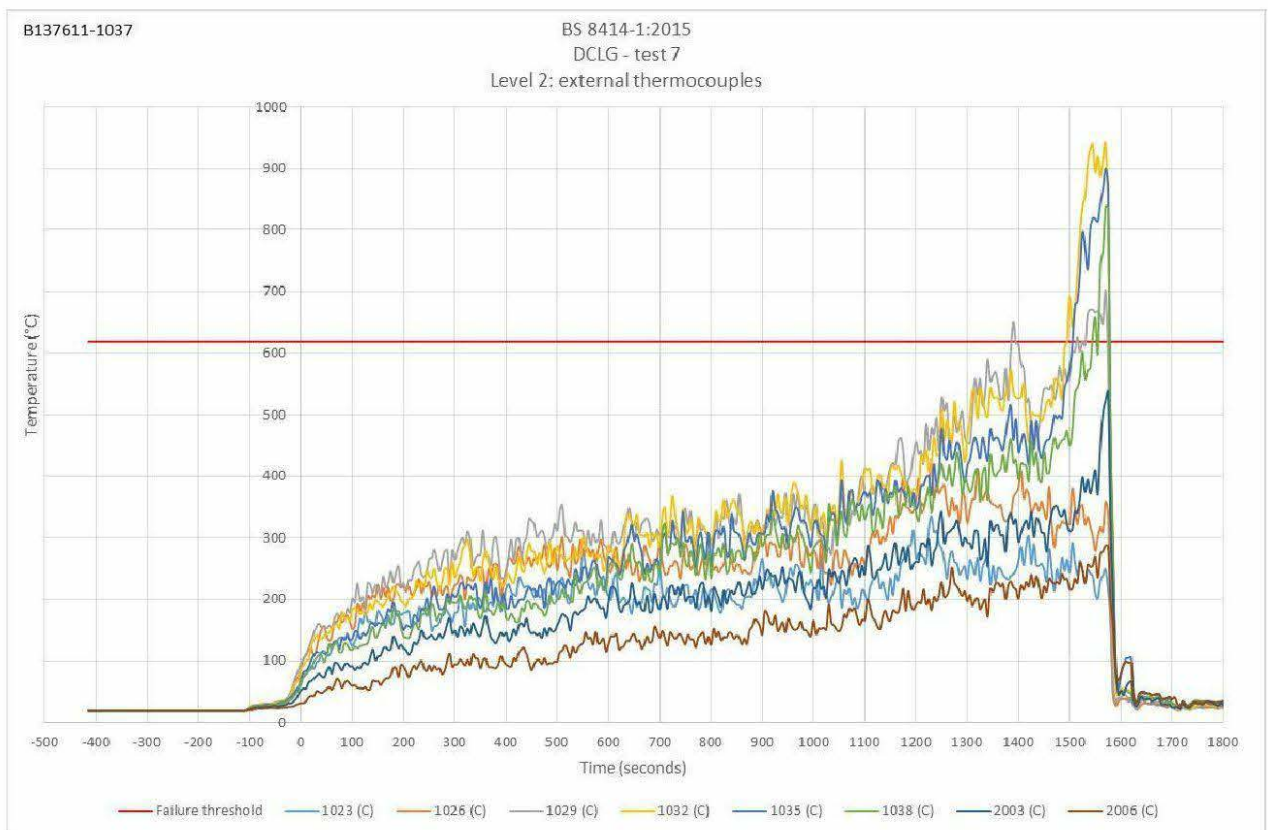
The Level 2 thermocouples reached 600°C above T_s at 1500 s. Although the Level 2 thermocouple recordings did not exceed a 600°C temperature rise above T_s for a minimum of 30s, within 15mins from test start time (t_s), failure to achieve the minimum test duration, due to flame spread off the top of the cladding system, prevents classification to BR135^[2].

Figure 19. Level 2 external thermocouples.
 $t_s=115s$ after ignition of the crib.

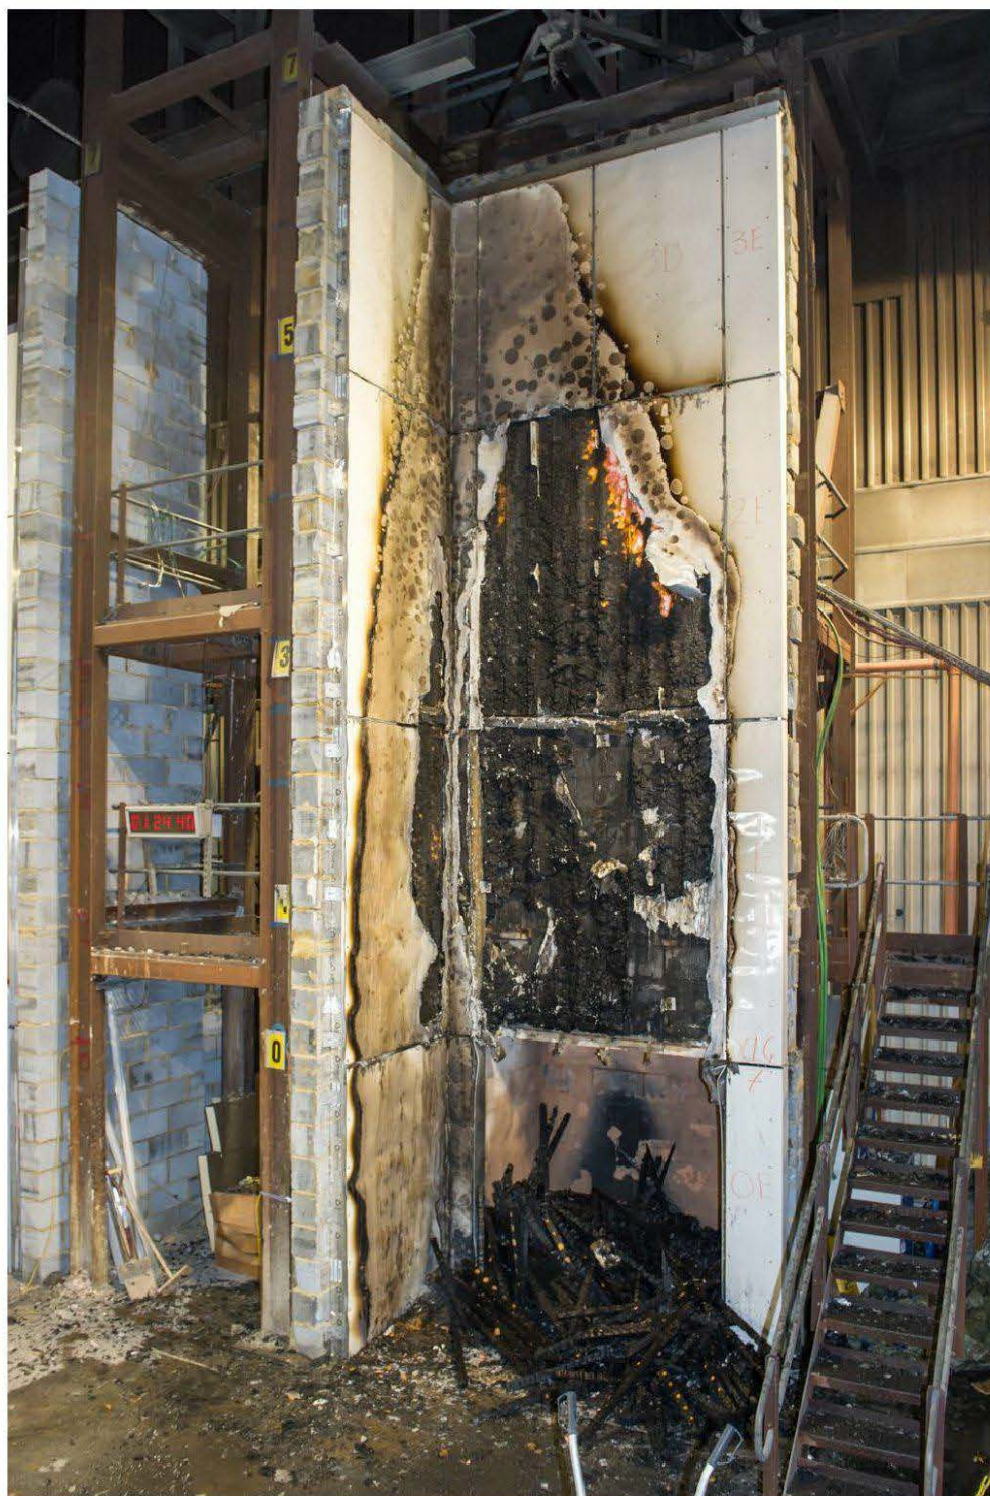
The cladding system was significantly damaged up to the height of the third horizontal cavity barrier – see *Figures 22-34*. The extent of the damage increased from discolouration of the ACM panels at the edges of the flame damage zone to complete consumption of panels, rail substructure, substantial charring and detachment of the insulation across the full width of the combustion chamber opening up to a height of approximately 5000mm – see *Figures 22-34*.

Figure 22. Full height photograph of system post-test – general.

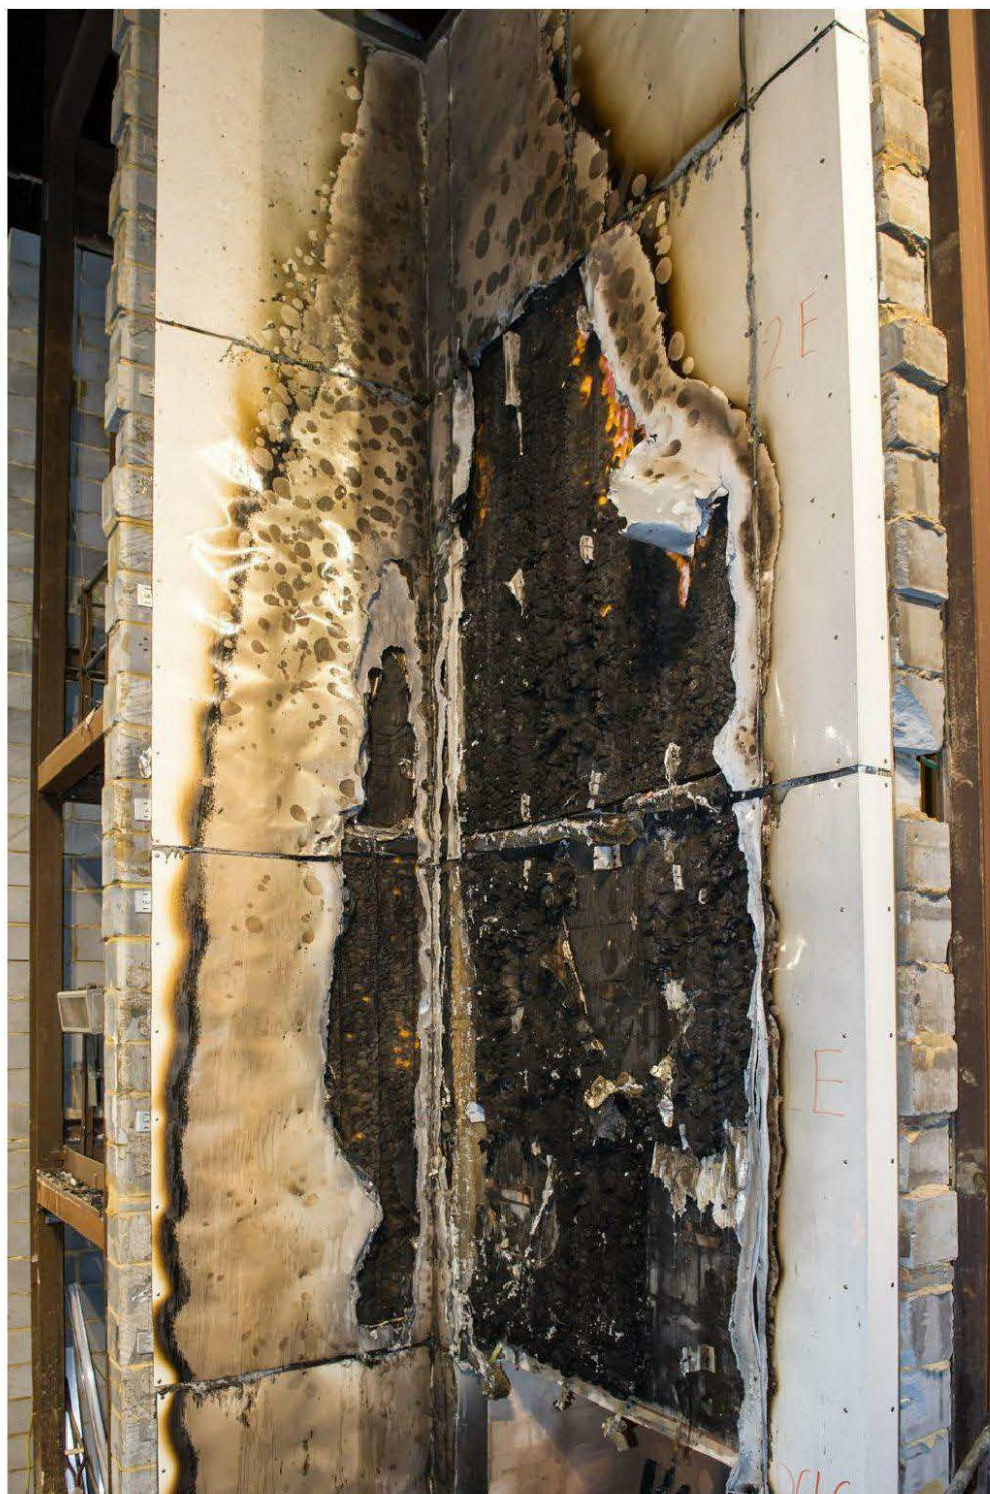
The wing wall was less severely damaged than the main wall with insulation charring adjacent to the main wall up to a height of approximately 4500mm above the combustion chamber (second fire break). Above the second fire break there was an area of damage where the foil was no longer present and there was surface charring of the insulation (approx 700mm high x 300mm wide at the base) consisting of one, and significant panel discolouration and distortion below the height of the third cavity barrier which reduced in severity towards the top of the cladding system – see *Figures 24-35*.

Figure 23. Photograph of system post-test – wing wall.

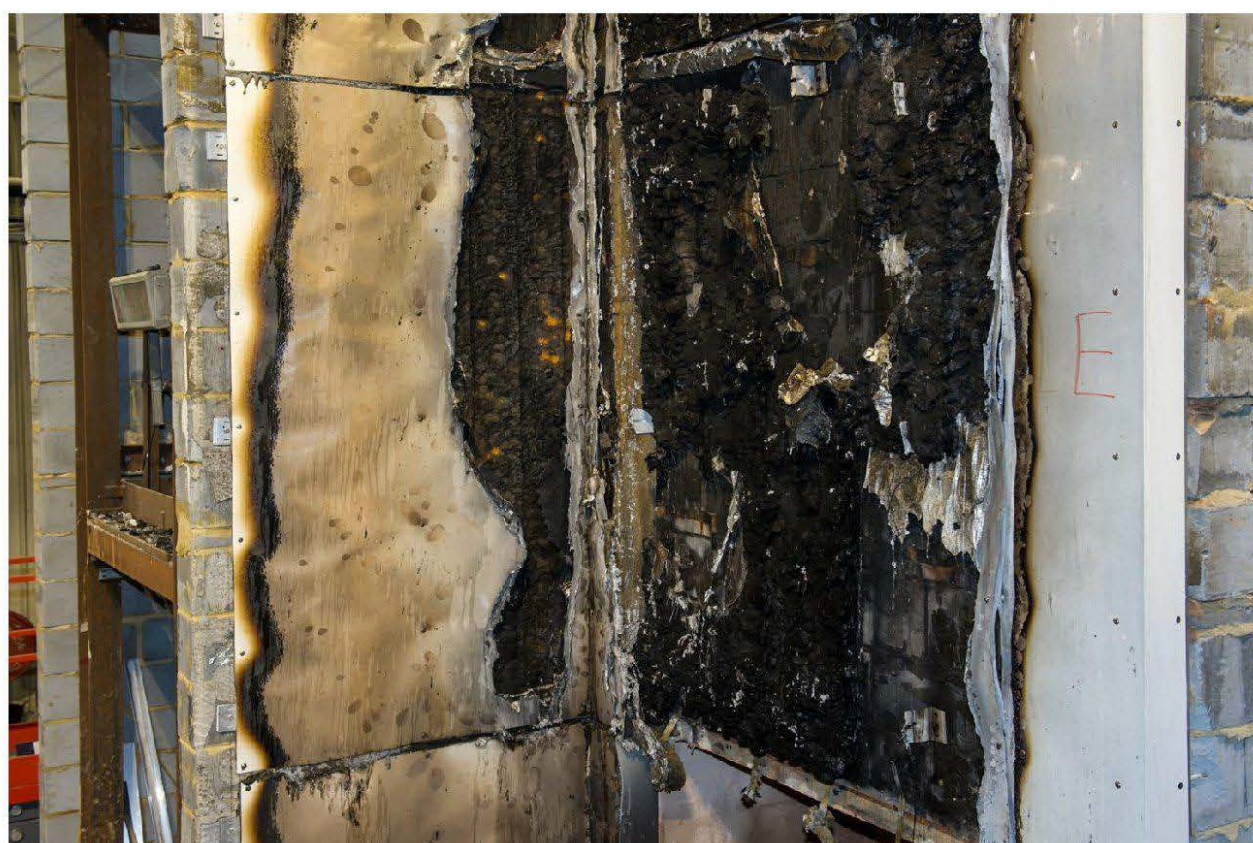
- Panel 0B. Distorted and surface discolouration of panel
- Panel OE. Largely undamaged.
- Panels 1C and 1D. 100% consumption of panels
- Panel 1B. 60% consumption of panel 1B. Panel 2B approximately 30% of the panel consumed
- Panel 2C. 90% consumption of panel.
- Panel 2D. 50% consumption of panel.
- Panel 2E. Surface discolouration extending for approximately 1m vertically from the base of the panel at the vertical joint between panels 2D & 2E
- Panel 3B. Panel in place. Discoloration across the full face of the panel. The panel was distorted.
- Panel 3C. Panel in place. Delamination of bottom edge of panels observed. Discolouration across 90% of the panel.
- Panel 3D. Panel in place. Some surface damage to the panels in the bottom left hand corner of the panel and heat distortion of the panel was observed.
- Panel 3E. Panel in place and largely undamaged.

Figure 24. First row ACM panels (directly above combustion chamber).

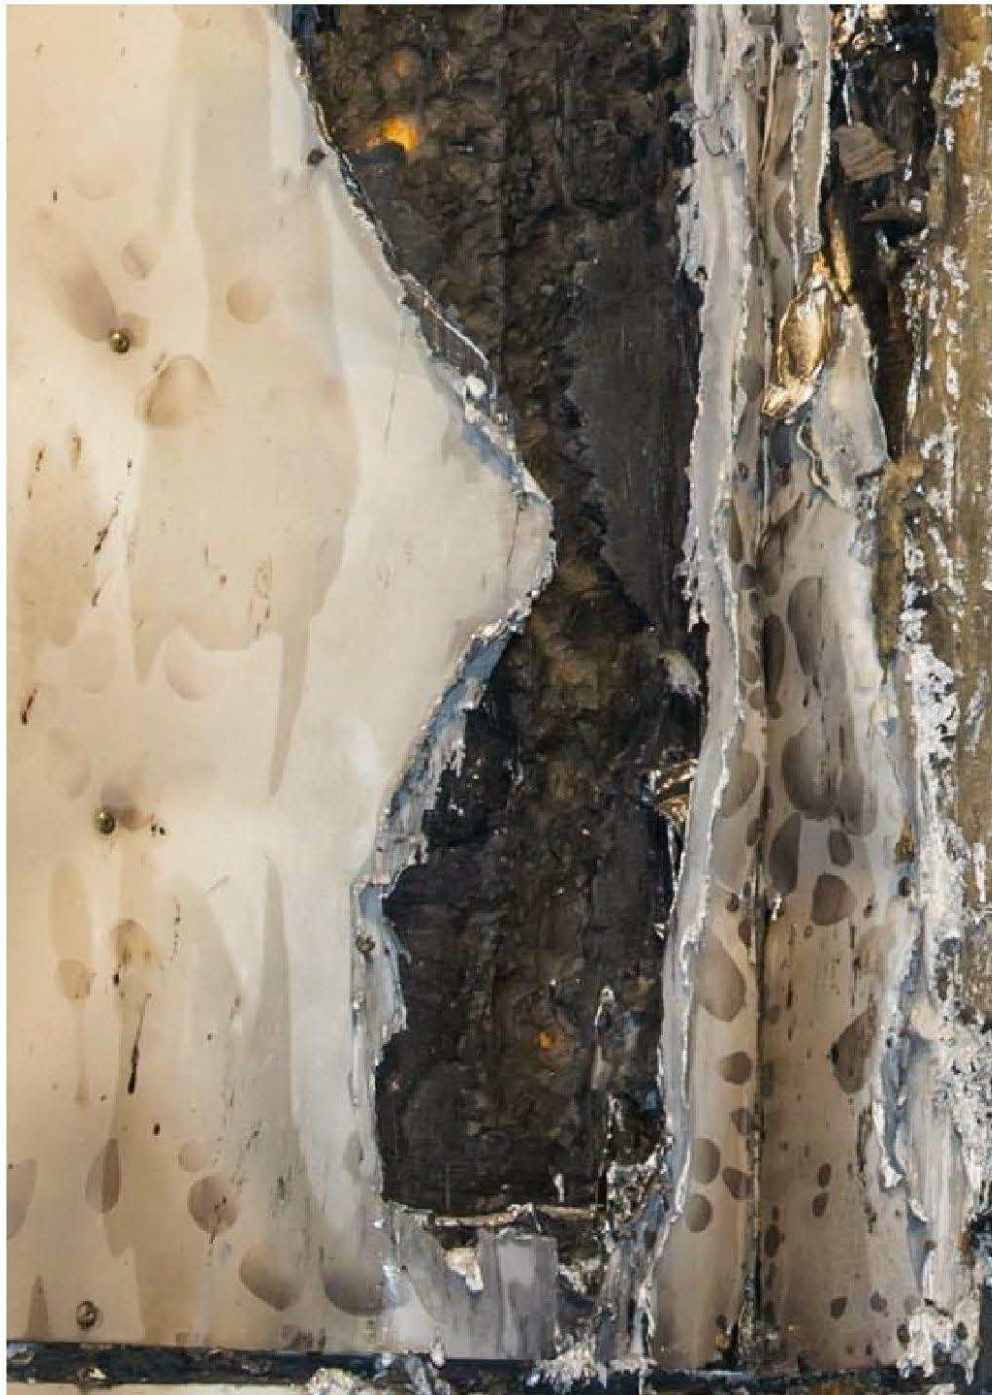
- Panel OA. Panel in place. Distortion and heat damage to the panel. A section of panel adjacent to panel OB approximately 700mm high and 150mm wide was consumed.
- Panel 1A. 30% of the panel consumed in a vertical strip adjacent to panel 1B exposing the insulation beneath. A small section of panel remained in place at the base of this panel. The remaining panel was in place.
- Panel 2A. A section of panel adjacent to panel 2B, approximately 300mm wide x 1000mm high was completely consumed exposing the insulation beneath. The outer aluminium above this for approximately 300mm was consumed leaving the inner layer of aluminium in place. The remaining panel was in place.

Figure 25. Close up view of partial panel consumption on the wing wall.

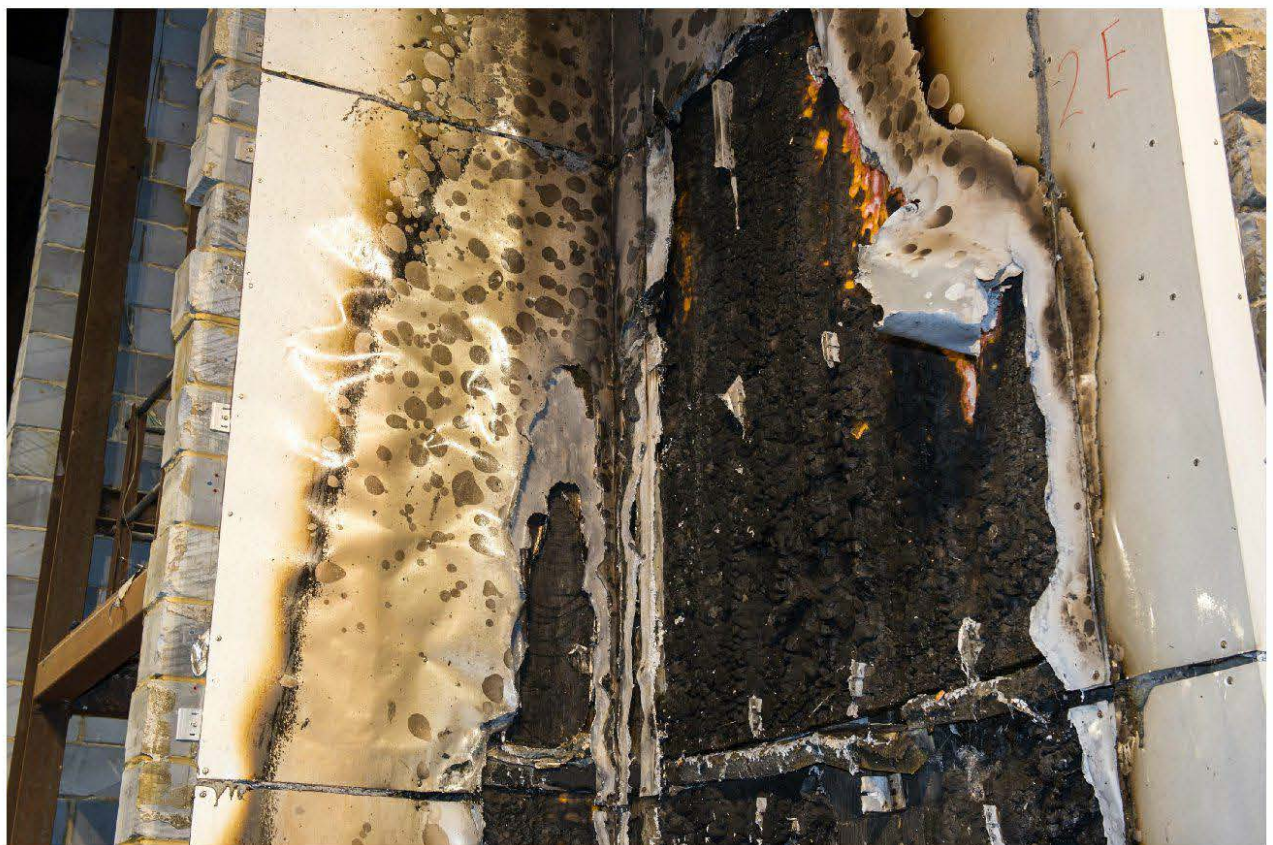
Figure 26. Second row ACM panels

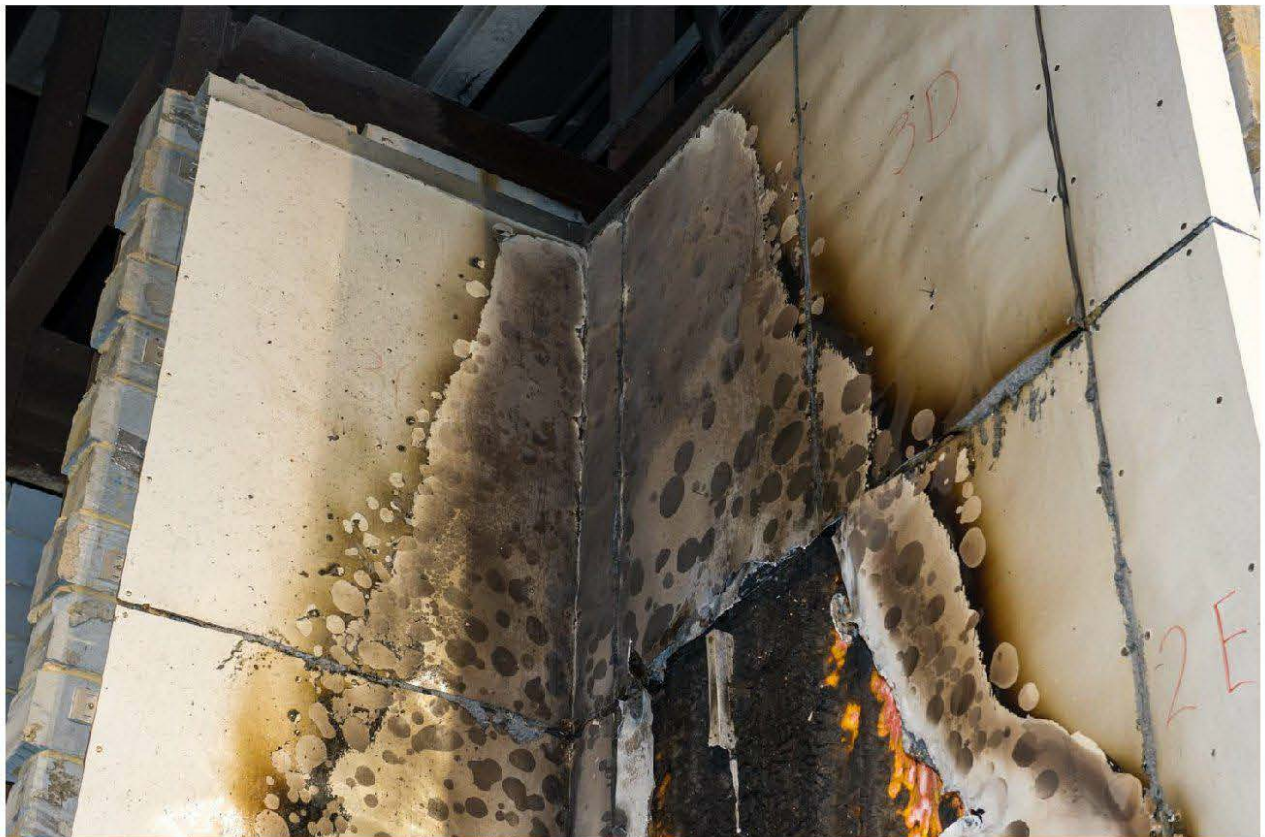
Figure 27. Third row ACM panels (approximately 4600mm-6500mm above combustion chamber).

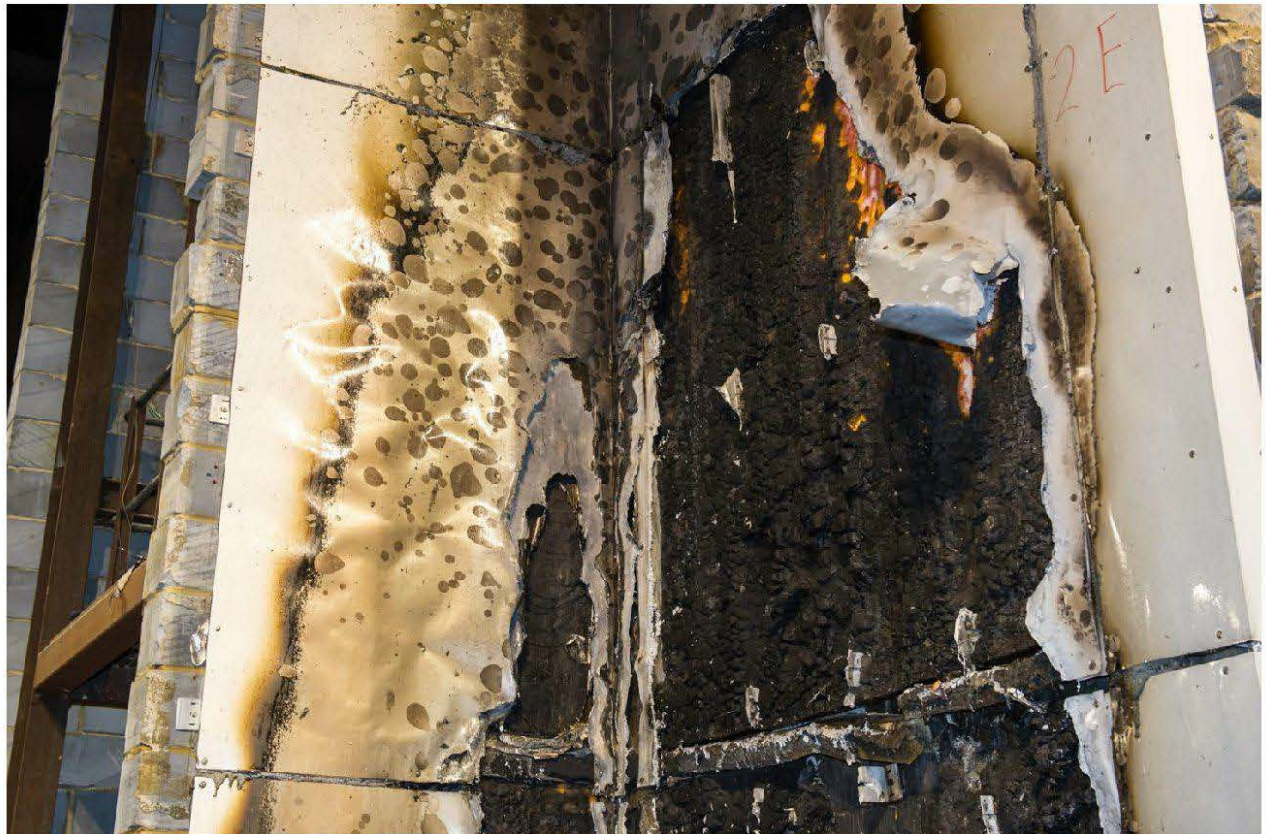
Figure 28. Distortion and damage to panel 2A– note delamination of the panel.

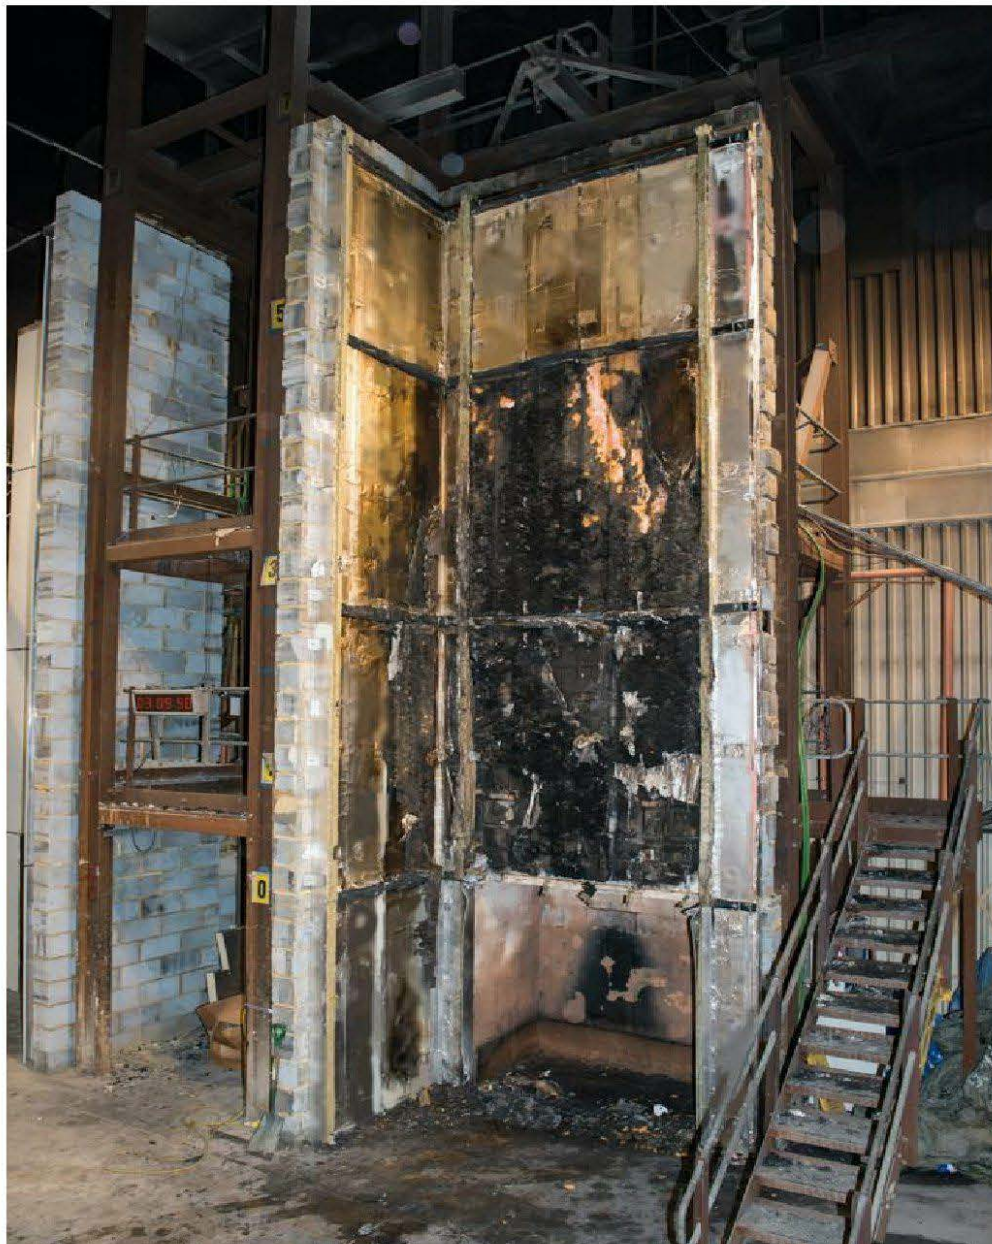
Figure 29. Full height photograph of system following removal of ACM panels.

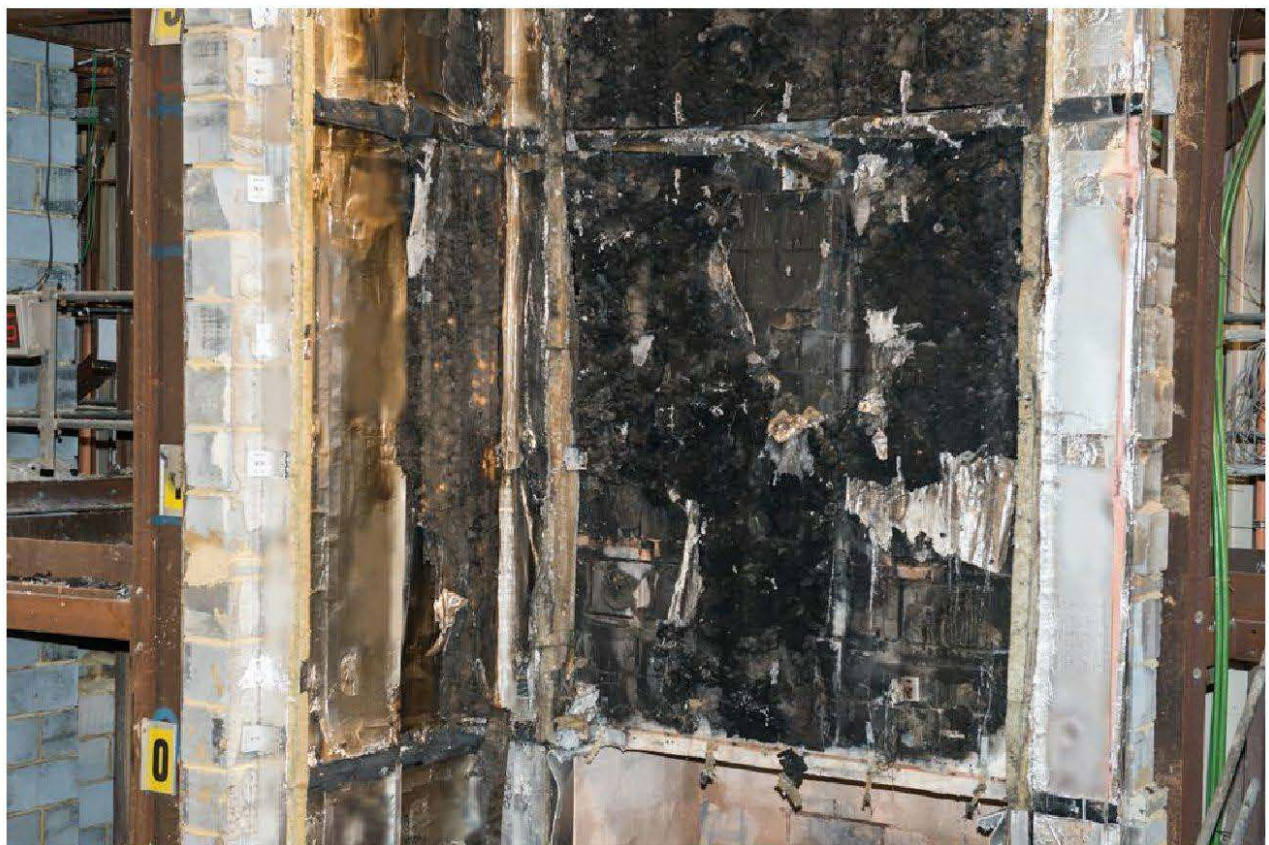
- 1C&1D, Approximately 50% of the insulation detached or consumed exposing the blockwork behind. Remaining insulation heavily charred. Some remains of foil facing.
- 1E. Insulation largely undamaged. Foil facing of insulation intact.
- 2C, charring of the insulation occurred in decreasing severity between the second and third cavity barrier. No foil facing was visible upon removal of the ACM panels.
- 2D, charring of the insulation occurred in decreasing severity between the second and third cavity barriers mirroring the damage to the ACM panel above.
- 2E Insulation largely undamaged with the foil facing intact.
- 3B Discolouration of the foil facing.
- 3C Discolouration of the foil facing
- 3D Discolouration of 50% of the foil facing.
- 3E Insulation undamaged.

Figure 30. Damage to cladding system beneath ACM panels directly above combustion chamber.

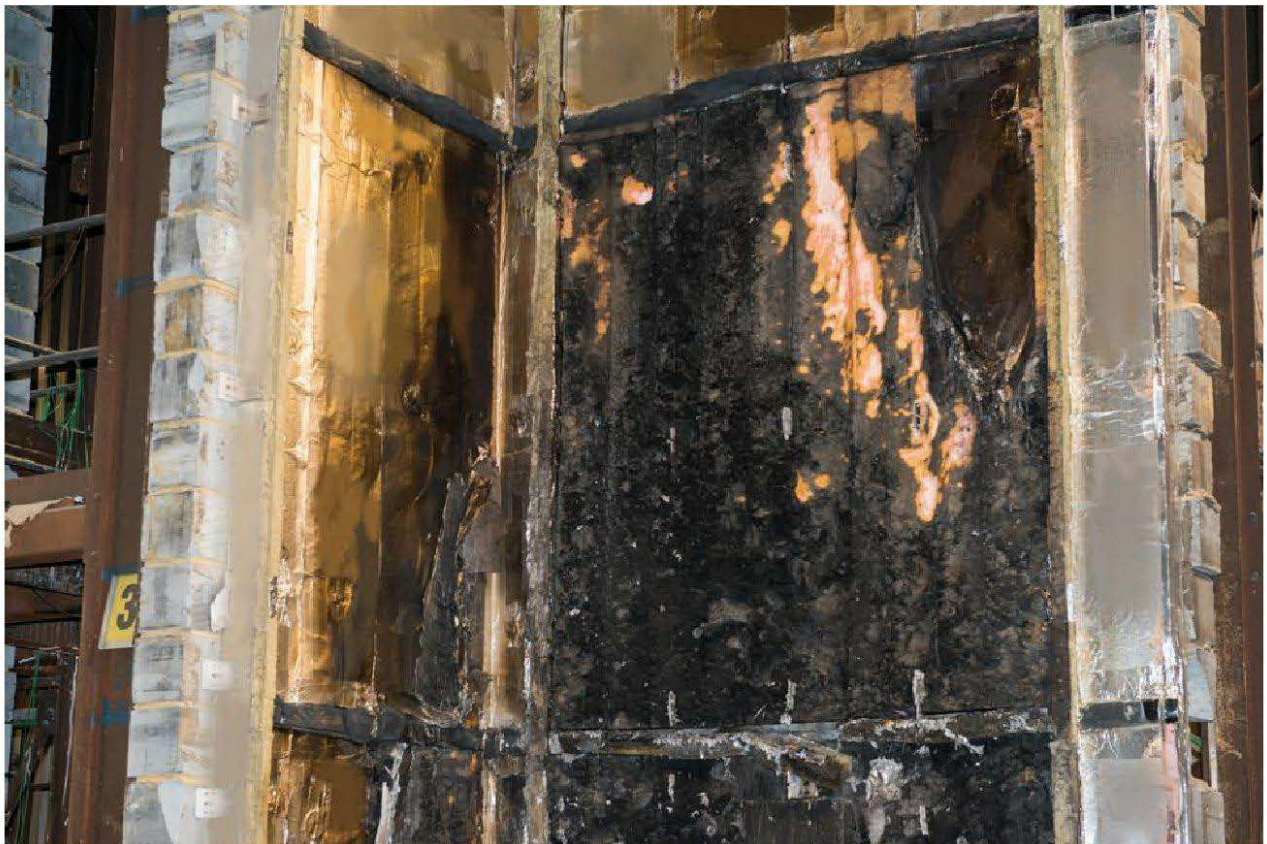
Figure 31. Damage to cladding system beneath ACM panels between the second and third horizontal cavity barrier .

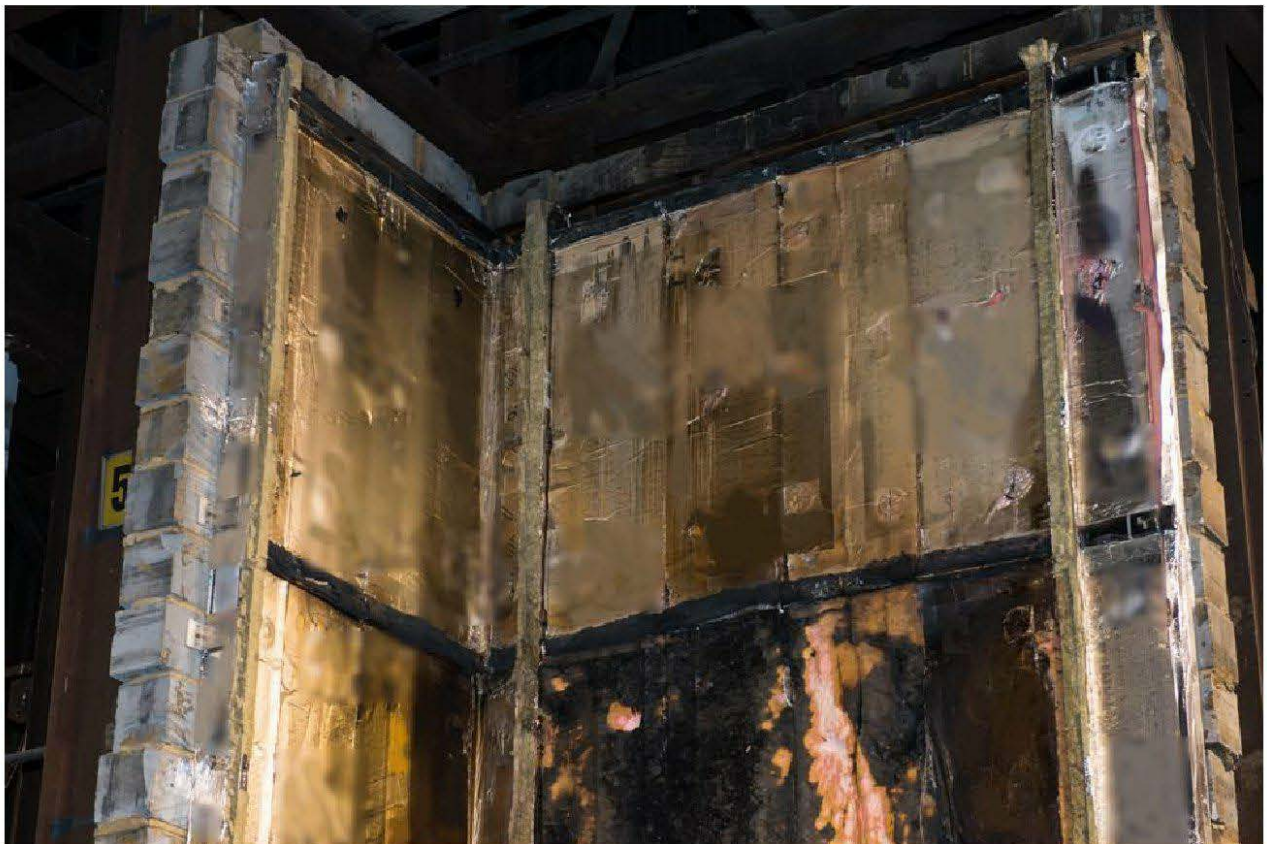
Figure 32. Damage to cladding system beneath ACM panels between the third and fourth horizontal cavity barrier

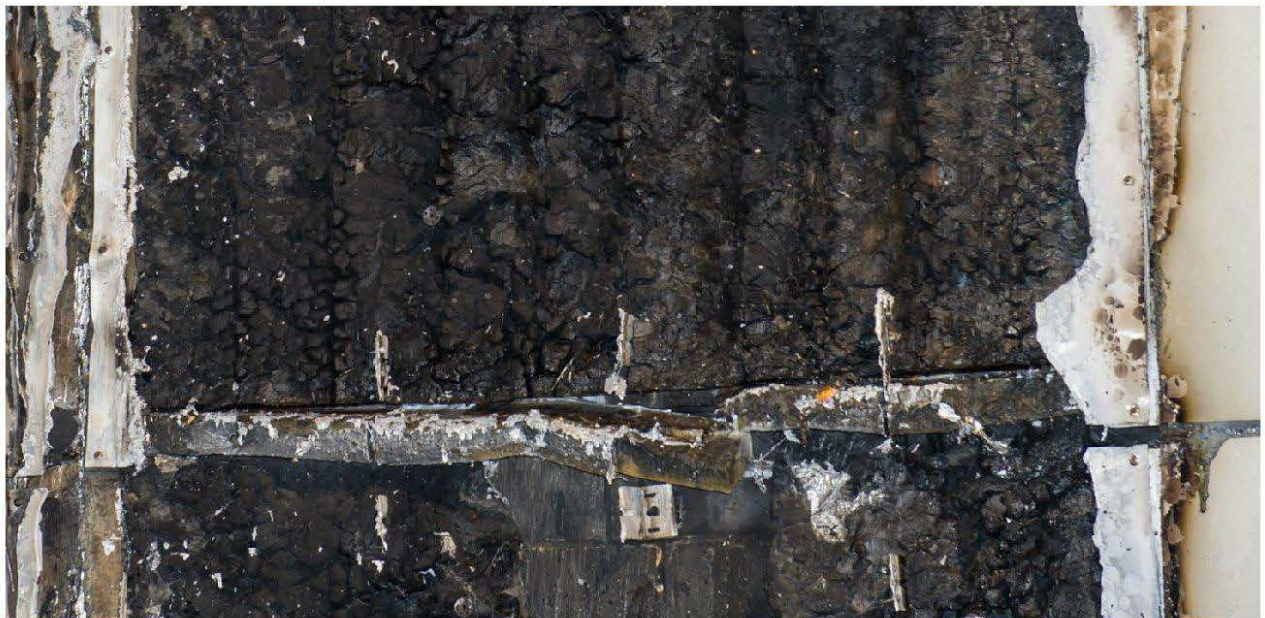
The second row horizontal cavity barrier on the wing wall at the junction of panels 1A and 2A, had activated and was still in place when the ACM panels were removed.

Figure 33. Close up of second cavity barrier in line with the combustion chamber opening.

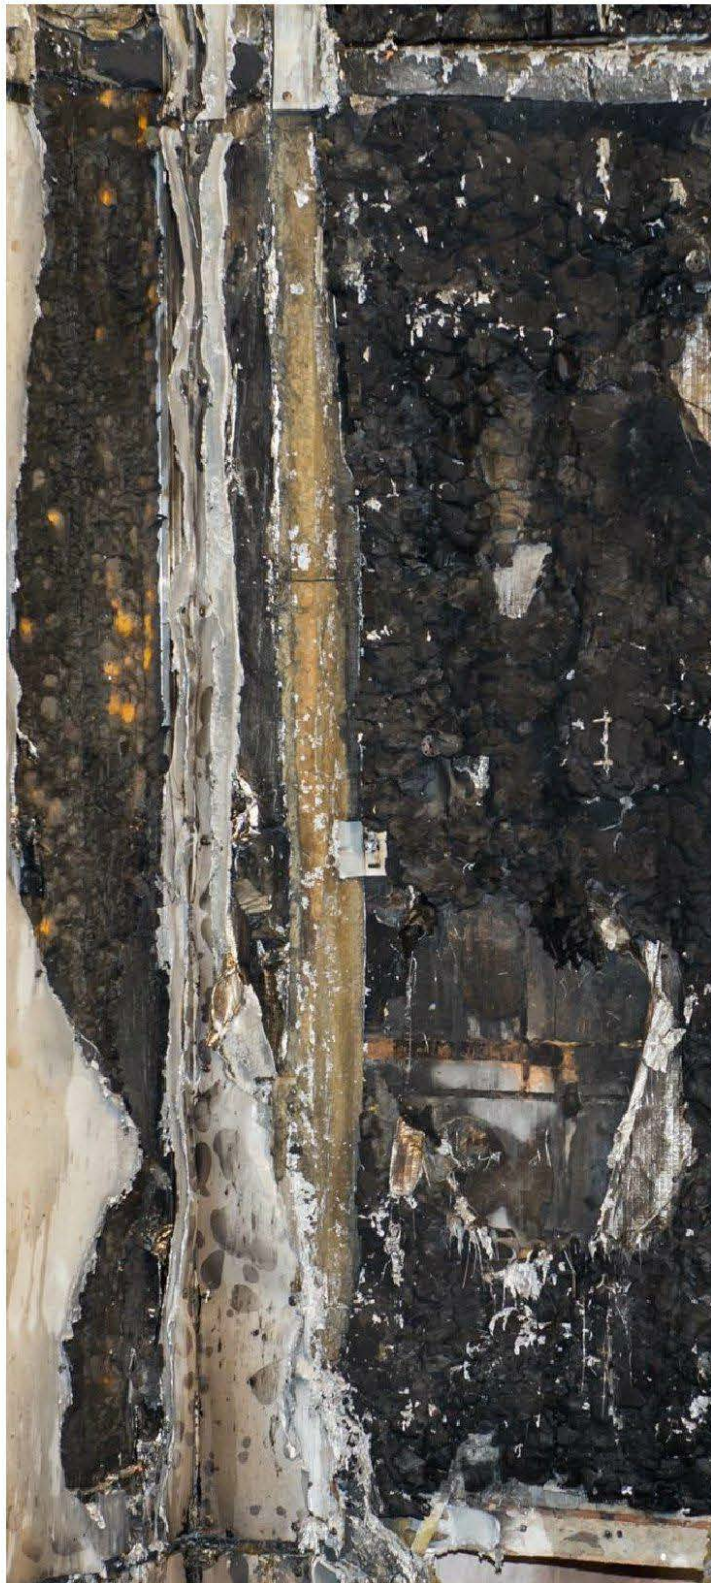
- 0A. The foil facing on the insulation remained intact.
- 1A. Insulation charred to the full height between the fire breaks on approximately 50% of the insulation adjacent to panel 1B. The foil facing on the remaining insulation was intact.
- 2A, A small section of the insulation was charred (approx. 300mm wide at the base and 800mm high). The foil facing remained intact on the rest of the insulation.
- 3A, minor discolouration to the foil facing – see *Figure 34*.

Figure 34. Close up of vertical cavity barrier adjacent to the wing wall directly above the combustion chamber –post test.
