BRE Global Test Report

BS 8414-1:2015 + A1:2017 test on a ventilated façade system with Kingspan Kooltherm K15 insulation and Alpolic/fr panels.

Date: 11th January 2018

Report Number: P109939-1000 **Issue:** 1

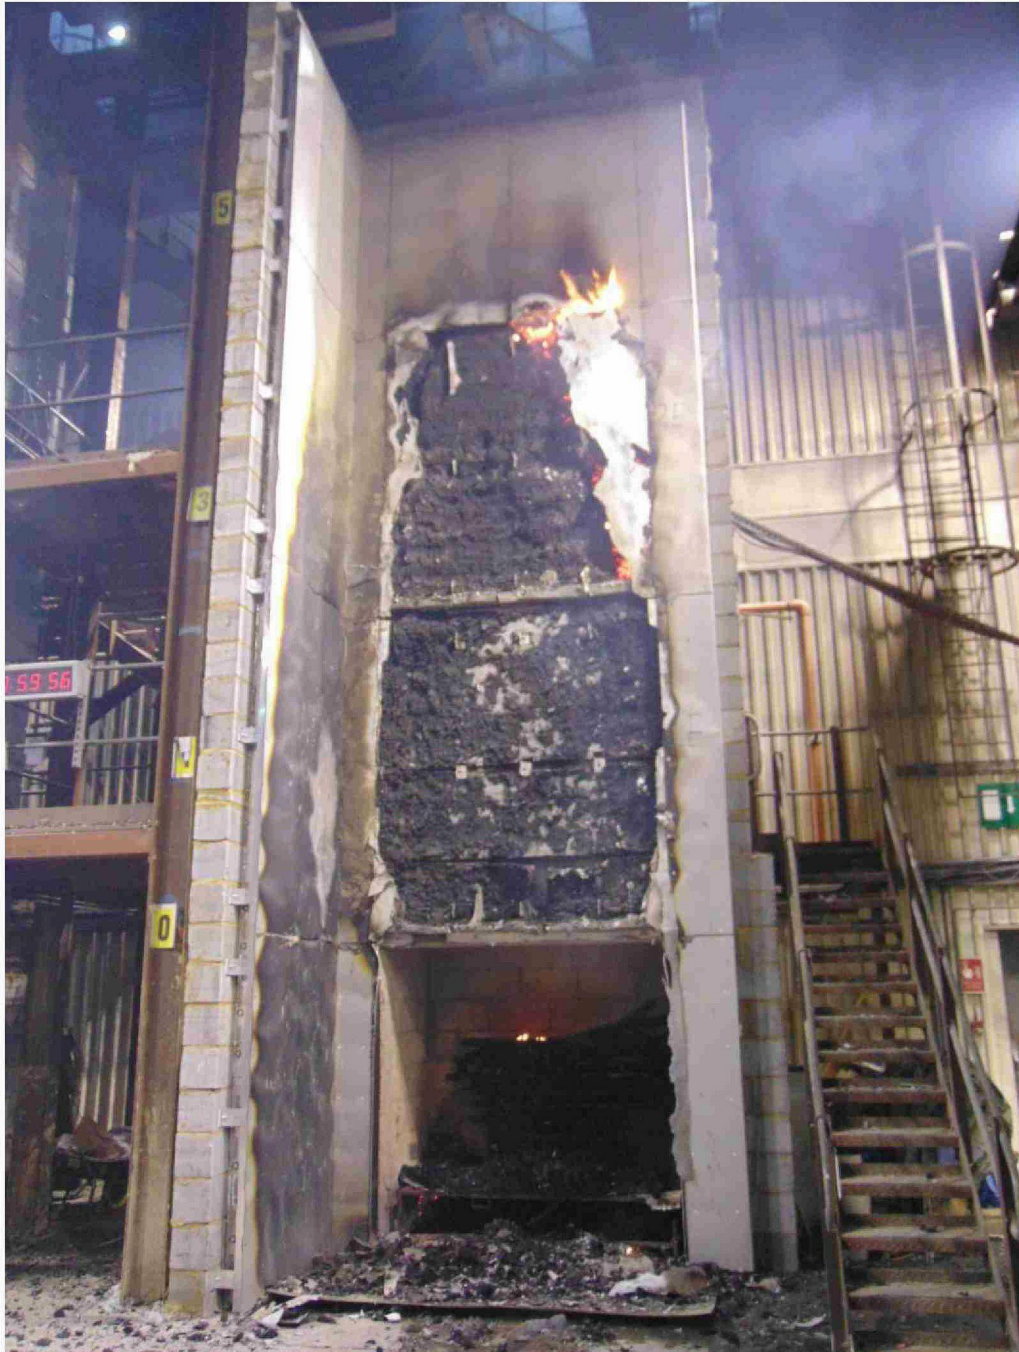
Panel 2C. Approx 90-95% consumed.

Panel 2D. Approximately 50% consumed. Section remaining in the form of an inverted triangle 600mm width at top x 100mm at base (full panel height). Panel loosely attached at outside vertical edge and distorted away from the wall.

Panel 3D. A section at the base of the panel approx. 250mm(w) x 75mm(h) consumed, remaining panel intact and in place. Some heat distortion and discolouration of the panel.

Figure 16. Full-height photograph at test termination.

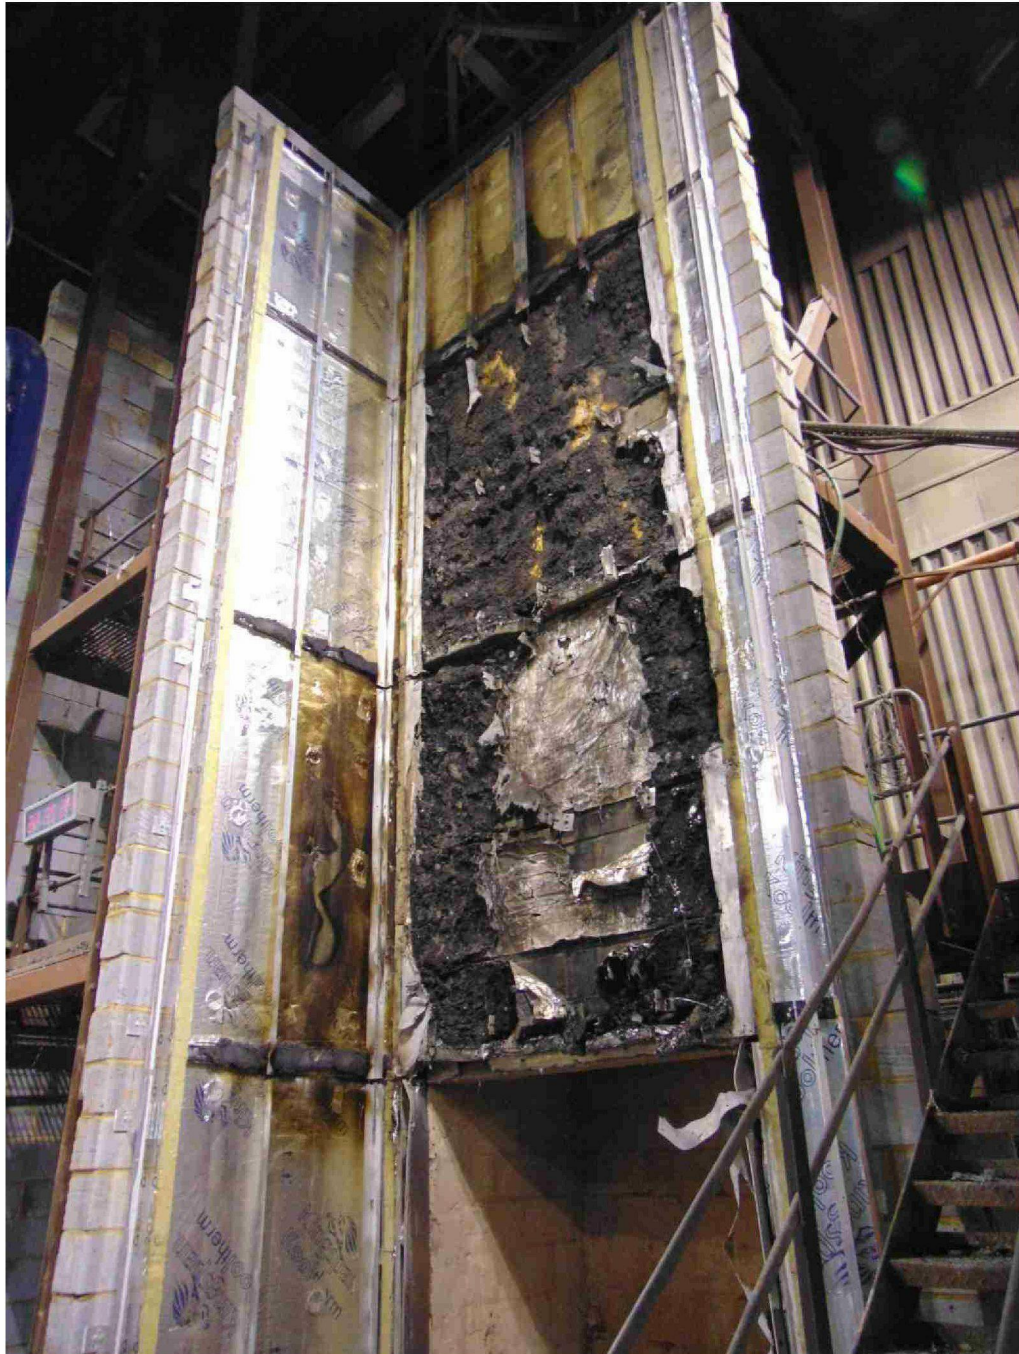
1C&1D. Insulation largely destroyed. Masonry substrate visible through foam.

2C & 2D Extensive damage and charring to insulation. Masonry substrate visible in places.

Figure 17. Full-height photograph of system following removal of ACM panels

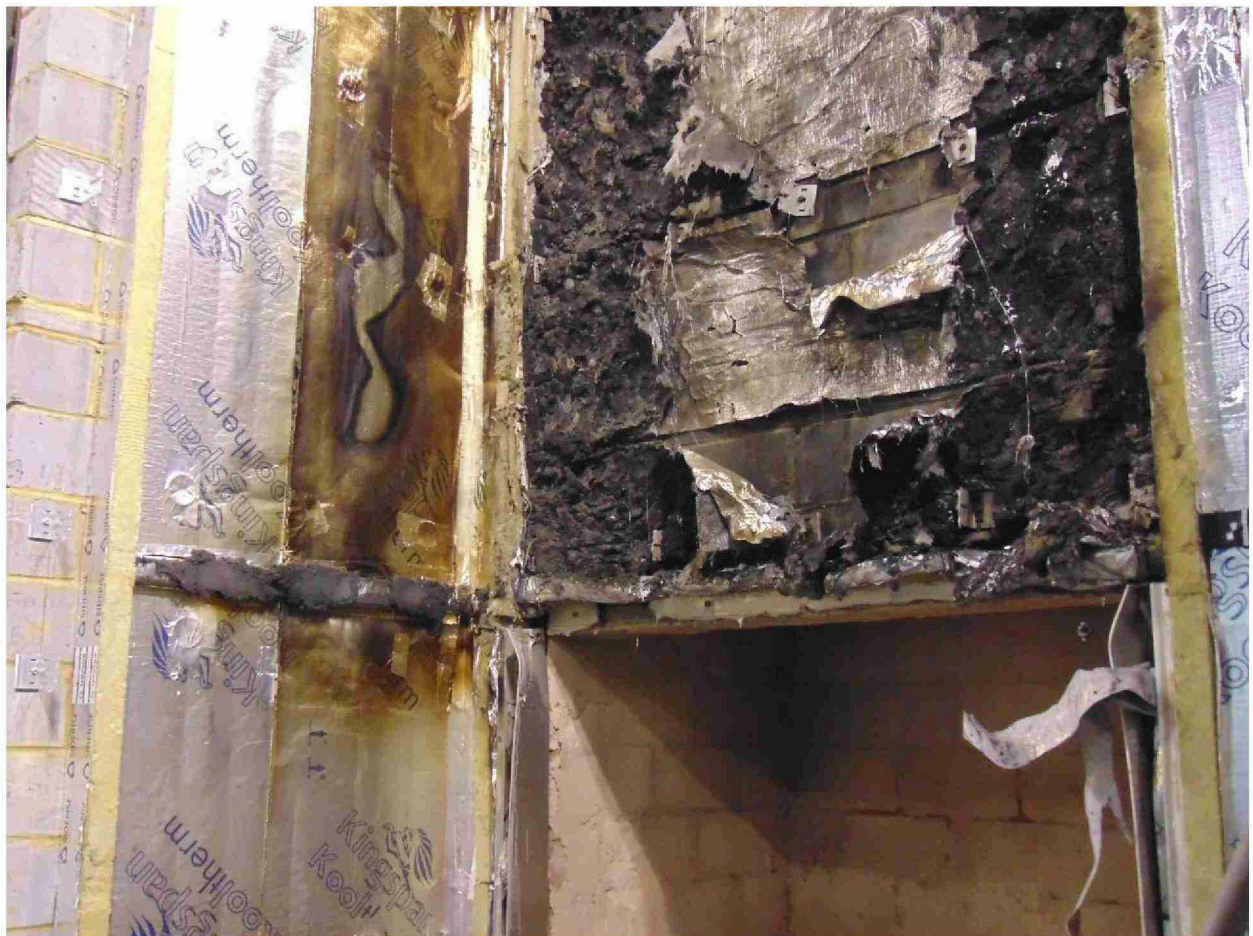
The cavity barrier directly above the combustion chamber was destroyed. At the junction of 0E & 1E it had not activated. On the wing wall, the barrier had activated across the full width.

Figure 18. Post-test photo showing insulation and cavity barrier above combustion chamber.

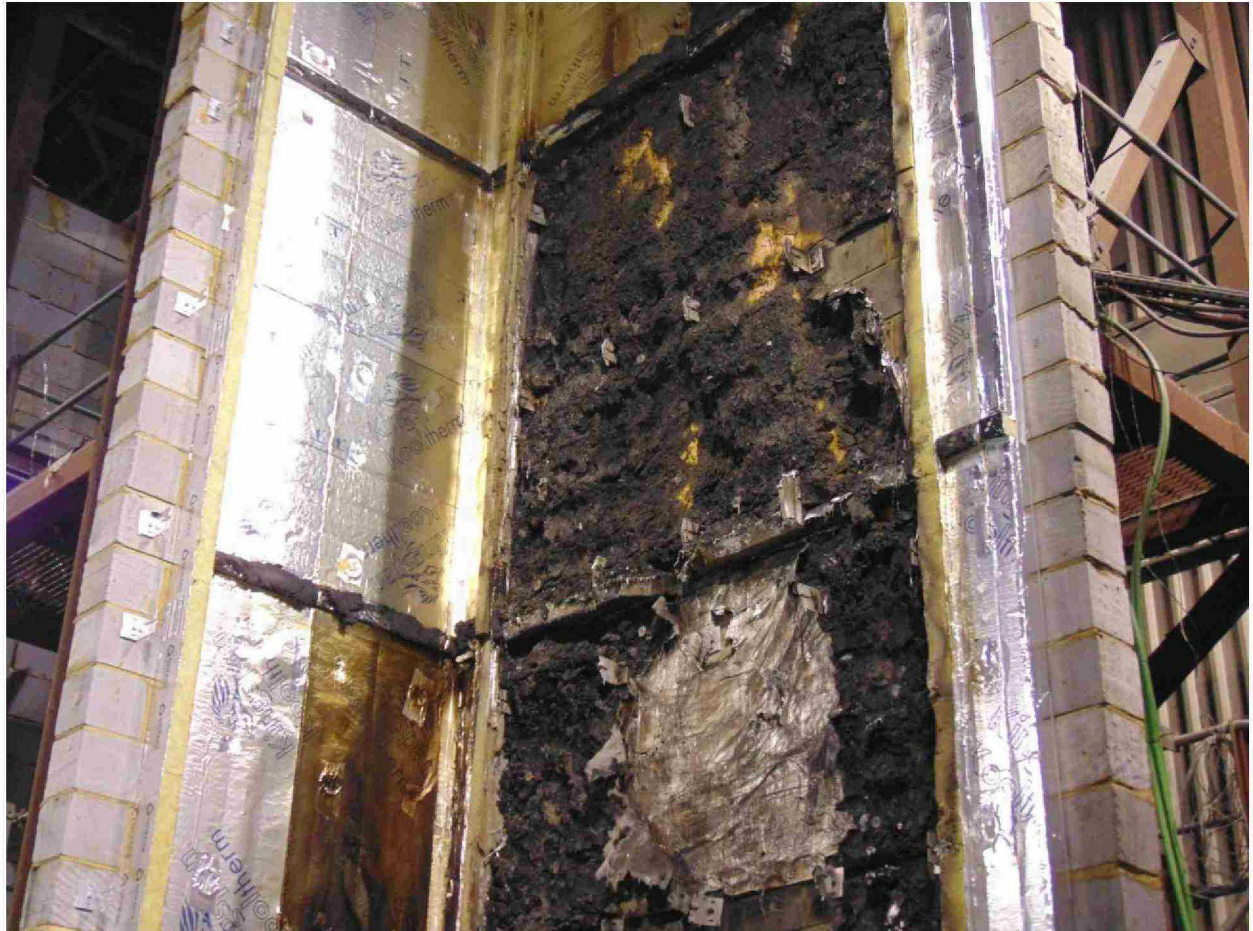
The stone wool section of barrier remained attached to the masonry substrate across the width of the main wall. The intumescent section was in longer in place directly above the combustion chamber, the remaining intumescent on the main and wing walls had activated.

Intact and in place. The intumescent had activated across the full width of the cavity barrier with the exception of the short section on the outside edge of the main wall.

Figure 19. Post-test photo showing second and third row Siderise RH25G 90/30 horizontal open state cavity barriers.

Note: majority of aluminium rail substructure has been removed.

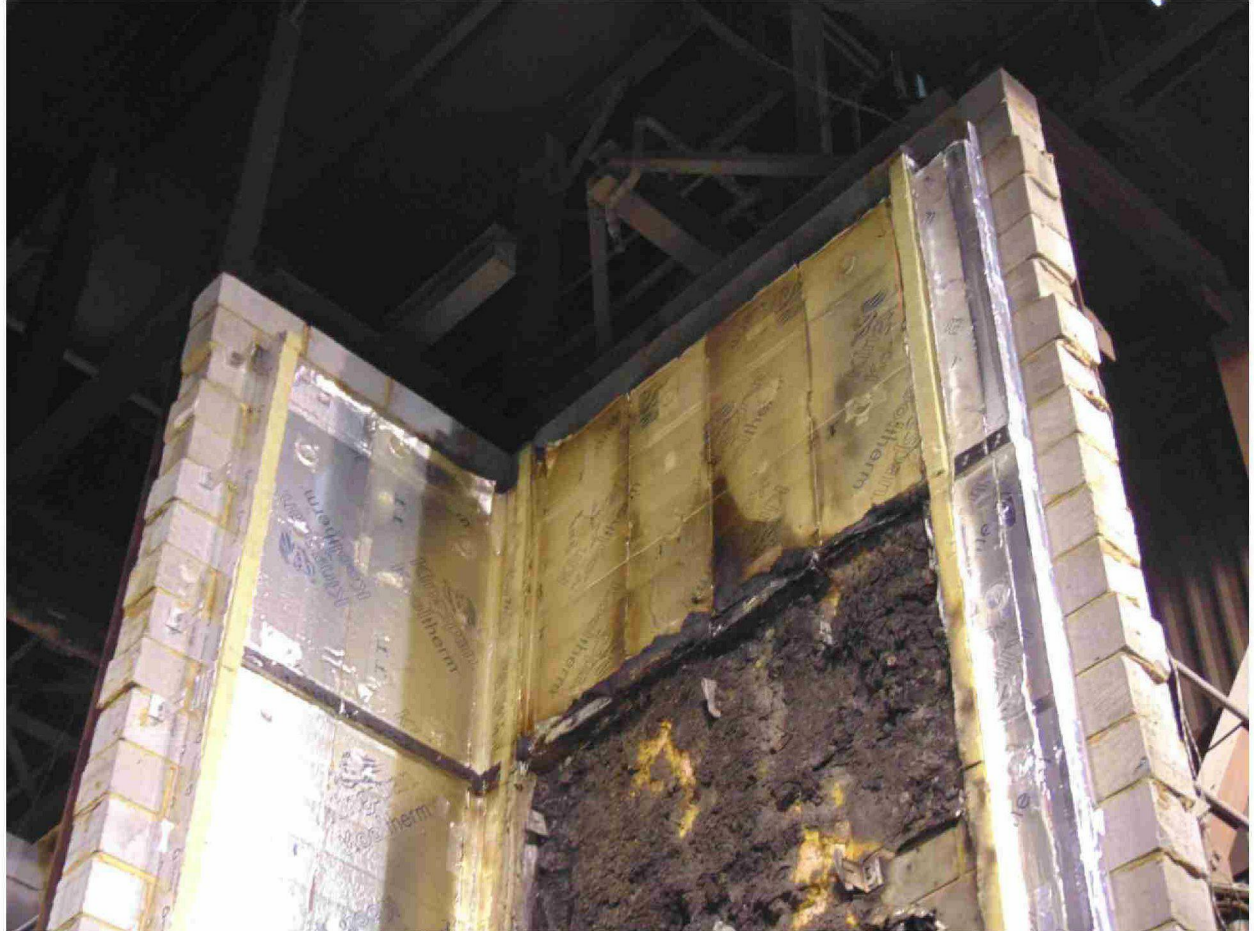
Intact and in place. The intumescent had activated across the central section of the barrier in line with the top of the combustion chamber.

Figure 20. Post-test photo showing third and fourth row Siderise RH25G 90/30 horizontal open state cavity barriers.

Note: majority of aluminium rail substructure has been removed.
