BRE Global Test Report

BS 8414-1:2015 + A1:2017 Test on Eternit Equitone Natura panel ventilated rainscreen system with Kingspan K15 insulation.

Prepared for: Kingspan Insulation
Date: 7th February 2020
Report Number: P114679-1000 Issue: 1

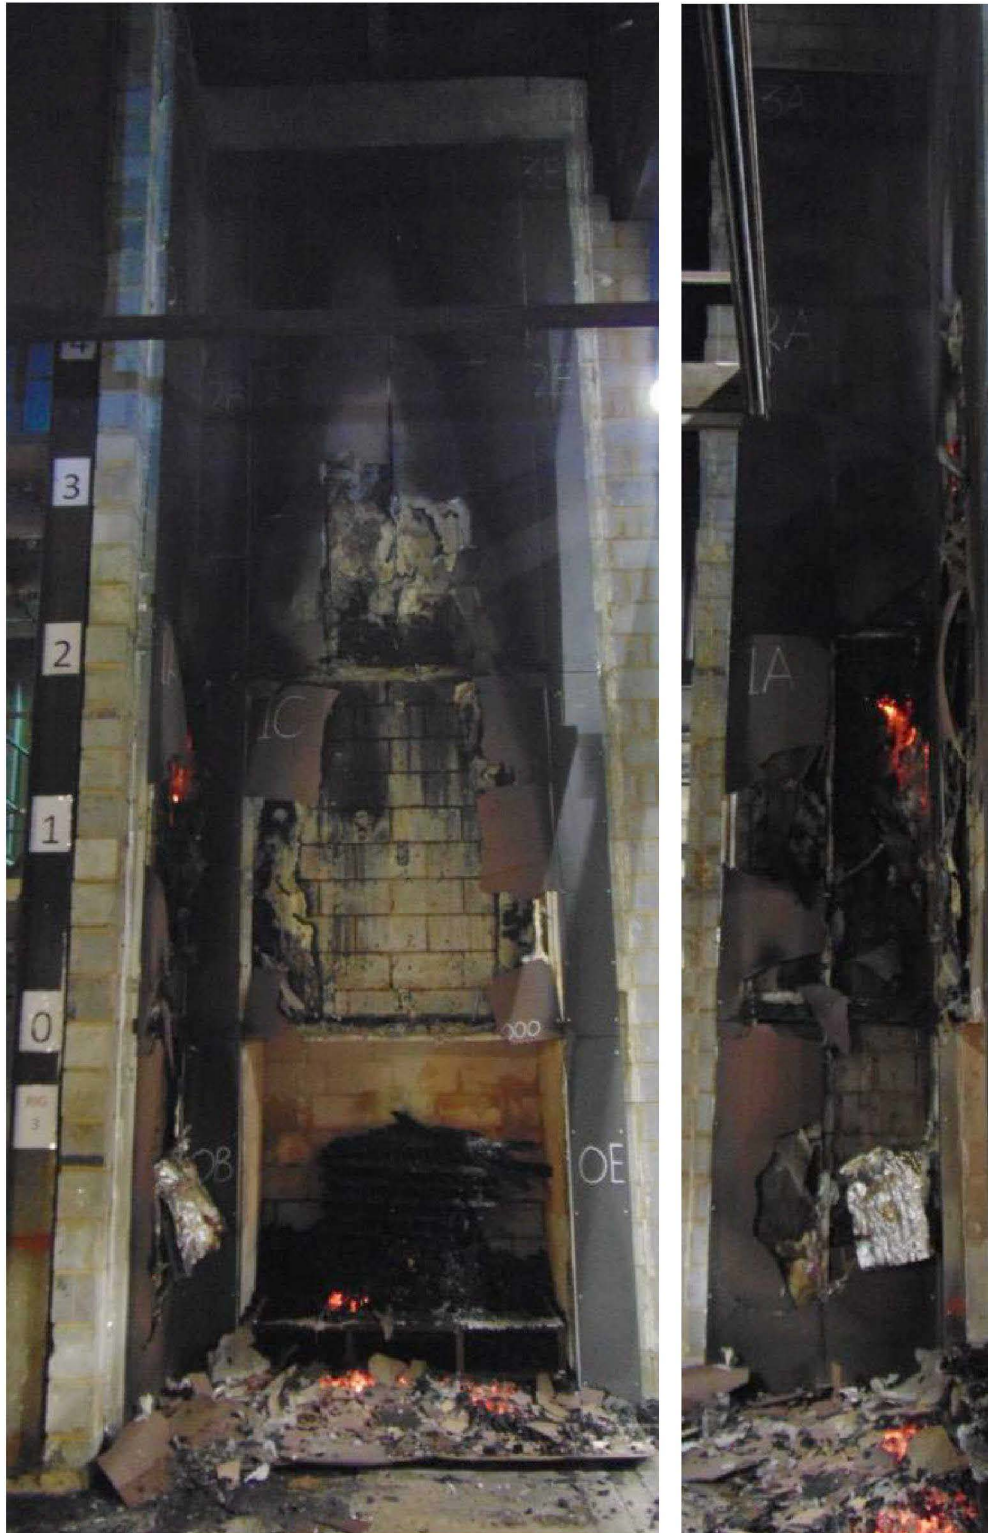
Figure 18. Full-height photograph of cladding system immediately after test.

On the main wall, the panels had fallen/burnt away exposing an area of approx. 1.2m-wide×3.9m-high (approx. 4.7m²) above the combustion chamber opening. The surfaces of the panels were cracked up to 4.6m and discoloured up to 5.5m above the combustion chamber opening.

On the wing wall, the panels had fallen/burnt away exposing an area of approx. 0.9m-wide×4.4m-high (approx. 4.0m²) from ground. The panels were discoloured up to approx. 3.5m-high covering the full width of the panels from ground with panels discoloured further along the main-wing wall up to approx. 6.6m.

See *Figure 18*.

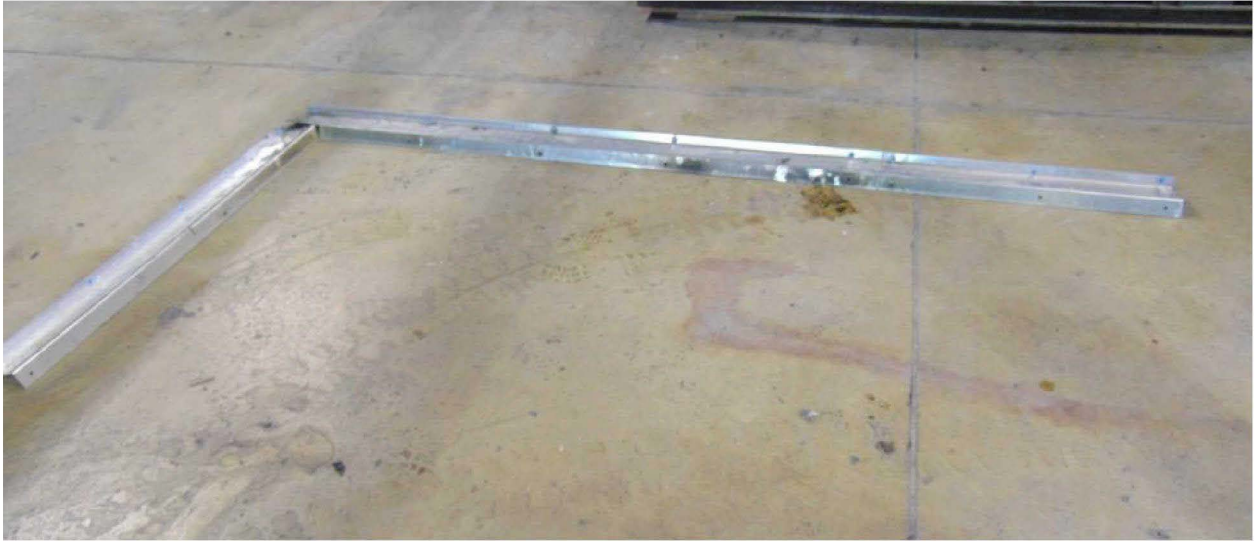
Figure 19. Capping at the top of the system.

On the main wall, the capping was discoloured to full width. On the wing wall, the capping was discoloured on main-wing junction. See *Figure 19*.

The combustion chamber surround pod top edge was consumed approx. 1.5m-wide. The vertical edges were distorted and discoloured.

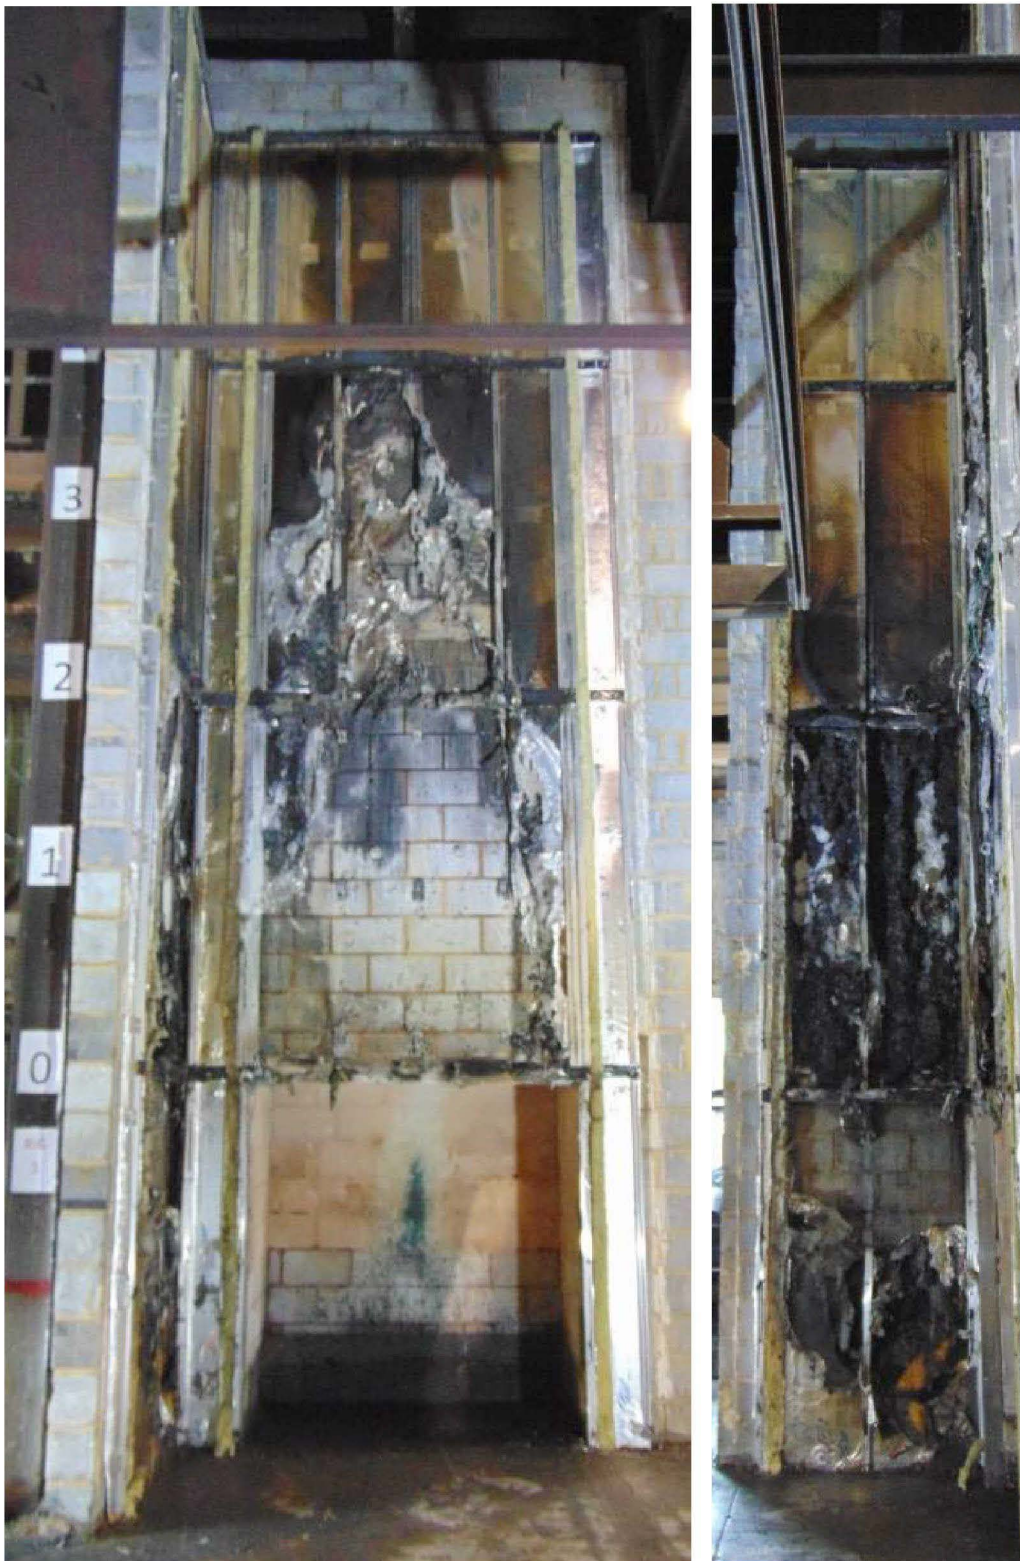
Figure 20. Post-test photograph following removal of panels.

On the main wall, the rail in line with the combustion chamber centre line was consumed to 6.7 from ground. The rails either side of the centre rail were consumed up to 5m and 4.m respectively. All rails up to 7m from ground were distorted between both vertical cavity barriers. The rails were discoloured between both vertical cavity barriers up to the top of the system.

On the wing wall, the central rail had consumed sections up to 2.8m. The rails were distorted to 4.4m and discoloured to 7m from ground.

See *Figure 20*.

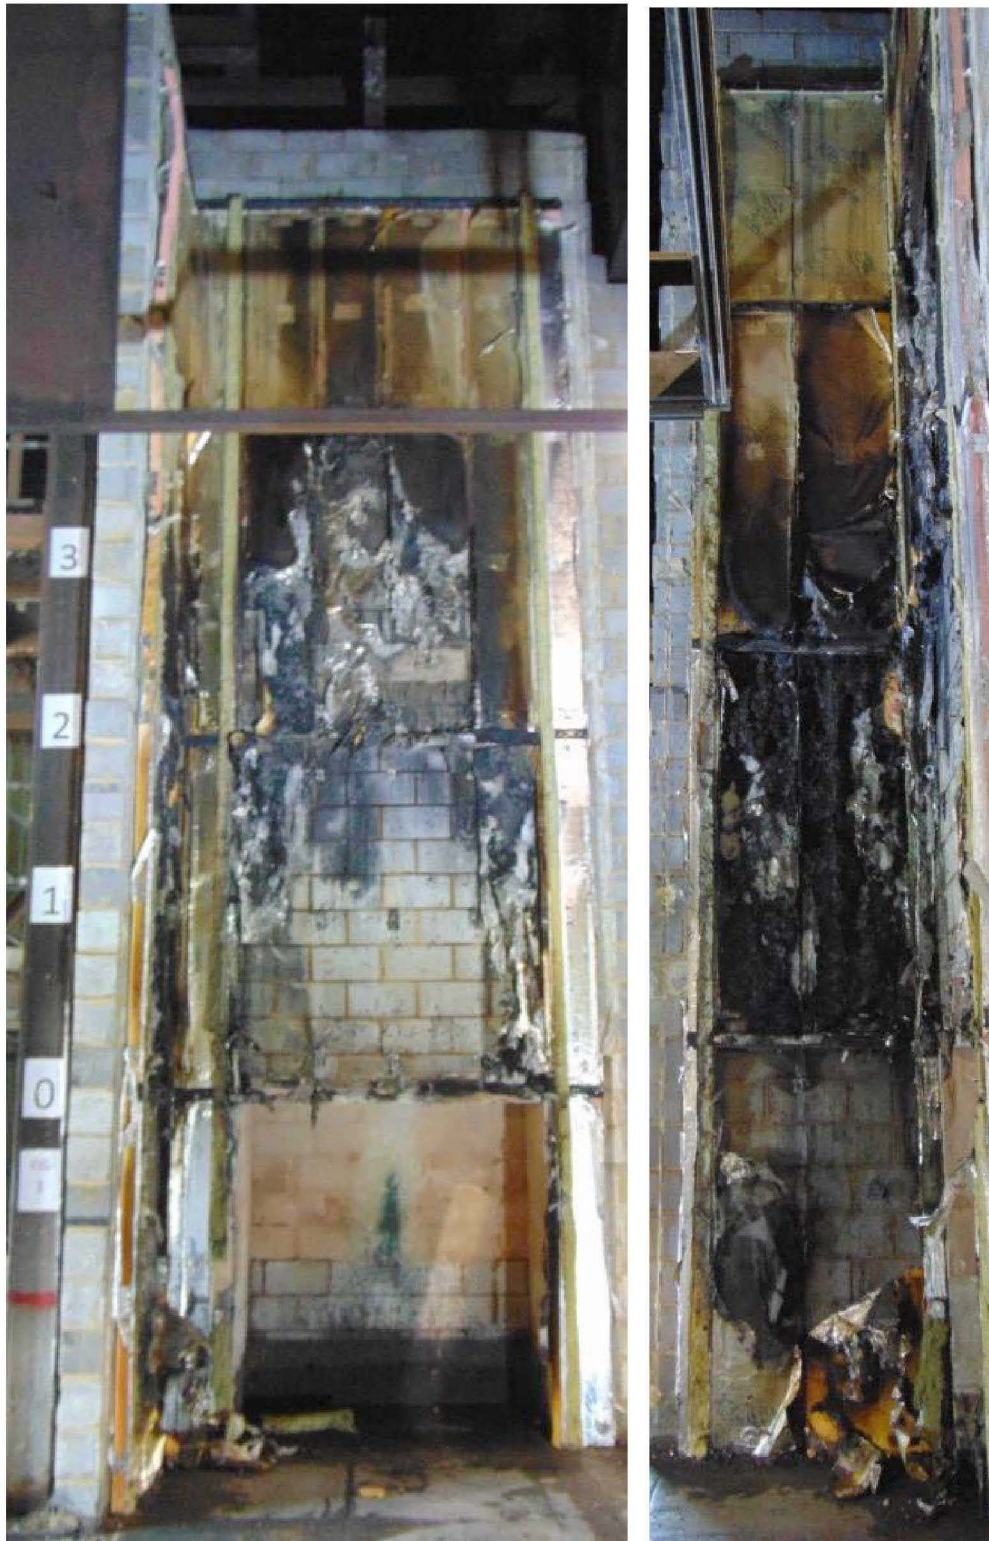
Figure 21. Post-test photograph following removal of rails.

On the main wall, the insulation had burnt/fallen away to approx. 2m-wide \times 6.7m-high from ground, in a tapering fashion reducing to 0.5m-wide. The insulation was discoloured between the combustion chamber opening to top of system, to a width of 2.5m measured from the main-wing wall junction.

On the wing wall, the insulation had burnt/fallen away to approx. 1.2m-wide \times 4.8m-high. The insulation was discoloured to the top of the system.

See Figure 21.

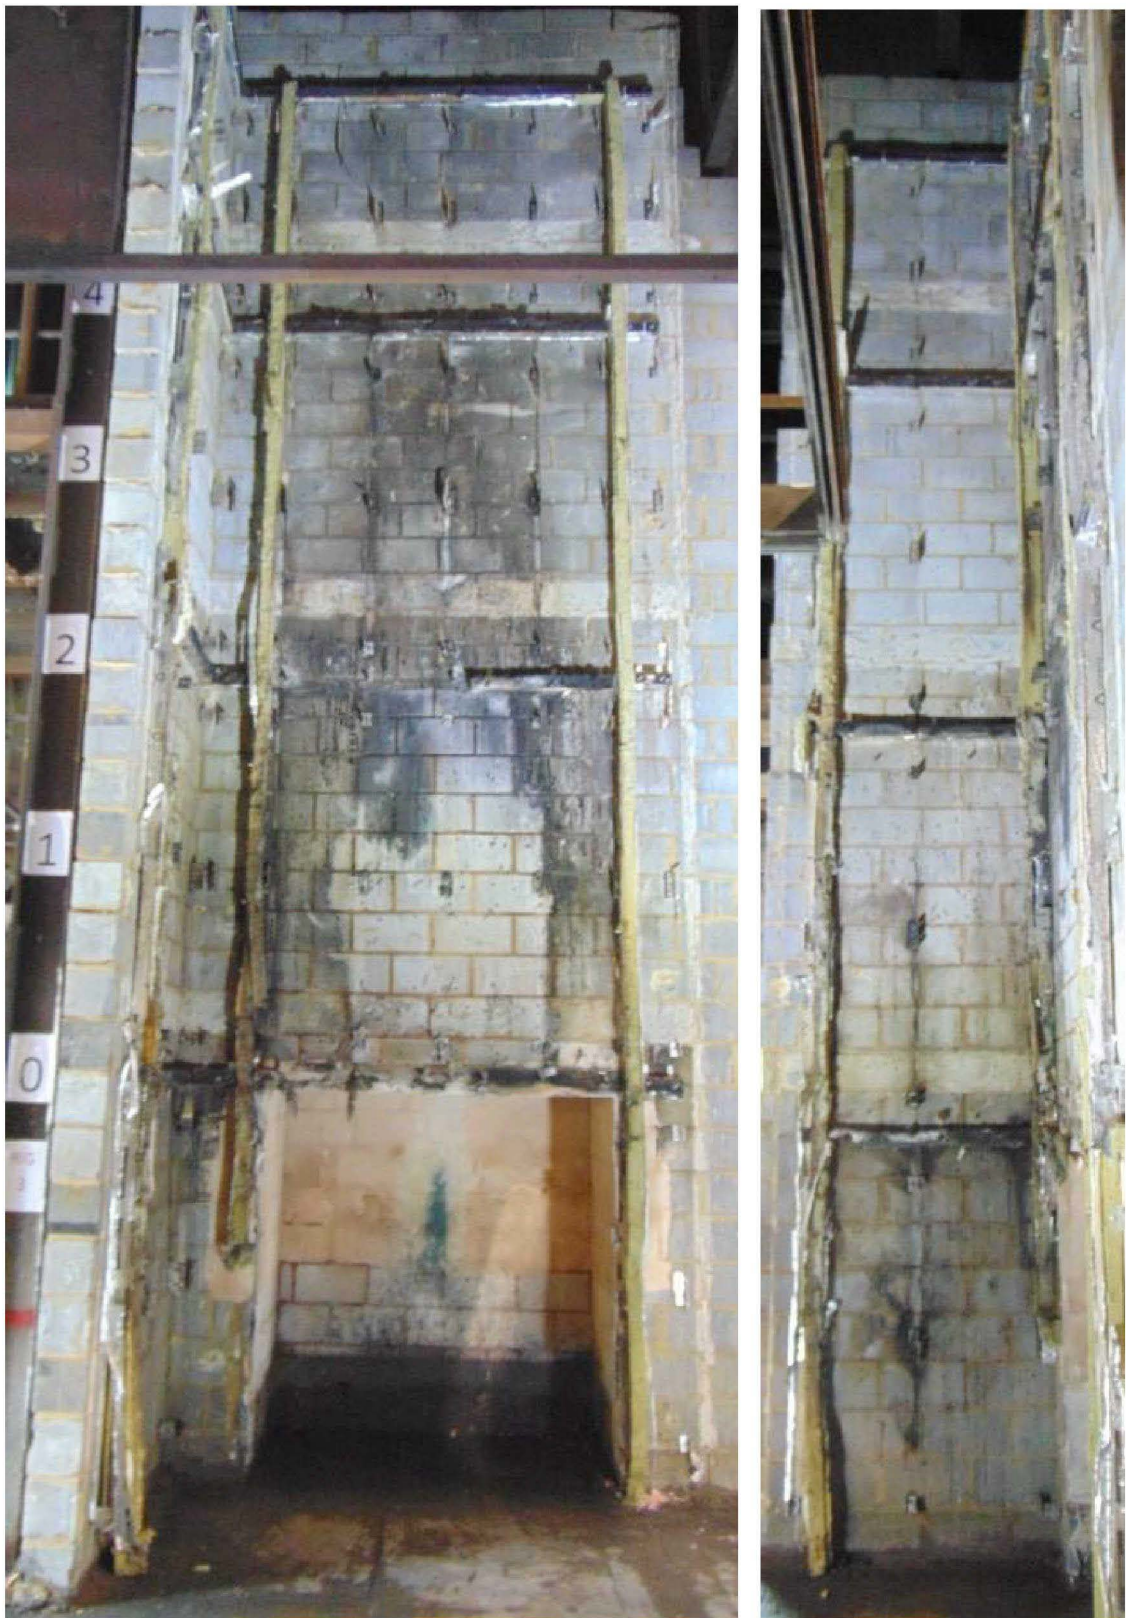
Figure 22. Post-test photograph of the horizontal and vertical cavity barriers

On the main wall, a 1m-wide section of horizontal cavity barrier had detached from the horizontal cavity barriers located at 2065mm and 4390mm from ground. The intumescent strip on the remaining sections and horizontal cavity barriers located at 6695mm and 8430mm from ground had activated.

On the wing wall, the horizontal cavity barriers located at 2065mm and 4390mm from ground were intact and activated. The horizontal cavity barriers located at 6695mm and 8430mm from ground had not fully activated.

See Figure 22

On the main wall, both vertical cavity barriers were intact and discoloured up to approx. 7m from ground. On the wing wall, the vertical cavity barrier surface had detached sections up to approx. 4m and discoloured up to 5.5m from ground. *See Figure 22.*

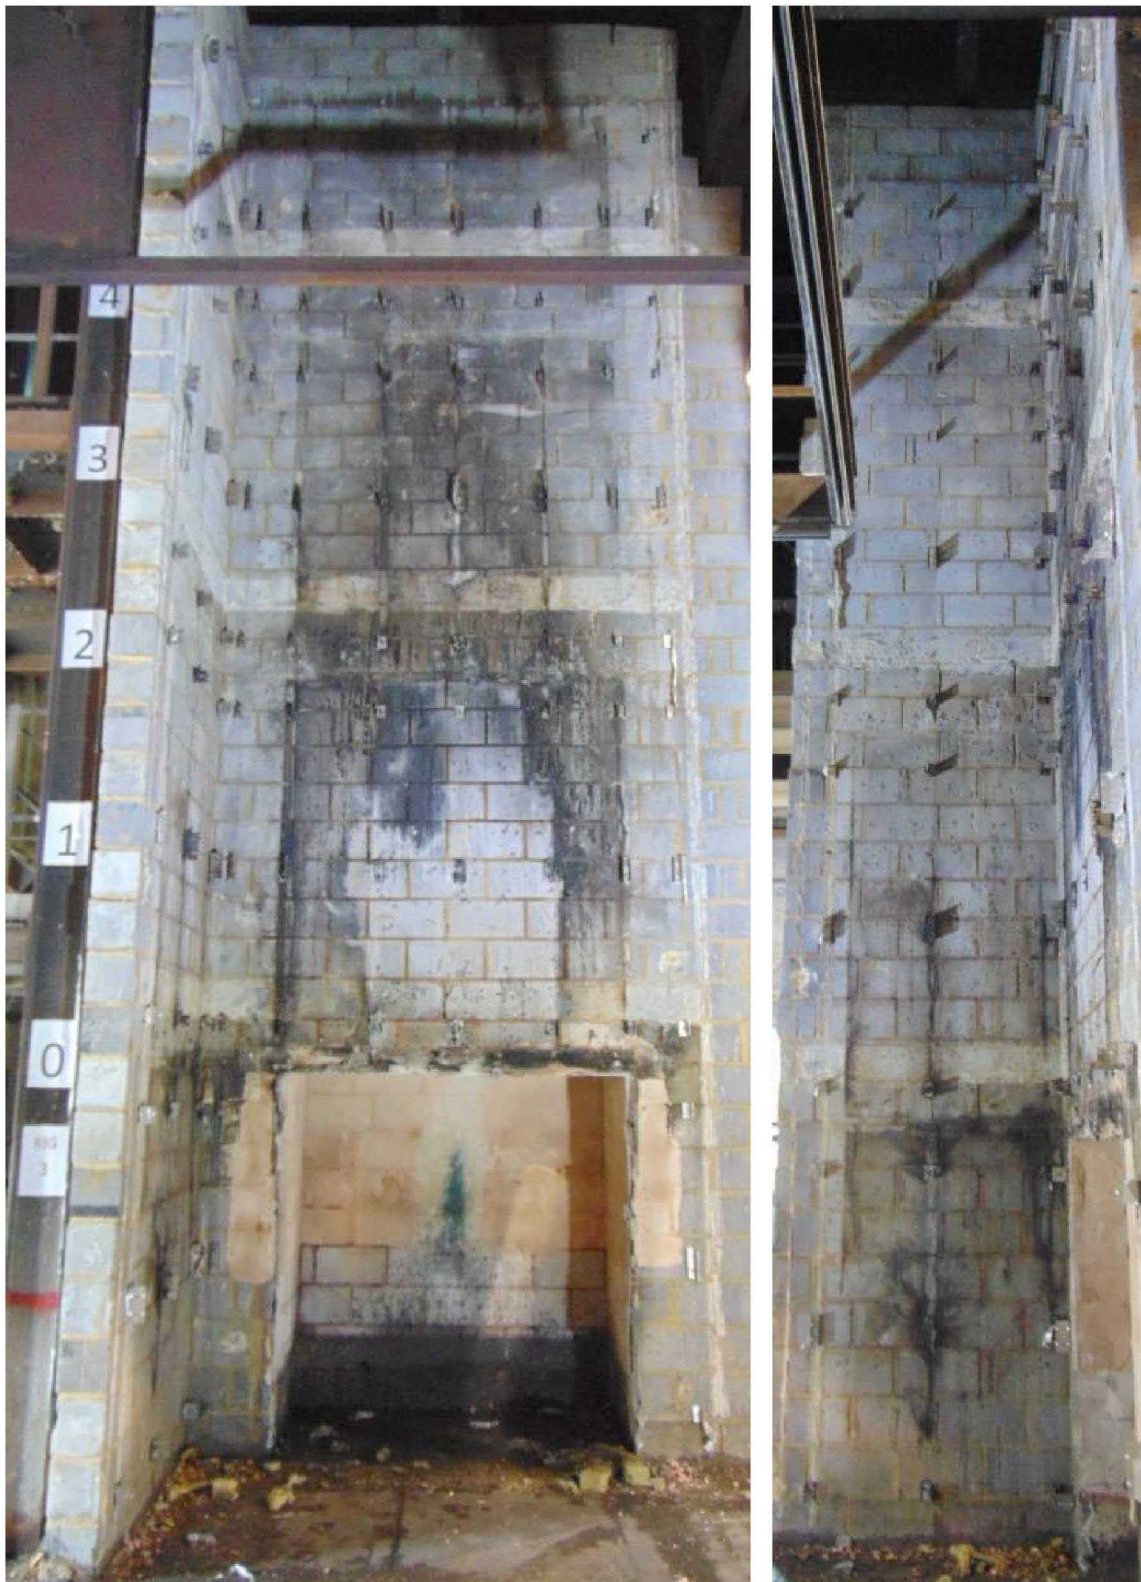
Figure 23. Post-test photograph of the 'L'-shaped brackets.

On the main wall, the three central columns of brackets were consumed in line with the combustion chamber opening to approx. 4m. The brackets were discoloured to of system, measured from the main-wing wall junction to 2.5m-wide.

On the wing wall, the column of brackets located at centre and the main-wing wall junction were consumed between 1m-2m from ground. The brackets were distorted up 4m

See Figure 23.
