REACTION TO FIRE TEST REPORT No EUI - 18 - FF - 000131

- Performed on: 27 June 2019
- **Test Standard: BS 8414-2:2015+A1:2017** Fire performance of external cladding systems Part 2: Test method for non-loadbearing external cladding systems fixed to and supported by a structural steel frame
- **Product referenced:** Façade system incorporating 90 mm Kooltherm K15 Rainscreen and 90 mm K15 Black Kingspan Insulation, cavity and Branco Michaela Granite stone cladding panels
 - Test sponsor : KINGSPAN INSULATION LTD Bree Industrial Estate, Castleblayney Co Monaghan AK75 X966, Ireland

KINGSPAN INSULATION LTD Bree Industrial Estate, Castleblayney Co Monaghan AK75 X966, Ireland

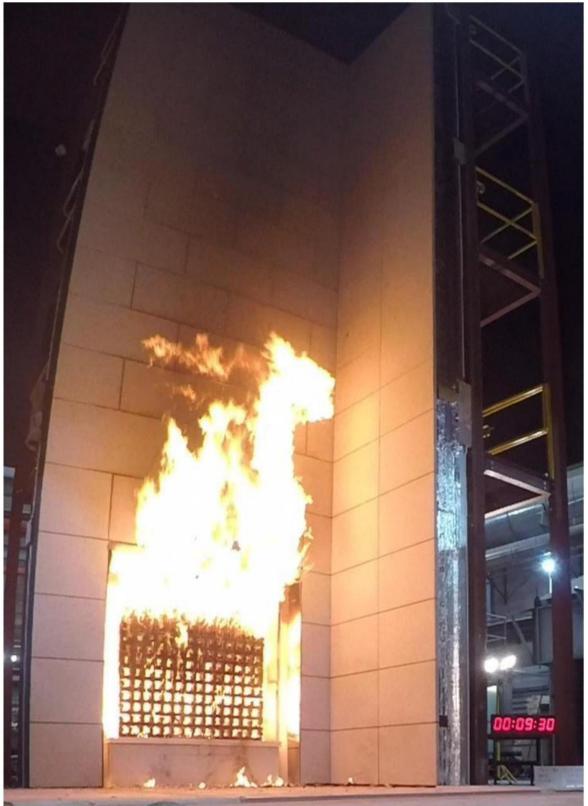
07:00	05:36	Flames constantly located at Level 1	
07:30	06:06	Pod-frame bended on top Crack visible on 2 nd row's stone panel at the left side of centreline above chamber

Figure 4.12. Cladding system during fire test (09 min 30 sec after ignition of the crib).

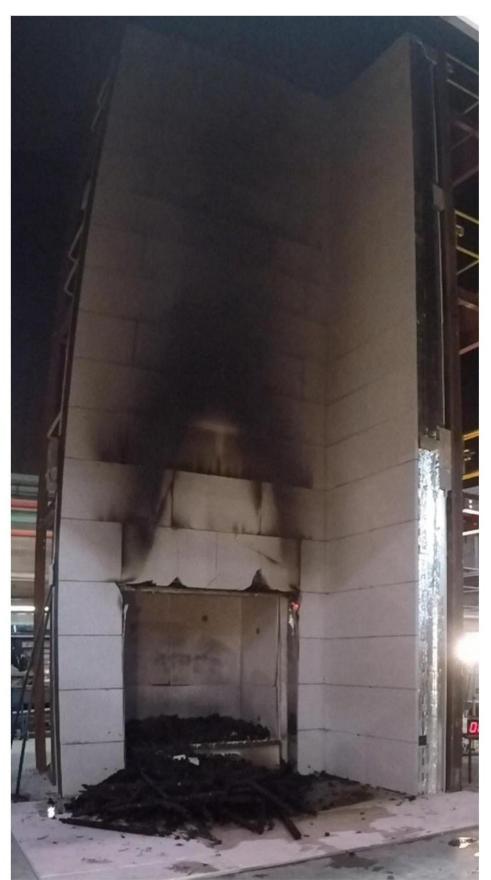
On the main face of the cladding system, all panels were in-place after testing. Some cracks were observed on three panels located just above the combustion chamber's opening. Discolouration was observed up to a height of 3000 mm.

Figure 4.15. Cladding system just after the fire test (60 min 01 sec after ignition of the crib).

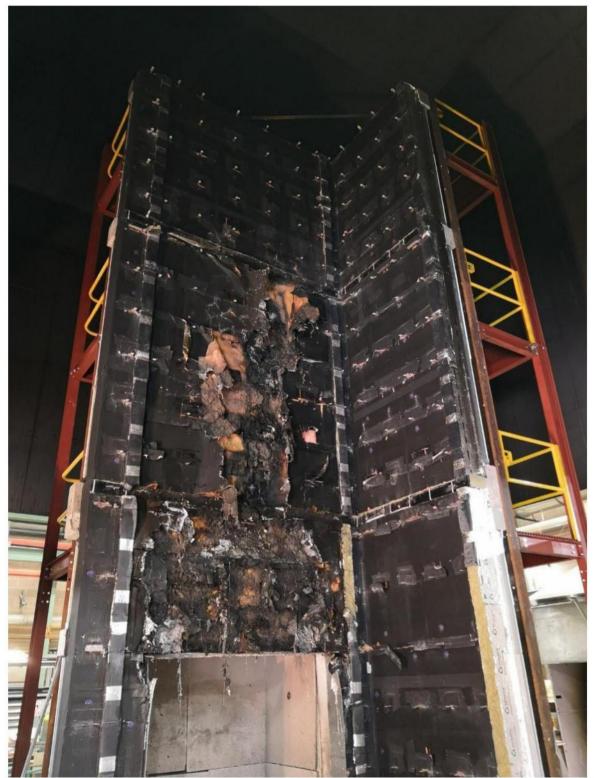
The reference Kooltherm K15 Rainscreen insulation layer on the main face was intact and in place after testing. There was no charring or damage observed on it. However, the layer of reference K15 Black insulation was charred and partially burnt on the area just above the combustion chamber up to a height of approx. 2500 mm above the chamber. That area was confined in the space between the two vertical barriers of the main face. Higher areas were without any damage or burnt being observed.

Figure 4.16. Post-examination damage. Insulation mainly charred and burnt above the combustion chamber on the main face; intact on the wing face. Vertical fire stop barriers in-place with some damage on the one located right of the chamber.

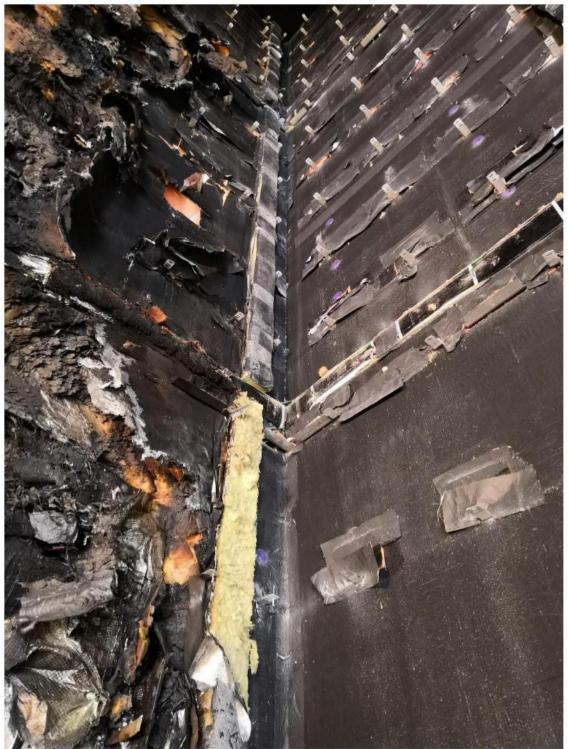
The vertical fire stop barriers were in place after the test without major damage. Only the right hand side vertical fire stop barrier was suffered some damage above the combustion chamber up to the bottom horizontal fire stop barrier.

Figure 4.17. Post-examination damage. Vertical fire stop barrier located on the corner of the system. Damage observed up to first horizontal fire stop barrier; rest in place without any damage.

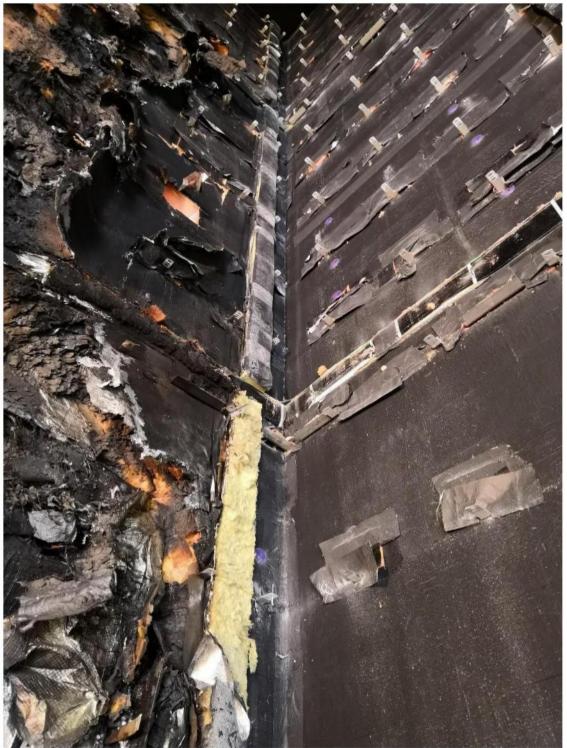
Figure 4.18. Post-examination damage. Vertical fire stop barrier located on the corner of the system. Damage observed up to first horizontal fire stop barrier; rest in place without any damage.

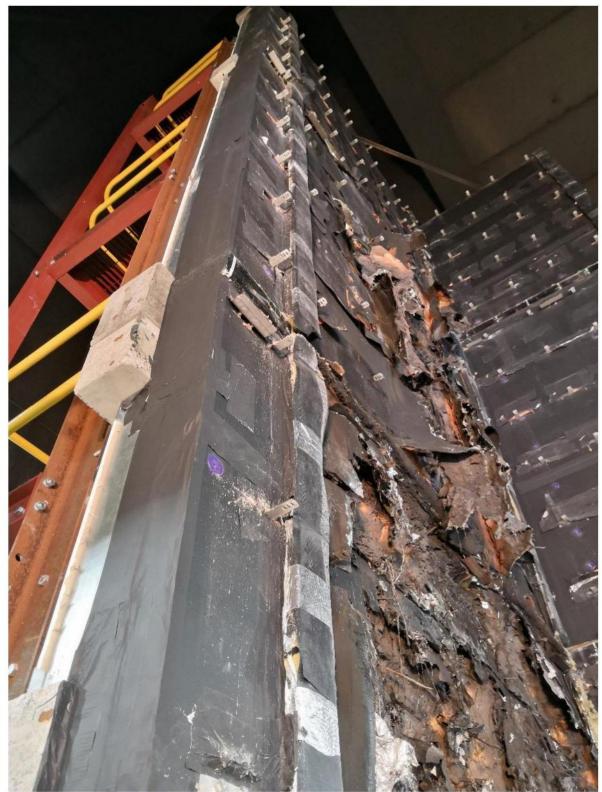
Figure 4.19. Post-examination damage. Vertical fire stop barrier located on the left-hand side edge of the system's main face. No damage observed; in-place and intact.

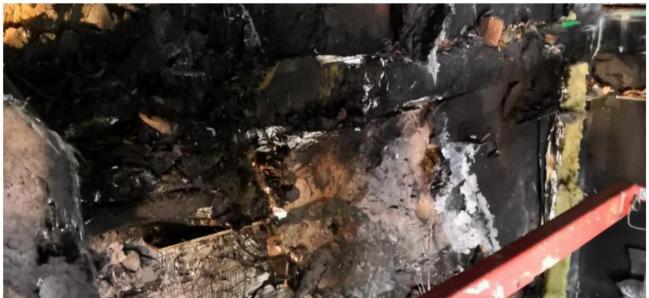
The bottom horizontal fire stop barrier installed was activated during the test along the two vertical fire stop barriers. It was partially damaged as about 15% was detached from the system. Only about 10% was intact; on the left hand side edge of the system's main face. The middle one was partially activated but was still in place without suffering any major damage. The top horizontal fire stop barrier was in place without been activated and without any damage or detachment.

Figure 4.20. Post-examination damage. Photo of the bottom horizontal fire barrier installed on the main face. Fully activated and partially detached (especially above the chamber).

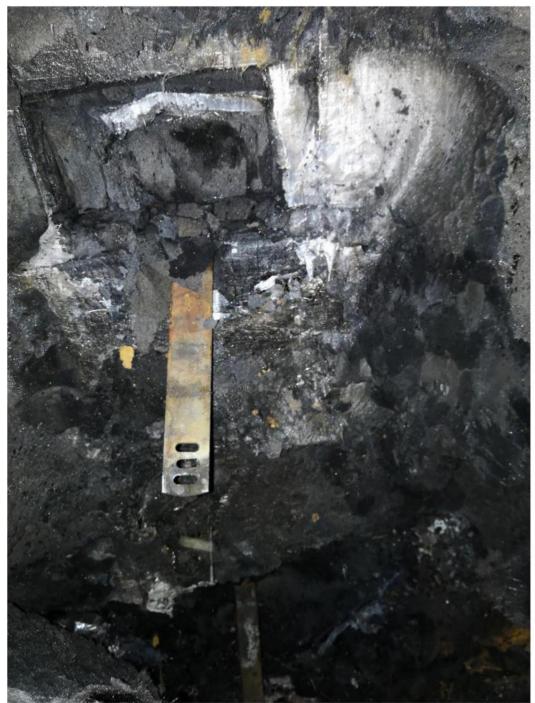
Brackets and restraints were intact and in place after the test. Some minor discolouration only observed on the ones just above the chamber's opening on the main face.

Figure 4.23. Post-examination damage. Photo of one bracket located just above the combustion chamber. No damage except discoloration observed.

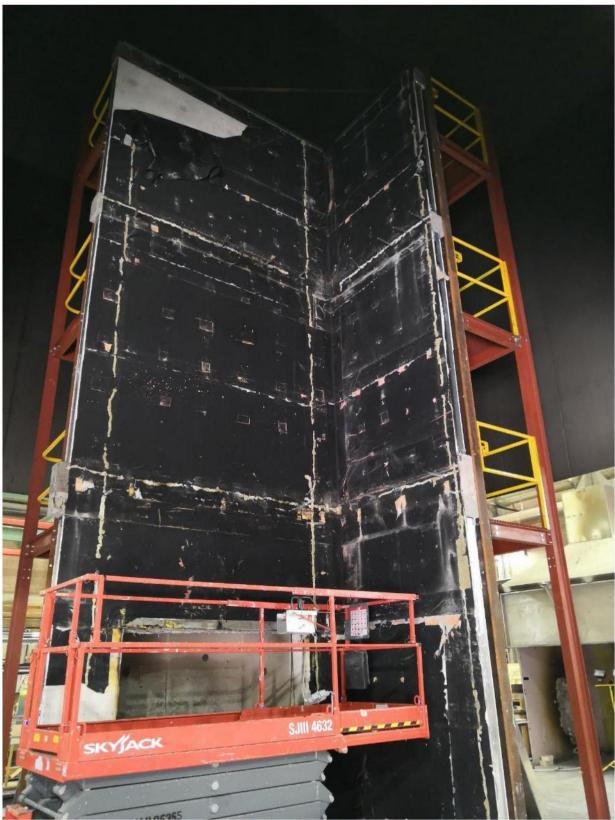
The waterproof membrane was in place and intact after testing. No damage was noted after removing the insulation layer from the system.

Figure 4.24. Post-examination damage. Waterproof membrane intact and in place after removing insulation layer from system.

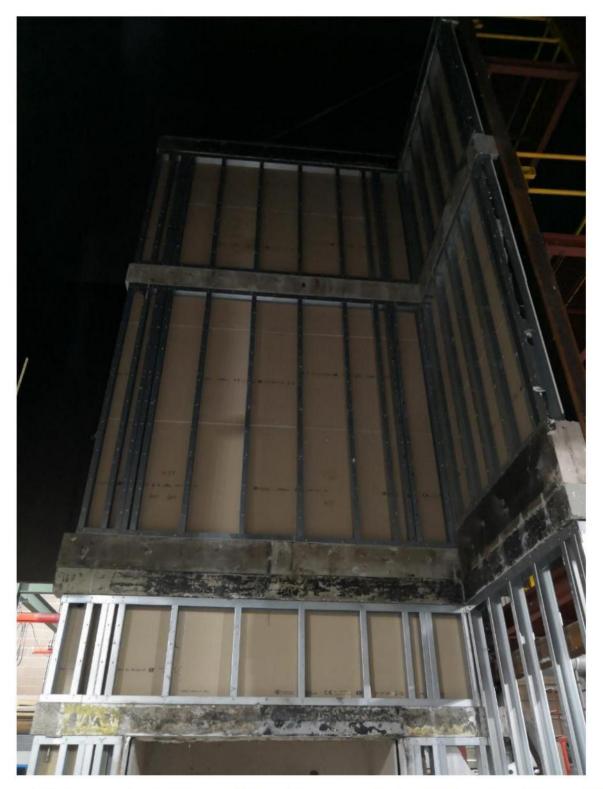
No damage was observed to plasterboard layer installed on the unexposed side of the system. No discoloration was observed.

No damage was observed to SFS Kingframe; all studwork was in place and intact after testing. No discoloration was observed.

Figure 4.25. Post-examination damage. Photo of the system showing the plasterboard layer and SFS Kingframe after the test.
