Fire and Safety Department Report

To: LFB/Fire Investigation Team - Dowgate
 For the attention of: WM M Boyle
 Our ref: LFB/16-372
 Your ref: 110281

Examination of Cladding Panels – Flat 28 Shepherds Court, 21 Shepherd's Bush Green, W12.

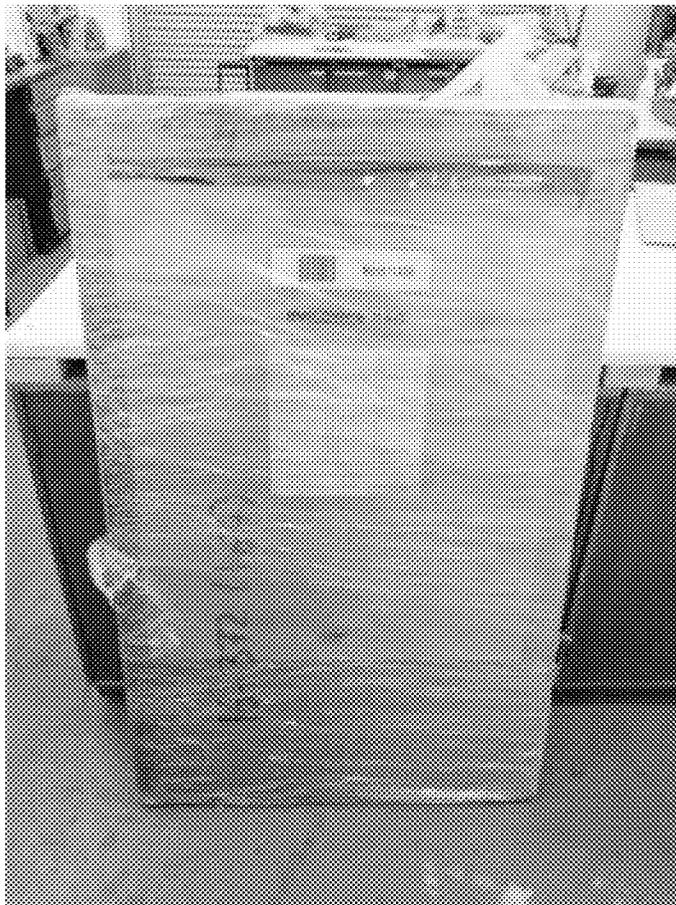
- 2.1 The sample received from the fire scene was 2 separate external cladding panels, measuring approximately 80cm by 127cm.
- 2.2 The first panel (incomplete) was sampled from outside the living room flat 58, on the 12th floor.
- 2.3 The second panel (complete) was sampled from outside the living room of the flat of fire origin (flat 28, 7th floor).
- 2.4 It was not known at the time of examination how long the panels had been fitted at the scene.

Photograph 1: Sample as received from the fire scene.

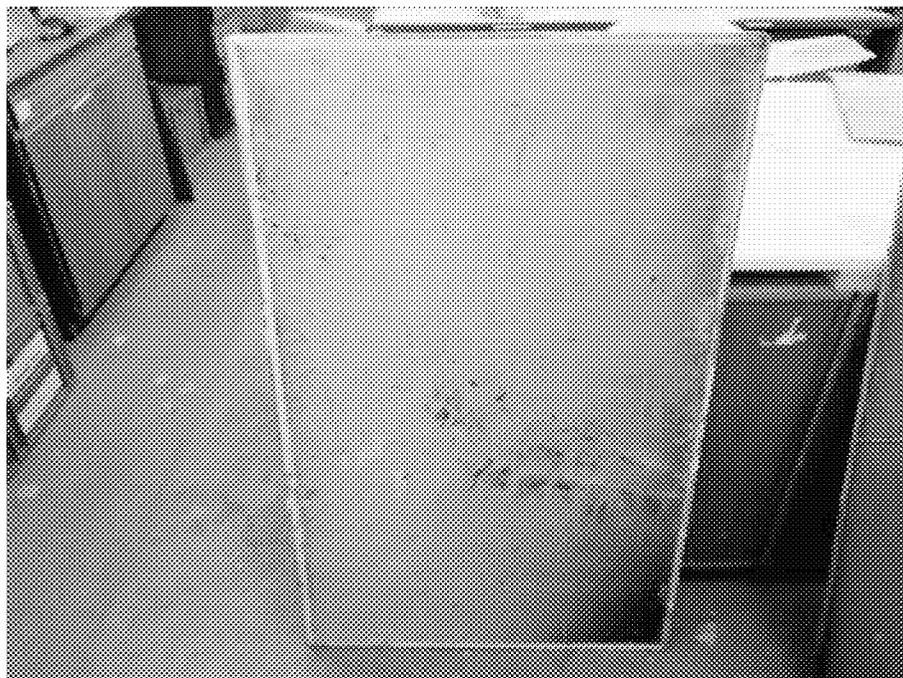
- 2.11 The second (complete) panel had suffered slight superficial fire damage on the front face from falling fire debris, but was otherwise intact.
- 2.12 The front surface of the complete panel was a metal sheet approximately 1mm in thickness; the metal sheet attracted a magnet and was therefore presumed to be steel.

- 2.13 The steel sheet was finished with a white decorative paint.
- 2.14 The complete panel (all layers together) was a thickness of approximately 31mm.

Photograph 2: Front (external) face of the complete panel.

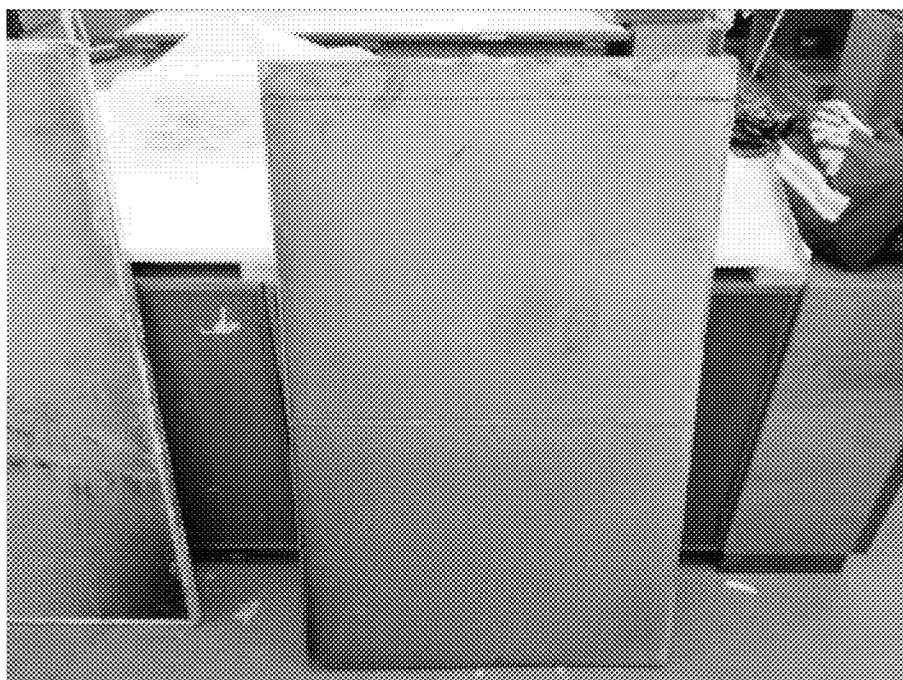
- 2.5 The first panel was incomplete as the external surface had come away during the fire, exposing blue plastic foam underneath.
- 2.6 The blue plastic foam was mounted on a plywood board, the thickness of which varied across the width of the panel (approximately in the range 17-23mm).

- 2.7 The blue foam had melted in some places, and had been blackened in others, particularly along the lowest edge of the panel.
- 2.8 The melting of the blue foam had exposed the plywood layer of the panel, particularly along the lowest edge of the panel.

Photograph 3: Front face of the damaged panel.

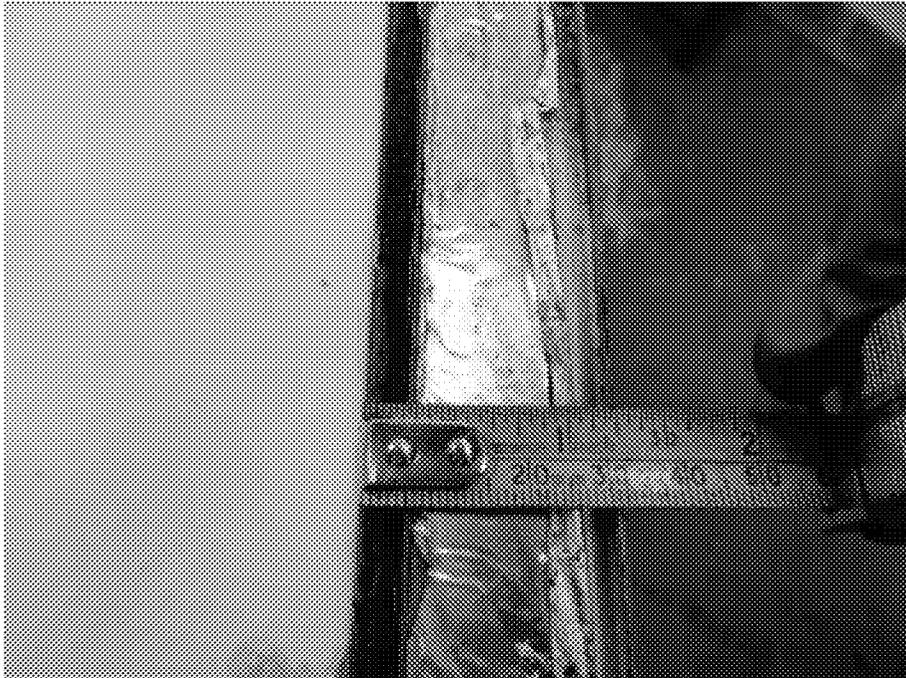
Photograph 4: Thickness of the complete panel (31 mm).

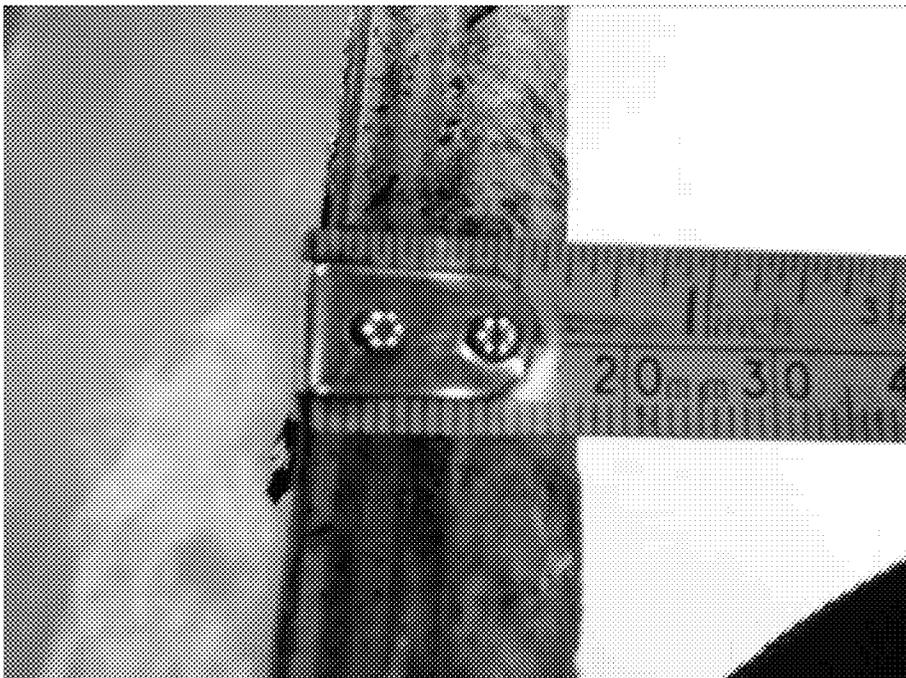
Photograph 5: Thickness of damaged panel (17mm pictured – although varied from 17-23mm across the width of the panel)

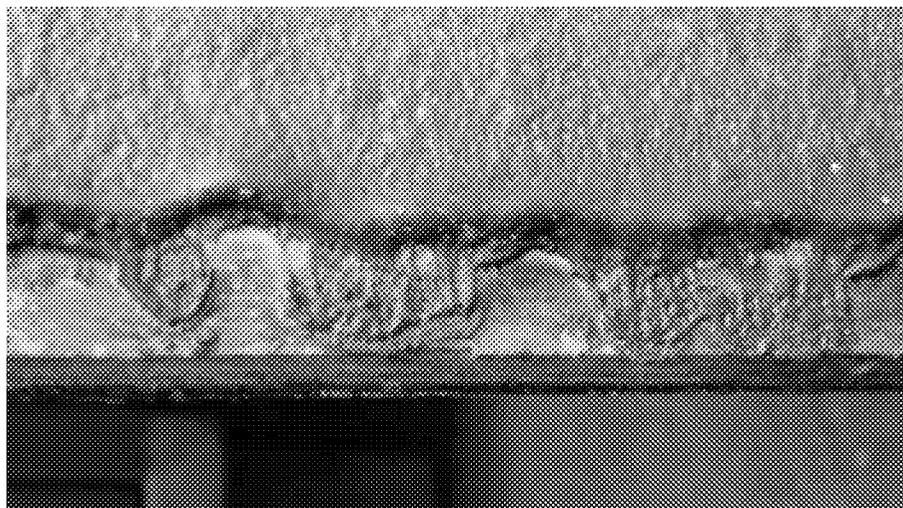
Photograph 6: Close up of fire damage to the blue plastic foam layer, exposing plywood layer underneath.

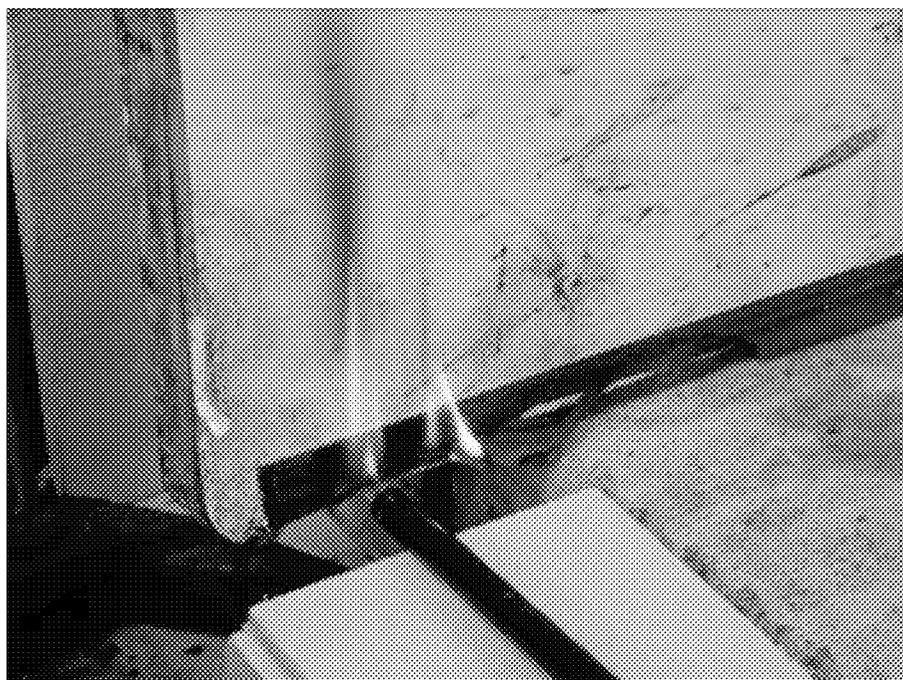
Photograph 7: ‘Small flame’ test on complete panel.

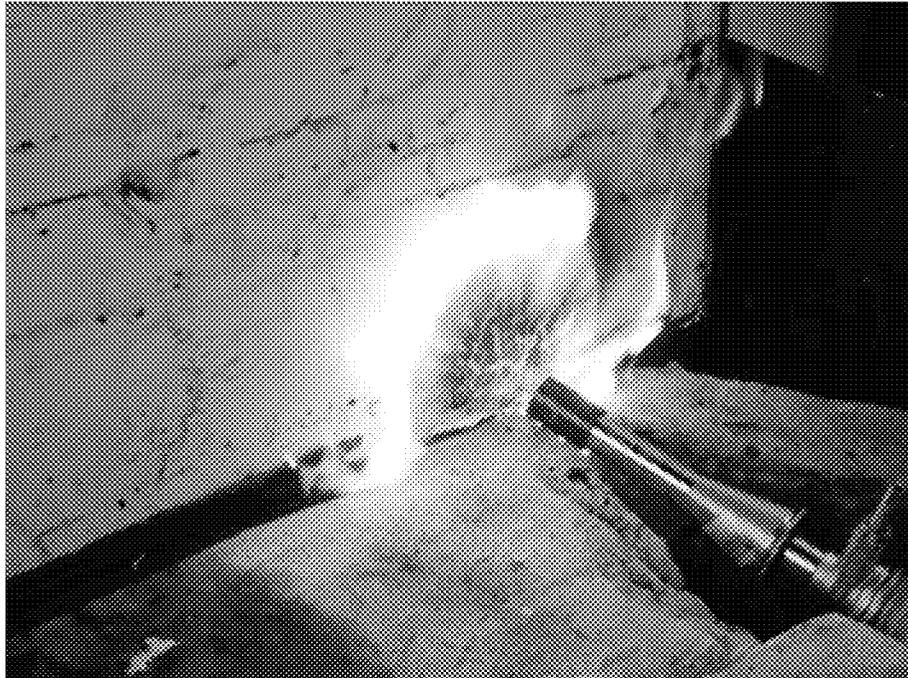
Photograph 8: 'Large flame' test on complete panel.

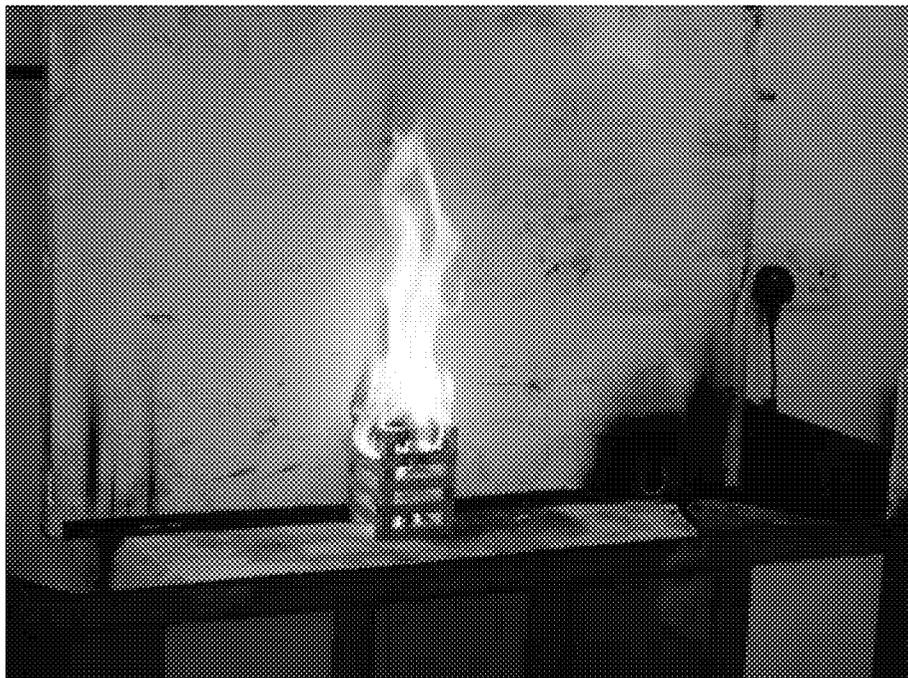
Photograph 9: 'Crib 6' test on the complete panel.

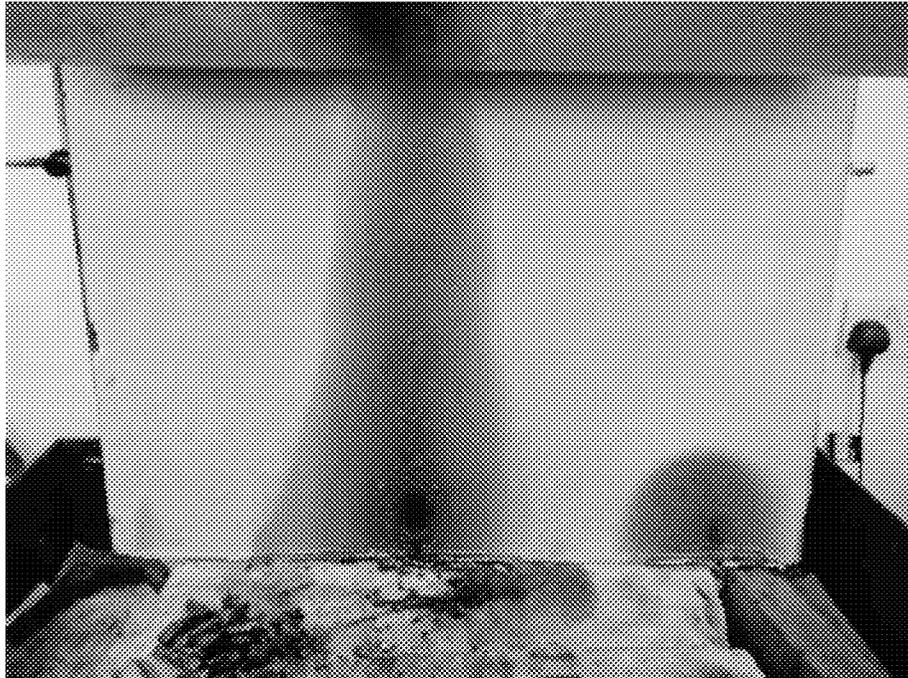
- 2.18 The tests were conducted for 1 minute on the complete panel, with the exception of the 'Crib 6' test, which was run for 10 minutes in total.
- 2.19 None of the flame tests penetrated the steel sheet, however, removal of the steel sheet revealed varying degrees of fire damage to the blue foam layer underneath.

- 3.3 The flame tests all inflicted negligible fire damage to the metal surface of the complete panel. Removal of the external steel sheet showed that the blue foam layer underneath the steel sheet at the location of the flame tests had melted away. In the ‘Crib 6’ flame test, the blue foam had also been completely destroyed in some areas exposing the plywood underneath.

Photograph 10: Complete panel after the 3 flame tests with front steel sheet removed.

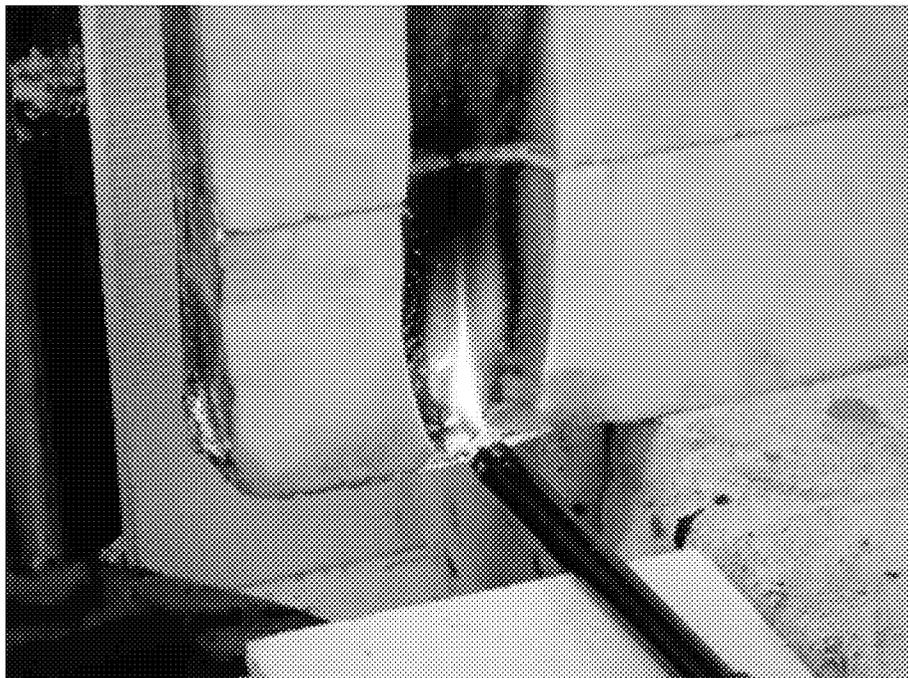
Photograph 11: Repeat of the 'Small flame' test against the blue foam layer.

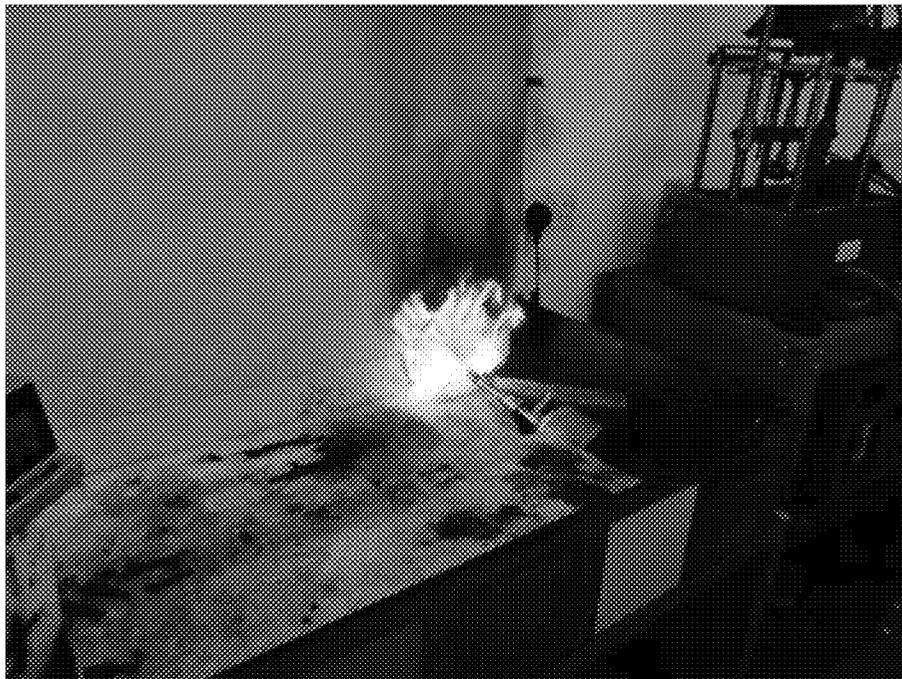
Photograph 12: Repeat of the 'Large flame' test against the blue foam layer.

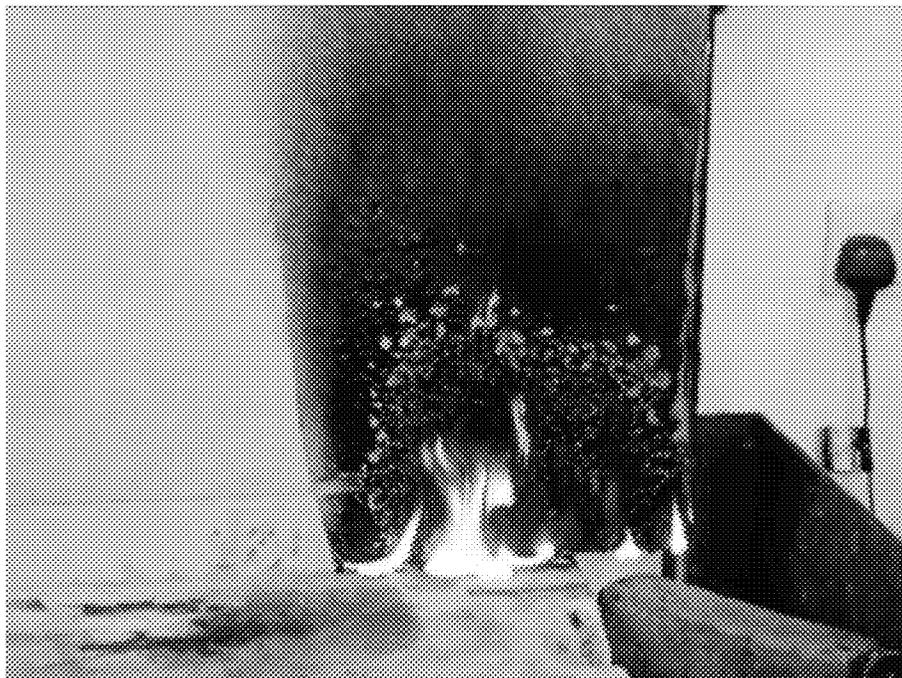
- 2.22 The panel used for the repeat tests had its blue foam layer rapidly destroyed by fire during the different flame tests, exposing the plywood layer underneath.

Photograph 13: After the 'Large flame' source had been withdrawn.

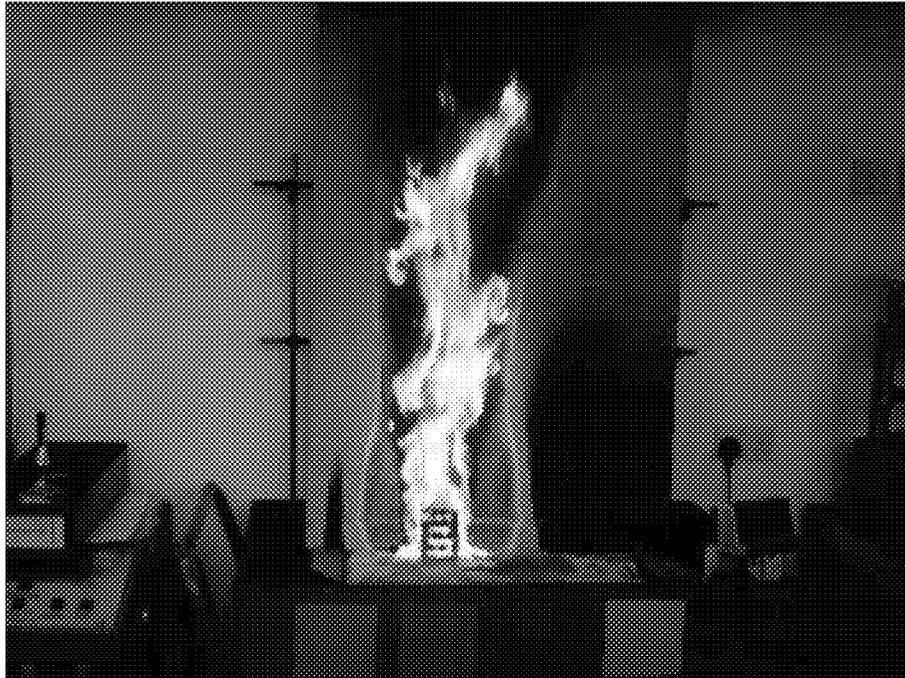
- 3.5 The repeat flame tests, with the ignition sources placed directly against the blue foam layer, behaved as per the previous tests, except the destruction of the foam layer was significantly accelerated.

Photograph 14: Repeat of the 'Crib 6' test against the blue foam layer.
