The Lakanal Fire

LFEPa Briefing

28th August 2013

David Crowder

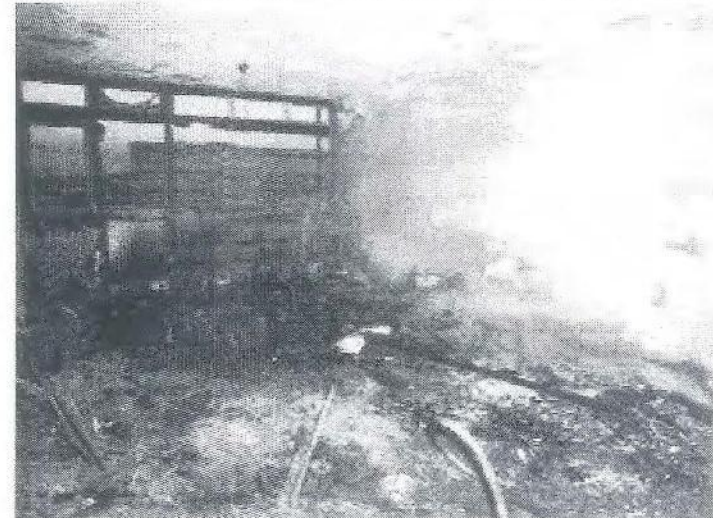
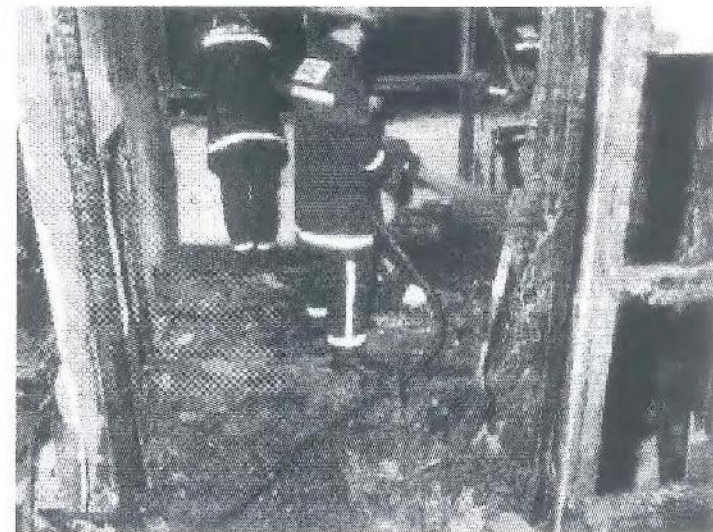
History of fires

- 1985
 - Flat 79
 - Significant damage to flat
 - Spalling of concrete
- 1988
 - Flat 95
 - Damage throughout flat
- 1997
 - Flat 81
 - Damage throughout flat
- Damage limited to flat of origin in all cases

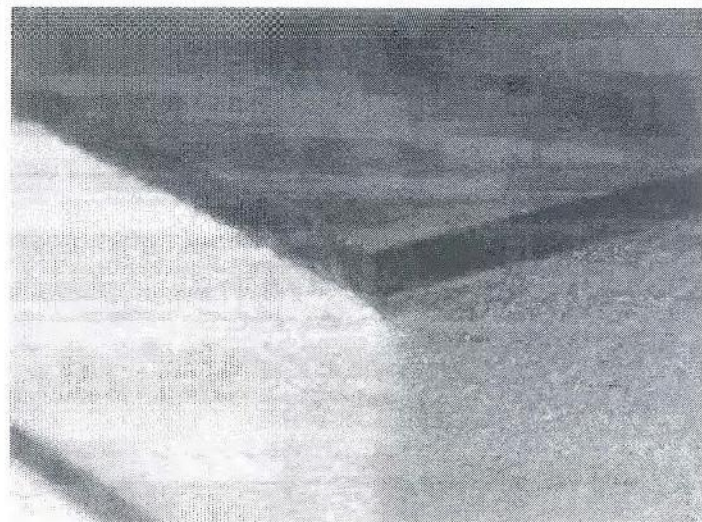
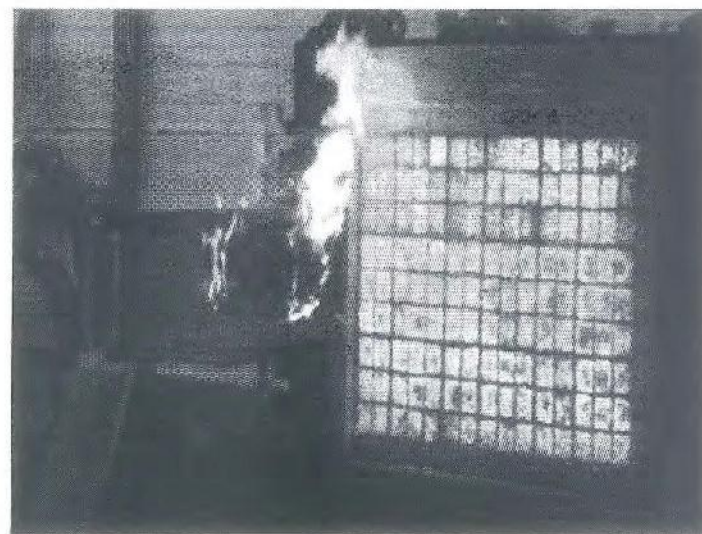
Composite panels

- Compressed resin outer layers and foam insulation core
- Class 3
- No fire resistance
- Ignited under flame impingement from burning flat below
- Burnt through in 4-5 minutes
- Introduced flaming on inside of flats
- Introduced during refurbishment 2006-2007, replacing asbestos

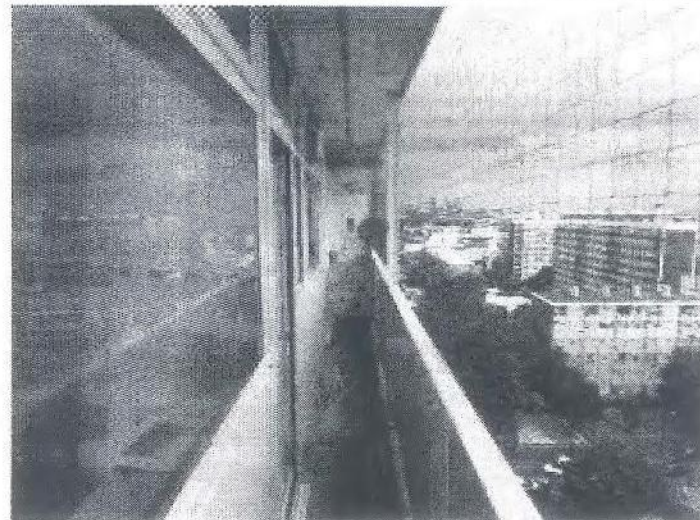
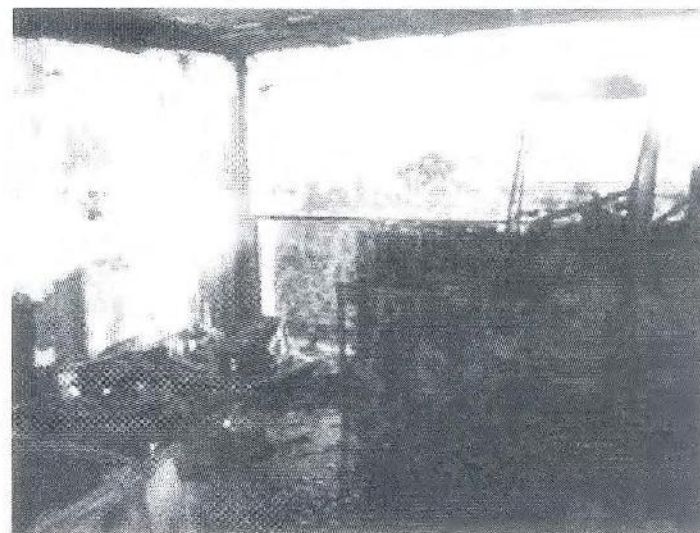
Balcony-flat doors

- Glazed upper half
- Composite panel lower half
- Aluminium frame
- Not fire resisting
- Introduced during refurbishment 2006-2007
- Replacement for fire resisting doors (full height)

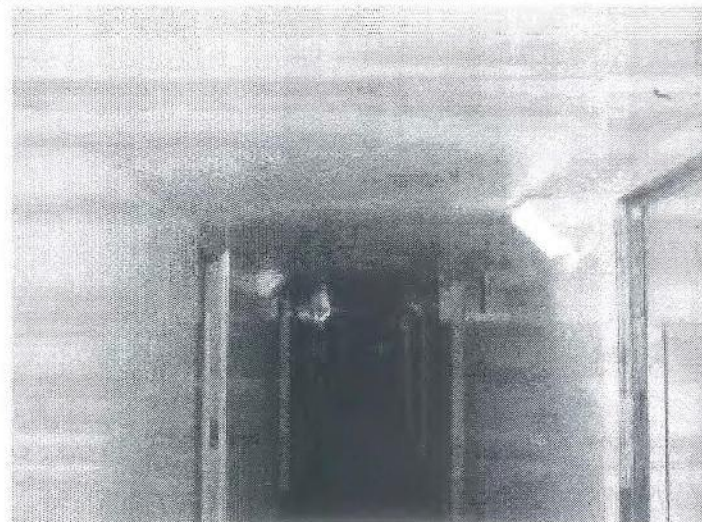
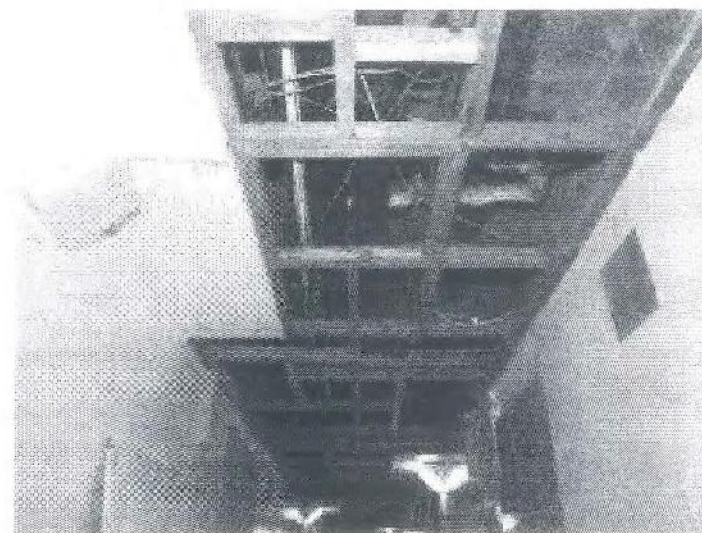
Suspended ceiling in common corridor

- Laminated particle board (fire retardant)
 - Timber supporting structure
 - No sub-division of void above
 - Significant quantity of fuel in void above
-
- Ceiling panels did not support flaming
 - Timber structure and fuel above contributed significantly
-
- Introduced in 1980s for central heating works

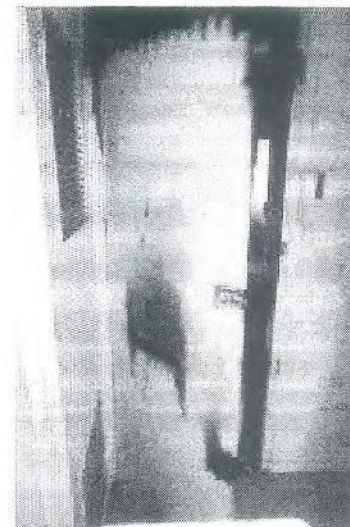
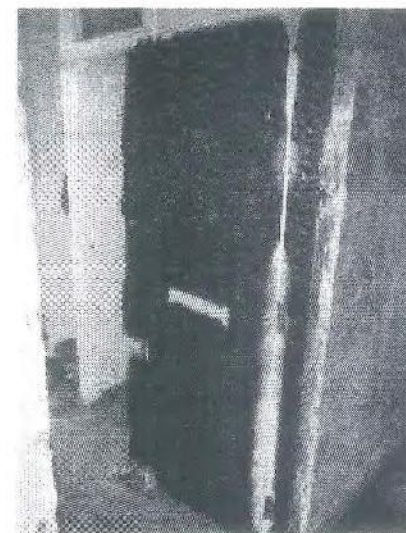
Front doors and escape doors

- Appeared to be FD30
- No smoke seals
- Allowed smoke travel
 - into corridors from flats
 - into flats from corridors
 - into stairwell from lobbies
- Piecemeal replacement over life of building
 - Some FD30, others not

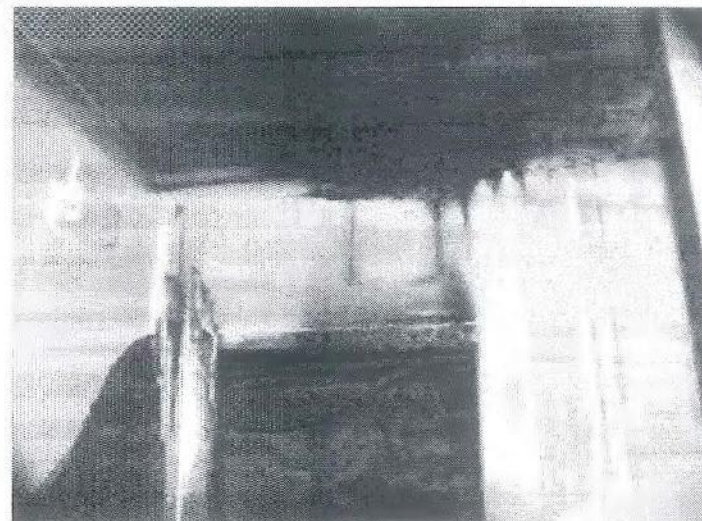
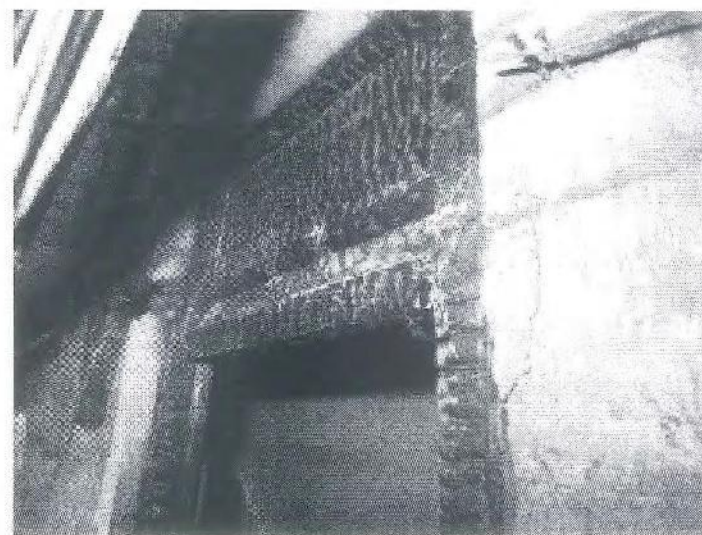
Panels above front doors

- Timber
- Some fire resistance, possibly as much as 30 minutes against standard furnace
- Originally part of doorset between flat and corridor
- Communicating with suspended ceiling void once this was introduced

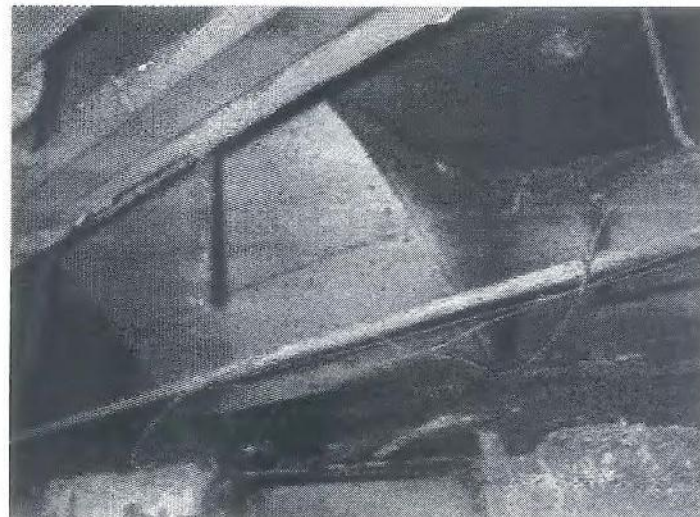
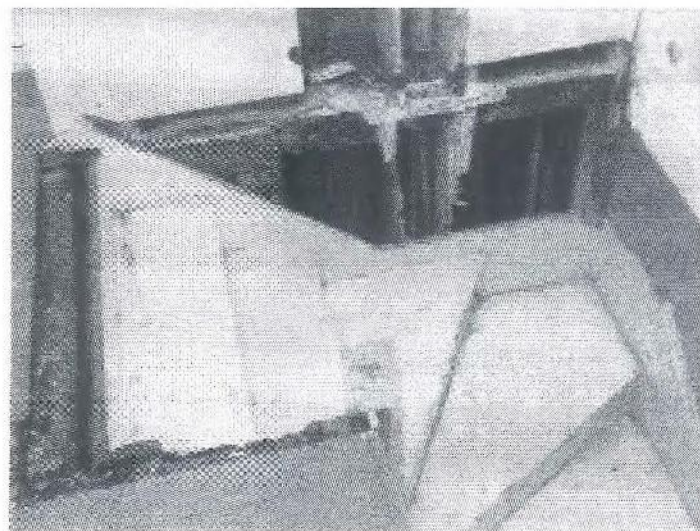
Boxing in under stairs

- Sheets of Supalux nailed to underside of timber stairs
- Negligible fire resistance
 - 2-3 minutes
- Original installation date not known
- Unlikely to be original, though similar arrangement previously in place

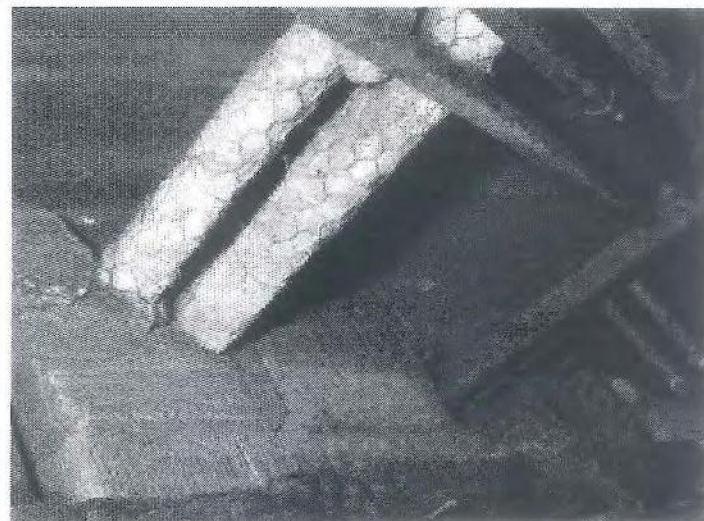
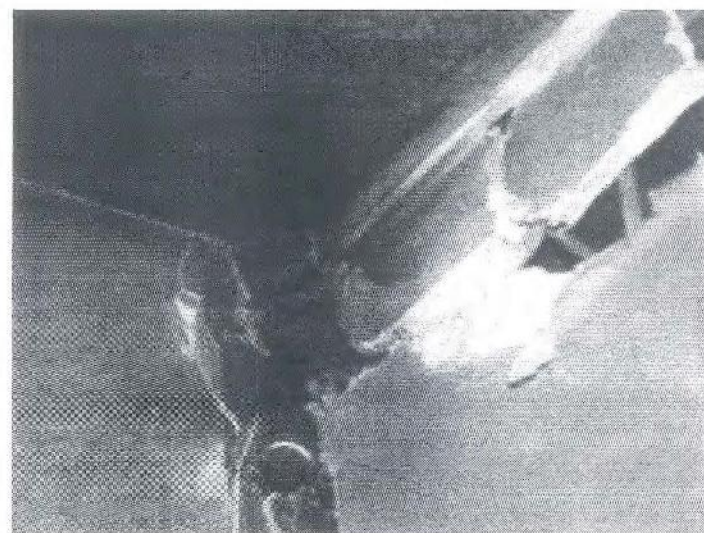
Corridor walls – fire resistance

- Concrete – likely 60 minutes FR
- Multiple penetrations in all flats
 - Original heating pipes
 - New heating pipes
 - Cabling
- Incomplete and absent fire stopping
- Allowed smoke to pass through

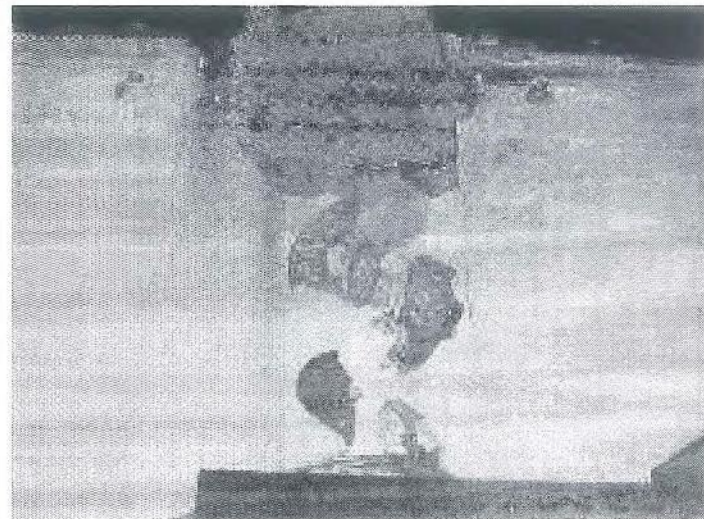
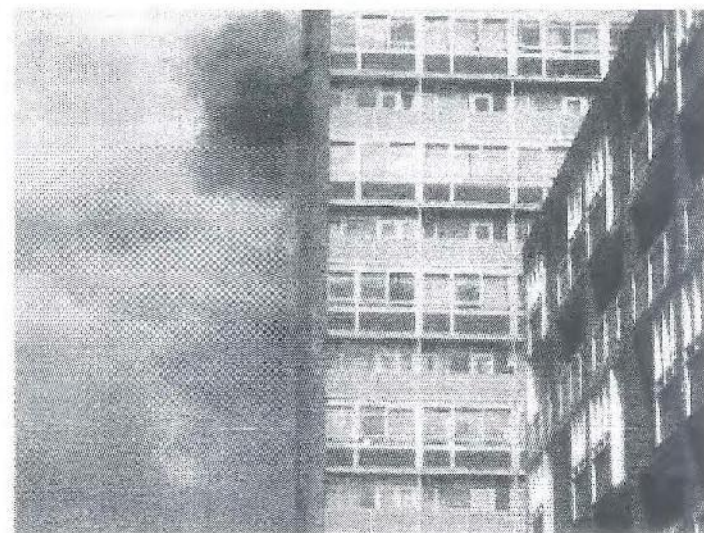
Corridor walls – reaction to fire

- Multiple layers of paint built up since original construction
- Some layers flame retardant
- Significant contribution to fuel load in corridor

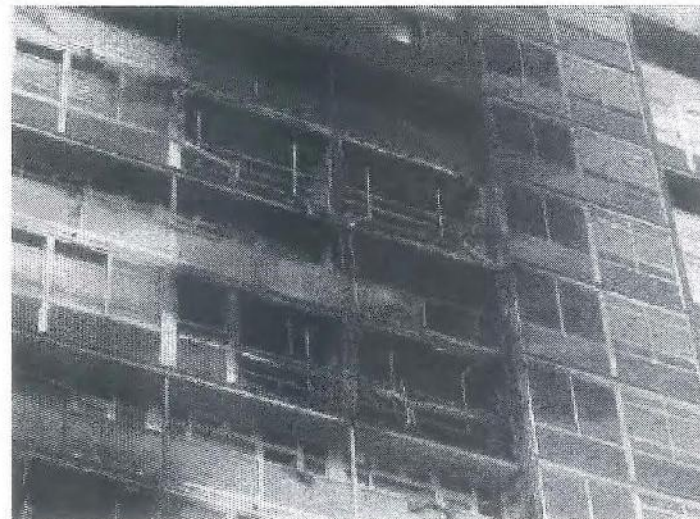
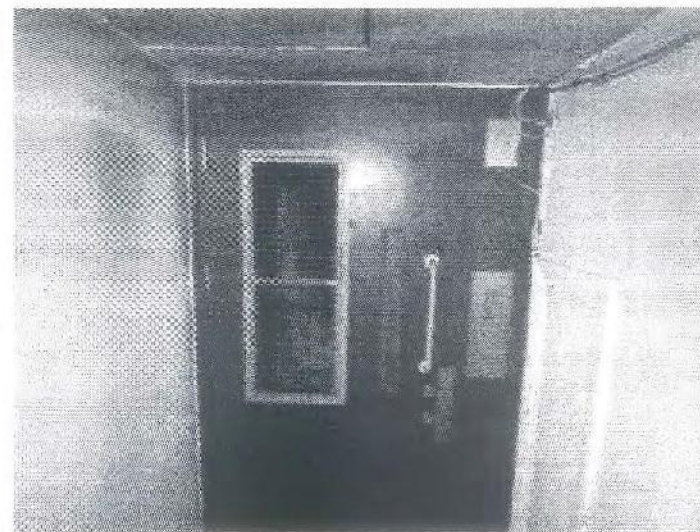
Cross ventilation scheme

- Original feature
 - ‘State of the art’ at the time of construction
- Compromised by installation of security doors in 1980s
 - Reduced ventilation area
 - Not enough free area to clear smoke
 - But not compartmented either

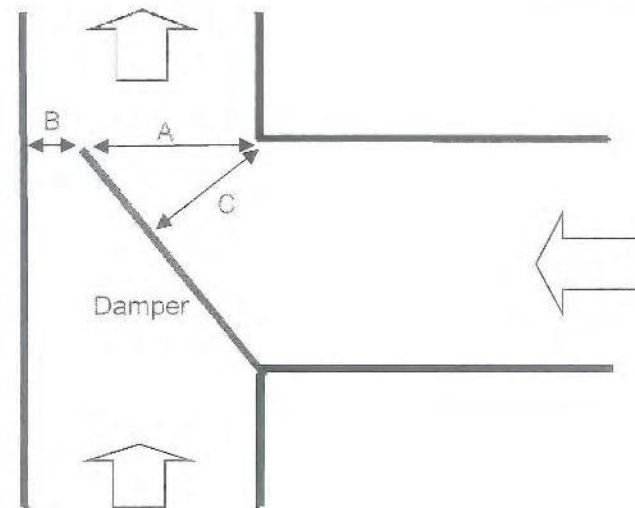
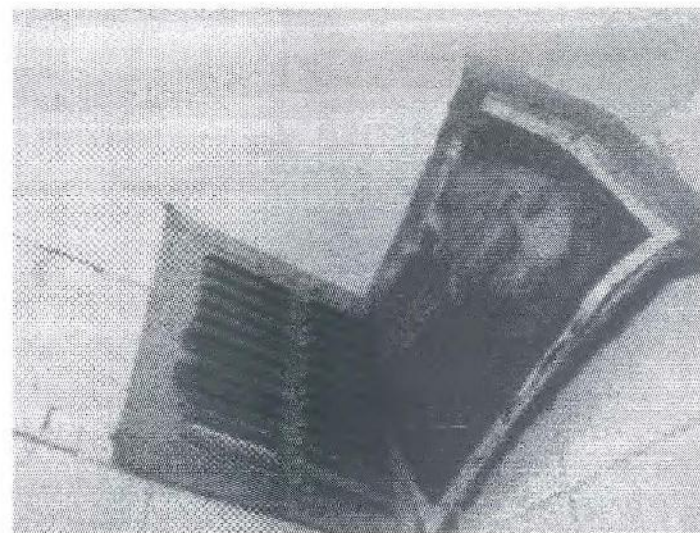
Bathroom extraction

- Original feature
- No separation of extraction between flats
 - Standard practice at time
- Provided route for smoke spread from Flat 53 to Flat 81

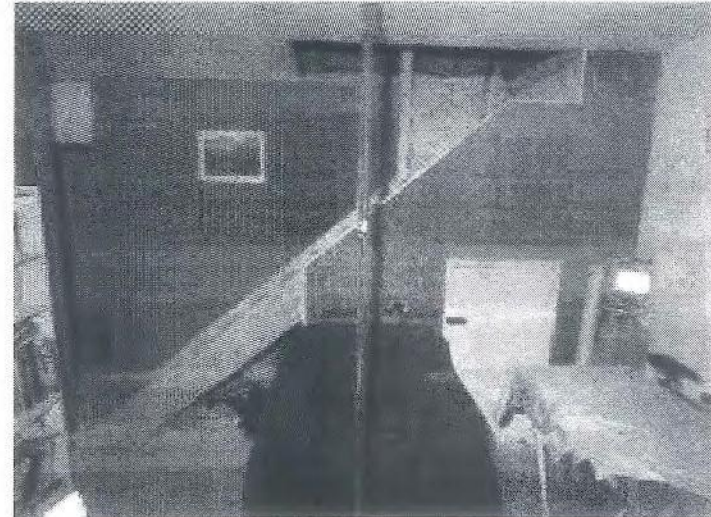
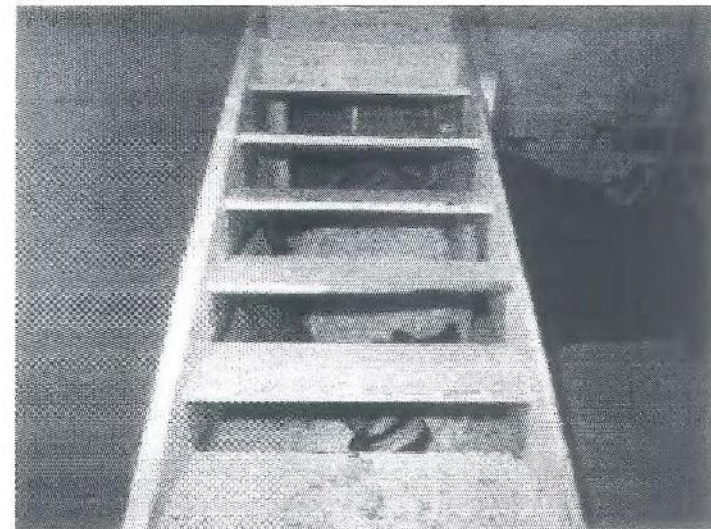
Flat 79 modifications

- Wall removed
- Risers in staircase removed
- Both done by occupant in mid 1990s
- Influenced fire spread

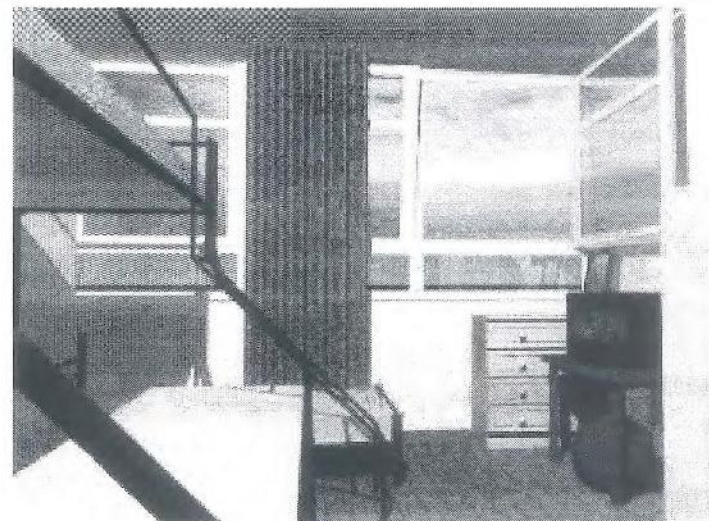
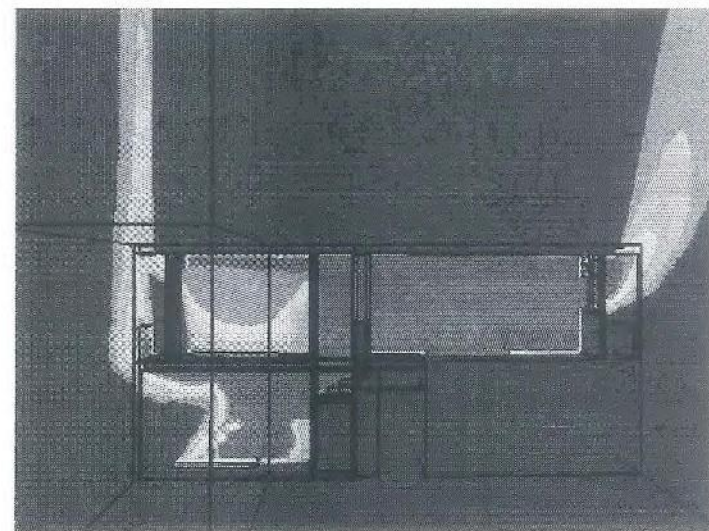
16:15 to 16:25 – Fire in Flat 65

- 16:15 – Fire starts in television set in bedroom 1 of Flat 65
- 16:16 – Fire alarm in Flat 65 actuates
- 16:18 – Fire well established
- 16:19 – First call to LFB
- 16:21 – Fire spreading to upper floor
- 16:23 – Smoke beginning to affect other floors; smoke logging escape routes and Flat 79 above
- 16:23 – First appliances arrive
- 16:25 – Flashover in upper floor, flames impinging on panels of Flat 79

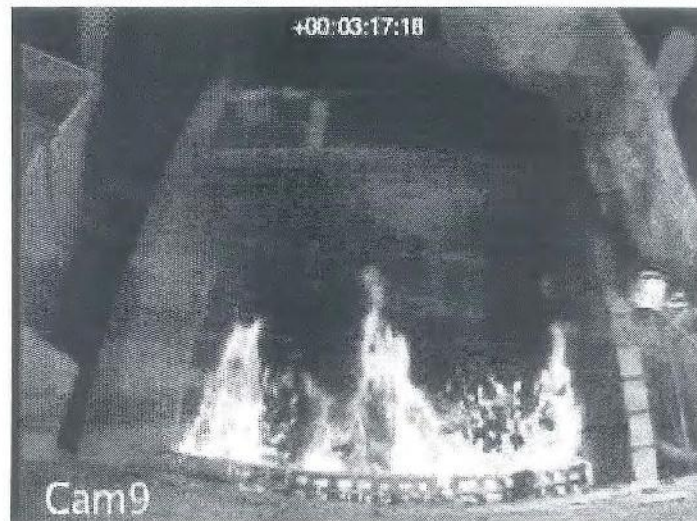
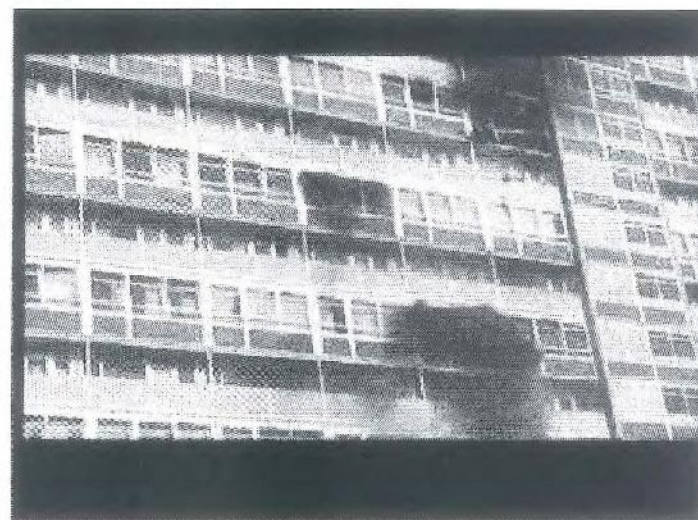
16:25 to 16:50 – Fire Spread to Flat 79 and Flats 37 & 53

- 16:25 – Flames impinging on panels of Flat 79, panels alight
- 16:30 – Fire spreads inside Flat 79 via window panels
- 16:30 – Bridgehead being established on 7th floor
- 16:36 – Fire fighters reach Flat 65
- 16:40 – Flat 65 fire suppressed
- 16:47 – Fire starts in Flat 37, 5th floor
- 16:49 – Fire starts in Flat 53, 7th floor
- 16:50 – Conditions in upper floor of Flat 79 no longer survivable

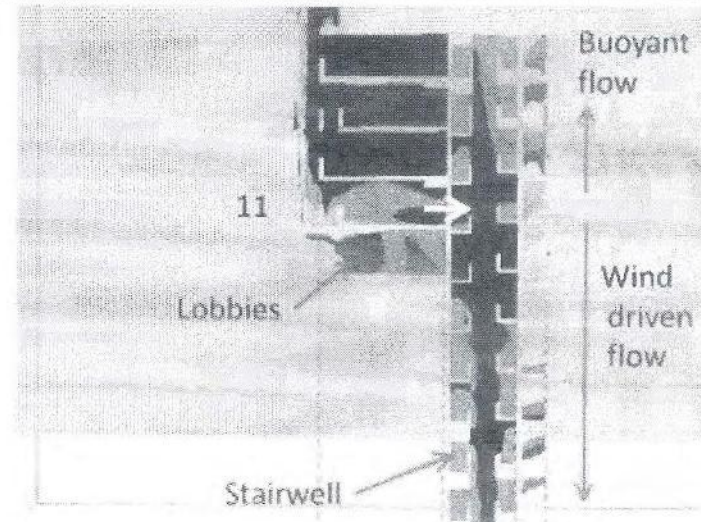
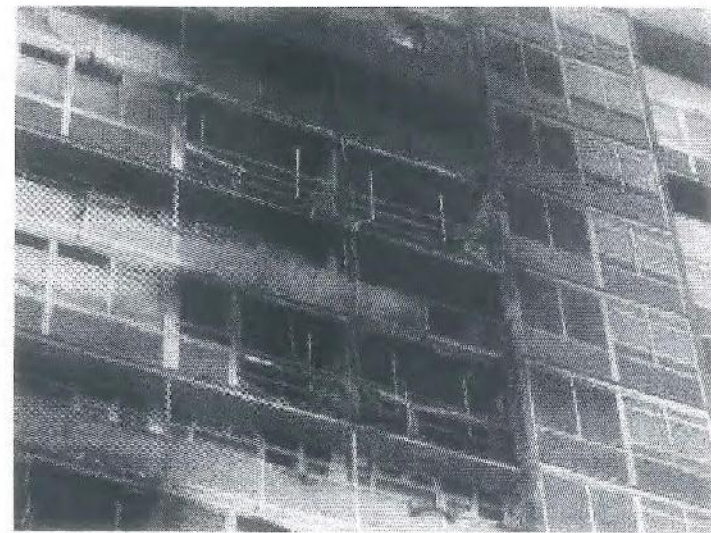
16:50 to 17:00 – Fire spread into 11th floor corridor

- 16:52 – Fire directly impinging on elements of compartmentation to 11th floor corridor
- 16:56 – Significant smoke logging at 7th floor bridgehead and throughout height of communal staircase
- 16:57 – Smoke entering flat 81 bathroom via
 - ventilation grille, from Flat 53
 - smoke leakage paths through Flat 81
- 17:00 – Bridgehead moved down, eventually re-established outside building at 17:17

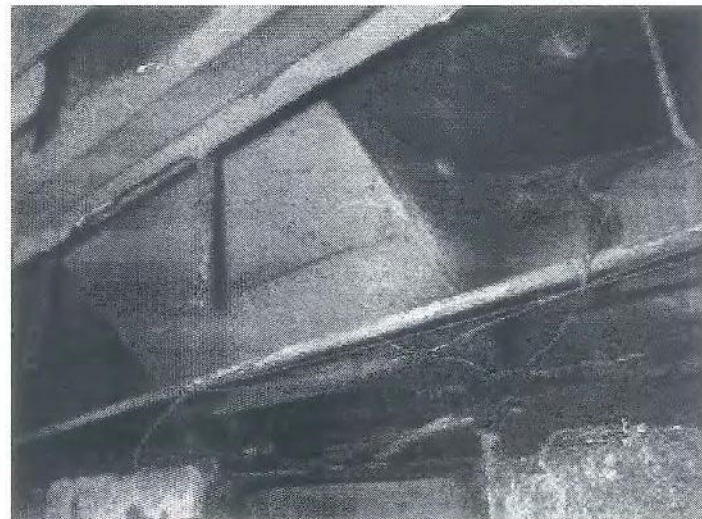
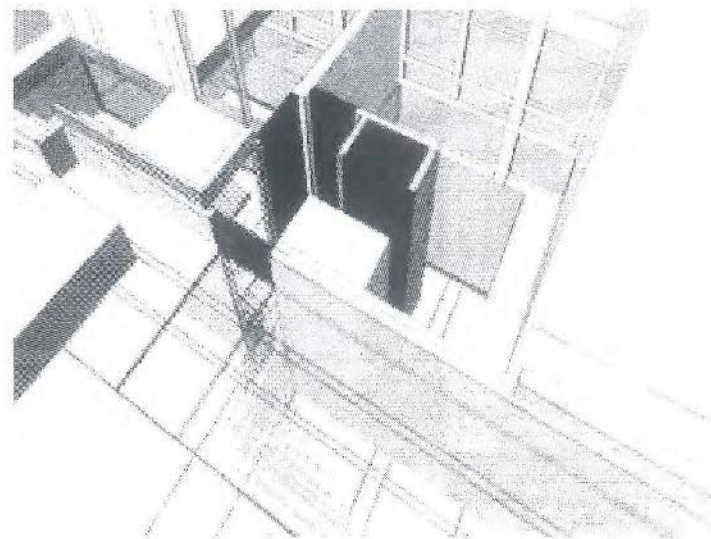
17:00 to 17:20

- 17:02 – Fire fighters reach Flat 53
- 17:06 – LFB crew committed to rescue family on 12th floor balcony
- 17:08 – Fire breaks through elements of construction into the suspended ceiling void of the 11th floor corridor
- 17:16 – Flat 53 fire suppressed
- 17:20 – The front door of Flat 79 collapses into 11th floor corridor
 - Severe fire rapidly develops in 11th floor corridor
 - Increase in smoke entering Flat 81

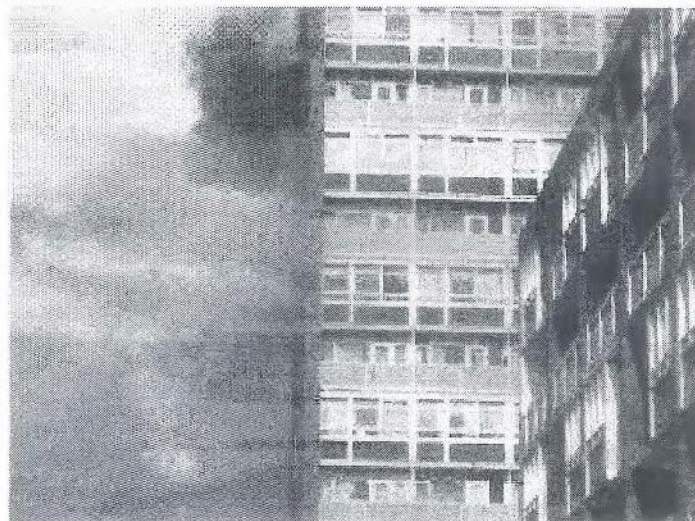
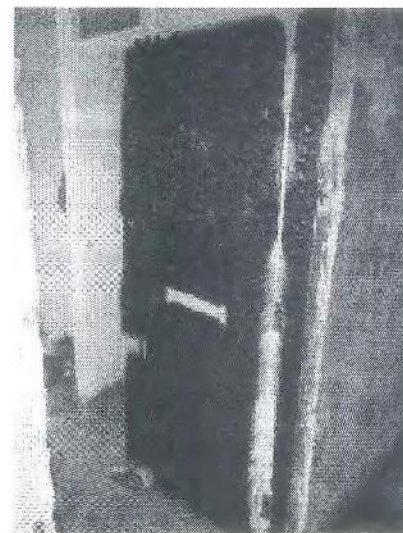
17:20 to 18:20

- 17:22 – Smoke seen from north end of 11th floor corridor
- 17:30 – Compartmentation of Flat 81 beginning to fail
- 17:36 – LFB encounter severe fire in 11th floor corridor
- 17:42 – Flat 37 fire suppressed
- 17:46 – LFB cannot identify Flat 81 due to numbers in 11th floor burnt off
- 18:00 – Conditions in bathroom of Flat 81 no longer survivable
- 18:20 – LFB find three casualties in Flat 81
