Site Visit Report

External Doors

Date of visit 31 May & 1 June 2011

Site visit report Nº2346

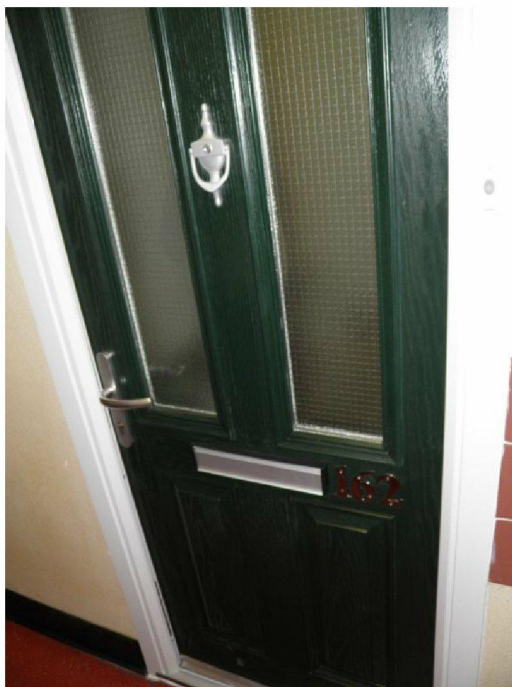
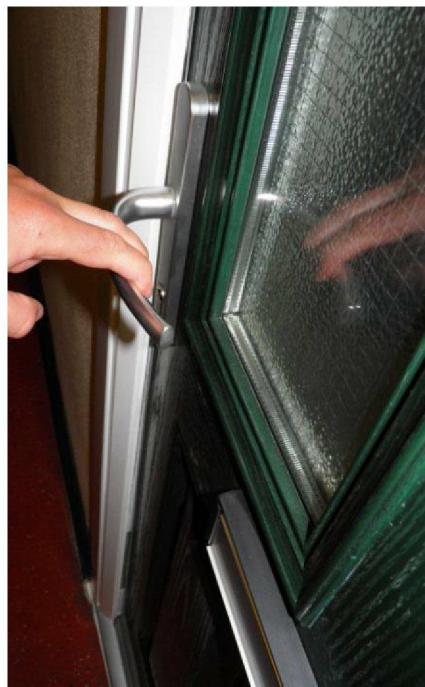
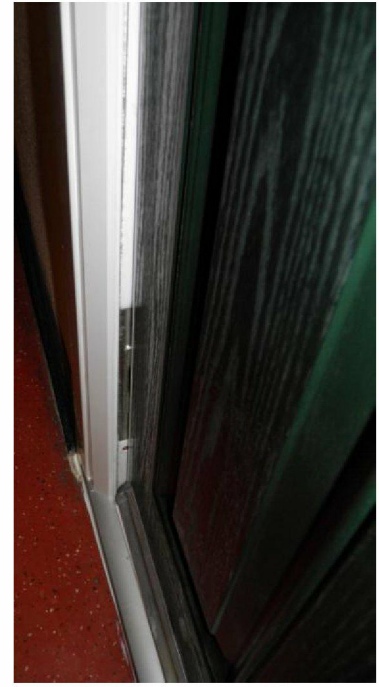
162 – door was frame was out of plumb and it was not possible to lock the door. RLO and fitters have been advised and it was confirmed that a rectification was arranged.

Flat 162 at Grenfell Tower where resident experienced problem with closing this door due to door/frame was fitted out of plumb.

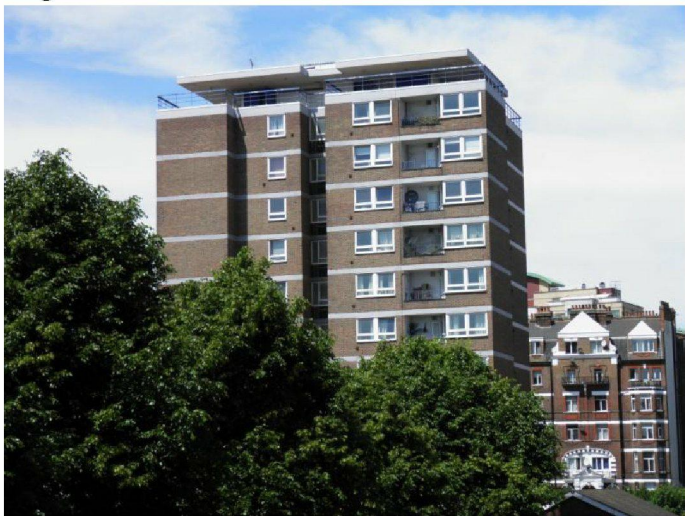
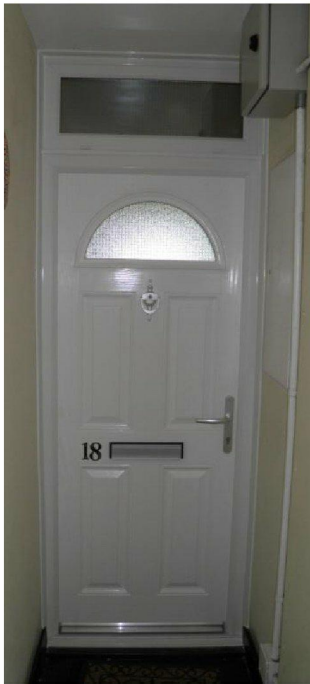
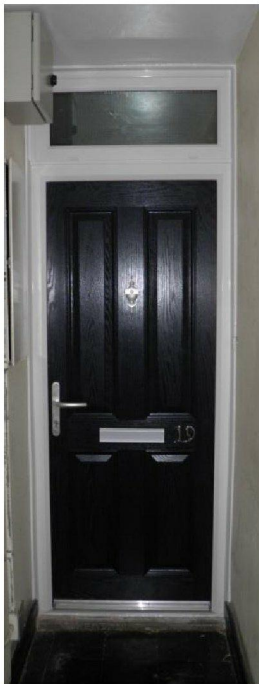
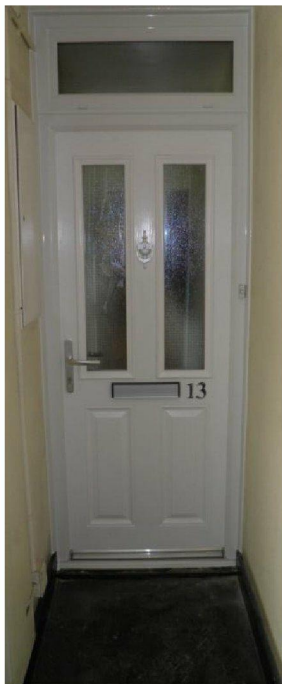
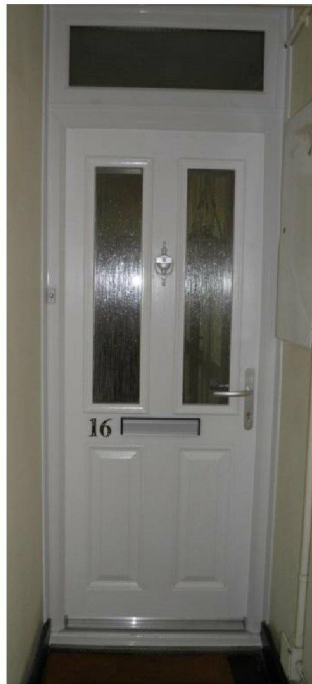
King Charles House

In this building an overhead fan light was installed with the door. Fan light is 30 min fire rated.

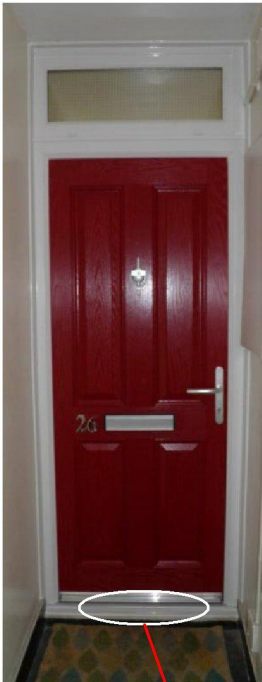
26 – door was inspected externally and it appeared to be professionally installed, however fixings and operation of door closer were not checked. Additionally there was a gap between the trim and threshold which needed to be filled with silicone.

Gap between the door threshold and the trim.

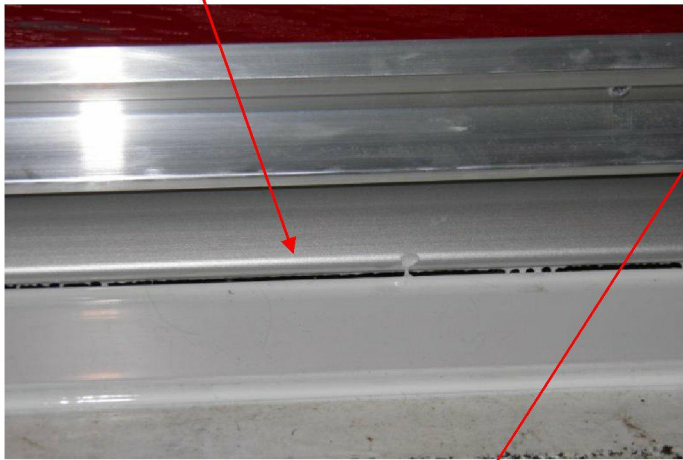
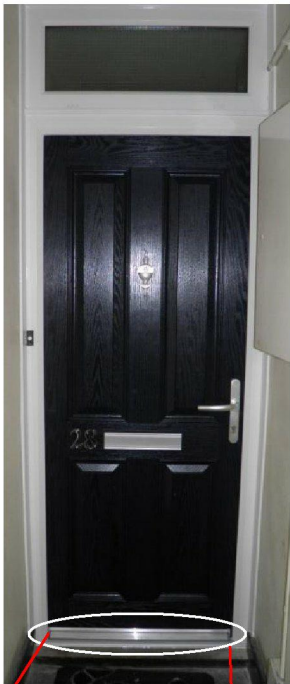
28 – door was inspected externally and it appeared to be professionally installed, however fixings and operation of door closer were not checked. Additionally drip detail was fitted off centre.

This image illustrates that drip detail was fitted off centre.

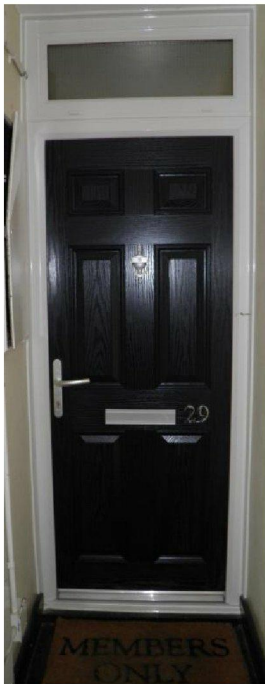
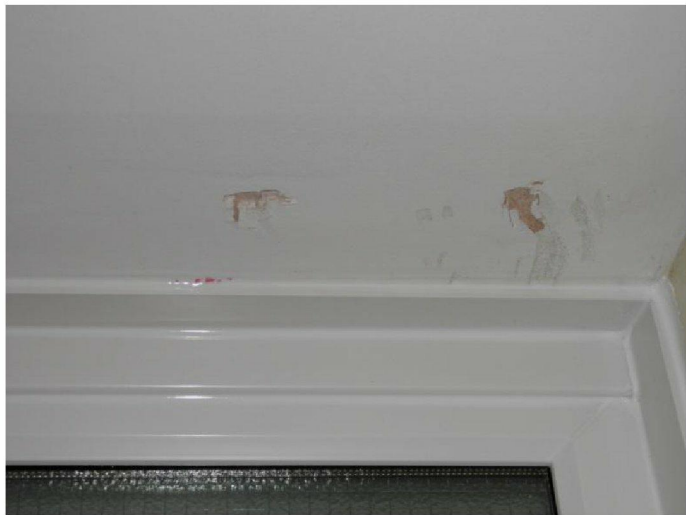
29 – door was inspected externally and it appeared to be professionally installed, however fixings and operation of door closer were not checked. Additionally ceiling before the door needed to be touched up with paint.

Ceiling needed to be touched up as it was slightly damaged during door installation.

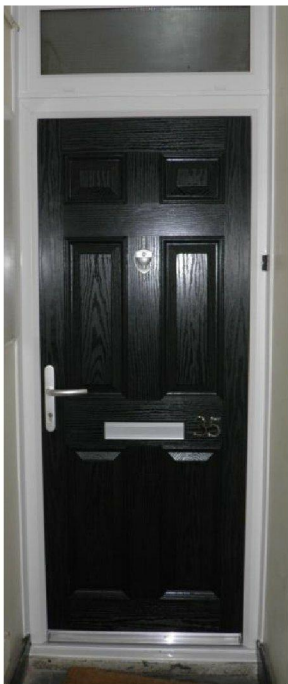
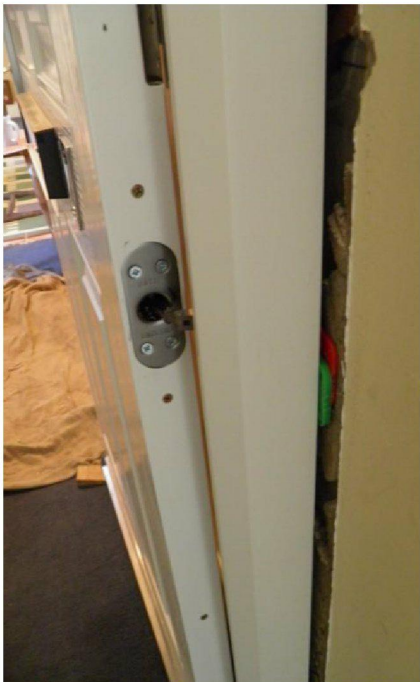
This door closer is supplied and fitted for all inspected doors.

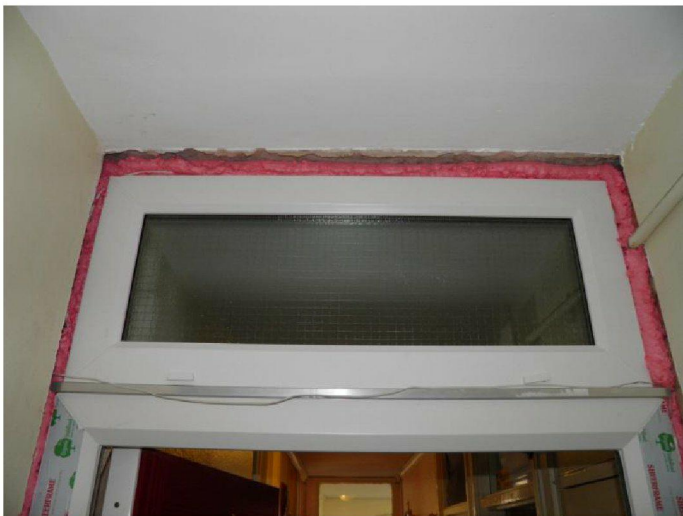
Fan light and door frames are fully foamed with fire rated foam.
