# Site Visit Report

## External Doors

Site visit report Nº2343

<b>LHC Nº</b>	<b>Project title</b>	<b>Participating Body</b>	<b>Technical Officer</b>
35052	C5 External Doors Programme	Royal Borough of Kensington and Chelsea	AF

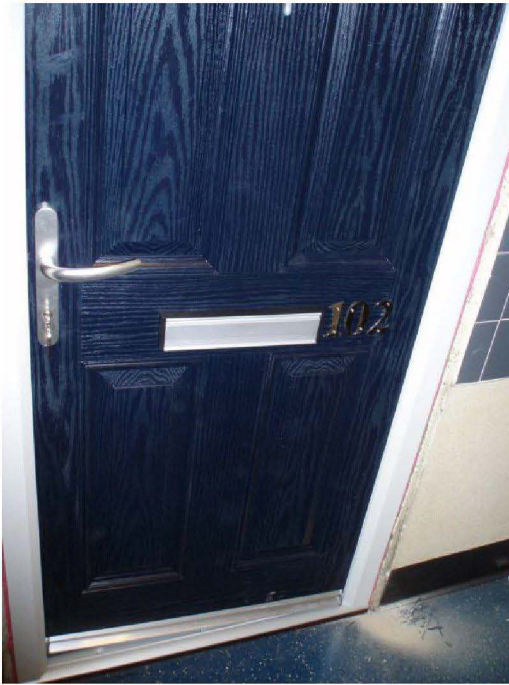
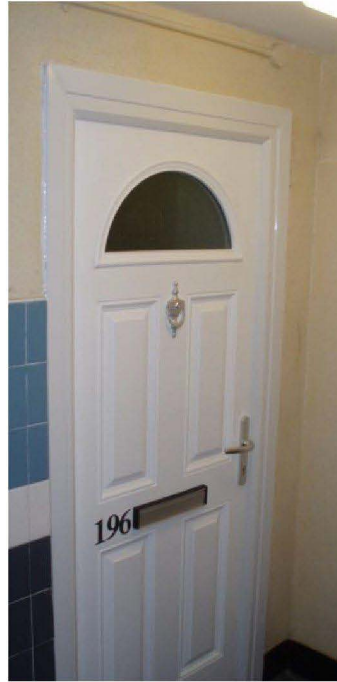
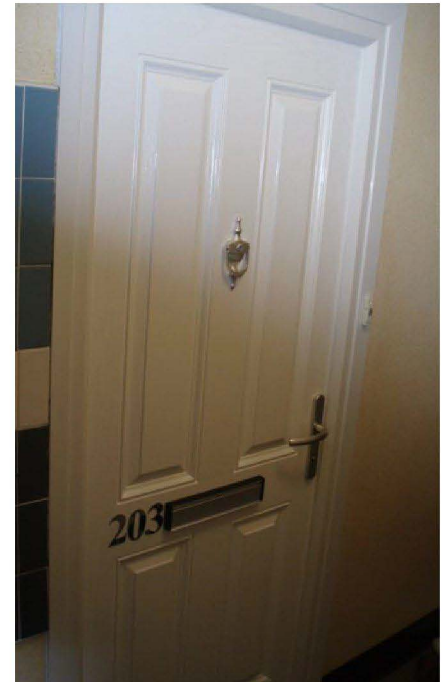
These images above illustrate residents' choices of the door types.

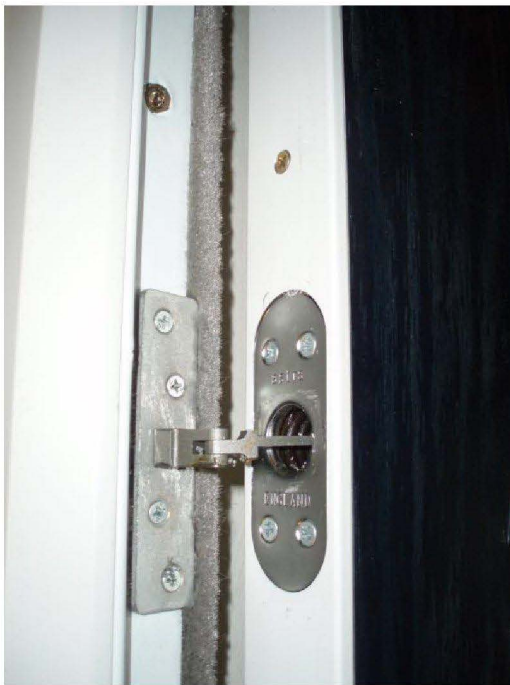
Image of the door closer type supplied for the project.

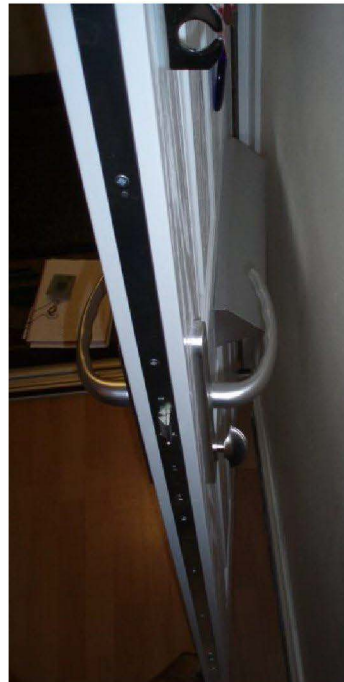
Door hardware, including handles, lock, chain keep and letter box cowl.

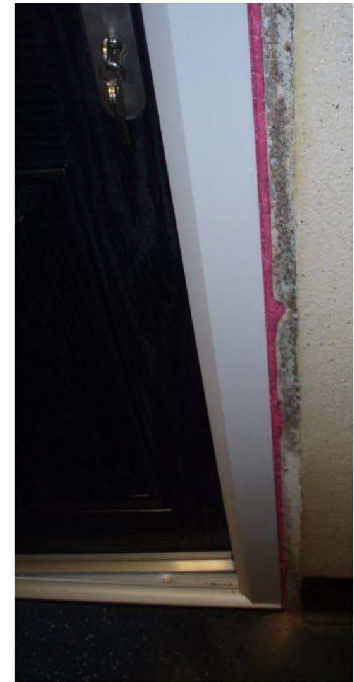
Frame was fully foamed and fitter was instructed to place packers in.

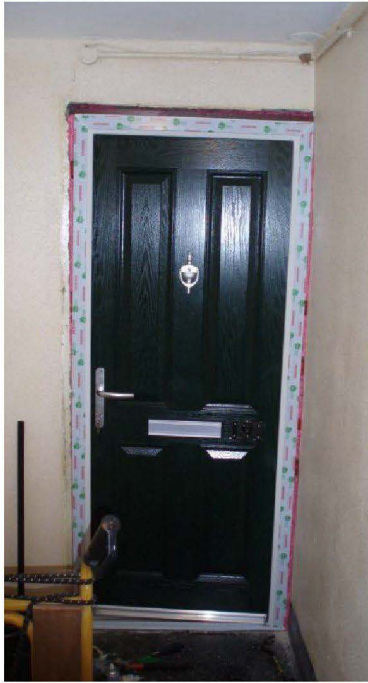
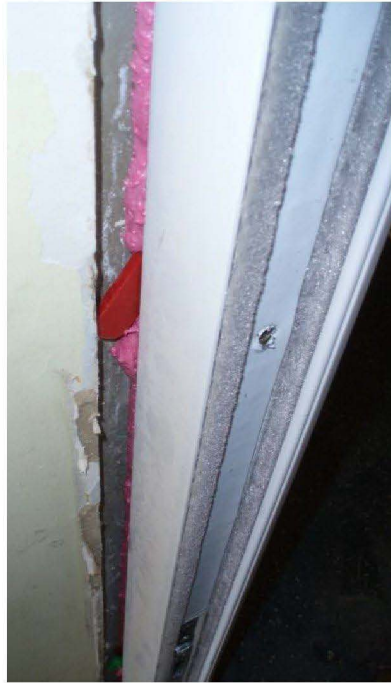
These two images illustrate packers being used next to fixings, fire foam has been applied around the frame. In this particular case fitters were asked to top it up.
